## RAILWAY OCCURRENCE REPORT

04-102 motor trolley, derailment, Lepperton

25 January 2004

## **Report 04-102**

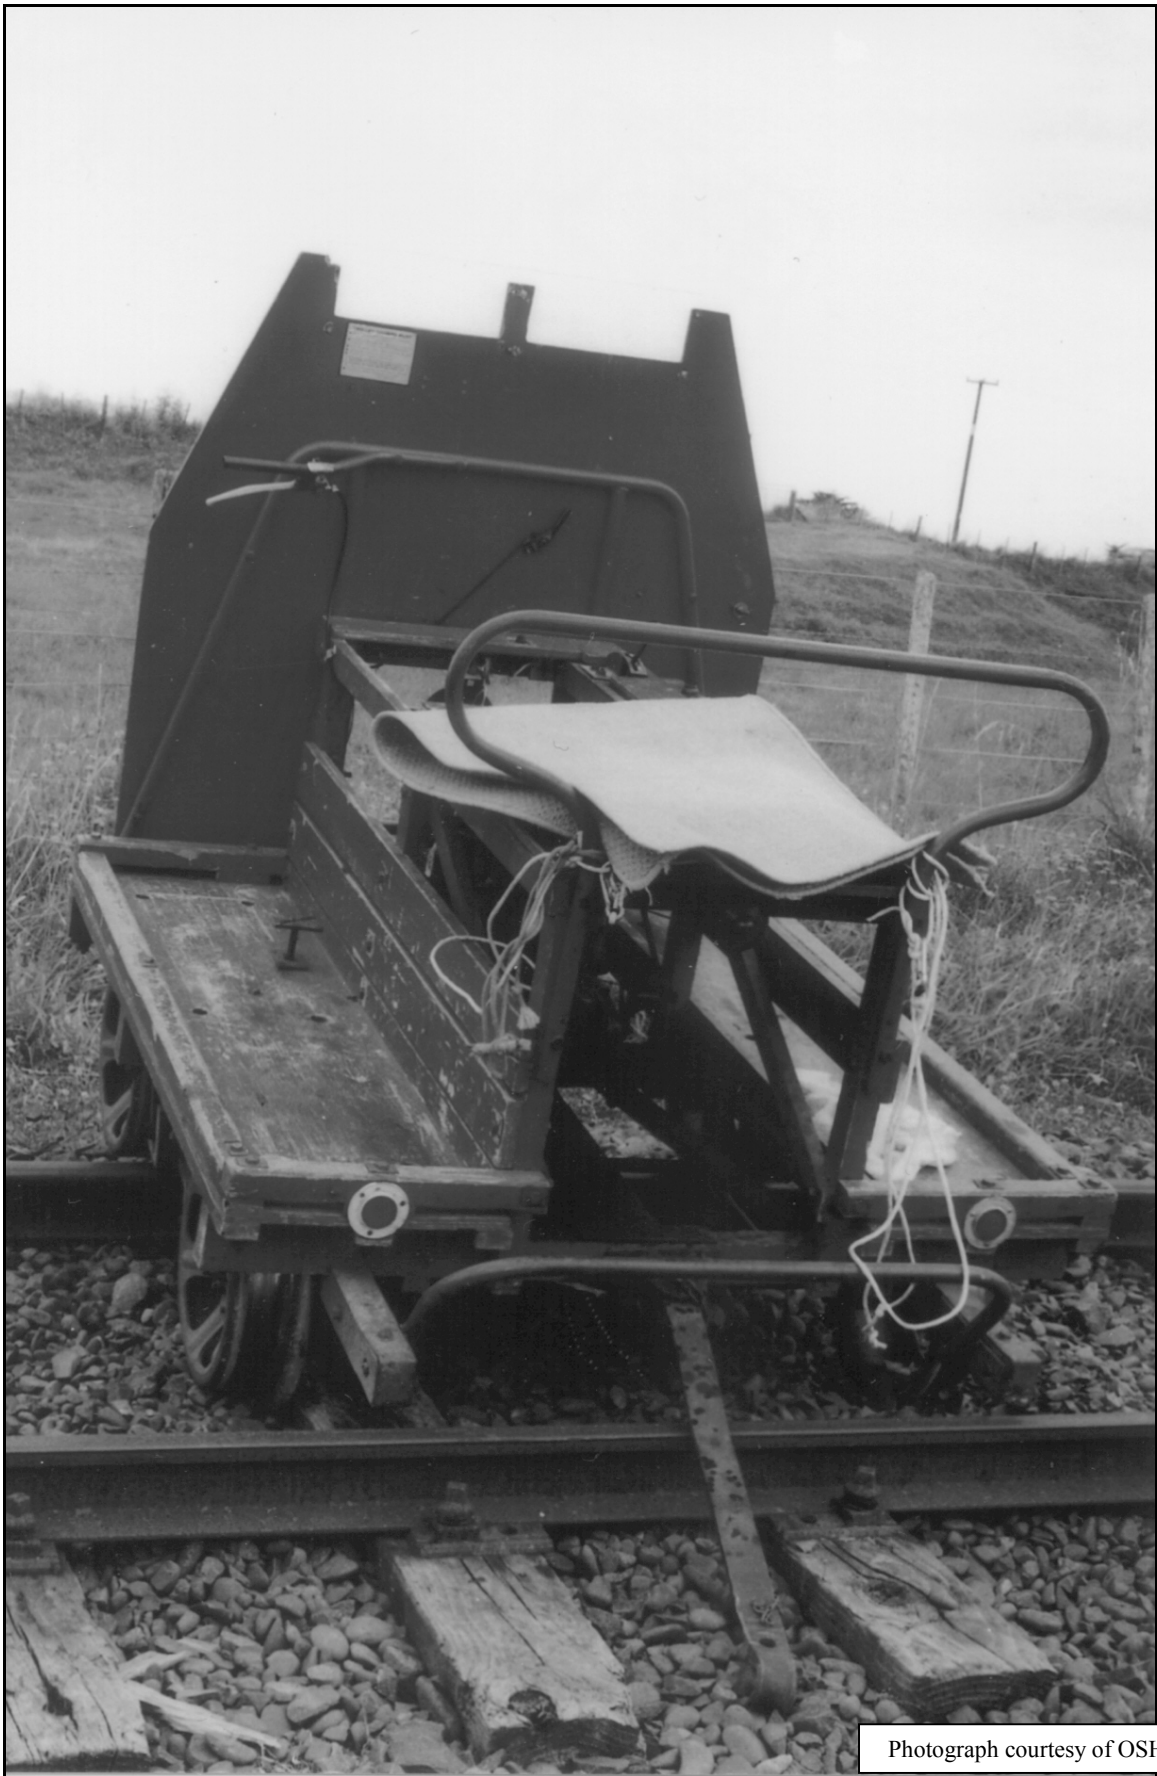
**Derailed motor trolley**

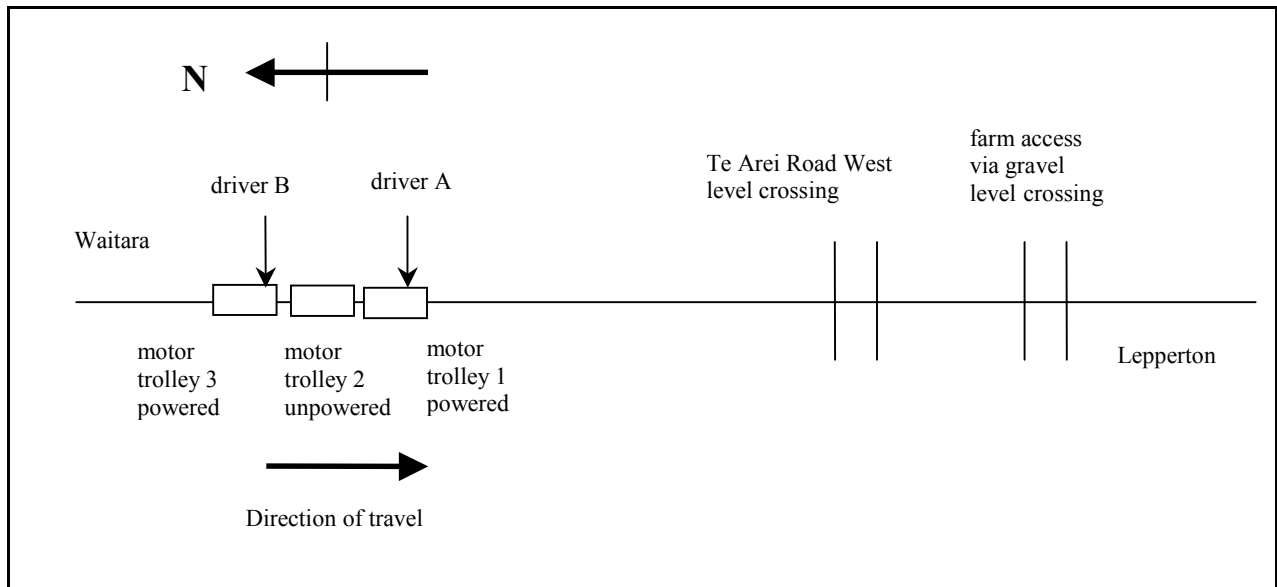
**Figure 1**  
**The outward journey (not to scale)**

- 1.2.4 There were 12 adult and 2 child passengers as well as the 2 crew members riding on the 3 motor trolleys. Figure 1 shows the positions of the crew members on the outward journey. There were 4 passengers and a driver riding on motor trolley 1.

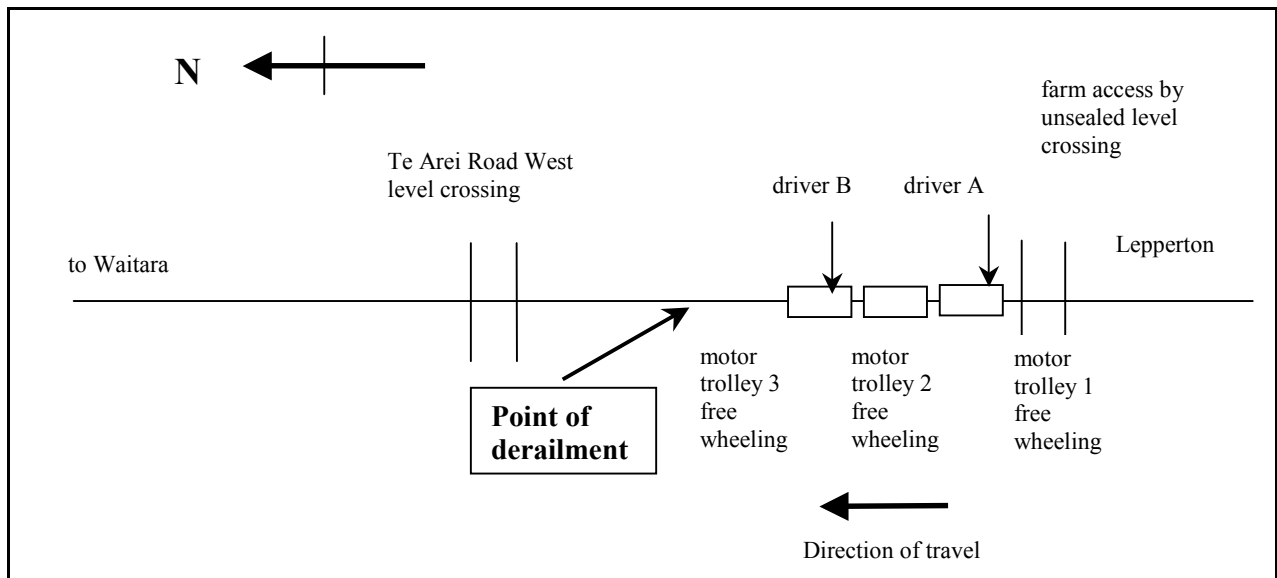
**Figure 2**  
**The return journey (not to scale)**

- 1.2.6 At about 1130, shortly after departing from Lepperton, the consist entered a right hand curve. As it did so, the draw bar between motor trolleys 1 and 2 detached from the lifting rail at the rear of motor trolley 2 (see Figure 6) and, while still attached to the front end of motor trolley 1, dropped to the right hand side of the track where it jammed against a rail screwspike.

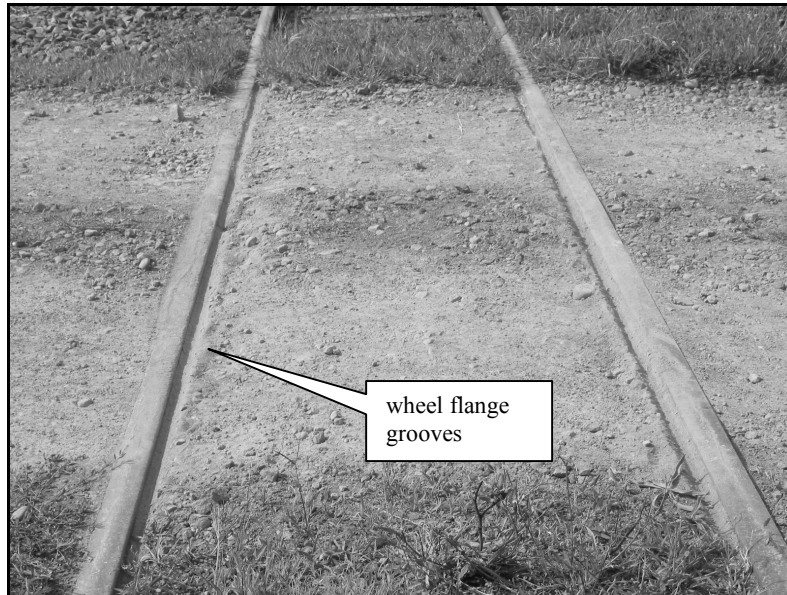
**Figure 3**  
**The unsealed farm access level crossing at Lepperton**

- 1.3.1 There was an unsealed farm access level crossing about 2 m wide and 50 m before the end of the line at Lepperton (see Figure 3). Use of the level crossing by road vehicles regularly resulted in the railway lines becoming covered with gravel and it was often necessary for the lines to be dug clear by WRPS staff before the motor trolleys could use the track.
- 1.3.2 The gradient from Lepperton averaged 1 in 220 for the first 200 m but then averaged about 1 in 60 for the next 1800 m, including the point of derailment.

- 1.5.4 Driver A said that shortly after departing from Lepperton, the consist crossed a farmers crossing, which he considered had a severe stone problem in the wheel grooves (see Figure 3). The stones on the crossing were a known problem and when travelling to Lepperton the motor trolleys were required to slow down to negotiate the crossing. However, when free-wheeling back at the start of the return journey, the stones tended to slow the motor trolleys anyway.

- 2.9 The ongoing poor condition of the unsealed level crossing was acknowledged by the operator in its procedure to dig the wheel grooves clear before commencing motor trolley operations. However, given the known condition of the unsealed level crossing, its continued use was probably questionable, particularly as it raised concerns with the passengers, even though they generally felt that the handling of the consist over the level crossing was appropriate. Stopping the motor trolleys before the unsealed level crossing would have reduced the length of the ride by about 300 m, but this would be insignificant over the total trip distance of about 14 kms.

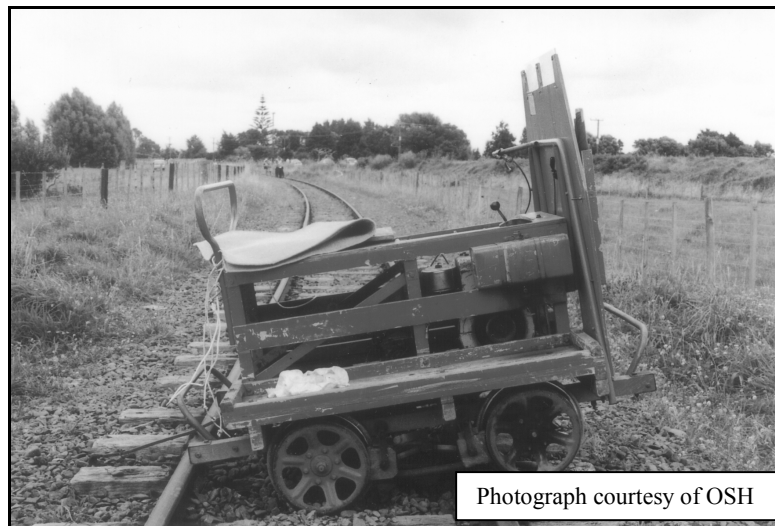
**Figure 4**  
**The derailed motor trolley at the point of derailment, looking back towards Lepperton**

- 1.3.3 The derailment occurred about 400 m north of Lepperton as the branch line negotiated the downhill gradient and entered a right hand curve. Figure 4 shows the derailed motor trolley at the point of derailment.

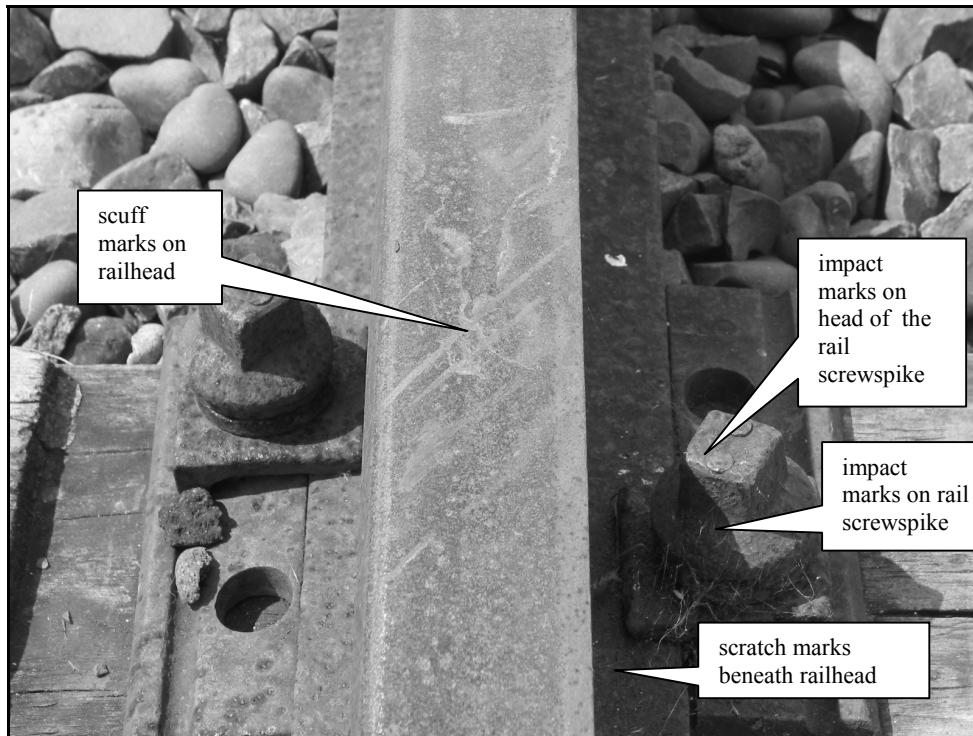
**Figure 5**  
**Marks at the point of derailment**

- 1.3.4 The point of derailment was identified from marks on the rail head of the right hand rail and marks on the head of an adjacent rail screwspike on the outside of the right hand rail (see Figure 5). Further scratch marks were also visible beneath the railhead immediately opposite the rail screwspike.

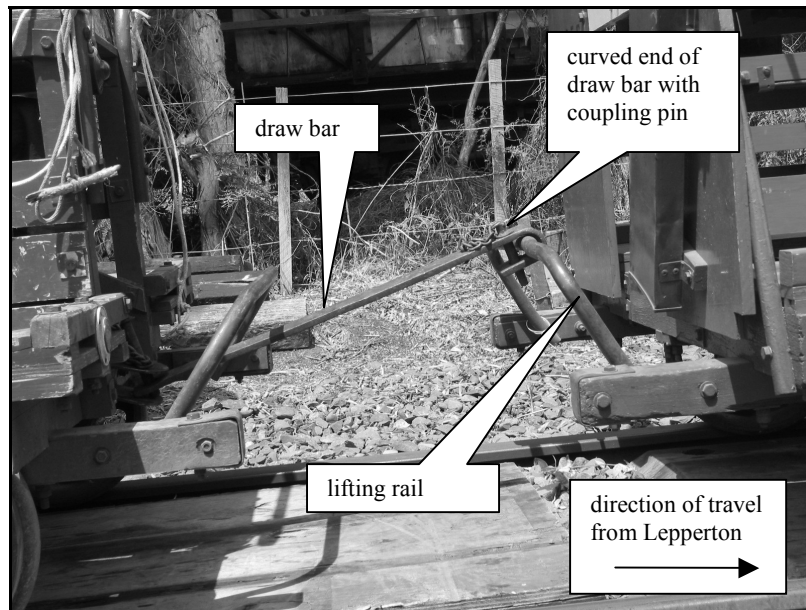
**Figure 6**  
**The draw bar as attached between motor trolley 1 (left) and motor trolley 2**

- 1.4.4 When the coupling pin was in place, about 20 mm of the pin extended below the lower hole in the curved end of the draw bar. There was a chain attached to the top of the coupling pin and welded to the draw bar, but there was no clevis lock on the bottom of the pin to stop it lifting or vibrating out. The pin fitted loosely when in place.

- 2.11 The initiating cause of the derailment was the apparent ability of the coupling pin to vibrate free from the curved end of the draw bar. This movement was possible because there was no restraining clip or pin at the base to secure the pin when the curved end of the draw bar was attached to the lifting rail. Had such a restraining clip or pin been in place the coupling pin would have been prevented from vibrating out and the derailment would probably not have happened. As part of the new coupling method, the operator has incorporated draw gear coupling pins, fitted with safety chains and a locking device so as to stop the pins from becoming detached, therefore no recommendation covering this issue has been made.

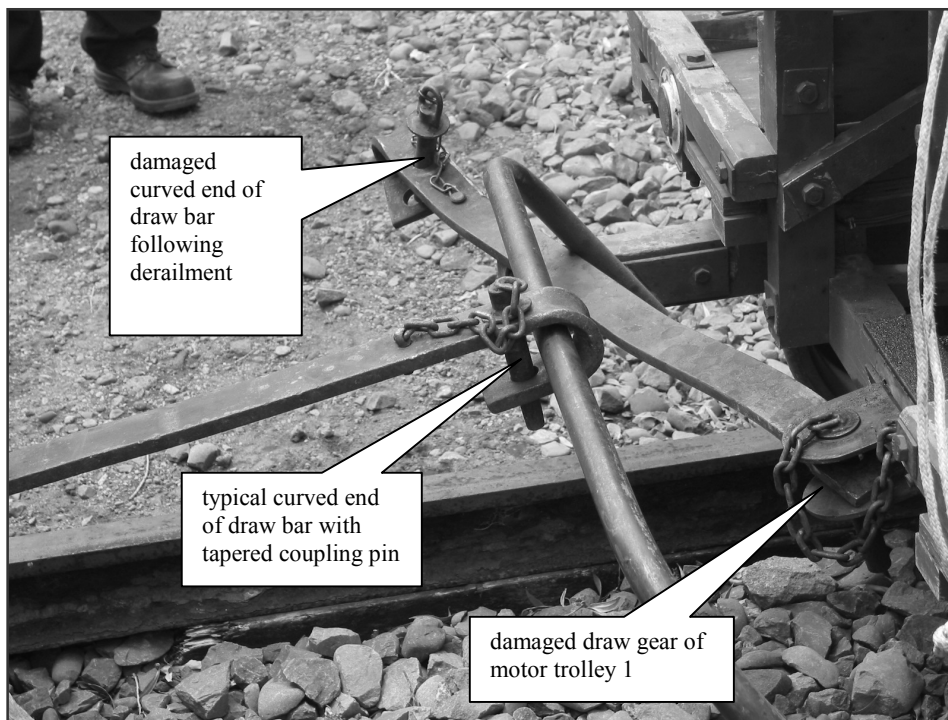
**Figure 7**  
**The damaged draw gear on motor trolley 1**

1.4.5 The flat end of the drawbar was secured to the draw gear of the next trolley. Once the draw bar became detached and dropped, the curved end was able to move 90 degrees to either side of the centre line (see Figure 7).

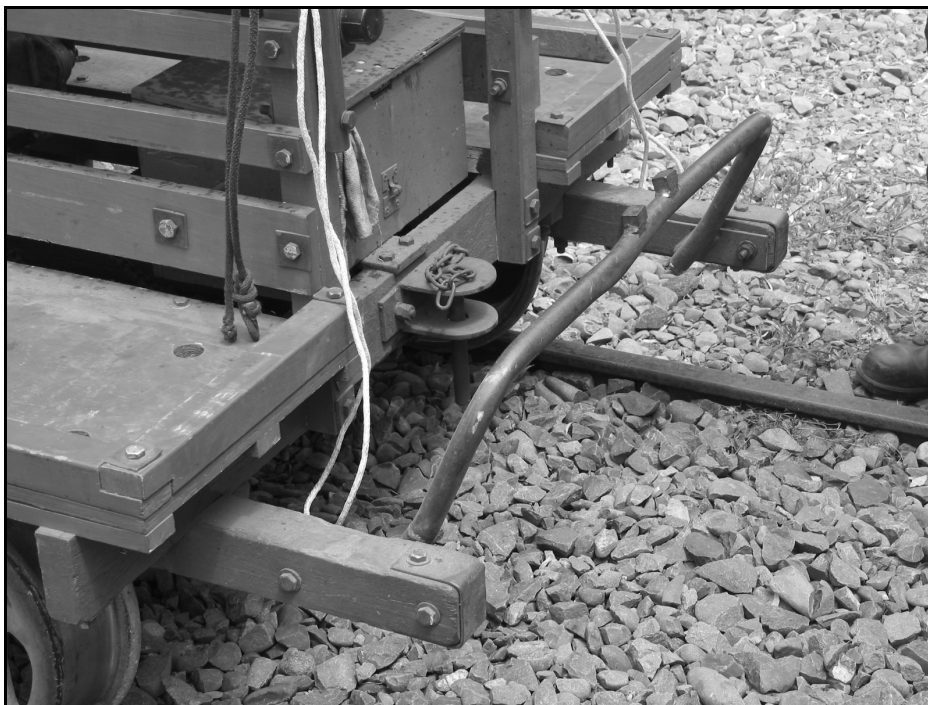
**Figure 8**  
**The central stoppers on the lifting rail of motor trolley 3**

- 1.4.11 Motor trolley 3 had central stoppers fitted to the lifting bar to stop the attached curved end of the draw bar sliding laterally from the centre of the lifting bar (see Figure 8).

- 1.4.12 These central stoppers had been fitted to some trolleys when they were working on the main line. Driver A said that at that time they had been used in conjunction with a drawbar that had a clevis pin and yoke that would not allow the yoke to slide sideways. However, if used with a U type bar, as it was with WRPS, it was able to slide either way. The central stoppers were present when the WRPS acquired the motor trolley.
- 1.4.13 There were no central stoppers fitted to the lifting rail of motor trolley 2.
