RAILWAY OCCURRENCE REPORT

04-103 Report 04-103, shunting service Train P40, derailment, 43.55 km 16 February 2004
near Oringi, 16 February 2004

Report 04-103
shunting service Train P40
derailment
43.554 km
near Oringi
16 February 2004

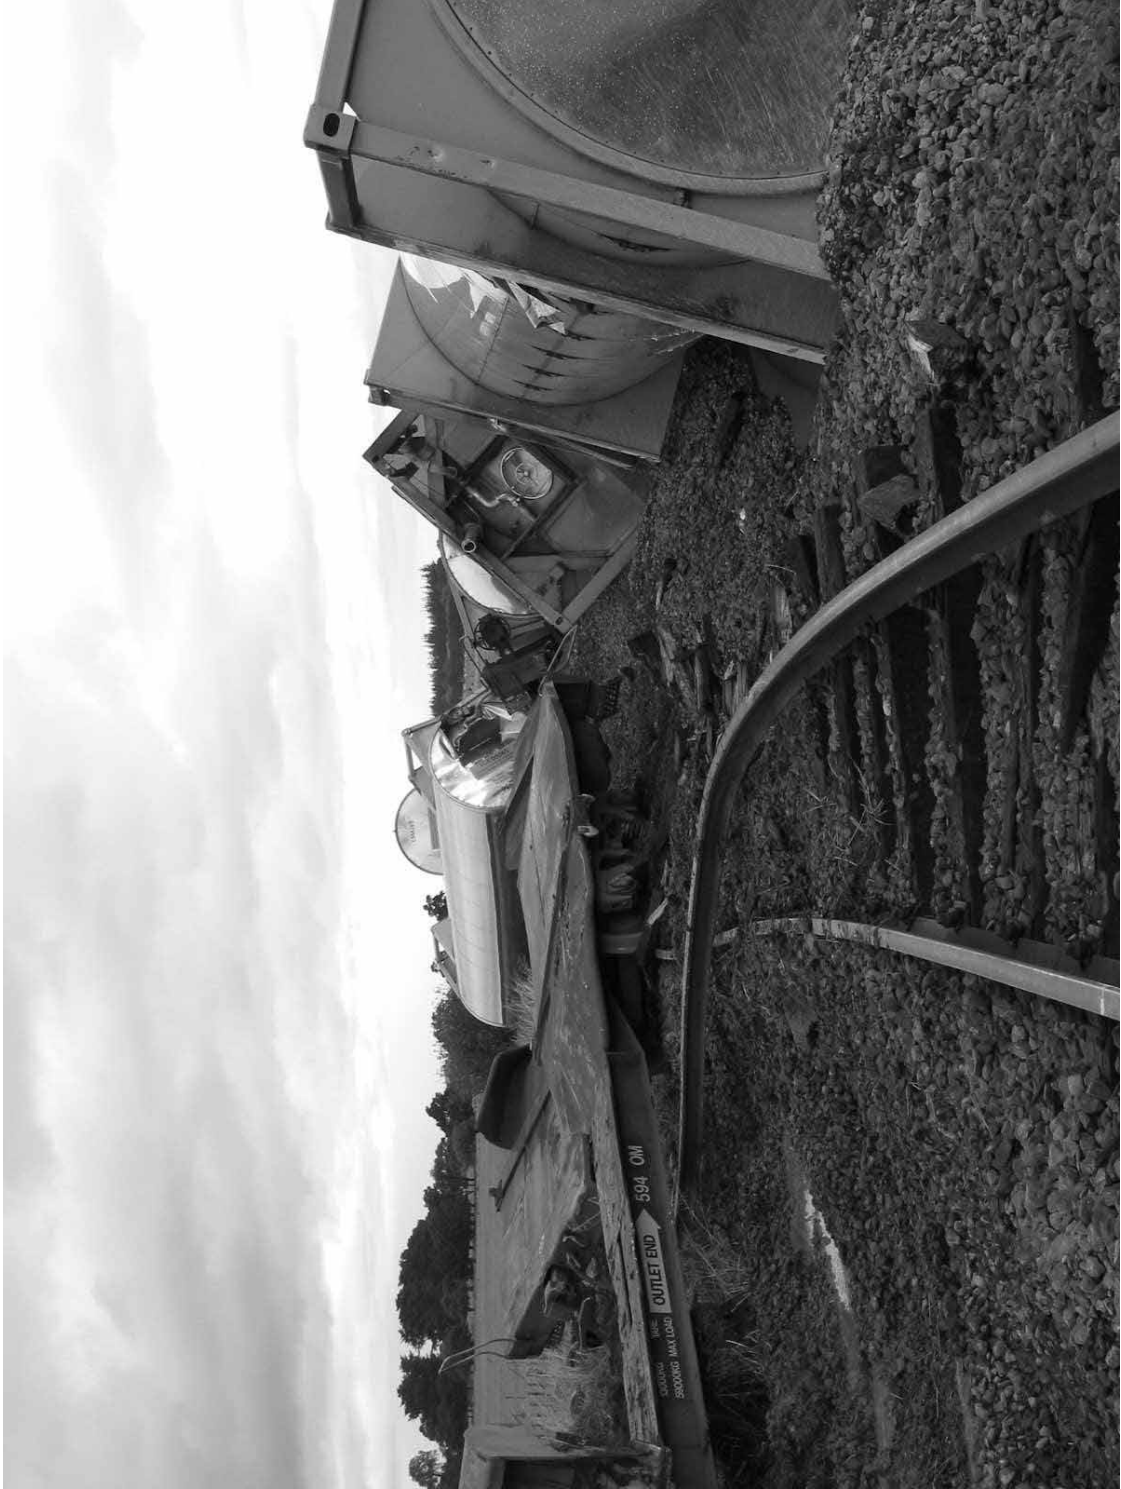
The derailment site

On Monday 16 February 2004 at about 0250 Train P40, a Palmerston North to Oringi return shunting service, derailed when it ran into a washout at the 43.554 km, between Oringi and Woodville on the Palmerston North – Gisborne Line. Six wagons derailed and about 150 m of track were damaged.

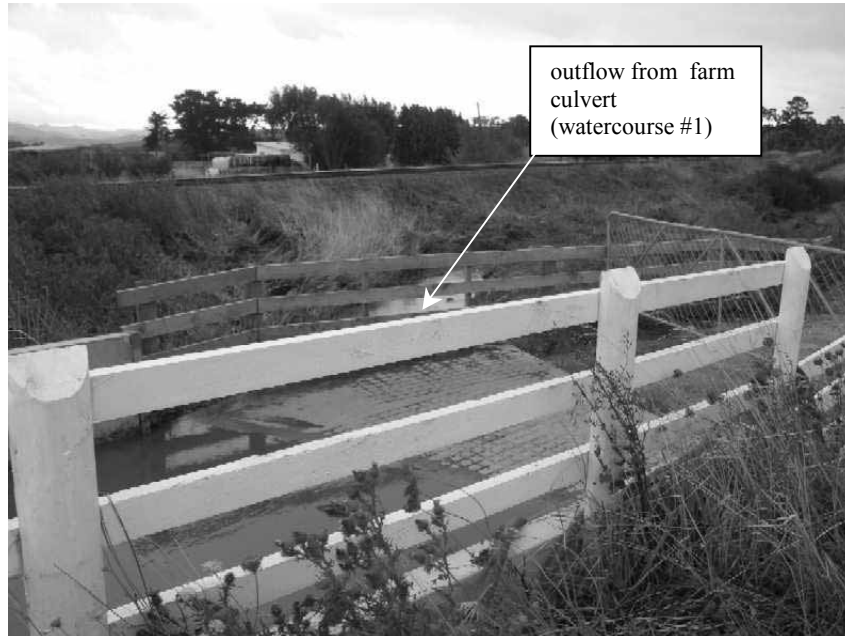
Figure 2

- 1.2.8 A 1200 mm concrete pipe culvert carried watercourse #1 beneath Old Main Road and the southern approach to the stock underpass (see Figure 1). After exiting this culvert (see Figure 2) watercourse #1 continued on and passed under the rail formation through culvert 43.114.

The outflow from the farm culvert towards the track formation

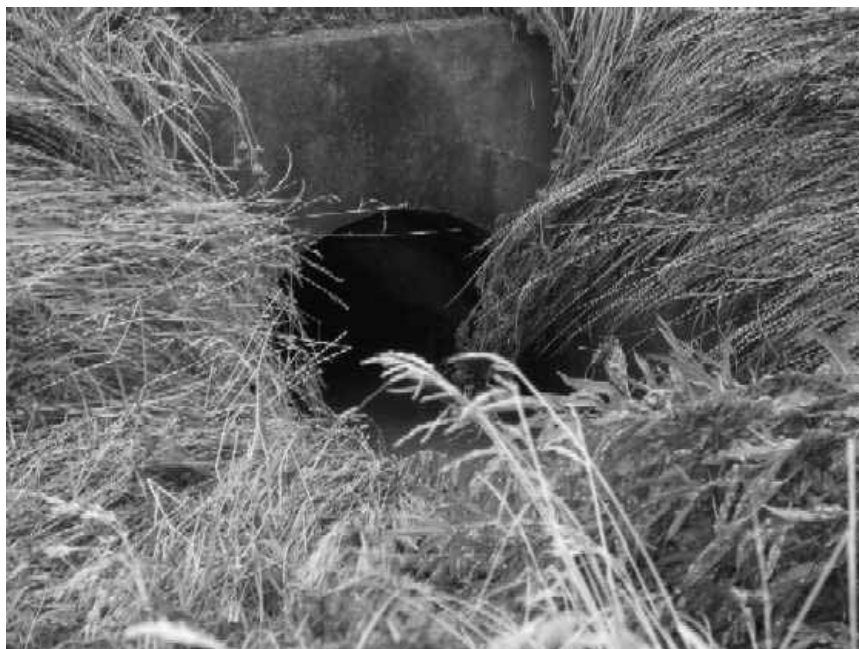
Figure 3

- 1.2.9 Although the entrance to the farm culvert was largely free of weeds (see Figure 3), flow in the watercourse had been impeded by an accumulation of weed and debris against a fence a few metres upstream (see Figure 4).

The entrance to the farm culvert after the flooding

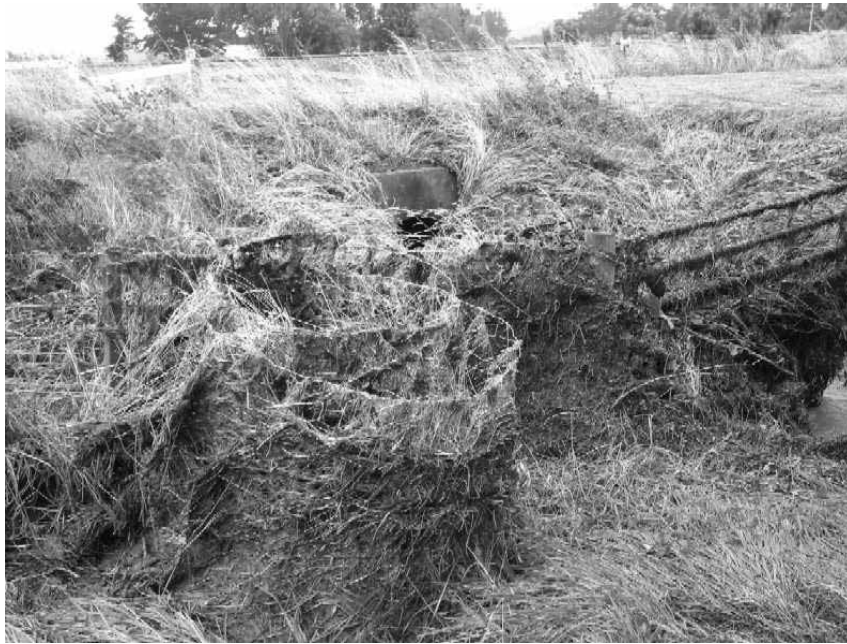
Figure 4
The fence in front of the farm culvert after the flooding

- 2.4 Water levels also rose in watercourse #1, to the extent that floodwater overflowed onto paddocks some distance upstream of the farm culvert. It is likely that its escape through culvert 43.114 was impeded by the farm culvert and debris against the fence just upstream, which may have caused surface flooding. This surface flooding probably made its way northwards through or past the stock underpass and added to the ponding on the upstream side of the railway.

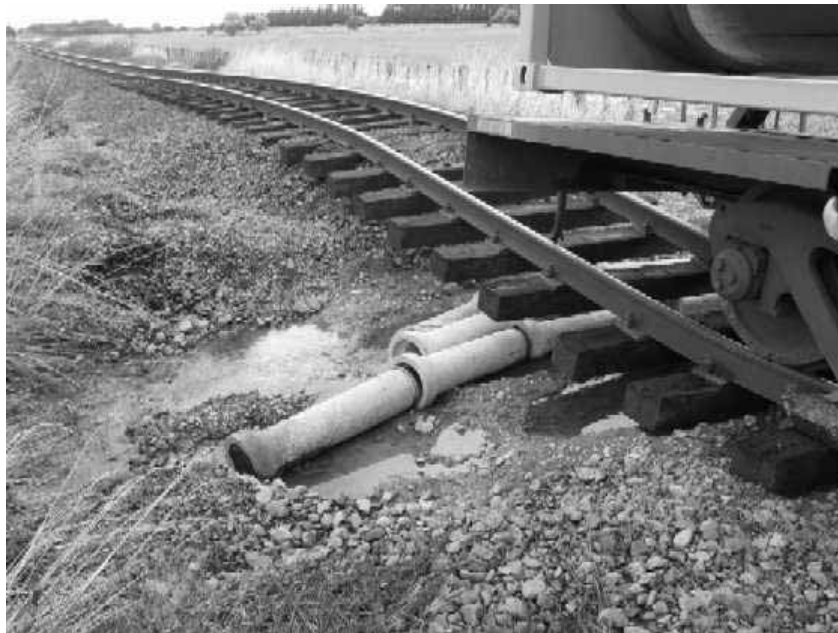
Figure 5
The upstream side of culvert 43.554 after the washout

- 2.6 Scour damage to the clay fill embankment was confined to the short length around culvert 43.554 that had been excavated and backfilled with gravel. It is therefore likely that the gravel filling scoured as result of internal erosion before the rising floodwaters overtopped the track ballast. The hydraulic gradient through the gravel was steeper than through the clay fill of the embankment, because the 6 m long culvert barrels were short compared with the 10 m or so wide at invert level clay formation. The clay filling was also more impervious.

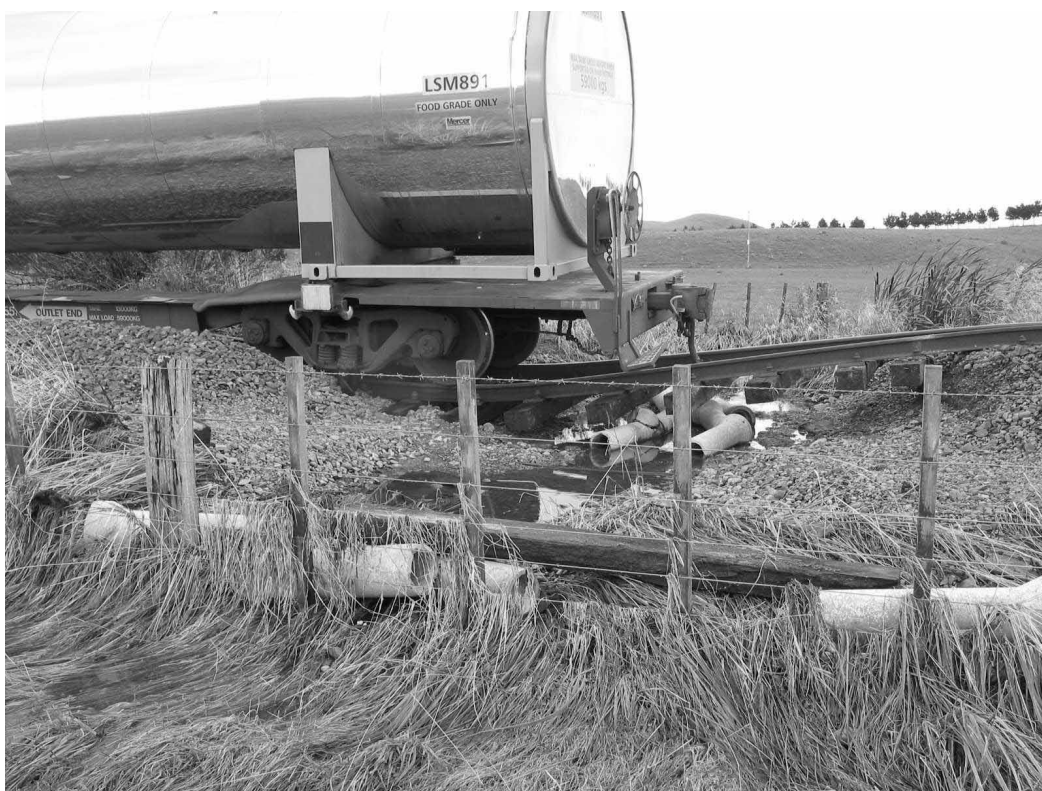
Figure 6
The downstream side of culvert 43.554 after the washout

- 1.2.16 The last detailed inspection of culvert 43.554 was carried out in 1998, at which time its condition had been downgraded from “good” to “poor” with the comment “Inlet / outlet to clear” endorsed on the M128W Work Order Check Inspection Report. A letter “M” had also been endorsed on the inspection sheet alongside the culvert details to indicate a current work order was in effect. However, there was no record to confirm whether or not the work had been done prior to the washout.

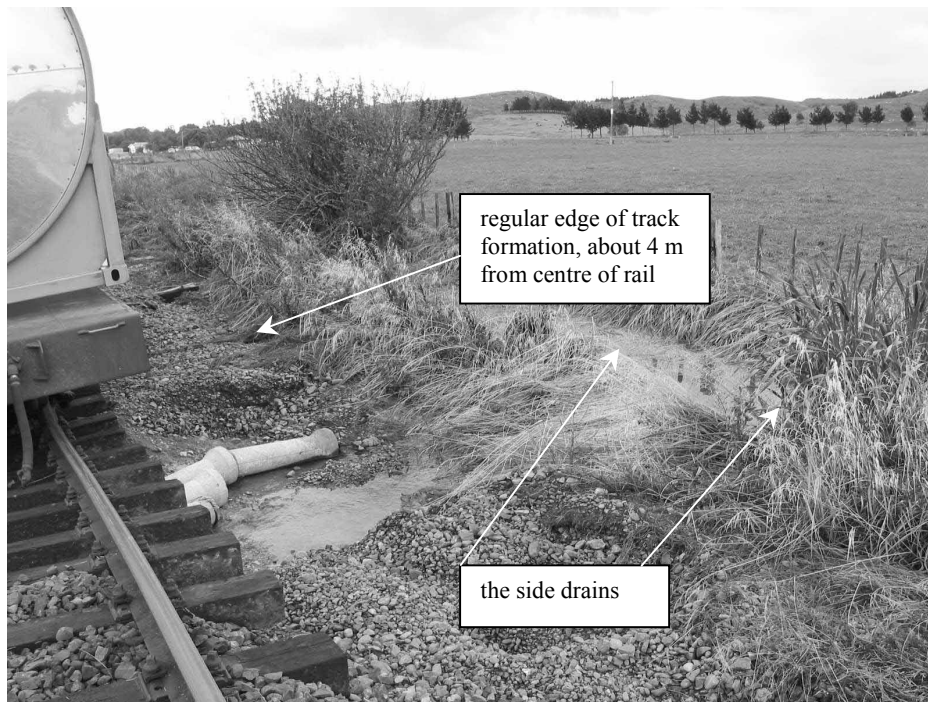
- 1.2.15 There was a side drain between Old Main Road level crossing and culvert 43.581, along the western (upstream) side of the formation, but its southern end was choked with growth and debris. The side drain continued past culvert 43.554 to the entry of culvert 43.581. A short lateral drain connected the side drain to the entry of culvert 43.554 (see Figure 7).

Figure 7
The edge of the track formation at culvert 43.554

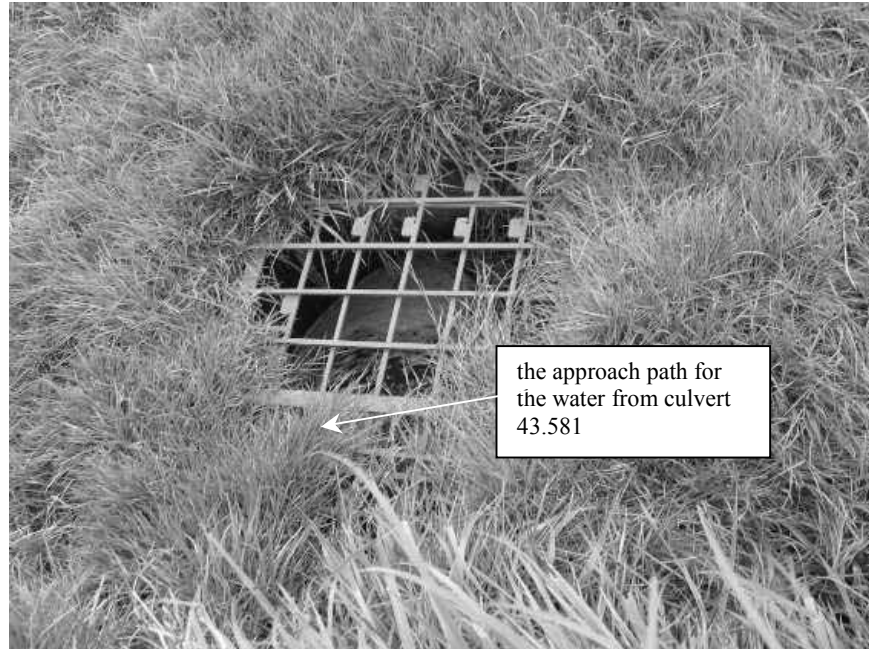
Figure 8
The sump near the exit to culvert 43.581

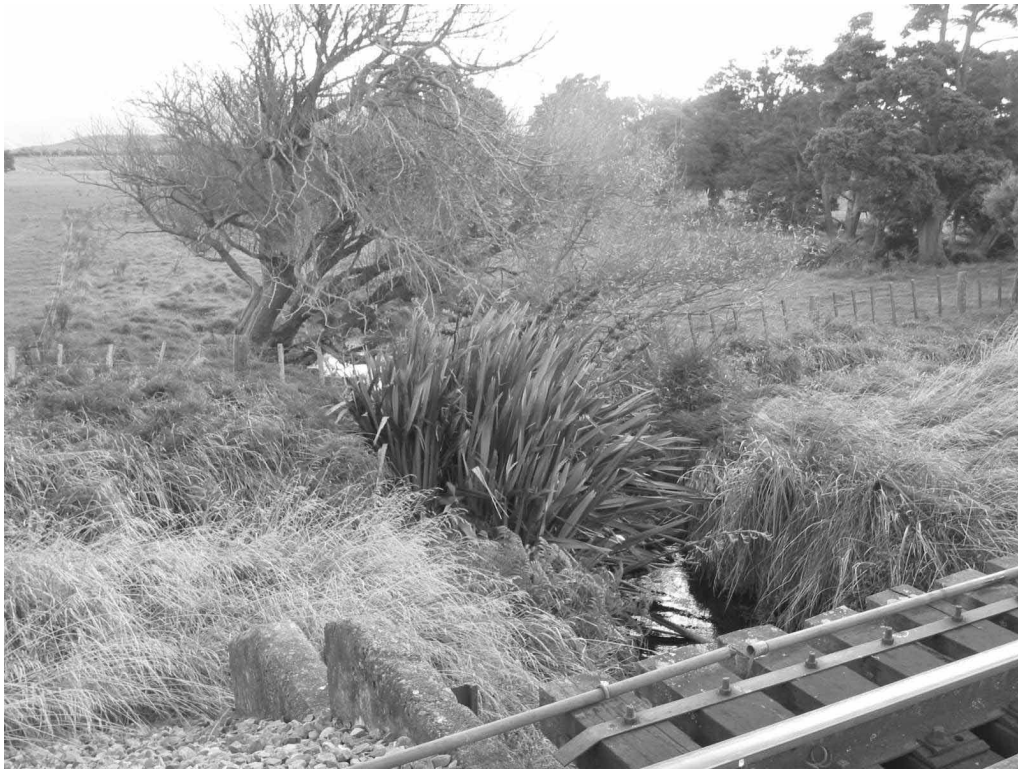
- 1.2.26 Bridge 136 was located at 43.990 km. It was about 15 m long and carried the railway line over watercourse #2 (see Figure 9).
- 1.2.27 When it was built, the bridge's waterway would have been considered adequate for a catchment of up to about 1500 hectares. However upstream growth in the channel would have reduced its discharge capacity (see Figure 9).

Figure 9
Watercourse #2 at Bridge 136

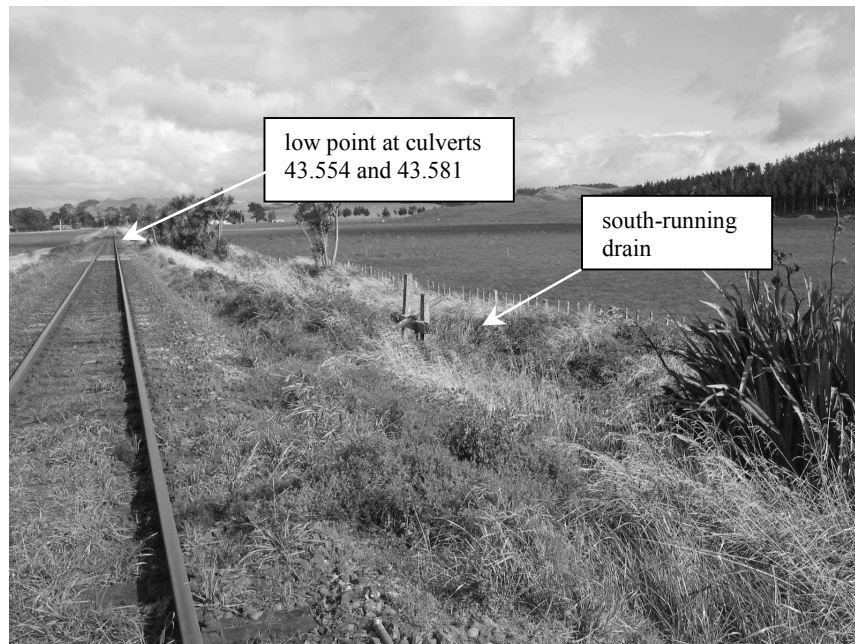
- 1.2.28 There was a drain running southwards alongside the track formation from near, but not connected to, watercourse #2 to the low point at culvert 43.554. If flood flows in watercourse #2 exceeded the discharge capacity of Bridge 136, the water would overtop the upstream southern bank and enter this drain to be carried towards culverts 43.554 and 43.581 (see Figure 10).

Figure 10
Looking south from Bridge 136

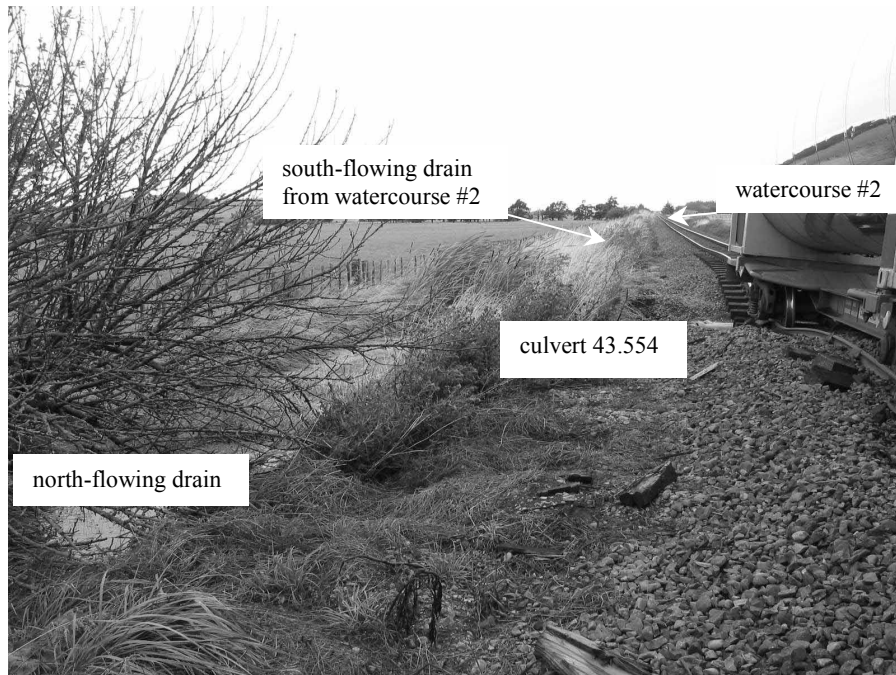
Figure 11
The drains converging at culvert 43.554

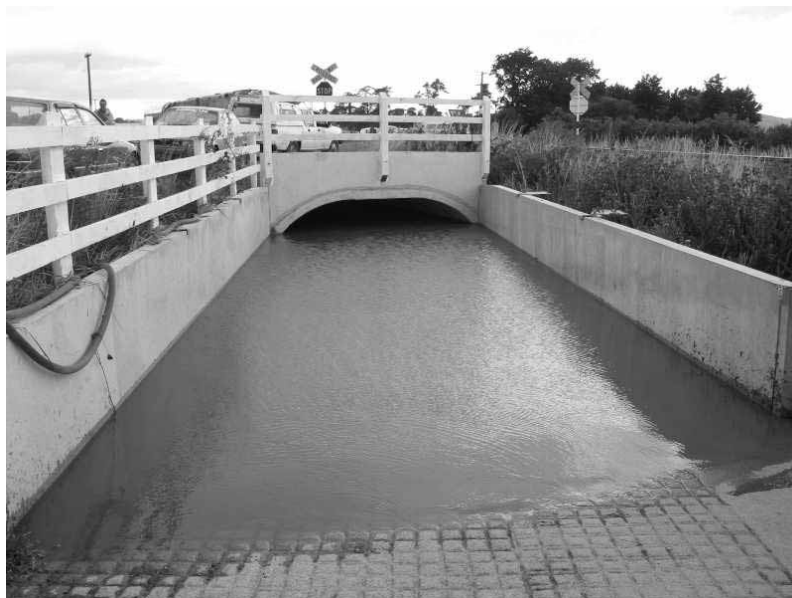
- 1.2.29 There was a stock underpass beneath Old Main Road. The underpass was 22 m long, 3.5 m wide and 2 m deep, but did not cross under the track formation (see Figure 12). The northern end of the underpass was about 250 m from the washout site.
- 1.2.30 A pump was installed in the underpass to remove runoff from its immediate vicinity, but the pump was not designed to cope with large volumes of floodwater and eventually it broke down.

Figure 12
The southern end of the flooded stock underpass

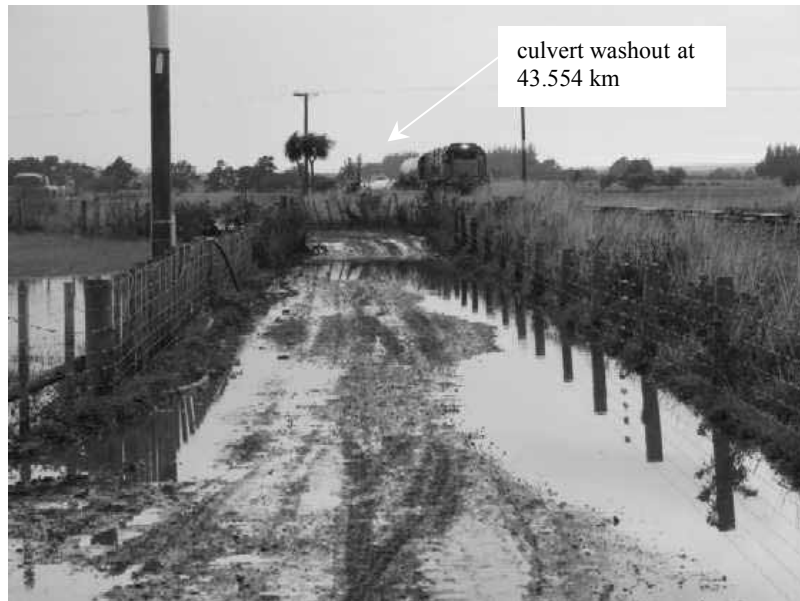
Figure 13
The cattle race looking north towards the washout site

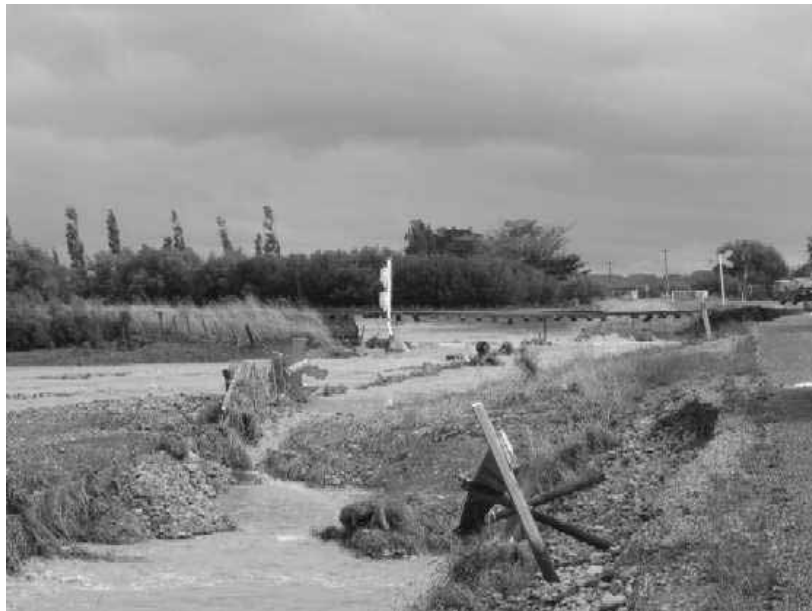
- 1.8.3 The locomotive engineer from Train P46 told the locomotive engineer of Train P40 that a creek just north of Woodville had burst its banks and the water was flowing over the balloon loop⁸ at Woodville. He also advised the train controller of the conditions at Woodville.

Figure 16
A section of the washed out balloon loop at Woodville

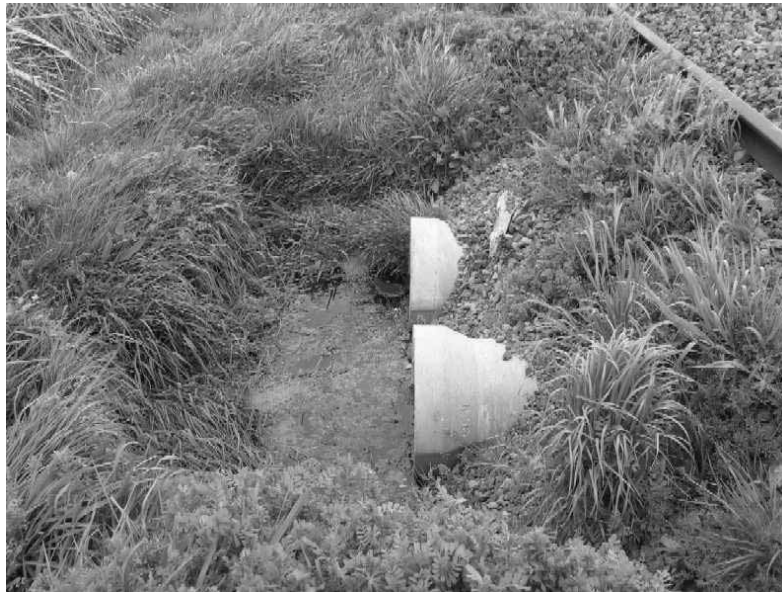
- 2.10 The culvert's installers appear to have failed to appreciate the risk of failure of the gravel bedding and backfill from internal erosion if water ponded against the embankment. The twin 450 mm diameter replacement pipes appear to be similarly vulnerable, and with inverts below ground level, prone to silting.

- 2.11 The increased pipe diameter sizes at culvert 43.554 will reduce the chances of blockages but will also increase the amount of water flowing into the adjacent paddock under similar conditions so, while the larger pipes will reduce the chances of a further washout at 43.554 the risk of flooding on the downstream side of the track formation will remain.

Figure 17
The replacement pipes installed at culvert 43.554

- 4.1 On 27 September 2004 ONTRACK advised that culvert 43.554 had been reinstated using 2 new 450 mm diameter pipes on 18 February 2004.
