RAILWAY OCCURRENCE REPORT

04-107 express freight Train 237, derailment, near Kopaki

24 March 2004

TRANSPORT ACCIDENT INVESTIGATION COMMISSION
NEW ZEALAND

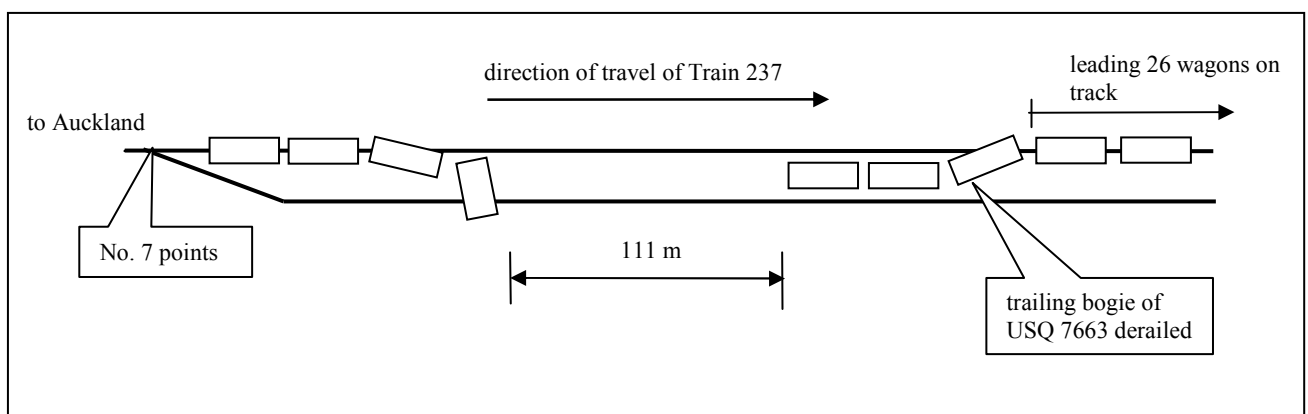
Figure 1
Kopaki crossing loop

- 1.1.3 The locomotive engineer secured the train, removed the portable radio from its cradle and proceeded to the rear of the train, checking the wagons on the way. He called the train controller when he was at the rear of the train and advised that the train had parted 4 wagons from the rear of the train, with a gap of about 80 m between the 2 portions. There were 3 wagons derailed at the rear of the front portion and 2 wagons derailed at the front of the rear portion. The last 2 wagons were not derailed (see Figure 1).

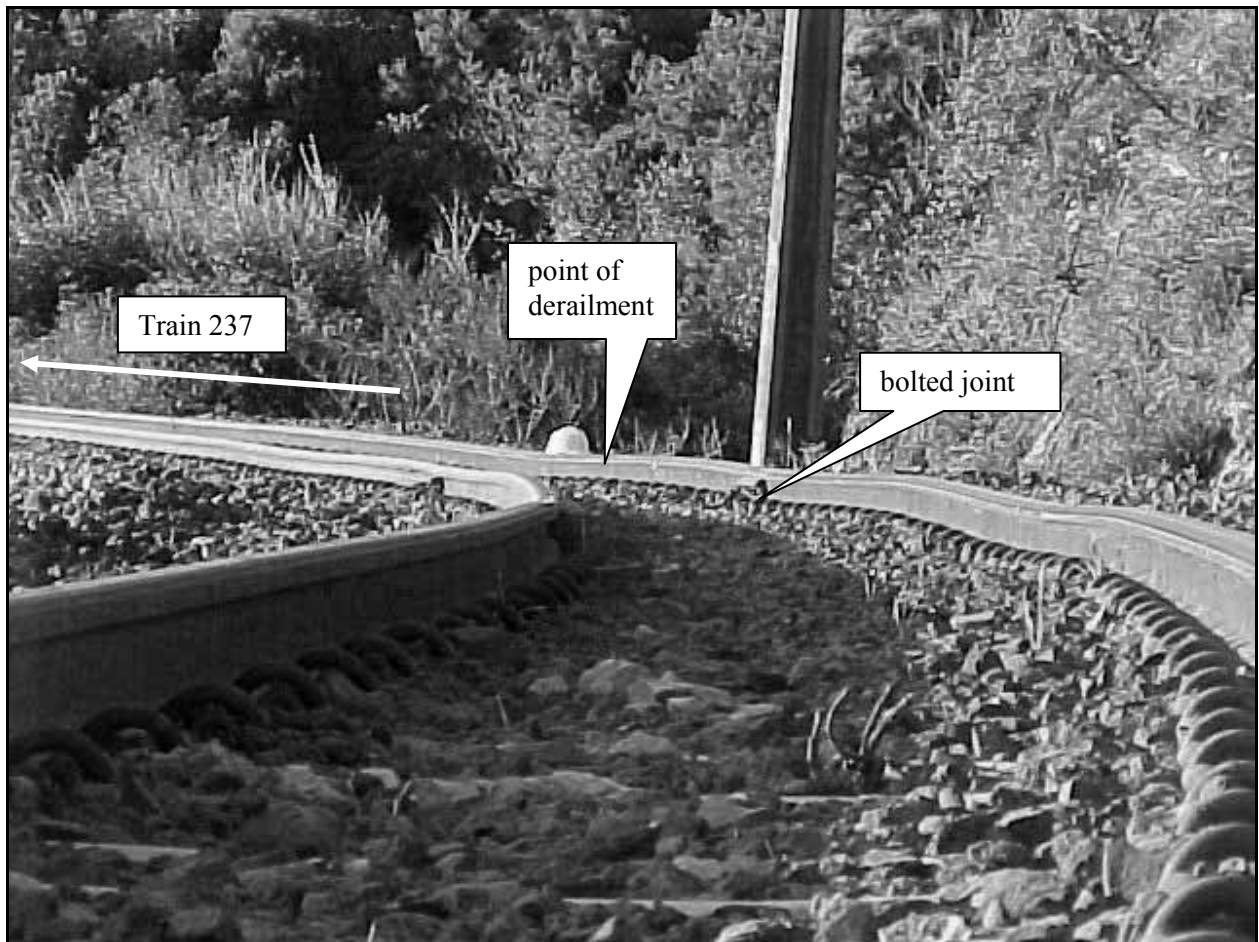
Figure 2
Track near point of derailment

- 1.2.1 The derailment occurred between Puketutu and Kopaki, on the North Island Main Trunk as Train 237 negotiated a 182 m radius left-hand curve on a rising grade of 1 in 70 (see Figure 2). The authorised curve speed was 50 km/h.

- 1.2.2 A light, 4.7 m long wheel flange mark was visible across the railhead of the right rail (in direction of travel). This identified the point of derailment (POD) as 455.946 km, about 9 m past a bolted joint.
- 1.2.3 Wagon USQ 7663 (with handbrake trailing) was the first of the derailed wagons on the front portion of the train. Track and wheel set damage indicated that the wagon ran from the POD to the mainline turnout (No. 7 points) at the north end of Kopaki crossing loop, 455.200 km, with the leading axle of the trailing bogie derailed. As the train passed over these points, the next 4 wagons derailed and the train parted. Five bogies from the derailed wagons, including the trailing bogie from USQ 7663, finished under the last wagon to derail, UK 13376 (see Figure 3).

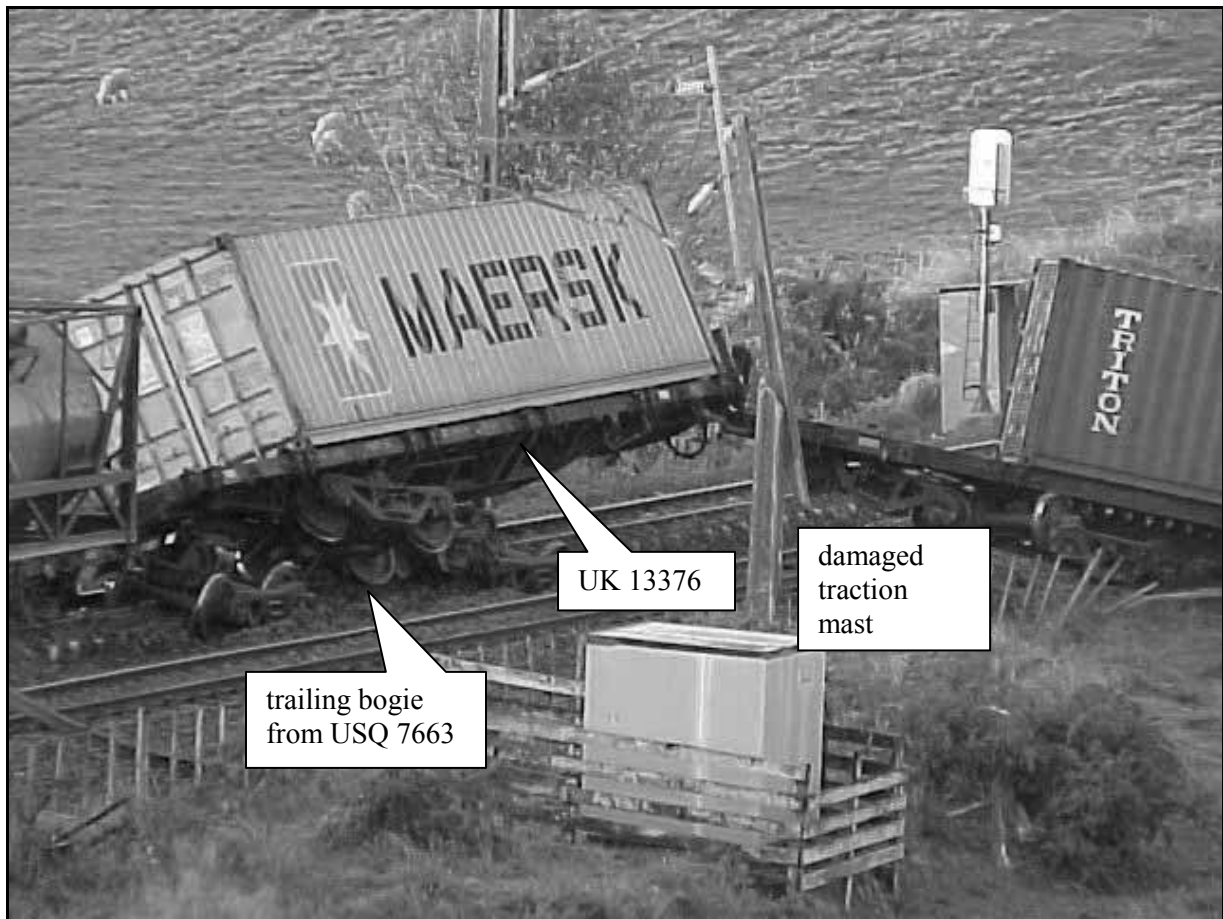
Figure 3
Derailed wagons at the rear of Train 237

1.2.4 When Train 237 stopped, the leading bogie of USQ 7663, the 27th wagon on the train, was at 454.921 km some 1026 m past the POD. There was a gap of 111 m between derailed wagons UK 20776 and IA 534. Although track damage from the POD to No. 7 points was relatively minor, the track was severely damaged from No. 7 points up to where USQ 7663 stopped. A concrete traction mast at 455.097 km on the loop side of the mainline was damaged in the derailment.

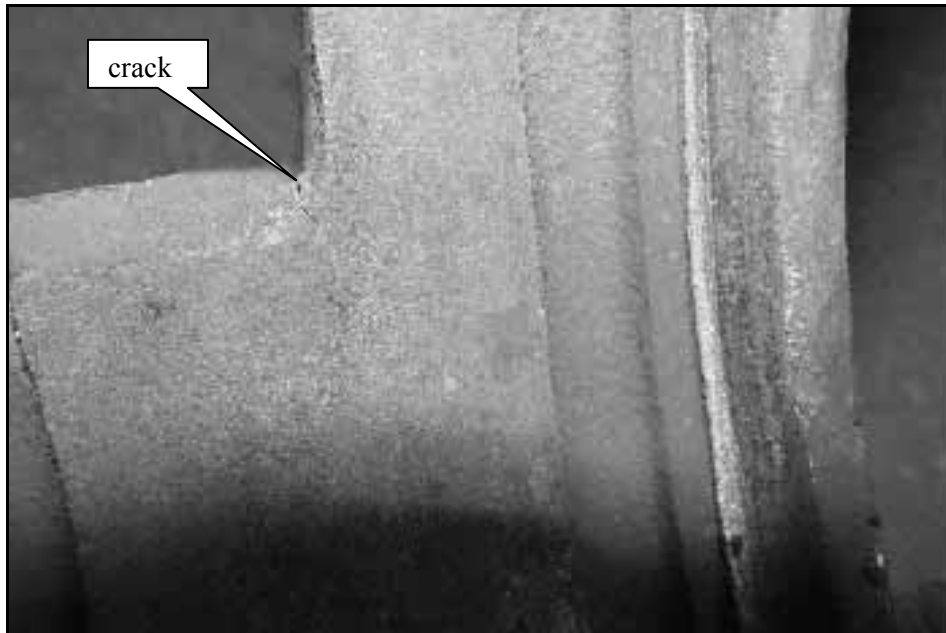
Figure 9
Crack on inside face of bearing adaptor

- 1.9.7 A more detailed examination of the derailed bogie of USQ 7663 was carried out on 11 May 2004, at the Alstom workshops at Hutt.
- 1.9.8 When the bogie frame was lifted off the axles it could be seen that the A2 wheel bearing adaptor was both damaged and distorted and had been running in a displaced position for some time. The locating lug was broken on the adaptor and there was a crack on the inside face (see Figure 9). When the adaptor was placed on the bearing, it could be slightly rotated about a vertical axis, and also rocked and slid backwards and forwards axially.

- 1.9.9 All bogie adaptor pockets were checked for dimensional compliance. All except that at A2 wheel were within the accepted tolerances. The A2 pocket was worn to an extent that it allowed 3 mm more longitudinal movement than the upper limit.
- 1.9.10 When the springs supporting the friction wedges were removed from the side frames, it was found that 2 of the inner springs on the B-side were broken at the same position, about one and a half turns from the bottom (see Figure 10).

- 3.6 The A2 wheel bearing adaptor was damaged but did not cause the derailment. However, the small resulting movement, in combination with other factors, may have contributed to the derailment.
- 3.7 The wear strips failed due to inadequate welding around their full circumference. The failed strips would have exacerbated the lack of damping and, while this would not have caused the derailment, in combination with other factors, may have contributed to it.
- 3.8 The broken springs and failed wear strips could not be identified during normal maintenance inspections.
- 3.9 The lack of a unique identification number on each bogie prevented tracking of its operational and maintenance history

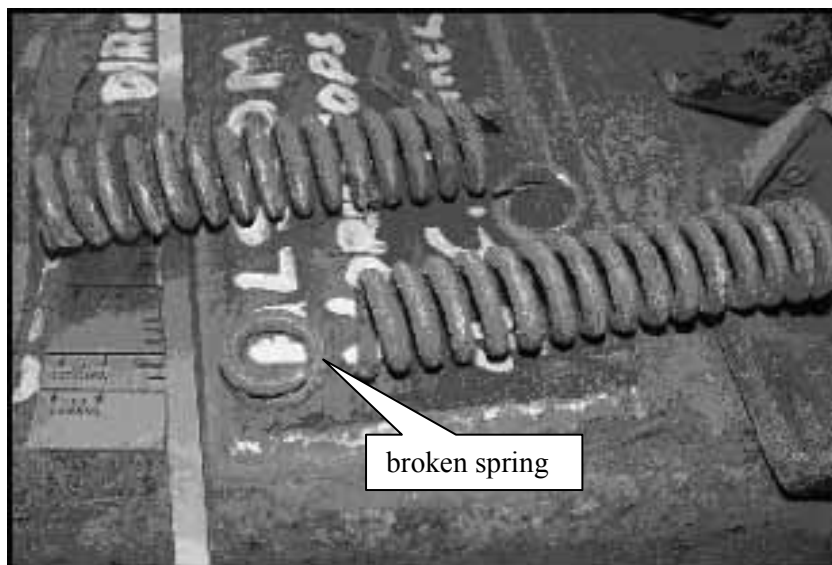
Figure 10
Broken springs

- 2.4 The derailment happened when the wheel flange of the leading axle on the trailing bogie of USQ 7663 climbed over the hi-leg rail when negotiating the left-hand curve. The fractured springs would have prevented the friction wedges being effective in damping out the rolling effect. Rolling oscillations would thus continue for longer durations, increasing the risk of these oscillations compounding should there be any small cyclic changes in track geometry.
- 2.5 The springs probably fractured before, rather than as a result of, the derailment. The springs were fitted in such a manner that it would not have been possible to identify the broken springs during a routine maintenance inspection, only when the bogie was dismantled.
