RAILWAY OCCURRENCE REPORT

04-109 passenger express Train 804, *Tranz Alpine*, stalled and slid back, Otira Tunnel 28 March 2004

Report 04-109

On Sunday 28 March 2004, at about 1541 shortly after entering the Otira Tunnel Train 804, the Greymouth to Christchurch *Tranz Alpine* passenger express, with 268 passengers and 6 crew on board, stalled and slid backwards. The locomotive engineer eventually brought the train under control but when he attempted to move forward again the locomotives could not develop traction and the train stopped.

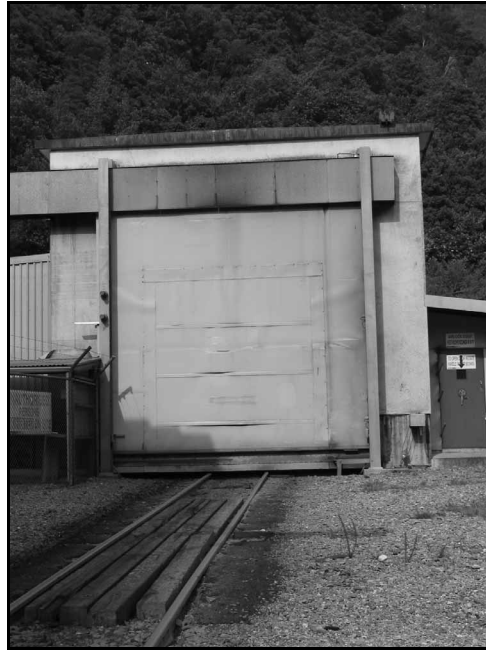
Figure 3
The sliding door in the closed position at the western portal of Otira Tunnel

- 1.2.3 In 1981, the rail in the tunnel had been replaced with 50 kg/m rail, and all joints were welded at that time.
- 1.2.4 Until 1997 all eastbound freight trains and most passenger trains had been hauled through the tunnel by 4 electric locomotives operating in multiple, using a 1500 volt overhead direct current electric system. In 1997, following the installation of 2 extraction fans and a sliding door at the western portal of the tunnel, electric operations had been replaced by full diesel operations. The fans worked in conjunction with the sliding door to provide cool air for the diesel locomotives hauling trains up the gradient from Otira to Arthurs Pass, as well as purging the tunnel of fumes (see Figures 3 and 4).

- 1.2.5 Once an eastbound train was inside the tunnel, the sliding door closed and the first fan started, which provided airflow through the tunnel for cooling the locomotives. When the train arrived at Arthurs Pass, the second fan started and both fans ran for 20 minutes to purge the tunnel of exhaust fumes before the door reopened.
- 1.2.6 After a westbound train cleared the tunnel, the door closed and both extractor fans started and ran for 11 minutes to purge the tunnel of exhaust fumes. When the fans stopped, the door reopened. Figure 4 shows the extractor fan exhaust outlets.

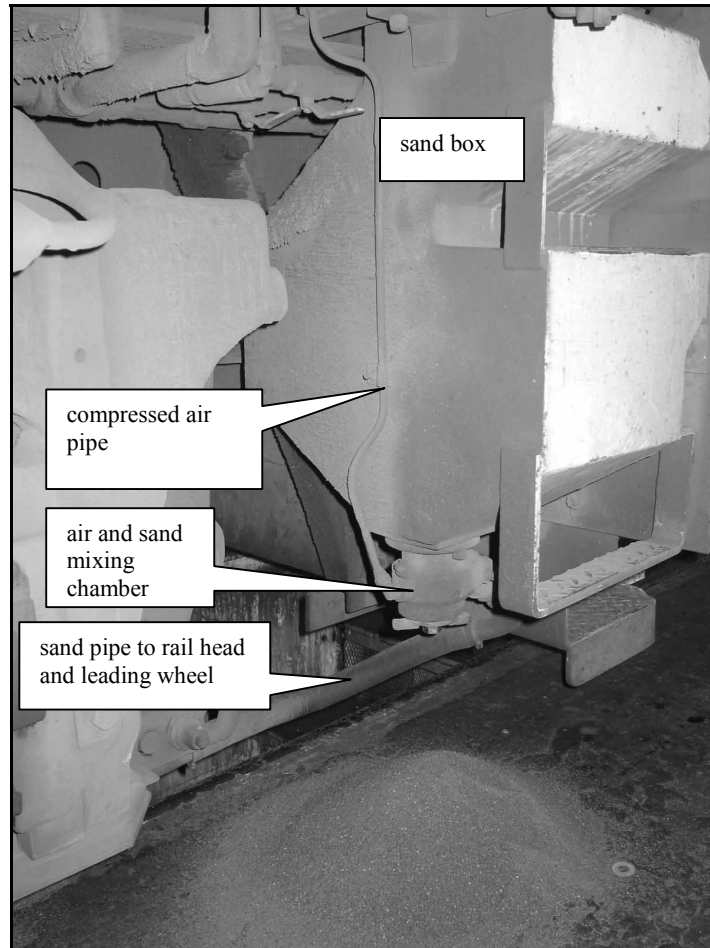
Figure 6
The sand box on a DCP locomotive

- 1.6.15 Sand was carried on DCP locomotives in boxes located in front of the leading wheels in the direction of travel. The sand was used to assist with adhesion and could be applied automatically by the locomotive's adhesion control systems, or manually by the locomotive engineer.

- 1.6.18 There was no filter on the top of the sand box to prevent pebbles mixed with the sand entering the sand boxes during refilling. Originally there had been a filter screen on the top of the sand boxes to take out any larger objects such as pebbles. When these filters corroded they were not replaced.
- 1.6.19 After the incident, the outlets of both sand boxes on the front end of the leading locomotive and one on the front end of the trailing locomotive were found to be blocked by pebbles.

- 5.1 On 16 December 2004 it was recommended to the Chief Executive of Toll NZ Consolidated Limited that he:
- develop and introduce appropriate specifications for the supply of locomotive sand that include quality assurance procedures to ensure the sand is fit for purpose. (081/04)
- and
- develop a regime to ensure that locomotive driving and idling wheelset axle weights are maintained within tolerance. (082/04)
- 5.2 On 11 January 2005 Toll NZ Consolidated Limited advised that they accepted the recommendations.

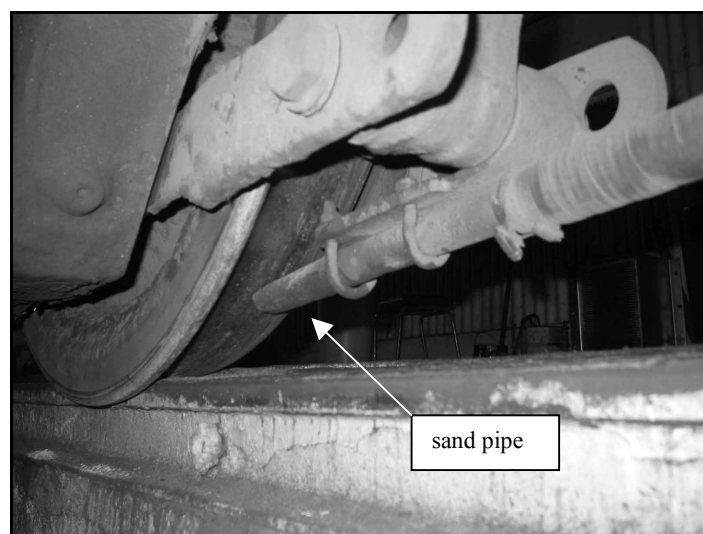
Figure 7
The sand pipe from the sand box

- 1.3.14 The banker locomotive consist was not due to arrive at Otira from Arthurs Pass for about 30 minutes after Train 804 arrived back in Otira, so the locomotive engineer took the opportunity to check the electrical circuits in the locomotive. He did not find anything that suggested a problem, so he checked the locomotive sand boxes. He found small pebbles had blocked the outlets from at least 2 of the sand boxes, preventing the sand from being deposited on the railhead.

- 1.6.16 When wheelslip was detected by the locomotive control system, sand was applied to the leading wheels only where wheelslip was detected. When the locomotive engineer worked the system manually, sand was applied in front of the leading wheels of all locomotives in the consist.
- 1.6.17 When the sanding equipment was activated, the sand dropped from the sand box into a chamber where it mixed with compressed air (see Figure 6) and was blown through a 25.4 mm pipe and deposited on the railhead immediately in front of the leading wheels (see Figure 7).
