RAILWAY OCCURRENCE REPORT

04-110 Wagon runaway, Owens siding, Onehunga industrial line 5 April 2004

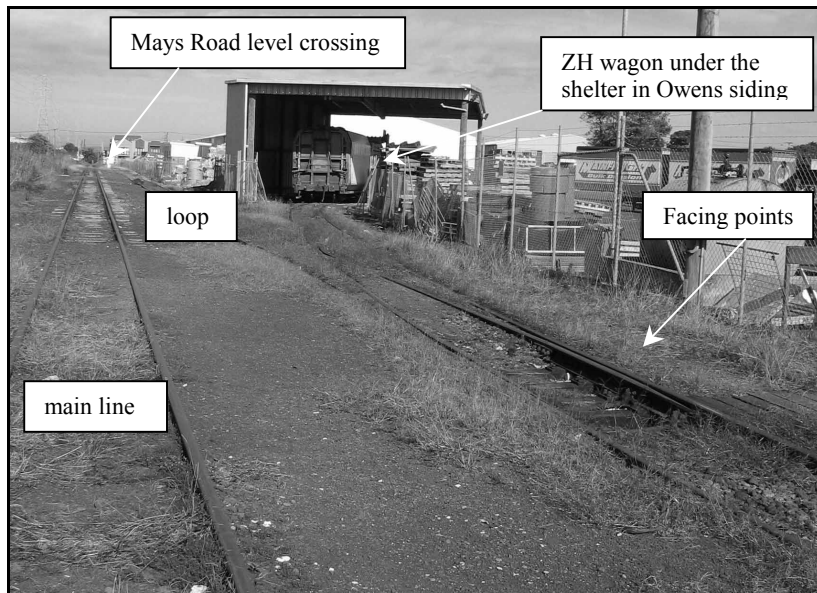
Figure 3
Owens siding looking towards Mays Road level crossing and Onehunga

- 1.2.6 Tranz Rail's operating procedures required the warning devices for each of the level crossings to be operated manually when it was necessary for rail vehicles to use the line beyond Owens siding. Owens siding connected to the loop and had standing room for 5 wagons. There was a shelter near the start of the siding with standing room for one wagon (see Figure 3).

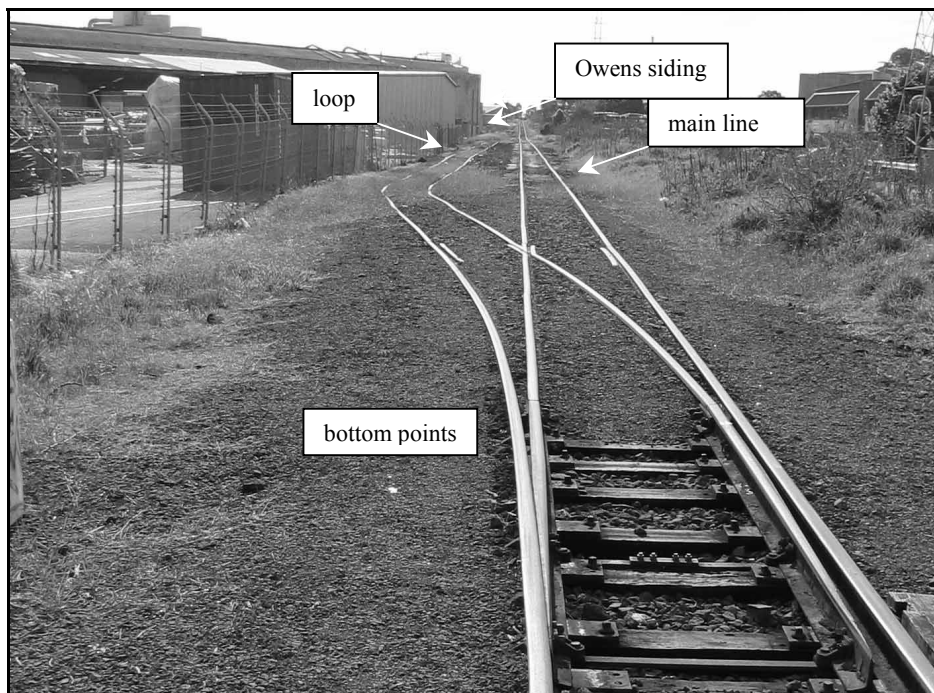
Figure 4
View from the bottom end points towards Penrose

1.2.8 At the Onehunga end of the siding, the loop rejoined the main line through the bottom points (see Figure 4).

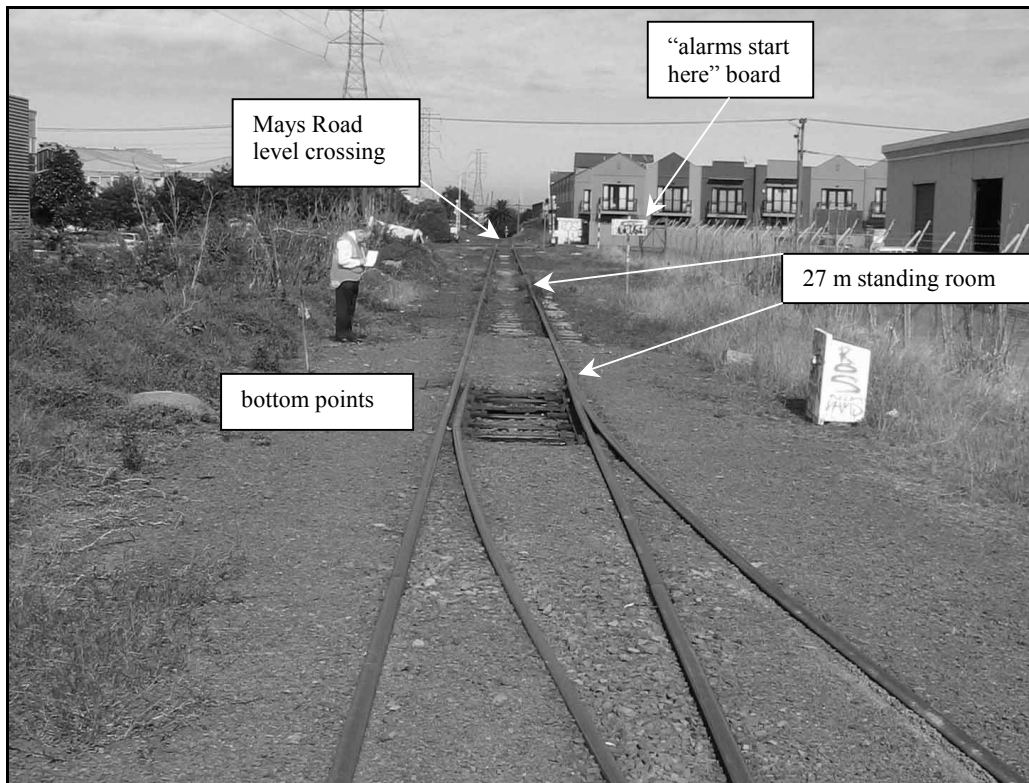
Figure 5
Bottom points and Mays Road level crossing

- 1.2.4 There was no derailing block on the loop to prevent runaway wagons from entering the main line and running down towards Onehunga.
- 1.2.5 There were no scheduled train services operating beyond Owens siding on the Onehunga industrial line and there had been none for a number of years. The absence of trains caused a build-up of rust on the unused rails beyond Owens siding. The layer of rust had the potential to insulate the wheels of any rail vehicles from the track circuits, resulting in unreliable operation of level crossing alarms from and including Mays Road to the end of the line (see Figure 2).

- 1.2.9 The main line had an even gradient, but the track on the loop had an undulating top with low rail joints. About half-way towards the bottom points, the loop was about one metre lower than the height of the main line. The undulating top on the loop can be seen in Figure 4.
- 1.2.10 The bottom points were situated about 107 m before Mays Road level crossing. There was an “alarms start here” board erected 80 m from the level crossing. This provided standing room for a locomotive and one wagon clear of the bottom points without starting the warning alarms at the level crossing (see Figure 5).

- 4.1 On 1 July 2004, the Commission recommended to the Chief Executive of Toll NZ Consolidated Ltd that he:
 - install a protection device on the loop at Owens siding to prevent an uncontrolled wagon movement travelling in a westerly direction beyond that point. (031/04)

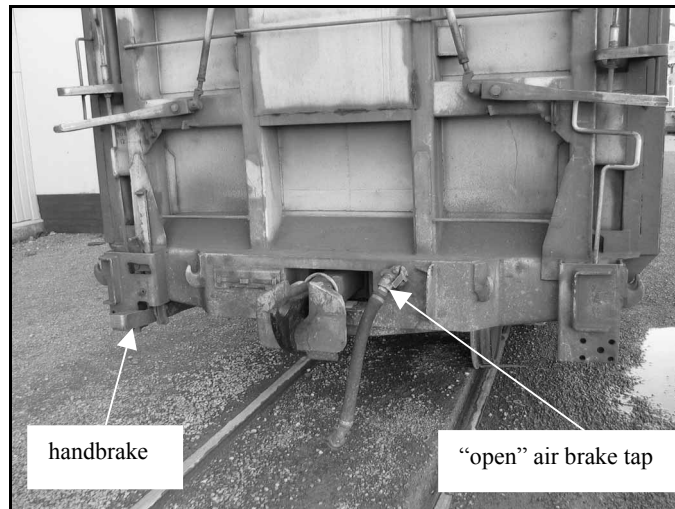
Figure 7
Handbrake end of a ZH class wagon

- 1.3.23 Although the air brake is accessible from both ends of the wagon, the handbrake is only located at one end (see Figure 7), in this case the trailing end in the direction of travel of the wagon.
- 1.3.24 The rail operator said the wagon continued to gather speed so about 2 wagon lengths from Mays Road level crossing he jumped off. He chased after the moving wagon on foot and when he located it he secured it and walked back towards Owens siding. About 500 m from the siding, he met the locomotive engineer walking towards him.
- 1.3.25 After discussing the situation they returned to the locomotive, obtained the necessary authority, and moved down to recover the wagon.
