RAILWAY OCCURRENCE REPORT

04-112

Diesel multiple unit passenger Train 2146, fire auxiliary engine, Boston Road

16 April 2004

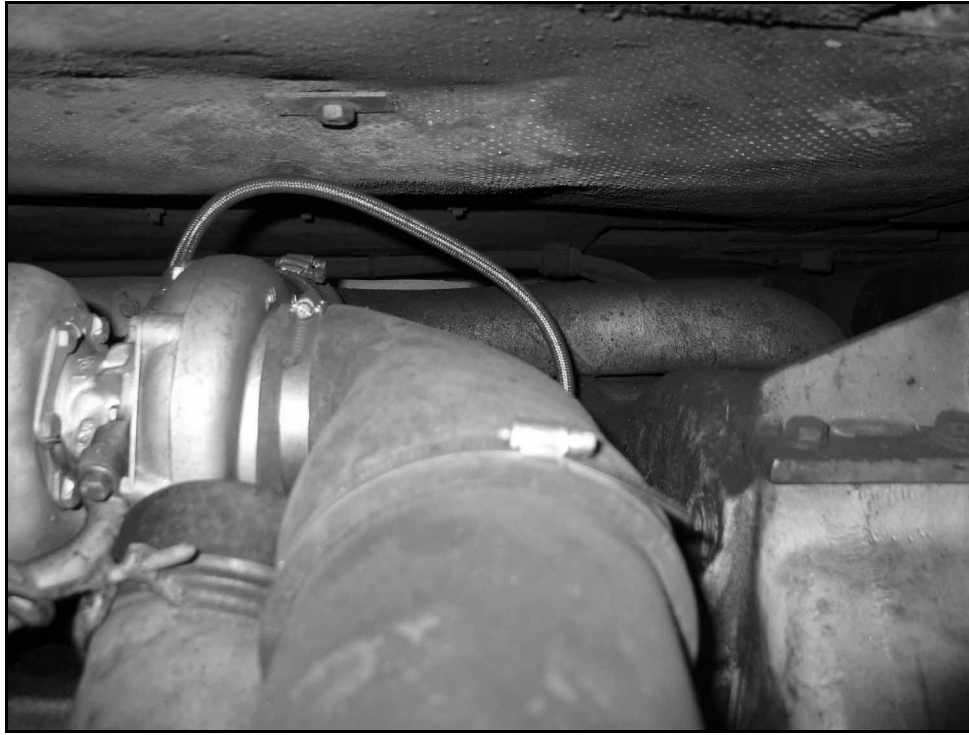
- 1.9.3 The straight fittings used to connect the oil inlet hose to the engine and the turbocharger resulted in the hose completing an unsupported 180° loop over the turbocharger air inlet (see Figure 3). This was Tranz Rail's preferred assembly rather than a route created by the angled connections between the turbo charger and the engine which, although shorter, would place the hose close to and over the hot engine block.

Figure 3
The replacement oil inlet hose looped over the turbocharger air inlet

- 2.4 The unsupported and looped oil inlet hose was subjected to constant heat and vibration while in service. Also, it was probably rubbing against the turbocharger air inlet pipe, which it would have exacerbated that vibration. Because of the fire damage to the hose, it was not possible to determine exactly what had pierced the exterior. If the hose had been subjected to torsional stress since its installation, this would have been a permanent stressful situation on the hose, thereby compounding the effect of the vibrations.

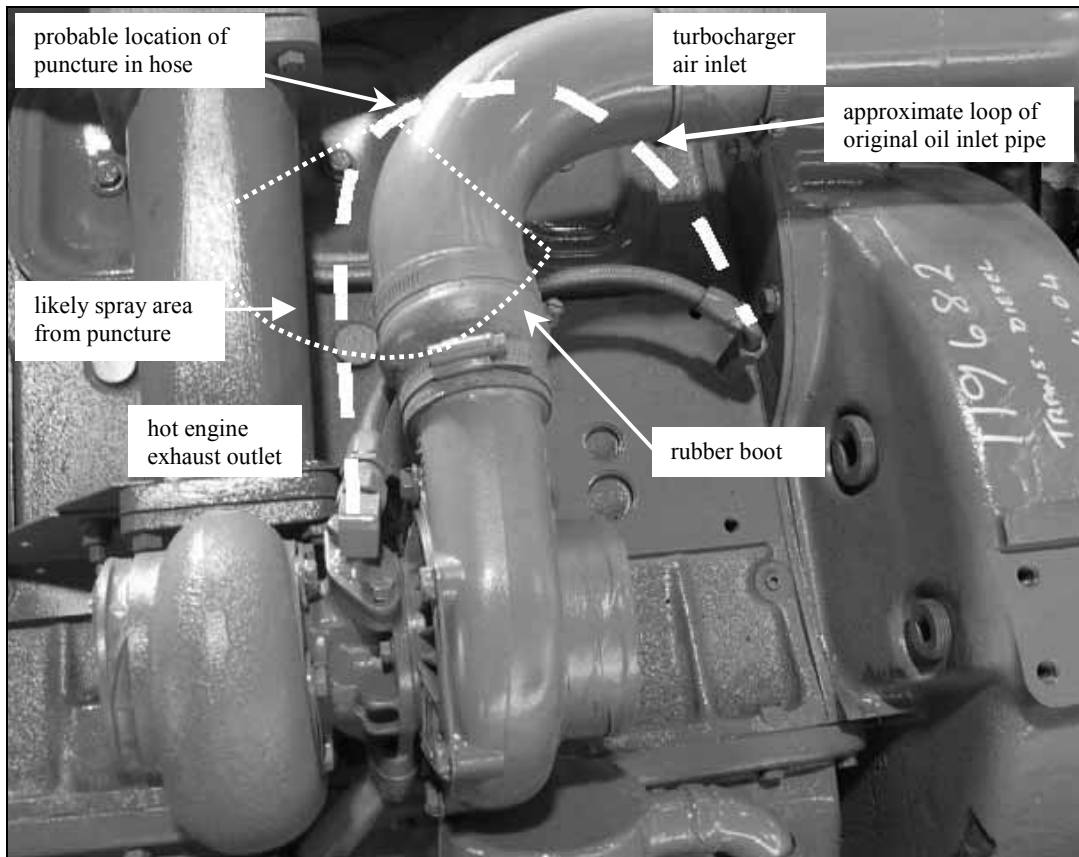
Figure 4

A reconditioned DMU auxiliary engine with probable fire damage details superimposed

- 1.11.2 The fire damage was limited to the turbocharger, the oil inlet hose and the immediate area around the exhaust manifold, with the turbocharger air inlet rubber boot showing evidence of burning.

- 2.6 The turbocharger casing and the engine exhaust outlet operated at about 450⁰C and probably ignited the oil mist as it drifted and landed on the hot surface. The flames would have quickly travelled to the oil-covered rubber boot a short distance away, which would have ignited. The rubber boot would have provided a source of fuel for the fire and, together with the burning oil mist and surrounding oil soaked dirt, would have created significant amounts of smoke.

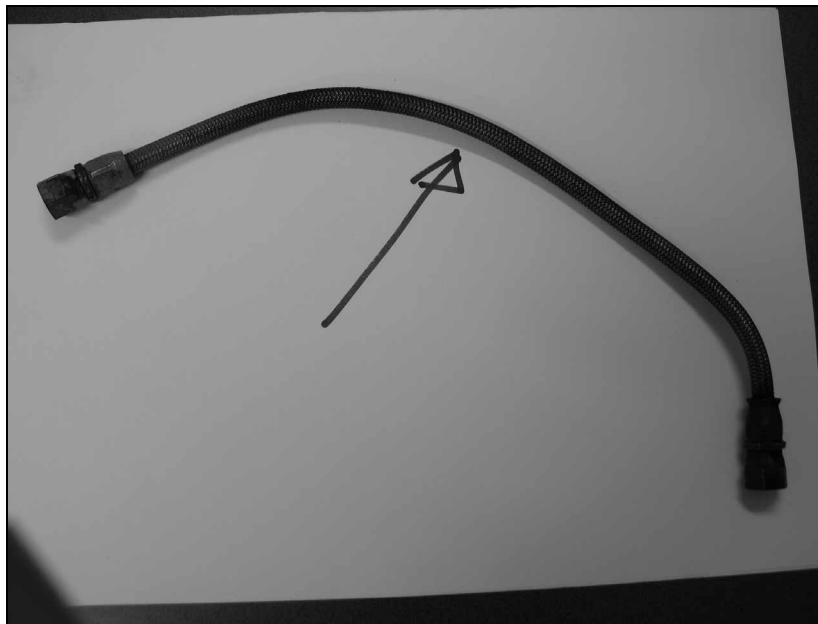
- 1.12.1 The outer surface of the steel braiding was darkened but exhibited no sign of breaks, kinks, cracks or corrosion. Figure 5 shows the blackened inlet hose, while the arrow indicates the approximate position of the pin-hole puncture in the hose.
- 1.12.2 The failed polymer tube was rigid near the ends but the mid-section was flexible. When cutting the flexible mid-section it was noticed that the internal tube appeared deformed.
- 1.12.3 Another cut was made into the hose about 50 mm from the original cut. At this point there was no polymer tube visible inside the braiding. However, while the hose was being moved, a small fragment of material fell out. Closer inspection revealed this to be a piece of heavily deformed and blackened polymer tube. The braiding on the hose was then removed to expose the remains of the internal tube. Figure 6 shows cross sections of the failed hose.

Figure 5
The failed oil inlet hose

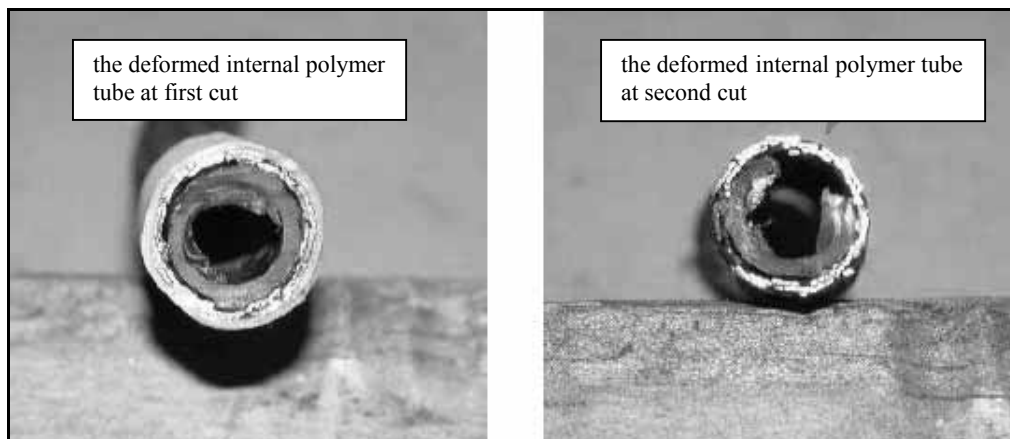
Figure 6
Damaged sections of the failed oil inlet hose

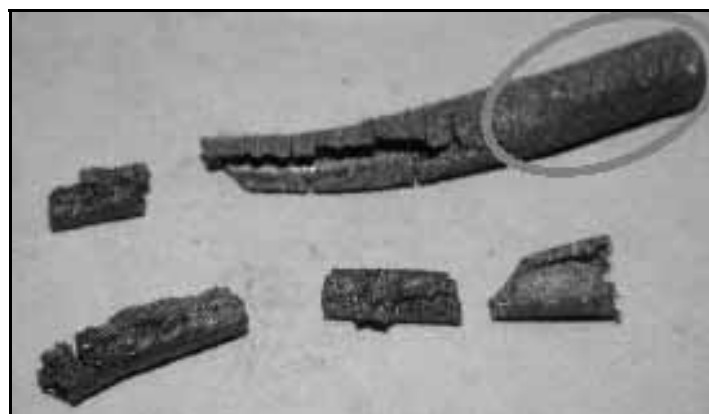
1.12.4 The damage to the internal polymer tube was localised along a section about 120 mm long, with the most severe damage being restricted to a length of about 50 mm (see Figure 7). The damage was more evident on one side of the polymer tube than the other. The tube was intact and undamaged in the more rigid parts of the failed hose, although the exterior braided tube surface was blackened.

Figure 7
Remains of the internal polymer tube

- 2.7 The hot oil on the polymer hose would also have ignited, and the resulting fire would have exposed the exterior to temperatures in excess of the shrink temperature for the tube. These temperatures far exceeded the in-service temperatures for which the hose was designed, and the exterior stainless steel braiding would have offered little protection from the heat to the internal polymer tube.

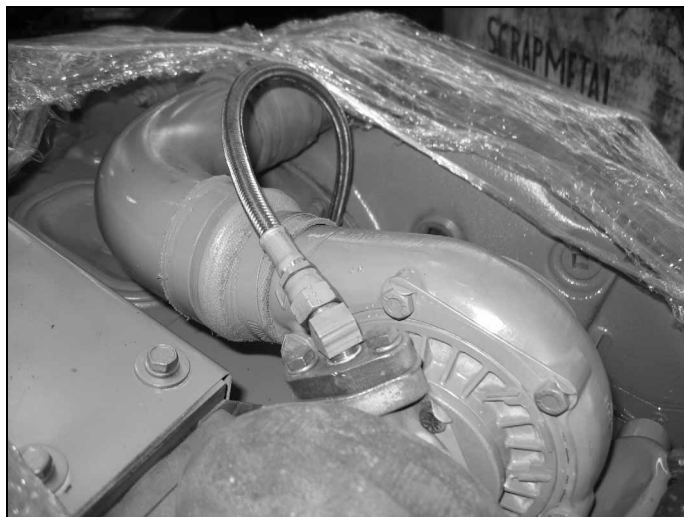
Figure 8
The new standardised fitting for the oil inlet hose

- 4.1 On 14 October 2004 Toll Rail advised that fittings on the oil inlet pipe had been standardised with the fitting of a 45° elbow to the turbocharger mounting and a straight adaptor fitted to the auxiliary engine (see Figure 8). This allowed the hose to be fitted within the allowable curvature specification.
