## RAILWAY OCCURRENCE REPORT

04-113

express freight Train 220 and empty truck and trailer, collision  
at farm access level crossing, 162.56 km between Maewa and  
Rangitawa

27 April 2004

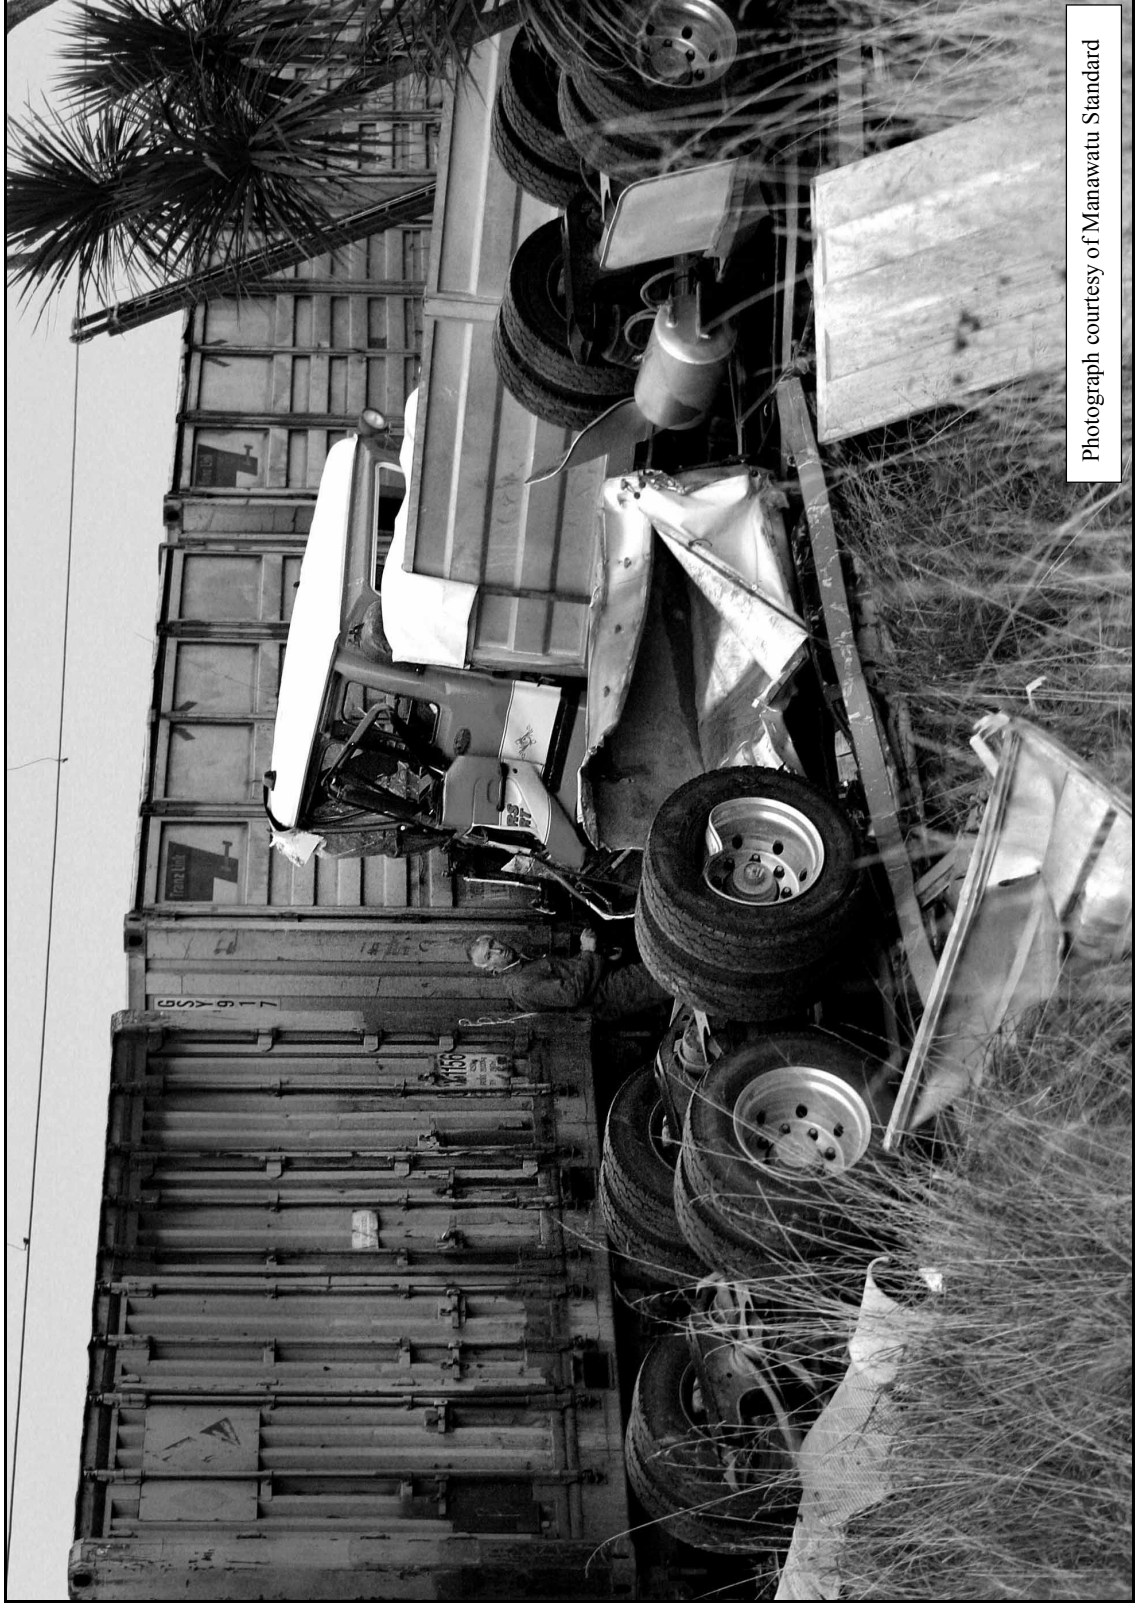
**Truck and Trailer unit alongside Train 220 after collision**

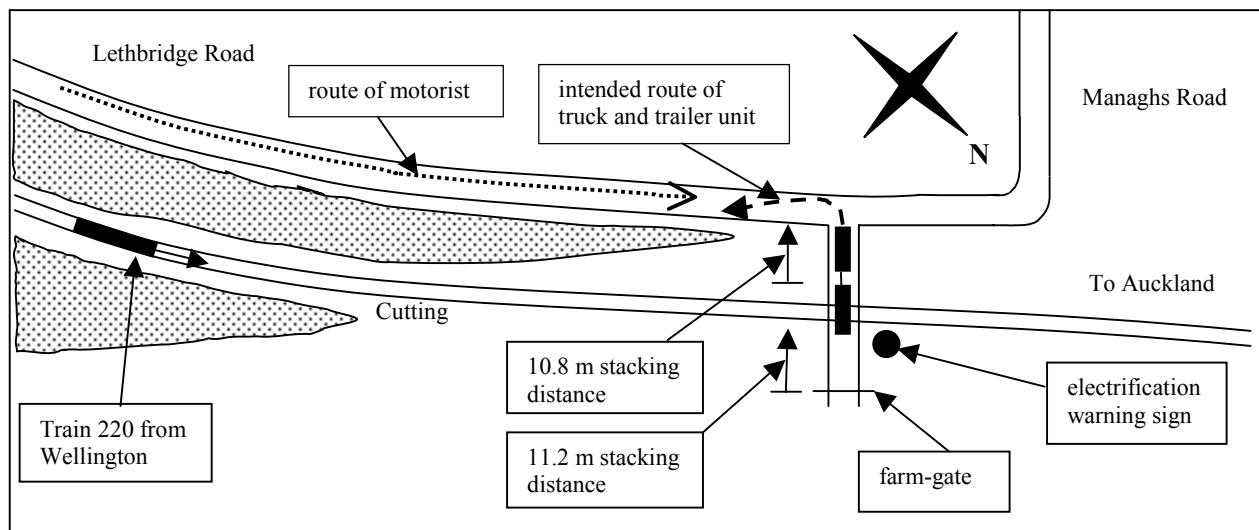
**Figure 1**  
**Site plan of the level crossing (not to scale)**

- 1.2.1 The level crossing was located at 162.56 km between Maewa and Rangitawa and gave access from Lethbridge Road to farm paddocks where a fertiliser storage bin was located.

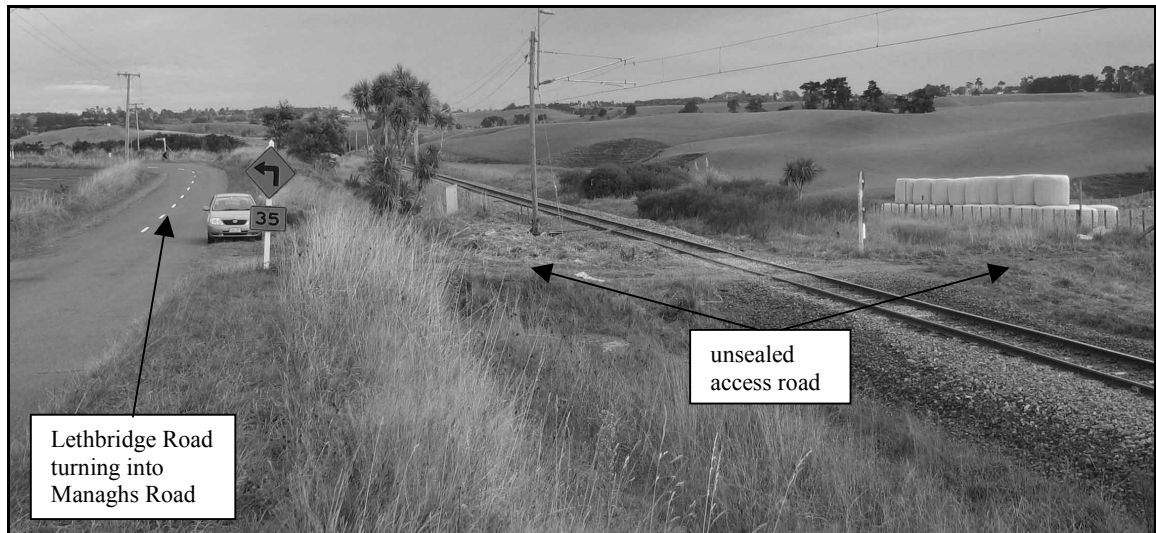
**Figure 2**  
**Overview of private level crossing and intersection with Lethbridge Road looking north**

- 1.2.4 The level crossing was not held under a deed of grant as required in Section 1.1 (b) of Tranz Rail's Infrastructure Code Supplement G417.
- 1.2.5 Access over the level crossing was unsealed and slightly inclined up to Lethbridge Road, which was a lightly trafficked rural road. Near the intersection there was a 35 km/h advisory road sign for northbound traffic on Lethbridge Road turning into Managhs Road. The location of this sign meant that traffic joining Lethbridge Road from the level crossing had to drive in a wide arc to avoid the sign (see figure 2).

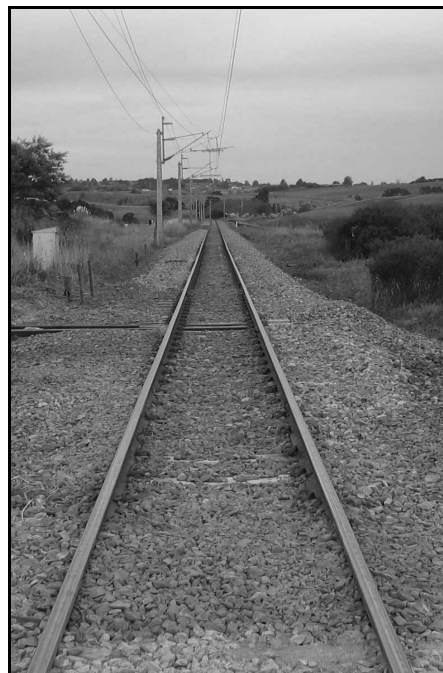
**Figure 3**  
**Looking north from the level crossing**

- 1.2.6 Users of the level crossing had good visibility of the track to the north with a view line of 450 m along an essentially straight track. Likewise locomotive engineers of trains approaching the level crossing from the north had good visibility of the crossing and any traffic using it (see Figure 3).

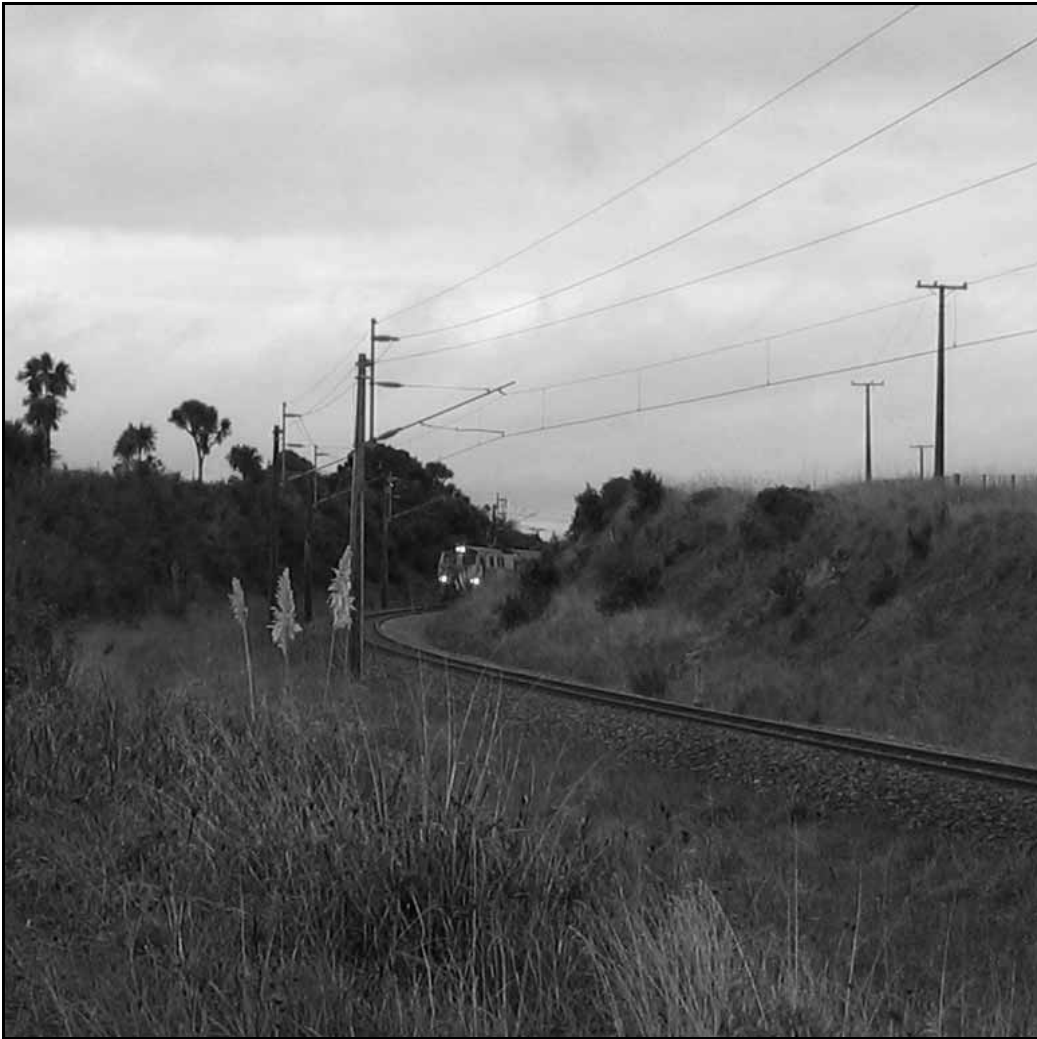
**Figure 4**  
**A northbound train emerging from the cutting**

- 1.2.7 The track to the south went through a 420 m radius curve in a shallow cutting. The view line for users of the level crossing and locomotive engineers was restricted to 140 m (see Figure 4).

- 1.2.8 The photograph in Figure 4 was taken from the farm gate, about 15m from the level crossing. From this position users would have the best possible line of sight for trains approaching from the south, because it was possible to see partway into the cutting and any approaching train when it was about 200 m away. Because of the cutting the line of sight reduced significantly as a truck moved nearer to the level crossing. In this instance, the truck driver did not see any approaching train from either the farm-gate or the level crossing.

2.2 The view lines to the south did not meet Tranz Rail's minimum standards for traffic at private level crossings so any application to register it would probably have been declined.

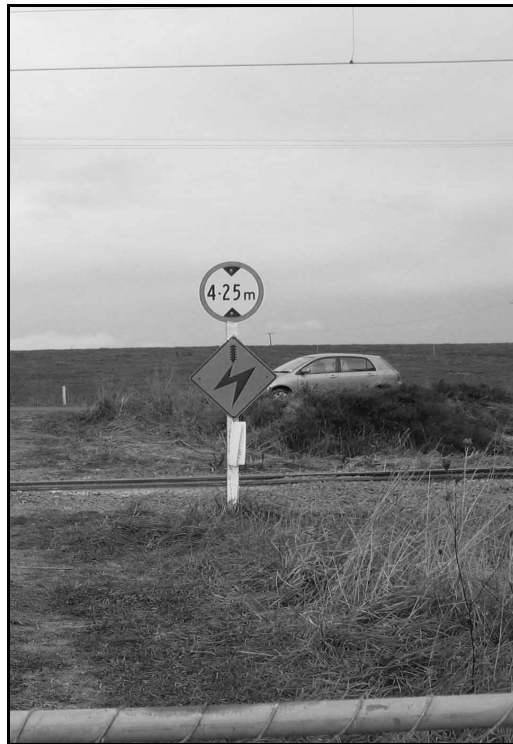
**Figure 5**  
**Electrification warning sign visible from farm gate**

- 1.2.9 The level crossing was not protected by warning devices or signage. However, there was a sign facing vehicles leaving the farm, warning of the presence and clearance height of the overhead catenary (see Figure 5).

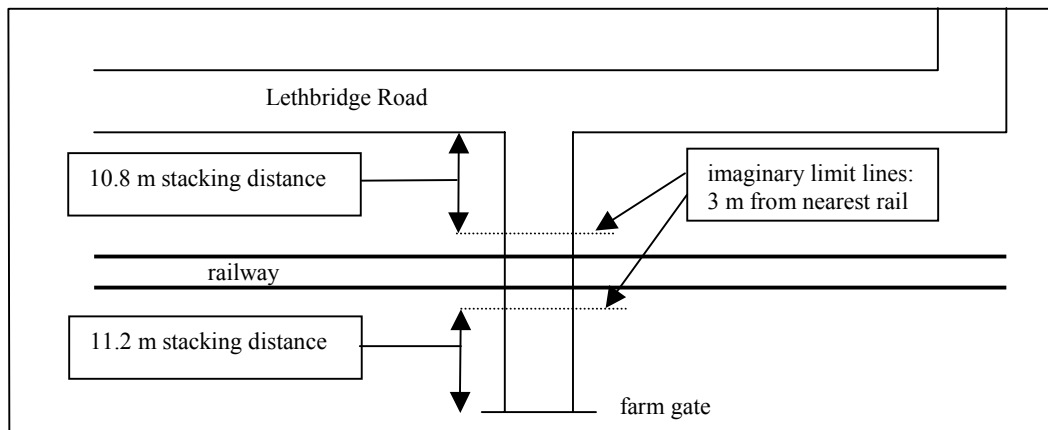
**Figure 6**  
**Detailed site plan of level crossing (not to scale)**

- 1.2.12 Neither the Manual nor Q517 stipulated a minimum distance clearance of the railway (stacking distance) to allow vehicles to stop on either side of a level crossing. However allowing a 3 m clearance to avoid conflict between the closest rail and the limit line, the following stacking distances were available at the level crossing:

- 11.2 m between the farm gate and an imaginary limit line on the farm side of the level crossing
  - 10.8 m between Lethbridge Road and an imaginary limit line on the road side of the level crossing (see figure 6)

2.3 The available stacking distance between the track and Lethbridge Road was adequate for trucks up to 10 m long, but not for truck and trailer units. At the time the level crossing was formed, traffic was probably restricted to trucks only, so the issue of inadequate stacking distances did not arise. However, developments within the road transport industry have seen the introduction of truck and trailer units impacting on the available stacking distances at all level crossings.

- 4.1.1 close the level crossing located at 162.56 km NIMT between Maewa and Rangitawa. (073/04)
- 4.1.2 identify all other private level crossings that are neither statutory nor granted, and either execute a deed of grant for each crossing that meets technical standards and there is a need to retain the crossing, or close the crossing. (074/04)
