## RAILWAY OCCURRENCE REPORT

04-116

passenger express Train 1605, fire in generator car, Carterton,

28 June 2004

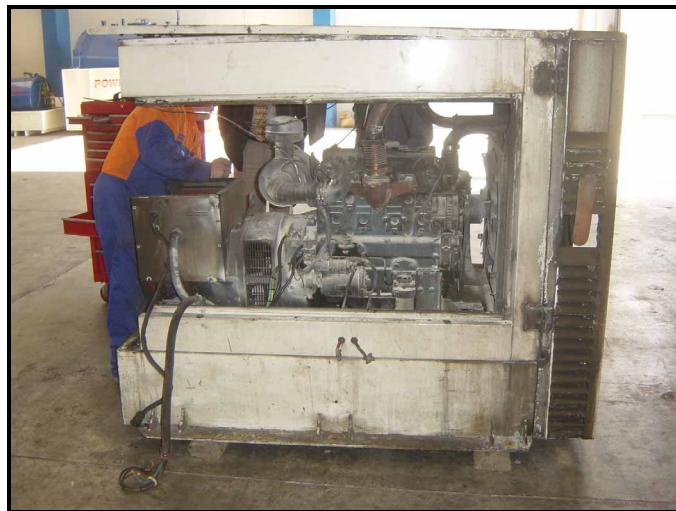
**Figure 2**  
**Generator enclosure with the side and front-end covers removed**

- 1.4.2 Engine aspiration and cooling air was drawn in from the roof intake vent and ducted to the generator enclosure. The axial radiator fan mounted at the rear of the generator housing, forced the enclosure cooling air out into the atmosphere at the rear of the passenger car. The air intake on the roof had provision for an air filter but was not fitted.

- 1.4.3 On 28 July 2005, Toll Rail advised that the air intake filters had been permanently removed in late 2000 after an investigation into an earlier fire in the other Wairarapa generator car, AL 2067, and following an investigation into hot-engine shut-downs on both Wairarapa AL generator sets in the Rimutaka tunnel. The investigations found that when the AL generator cars were in the tunnel the air intake filter and fan assembly was too restrictive and resulted in temperatures of up to 95°C around the generator set, leading to overheating and shutdown. The generator overheating problems and the vulnerability to fire in the intake filter were resolved by permanently removing both the filter and its companion fan.

- 2.4 The generator enclosure was poorly designed in that it allowed the cooling air to bypass the alternator. The alternator was positioned in a dead air space where the ambient temperature was likely to rise significantly above that in other parts of the enclosure. The air circulation around the alternator was so restricted that hot alternator exhaust air could be recycled through the alternator intake grill. A safety recommendation has been made to the Chief Executive of Toll NZ Consolidated Limited to address this issue.

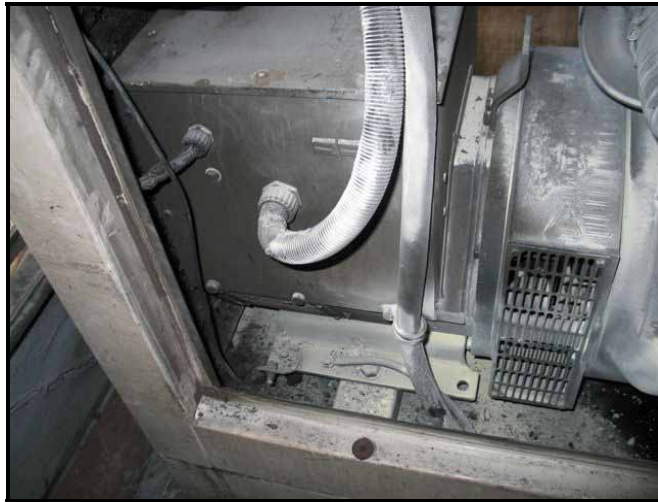
**Figure 3**  
**Alternator air intake and exhaust grill**

- 1.4.4 The alternator was directly coupled to the front end of the diesel engine drive shaft. The engine and alternator were completely enclosed within a metal clad enclosure with egg carton style plastic foam soundproof lining. The alternator cooling air was drawn from the air within the generator unit enclosure, entered the alternator at the front and was forced out at the rear near the diesel engine (see Figure 3).

- 2.1 The initial fire seat appeared to be near the alternator grill but it was not possible to determine the exact cause of the fire. It was possible, but unlikely, that a hot cinder emitted from the locomotive exhaust would have travelled the length of 3 passenger cars to be ingested into the generator enclosure and lodged in a collection of dust and diesel oil, and remained hot enough to provide an ignition source. The locomotive exhaust may have been a contributing factor had generator car AL 2073 been marshalled directly behind the locomotive and the train was travelling through the Rimutaka tunnel.

- 2.2 However, it was probable that airborne particles of dust within the alternator were heated and deposited on the soundproof material near the alternator exhaust grill. The accumulation of heated particles may have combined with oil deposits left by fumes from the diesel engine and eventually ignited the soundproof insulation material. Other airborne particles may have also been heated by the engine exhaust pipe work and found their way down to the alternator area. The poor air circulation and lack of cooling in the alternator area allowed the temperature to rise to ignition temperature.

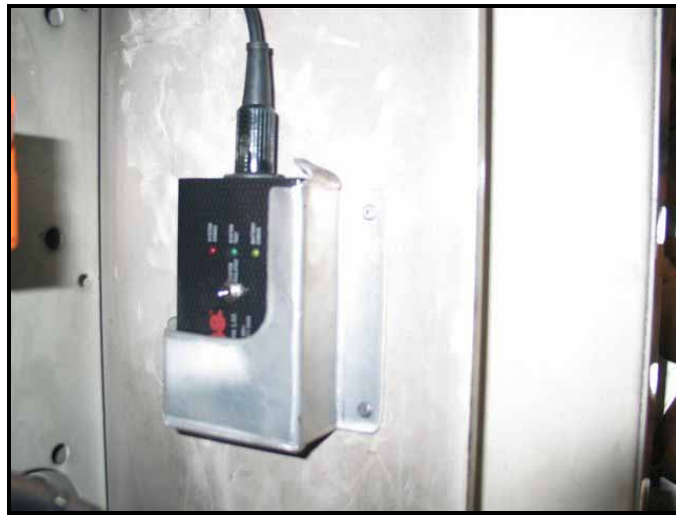
**Figure 4**  
**Power pack and control module**

1.5.5 Lifeline fire suppression systems had been designed for use in rally cars and vehicles participating in motor sport events. It was controlled by a power pack which had a 3-position manual switch that enabled the operator to "Test", "Isolate" or "Arm" the system as required (see Figure 4). The control module was fitted with a Light Emitting Diode (LED) to indicate that the system was operating.

- 1.5.6 The power pack was fitted with a PP3 9-volt alkaline battery, commonly used in domestic smoke alarm detectors and capable of about 200 mA hour capacity. The system supplier recommended selecting the “Isolate” position when the generator was not in use to extend the battery life. Because of the variability of battery life, the battery was checked weekly and replaced, regardless of condition, every 2 months. The battery was checked on Monday 21 June 2004 and was due to be checked on the day of the fire, after Train 1605 arrived in Wellington. Toll Rail advised that the battery was flat on the day of the fire.
- 1.5.7 A manual switch, located by the door leading into the generator room, was connected in parallel to a common control module (see Figure 5). Thus, with a flat battery the manual switch would not operate.

2.6 A constant current drain on current from an illuminated LED fitted to the control module of the fire suppression system meant that the expected life of a PP3 battery was probably a few weeks only and was therefore likely to fail between weekly checks and before the scheduled replacement. Because the battery in the control module had failed sometime during the week before this incident, both the automatic and manually operated fire extinguisher system was inoperative at the time of the fire.

Following the fire the control module on AL2073 was replaced with an older style module. The older style does **not** have the LED light that blinks to indicate that the battery is operating, that the newer style has.

The batteries on the newer style module require replacing approximately every two months due to the drain from the LED, whereas the older style requires battery replacement yearly and is replaced at the same time as the electrical warrant inspection.

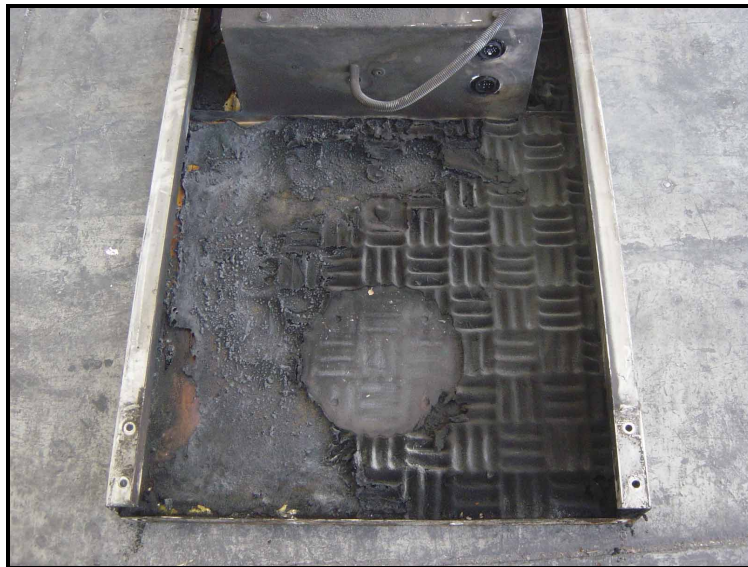
**Figure 6**  
**Burn marks to the soundproofing material**

- 1.6.1 Fire damage was contained within the generator enclosure. There appeared to be an initial fire seat near the alternator grill, with the flames then travelling vertically up the soundproof insulation material and spreading along the inside ceiling of the enclosure. Insulation on some cables and flexible conduit within the enclosure had melted but the cables were generally intact. The most significant damage was soot, extinguisher deposits and burnt soundproofing material along the front wall and ceiling.

- 1.6.2 The front-end panel of the generator enclosure had a compression mark where the alternator end plate had been pressing hard against insulation material (see Figure 6). A sample of the soundproof material was cut off and attempts made to ignite it. The material did not ignite but smouldered.

Covering the existing insulation with Flamestop insulation to prevent oil impregnation and contact with hot cinders will prevent a repeat of this incident. We intend to have this installed in all AL generator cars by the end of 2005. (068/05) and (069/05)
