RAILWAY OCCURRENCE REPORT

04-120 Express freight Train 726, collision with runaway locomotive, Pines

18 August 2004

Report 04-120
express freight Train 726
collision with runaway locomotive
Pines
18 August 2004

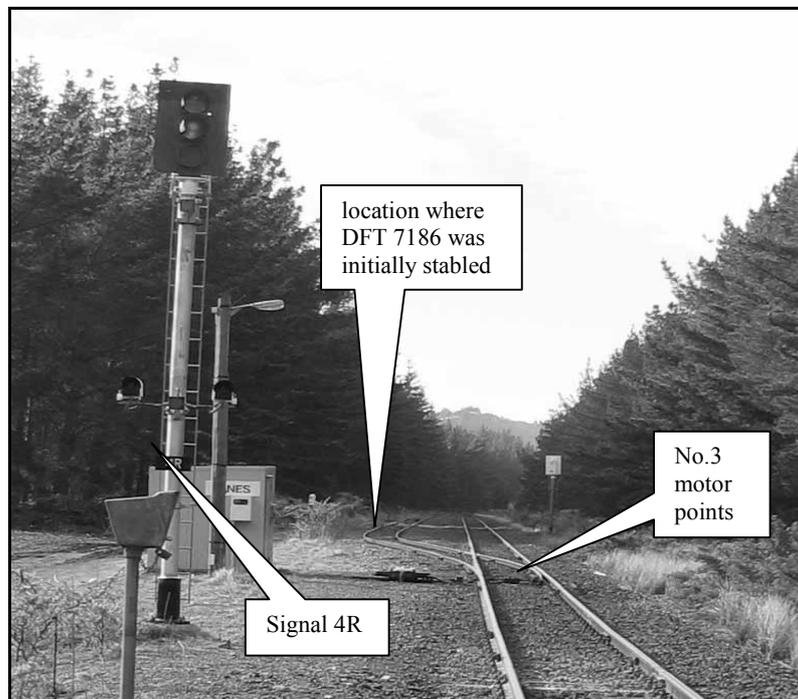
Figure 1
Pines crossing loop, looking north

- 1.1.5 On arrival at Pines, the locomotive engineer detached DFT 7186 and drove it onto the loop, and shut it down (see Figure 1). Having stopped DFT 7186 with the independent air brake, the locomotive engineer applied the handbrake to secure the locomotive before leaving it unattended.
- 1.1.6 The train was to continue to Picton with one locomotive only. Because the remaining locomotive would be long hood leading, a roving shunter³ was summoned to act as second person⁴. The shunter arrived at about 0410, and Train 722 resumed its journey.

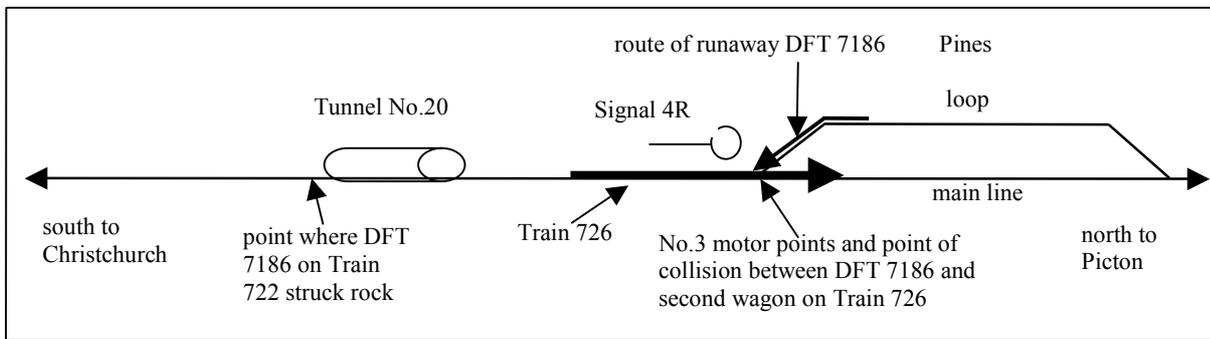
Figure 2
Track layout between Pines and tunnel No.20

- 1.2.3 The 945 m length of the loop at Pines sloped downhill to the south on a gradient of 1 in 280, but the gradient steepened to 1 in 130 about 300 m north of No.3 motor points.
- 1.2.4 From 0900 Tuesday 17 August 2004 to 1200 Wednesday 18 August 2004, a severe weather warning had been in effect for the MNL with heavy rain and strong winds.
- 1.2.5 A range of hills rose steeply to a height of about 540 m parallel to the track alignment where the rock fall occurred.

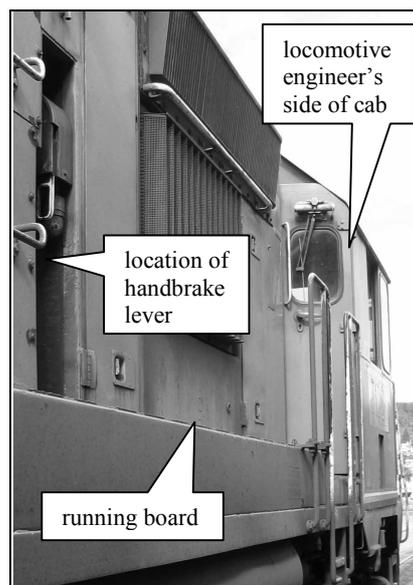
Figure 3
General location of handbrake on DFT 7186

- 1.3.1 DFT 7186 was one of a fleet of 30 diesel electric mainline freight and passenger locomotives built by General Motors of Canada and entered service between 1979 and 1981. The fleet was rebuilt after being fitted with turbo-chargers between 1992 and 1997. DFT 7186 weighed 87.6 t and was equipped with a handbrake mechanism outside the locomotive on the long hood end, behind the locomotive engineer’s side of the cab (see Figure 3).

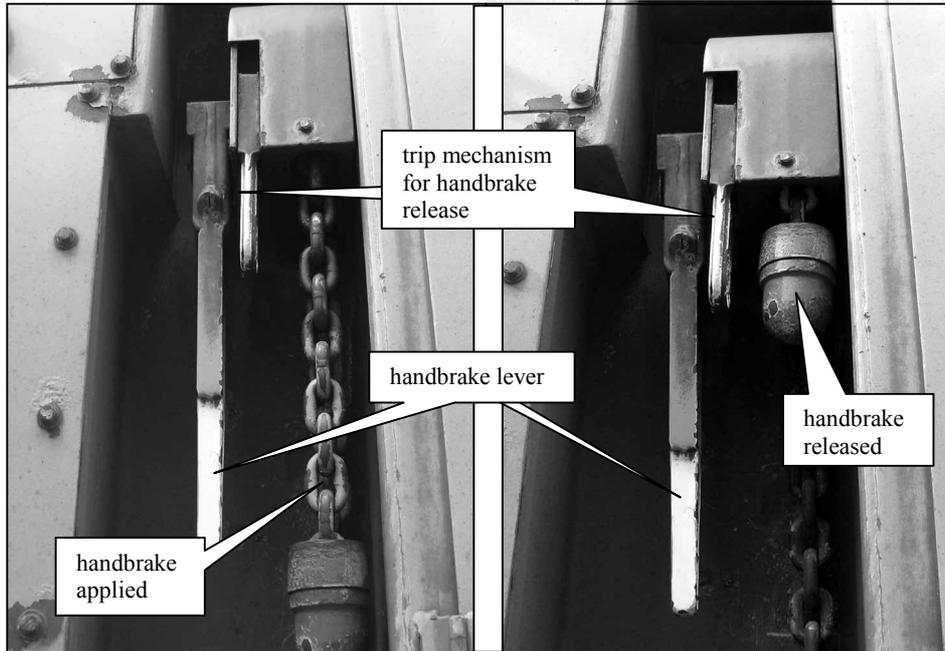
Figure 4
Handbrake applied (left) and handbrake released (right)

1.3.3 The handbrake was a gear-type device that delivered a braking force equal to, or greater than, the air brakes. The handbrake was applied by use of a ratchet handle attached to a chain connected directly to the brake rigging on the bogie located under the cab. During a handbrake application, the chain assembly movement applied the brakes. Depending on the adjustment of the chain, about 6 to 8 pulls on the ratchet handle were normally required to fully apply the brake. A weighted trip mechanism released brake tension (see Figure 4).

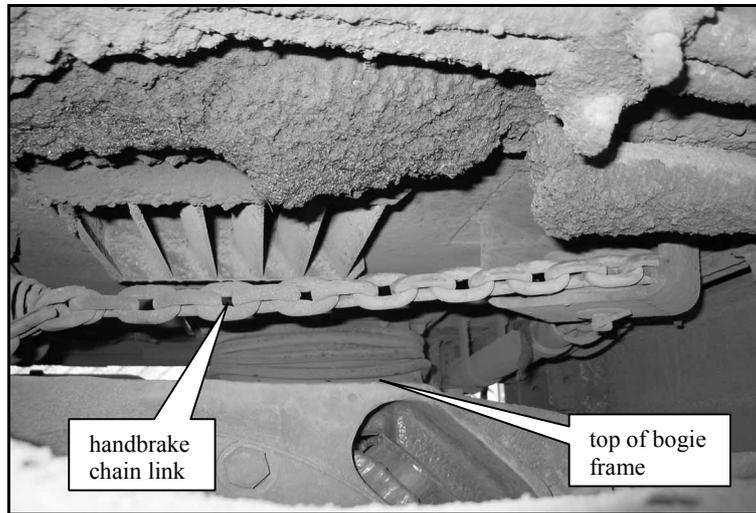
Figure 5
Handbrake chain link mechanism between locomotive underframe and bogie

- 1.4.22 The supervisor climbed to the running board, released and then attempted to reapply the handbrake. During this reapplication, the handbrake came up to what he later described as a tight point, which did not feel normal. He then exerted more pressure and the mechanism suddenly came free and he was able to apply the handbrake fully.
- 1.4.23 The supervisor re-examined the front bogie and found some freshly broken stone fragments, all about the size of a 20-cent coin, on top of the bogie frame in the area where the chain links travelled from the locomotive underframe to the bogie.

- 2.3 The handbrake could be fully applied only after the Alstom supervisor had later exerted the extra pressure, which suddenly released the mechanism. The shattered fragments of rock that he found on top of the bogie had probably been lodged in the chain link mechanism after the collision with the rocks at tunnel No.20, and been ejected when he applied extra pressure.

- 3.3 When the locomotive engineer applied the handbrake of DFT 7186, the fragments of rock prevented a full application, although the locomotive engineer had no indication that it was other than fully applied.

introduce a procedure for stabling of locomotives, so that the person applying the handbrake is able to confirm application by visually checking contact between the brake blocks and wheels (011/05).
