RAILWAY OCCURRENCE REPORT

04-121 Locomotive DBR1199, derailment, Auckland

24 August 2004

**TRANSPORT ACCIDENT INVESTIGATION
COMMISSION
NEW ZEALAND**

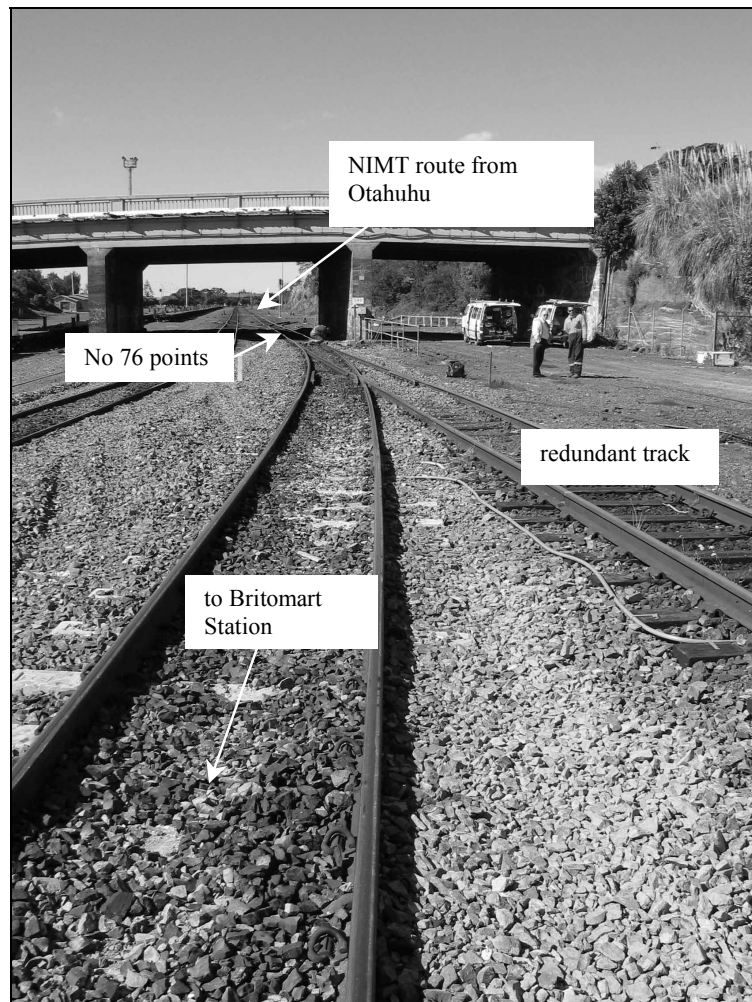
Figure 1
No 76 points at Auckland

- 1.2.1 No 76 points were permanently secured in the direction of Britomart Station, away from a section of redundant track (see Figure 1).

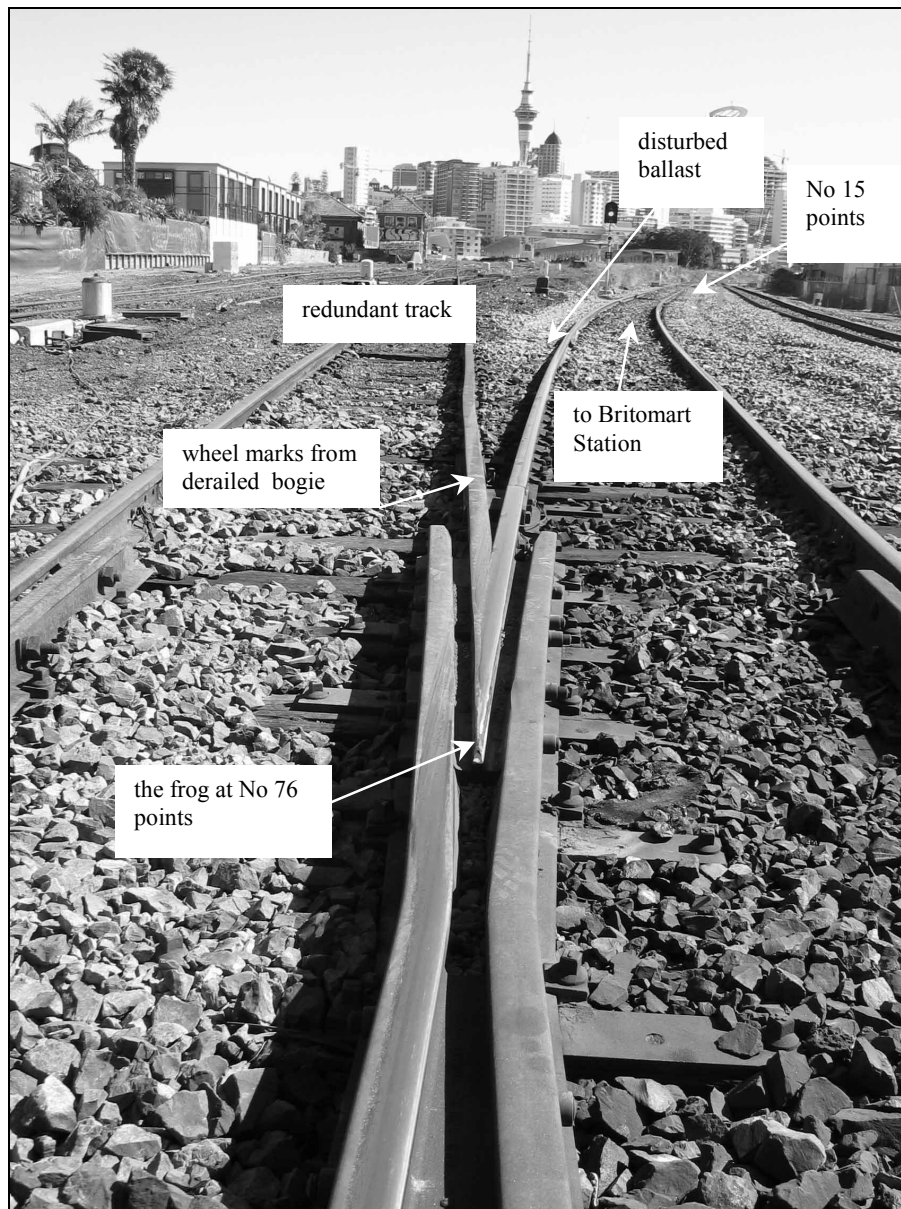
Figure 2
The frog and diverging routes at No 76 points

- 1.2.2 The frog at No 76 points showed signs of impact damage and the diverging redundant rail had wheel marks on the railhead for a short distance (see Figure 2).

- 2.2 As the trailing bogie of DBR1199 traversed No 76 points, the rail divergence at the frog and displacement of the wheel flange were sufficient to cause the loose tyre on wheelset 4A to take a diverging route from the rest of the train, pulling the wheel at the opposite end of the axle in the same direction until both wheels derailed. Track damage indicated that as DBR1199 continued towards No 15 points, the right-hand derailed wheel on axle 4 was travelling on the concrete sleepers between the rails on the up main line while the left-hand wheel (wheelset 4B), with the defective tyre, was travelling in the ballast on the left-hand side of the rails, beyond the edge of the sleepers.

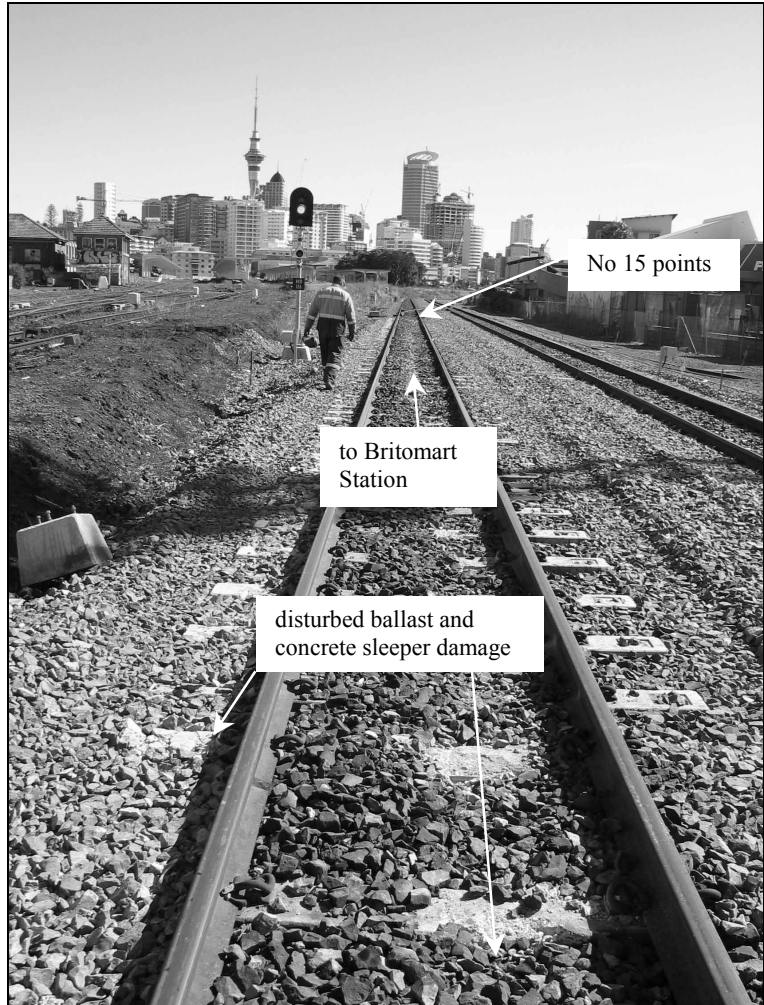
Figure 3
Track damage towards No 15 points

- 1.2.3 The track between No 76 points and No 15 points, a distance of about 100 m, showed evidence of disturbed ballast and concrete sleeper damage (see Figure 3). There was also bruising on the treated pinus radiata sleepers at No 15 points (see Figure 4).
- 1.2.4 A permanent 40 km/h speed restriction was in effect over No 76 points and on the approach track to Britomart Station.

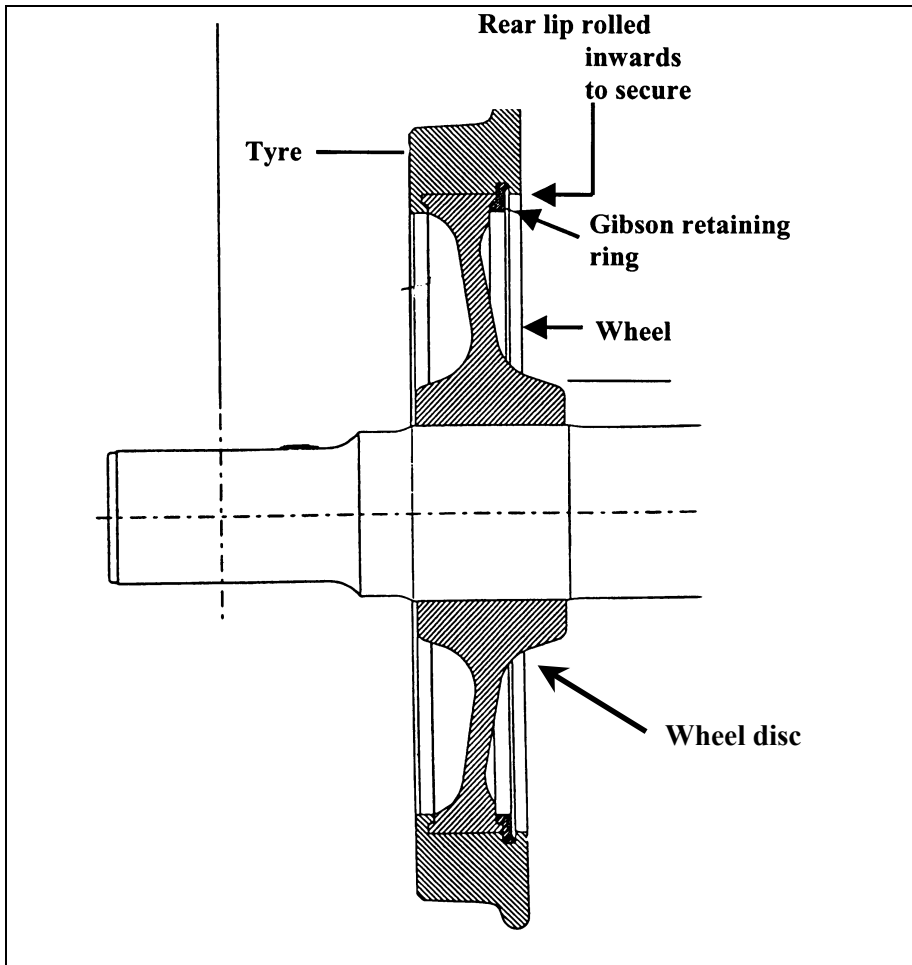
Figure 5
Diagram showing tyred wheel assembly

- 1.6.2 The method of fitting and retaining tyres involved shrink-fitting from a high temperature. The tyres were heated to a high temperature, placed on the wheel disc and, as the temperature cooled and the tyre contracted, a shrink-fit on the wheel resulted. A Gibson retaining ring was placed in position and the tyre lip was then rolled until the retaining ring was tightly gripped to retain the tyre in its correct position (see Figure 5).

- 1.6.3 The loosening of a tyre on the wheel disc was a known phenomenon. In this event, the Gibson retaining ring could only restrain a loose tyre for a short period. If a tyre became overheated, perhaps due to repeated heavy braking action, the shrink-fit on the wheel disc was reduced. The outer lip of the tyre and the Gibson retaining ring were intended to retain the tyre in place until it cooled and regained its shrink-fit.

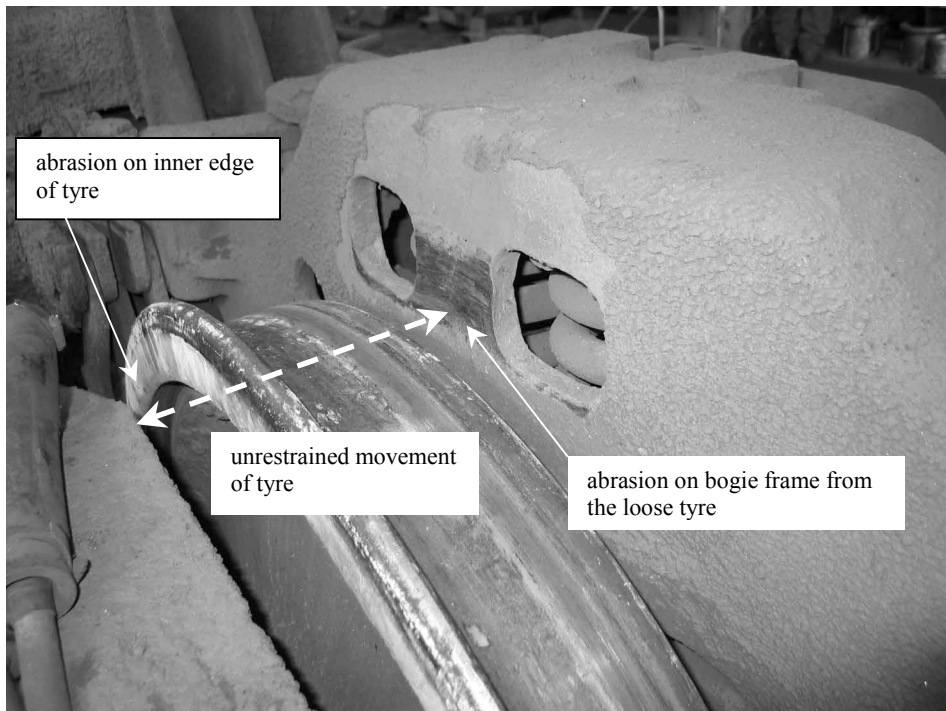
Figure 6
Wheelset 4A and bogie frame showing signs of wear from loose tyre

- 1.6.4 If overheating continued, for example through dragging brakes or repeated heavy brake applications, the tyre could turn on the wheel disc and wear away the interface so that when the tyre cooled down it could still be loose. This would increase the wear between the original interface surfaces and also gradually erode the Gibson retaining ring. If the Gibson retaining ring failed, there would be nothing to stop the tyre from moving to the outside of the wheel disc (see Figure 6).

- 2.1 Following the derailment the Gibson retaining ring was missing. Without the retaining ring, the tyre was able to move laterally, but the bogie frame prevented the loose tyre breaking free of the axle.

- 2.11 The derailment was caused by a loose tyre on wheelset 4A of DBR1199 moving laterally on the wheel disc and striking the frog of No 76 points.
- 2.12 The tyre was able to move laterally because excessive heat had probably, as a result of repetitive heavy braking over time, loosened the shrink-fit of the tyre on the wheel disc, resulting in the wearing away and subsequent collapse of the Gibson retaining ring.

- 2.23 On 27 September 2004 Toll Rail advised that a new policy had been adopted to lift the condemning limit for tyred wheelsets from 32 mm to 35 mm for all locomotives. Two of the DC class locomotives rostered for passenger service between Wellington and Masterton had completed bogie changes.

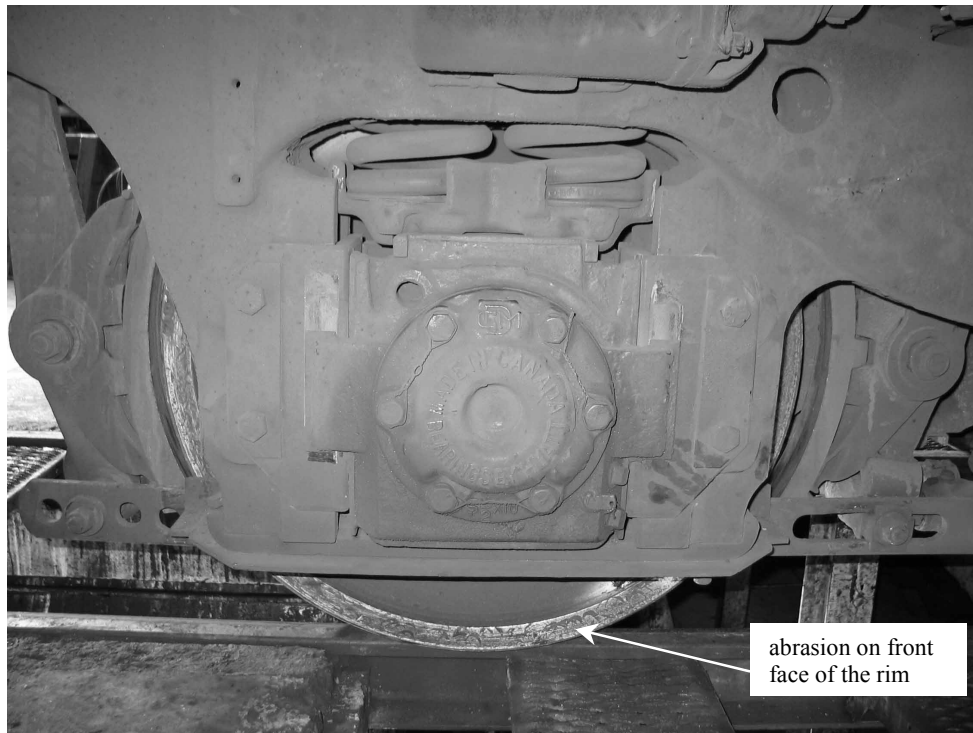
Figure 7
Abrasion on the front face of the rim

- 1.6.4 Figure 7 shows the abrasions on the front face of the rim caused by the tyre rubbing against the bogie frame.
- 1.6.5 Wheelset 4A was measured following the derailment and was found to have a tyre thickness of 32 mm, which was the condemning limit defined by the manual.
