## RAILWAY OCCURRENCE REPORT

**04-123    Electric multiple unit traction motor fires,    7 May 2004 – 30 September 2004**  
**Wellington Suburban Network**

**TRANSPORT ACCIDENT INVESTIGATION  
COMMISSION NEW ZEALAND**

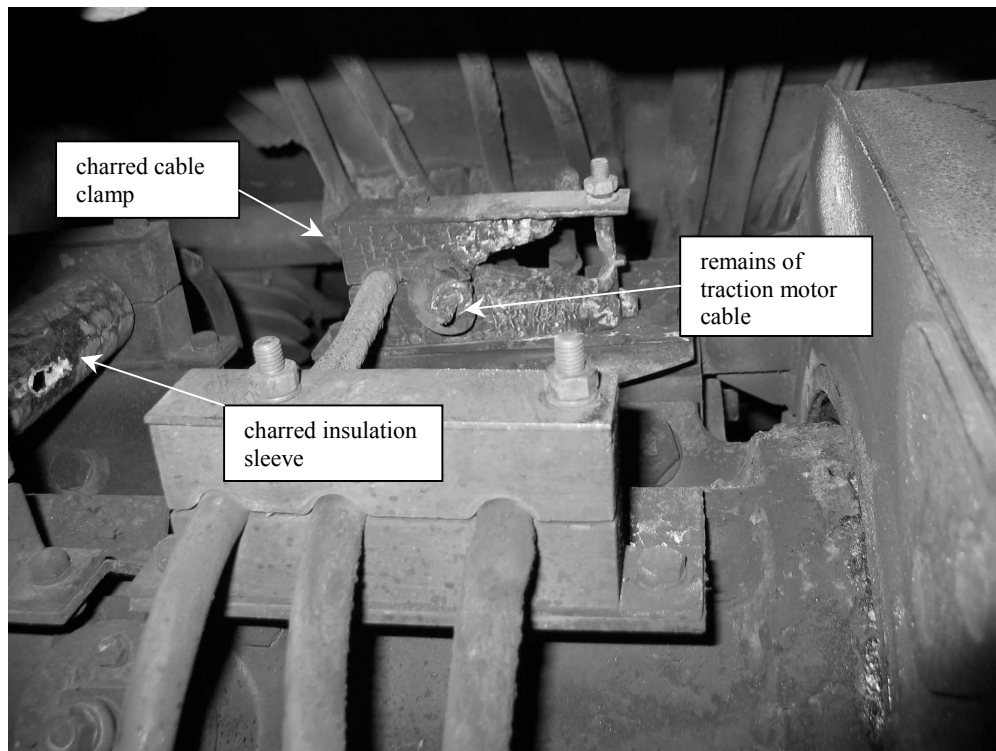
**Figure 1**

- 2.1.9 Inspection of EM1315 at the EMU depot revealed that the nuts and bolts securing the wooden cable clamps had vibrated free and allowed the traction motor cables to hang loose. The wires of the cable were frayed adjacent to the crimp connection.

**The fire-damaged cable joint area, including the cable clamp, on EM1315 (Train 6260)**

- 2.1.10 There was evidence of a small, localised fire in the vicinity of the wooden cable clamping block, which had burnt.
- 2.2 Occurrence 04-114, Train 5612, Petone, 7 May 2004**

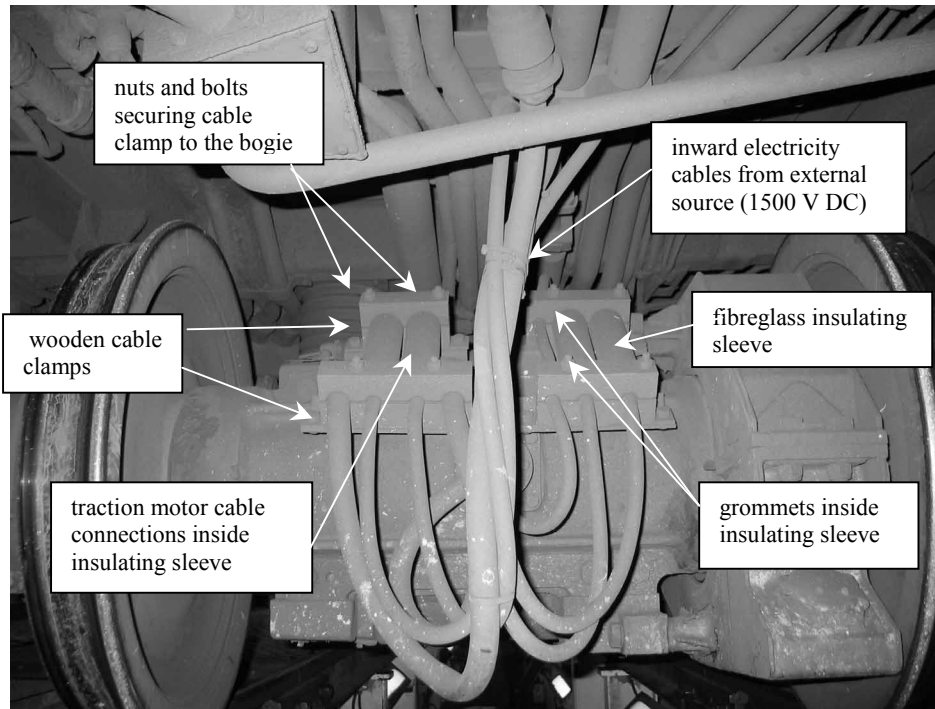
**Figure 2**  
**Typical traction motor connections, insulated and clamped**

- 3.1.1 The traction motors on each powered unit were arranged in 2 sets of 2 with one set on the front bogie and the other on the rear bogie. Each motor came with short cable tails fitted with crimp lugs for connection to the fixed wiring of the unit.
- 3.1.2 The traction motors were connected to the fixed wiring by bolting the respective cable end crimp lugs together. The cables were clamped between wooden blocks, placed either side of the uninsulated crimp connectors, and the joints insulated using fibreglass sleeves which fitted snugly between the wooden cable clamps (see Figure 2).

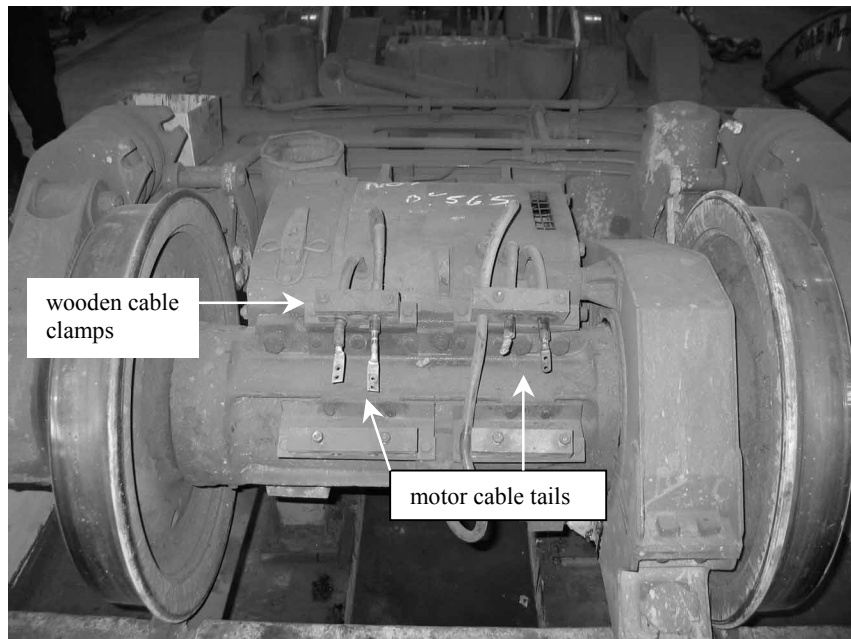
**Figure 3**  
**A traction motor bogie showing motor cable tails and cable clamps**

- 3.1.3 The wooden cable clamps through which the cables passed before entering the insulation sleeve were fastened to the bogie by nuts and bolts. The clamps secured the cable connection by preventing movement while the vehicle was in motion. However, that part of the bogie did not have suspension, so the clamps and cable connection within the insulation sleeve were subjected to continuous shock loads<sup>3</sup> and vibration as the train moved.

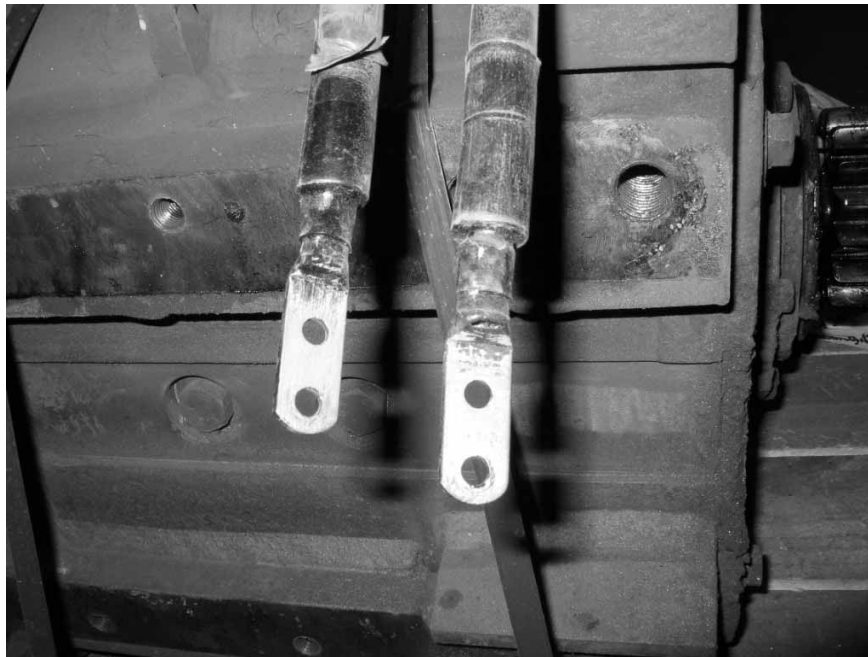
**Figure 4**  
**A 35 mm<sup>2</sup> lug crimped to the 35 mm<sup>2</sup> cable ends**

- 3.1.4 The lugs were constructed of cadmium-plated copper (see Figure 4) and were crimped to the exposed ends of the 35 mm<sup>2</sup> cables with a mechanical crimping tool.

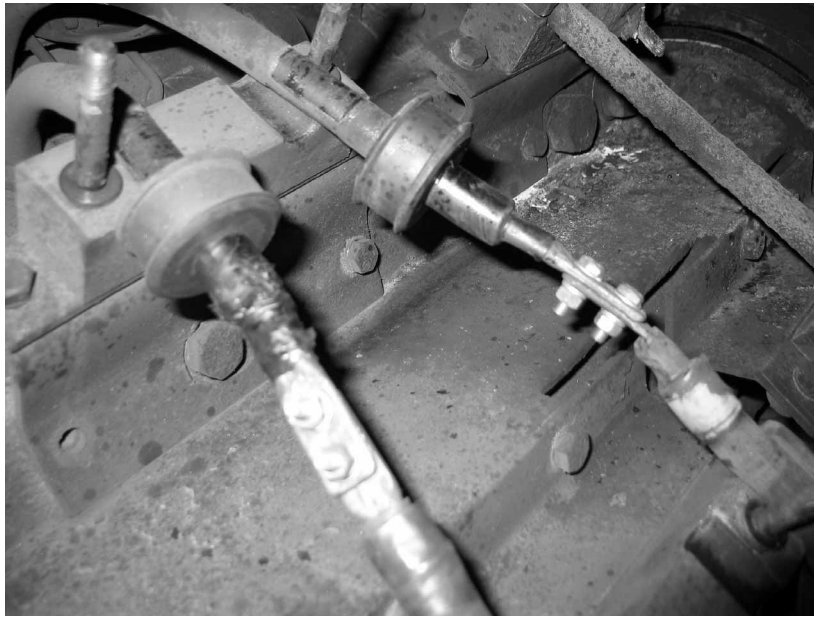
**Figure 5**  
**The exposed cable connection**

- 3.1.5 The cables carrying the voltage from the overhead pantograph were 35 mm<sup>2</sup> and were joined inside the insulation sleeve to the traction motor cables by bolting together the crimped lugs at each end of the joining cables (see Figure 5). Design specifications required that 35 mm<sup>2</sup> lugs be used.

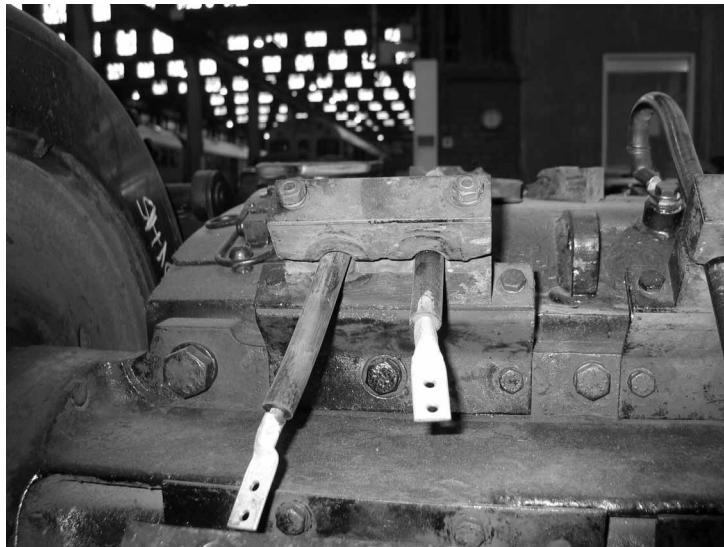
**Figure 6**  
**A 50 mm<sup>2</sup> lug crimped to the 35 mm<sup>2</sup> cable end**

3.3.1 A shortage in the supply of 35 mm<sup>2</sup> lugs meant that mechanical depot and workshop staff had resorted to the use of 50 mm<sup>2</sup> lugs. However, when 50 mm<sup>2</sup> lugs were crimped to the 35 mm<sup>2</sup> cable ends, a weak point was created between the lug and the cable insulation (see Figure 6). If the cable connection within the insulation sleeve could move for any reason the resulting stress caused the exposed cable strands to fray and the remaining strands overheated, as they took more current.

- Toll Rail was employing an electrical engineer to review the problems and become involved in the fixes
- Tranz Metro were intending to start replacing the lugs on all traction motor cables with new 35 mm lugs which were due to arrive from the manufacturer on 4 October 2004
- A staff member was being put on late shift to undertake the replacement work, it was anticipated this would start on Monday 11 October 2004. The plan was that one car would be done per day, 5 cars per week, which would see the 44 EM cars finished by Christmas 2004.

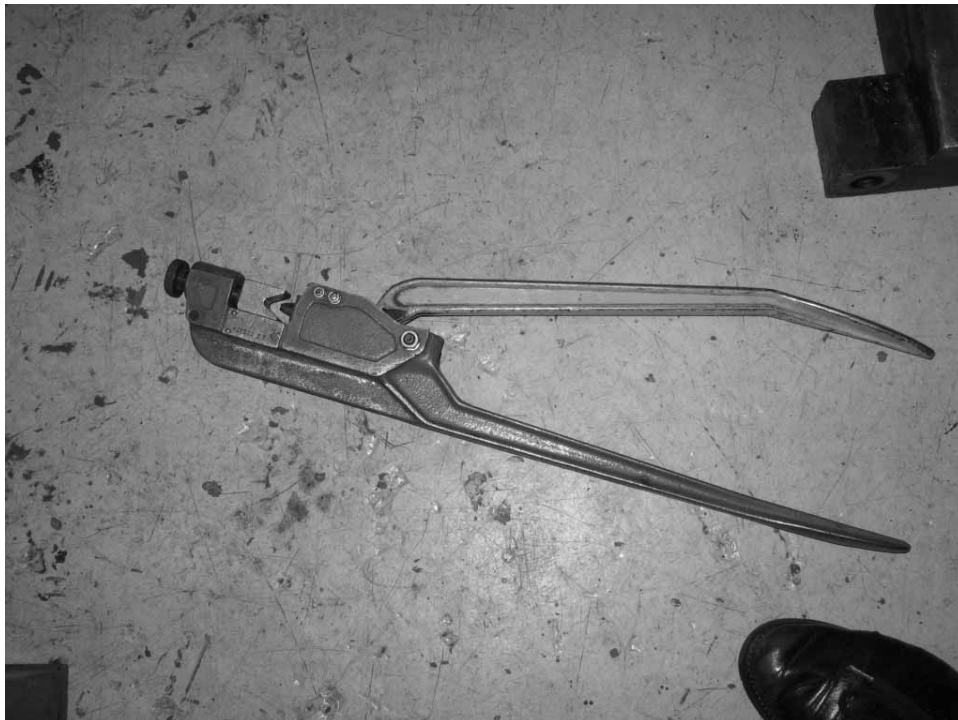
**Figure 8**  
**The manually operated, adjustable crimping tool in use at Alstom Hutt**

- crimp connections at Alstom Hutt were made with a simple hand tool (see Figure 8) using 35 mm<sup>2</sup> cable and 50 mm<sup>2</sup> lugs. The crimp method was a V shape barrel distortion and indent. The tool was adjustable for a range of several cable sizes but the operator technique determined the quality of the joint and depth of the indent. The operator noticed that the crimp connections were usually loose so often made 2 crimp indents on each lug

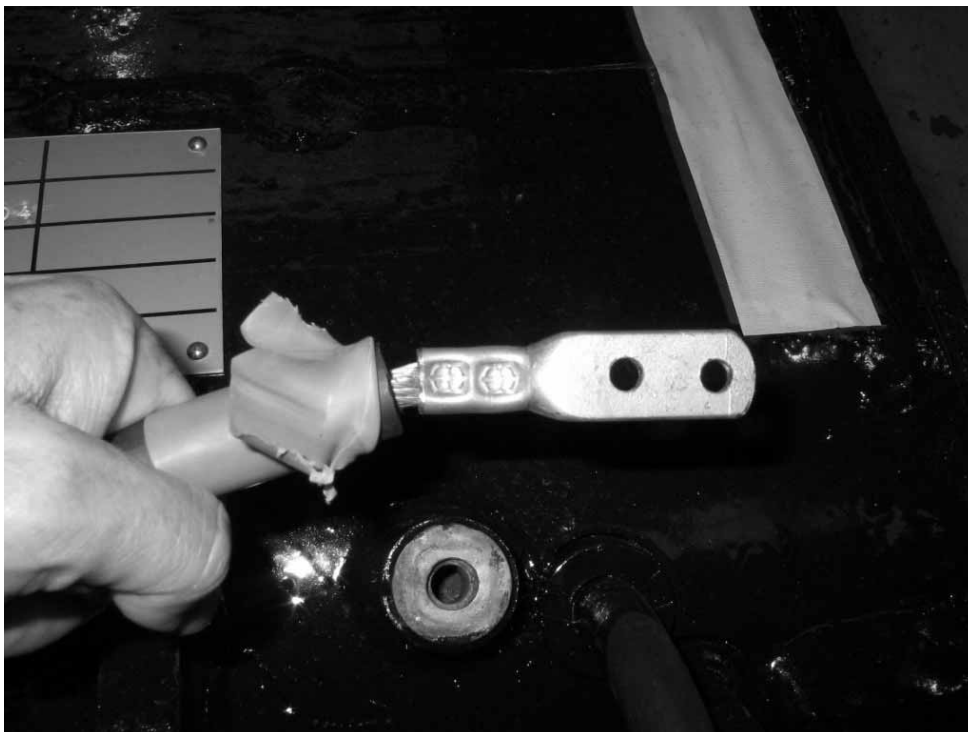
**Figure 10**  
Standard 50 mm<sup>2</sup> crimp on 35 mm<sup>2</sup> highly flexible cable  
showing excessive clearance (Alstom Hutt)

5.6.3 These reduced quality crimp joints created high contact resistance between individual cable strands and the crimp connector barrel due to low contact pressure. This extra electrical resistance generated heat under load. The effect of this poor quality connection was to reduce maximum current capacity to a point where normal operating load currents generated excessive heating at the joint.

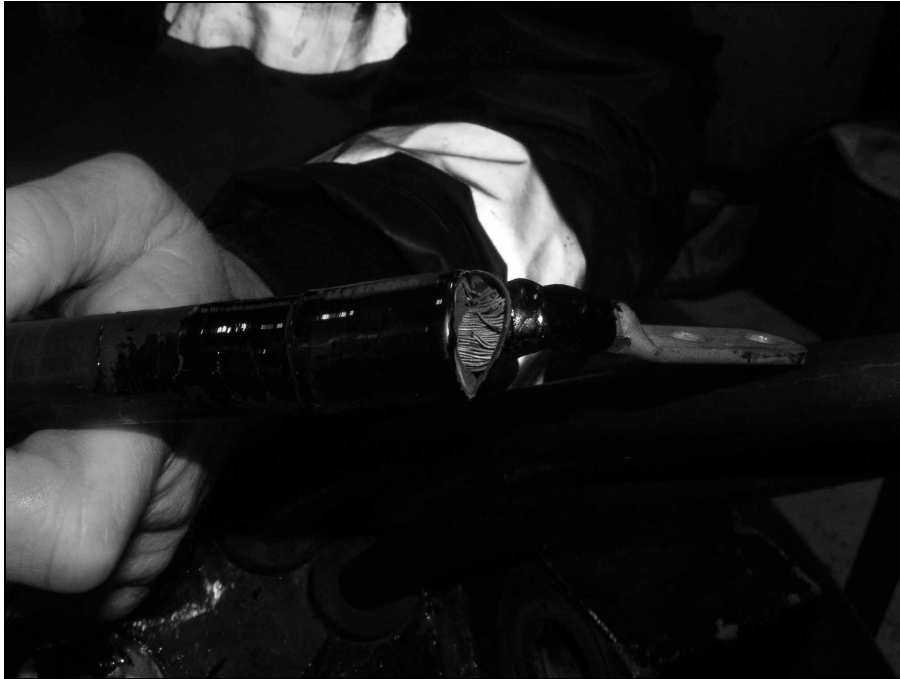
- recently crimped connections at Alstom Hutt were found to have loose strands inside the crimp lug barrel

**Figure 11**  
**Recently crimped joint showing loose cable strands (Alstom Hutt)**

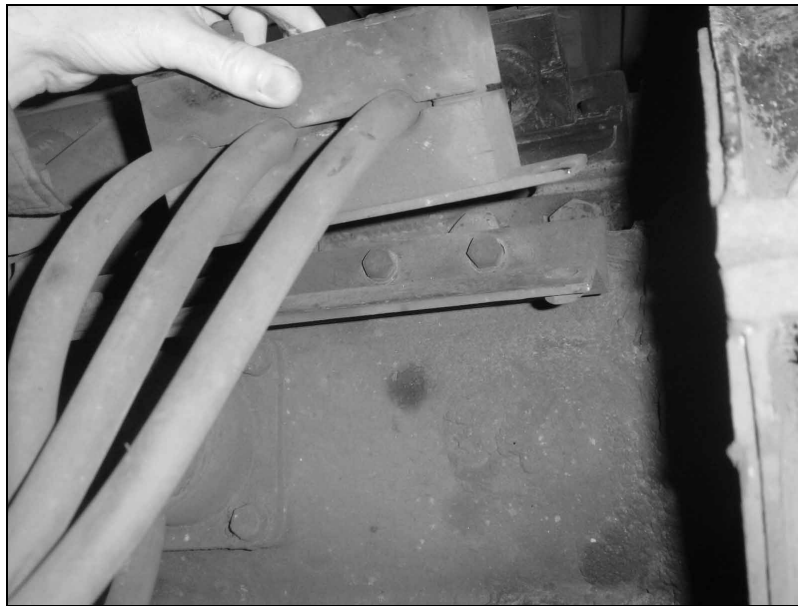
- 6.2 Wooden cable clamps and fibreglass sleeves around the crimp lug connection were fitted by the manufacturer to reduce the vibration effect upon the cable joint. . This had proved reasonably effective but could still fail. A traction motor fire inspected on 1 October 2004 was a result of such a failure when one bolt holding the wooden cable-clamping block came adrift and allowed the block to pivot on the remaining bolt. The mechanical stress was absorbed by the cable crimp lug until it eventually failed. The palm broke across the bolt hole and separated. The broken joint arced as it parted, which caused a motor failure with smoke in the carriage.

**Figure 12**  
**The wooden cable clamp with the mounting bolt missing**

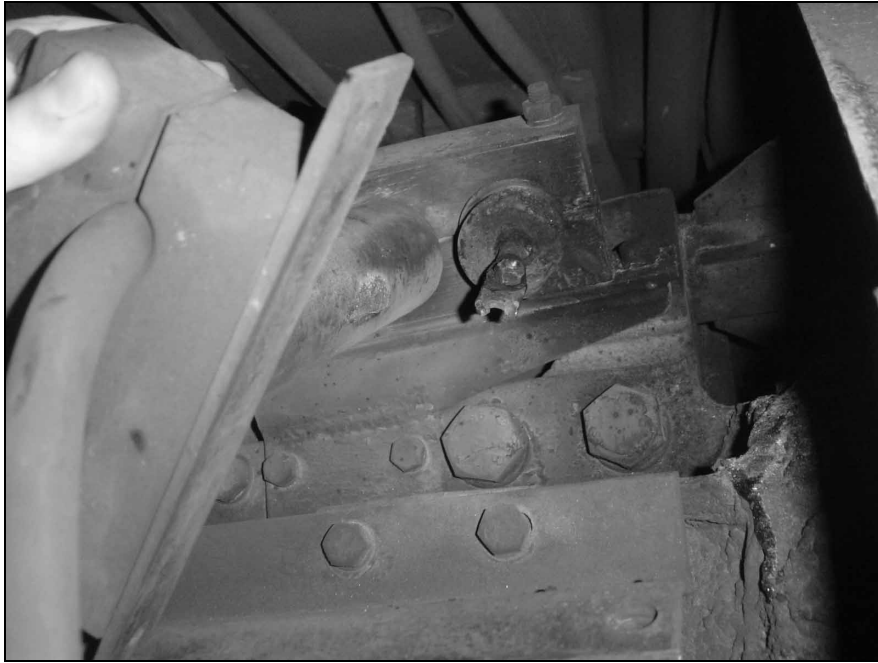
- 6.3 The flexible cable was now suspended between 2 fixed points (the wooden cable clamps), approximately 300 mm apart, with both points firmly connected to the bogie and fully exposed to the train vibration. In the centre of this short cable span was a solid mass formed by the crimp lugs and bolts. The mass of this connection, suspended by a flexible cable, was free to oscillate with the vibrations of the bogie. This continually stressed the cable lugs and the cable at the point where it entered the fibreglass barrel.

**Figure 13**  
**The cable clamp free to pivot and the failed crimp lug in the rear**
