## RAILWAY OCCURRENCE REPORT

04-125      collision between an over-dimensioned road load and rail over road      2 October 2004  
bridge No.98 on Opaki-Kaiparoro Road, between Eketahuna and  
Mangamahoe

**Report 04-125**

**collision between an over-dimensioned road load**

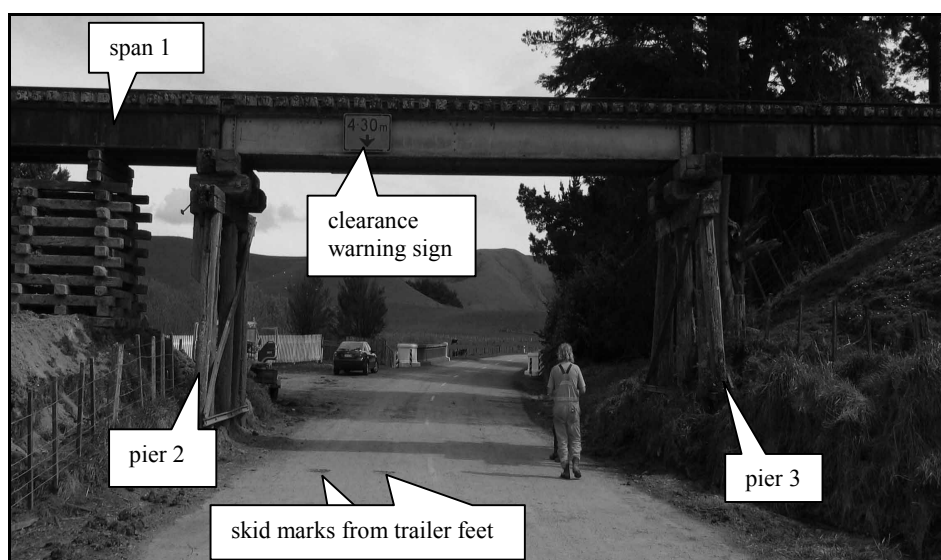
**Figure 4**

- 1.2.3 Bridge No.98, a rail over road bridge was located at 117.95 km on Opaki-Kaiparoro Road between Eketahuna and Mangamahoe. The bridge was first built in the late 1880s when the Wairarapa Line was built through the area, rebuilt in 1917 and the centre girder was replaced in 1966.
- 1.2.4 Bridge No.98 consisted of 3 two-leaf deck plate girder spans supported by 2 hardwood pile abutments and 2 hardwood timber pile piers. The bridge was on a 300 m radius right-hand curve and speed across the bridge was reduced to 60 km/h. The clearance between the roadway and the centre span was posted as 4.30 m (see Figure 4).

### **Bridge No.98 after temporary repairs looking north along Opaki-Kaiparoro Road**

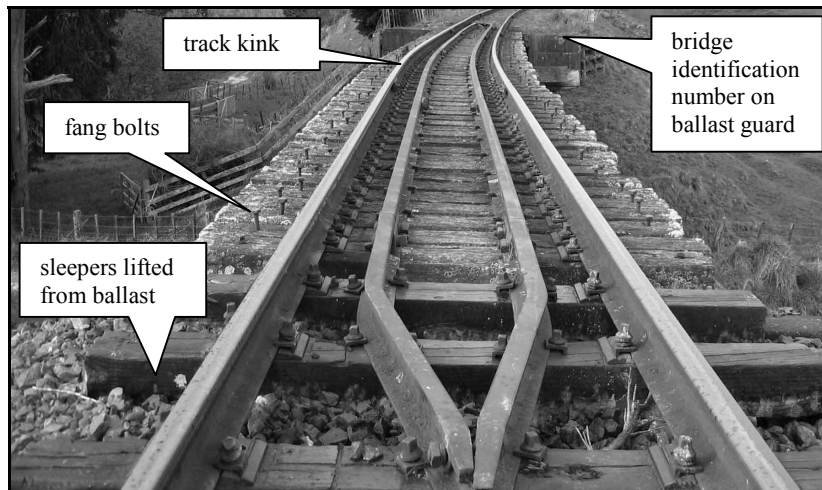
- 1.2.5 Following an inspection, the damage to bridge No.98 was reported as:
- The sleepers on southern side on span 1 had been lifted 80 mm vertically above the running beam<sup>5</sup> with the fang bolts pulled out of the running beam (see Figure 5).

- The track across the bridge had been pushed to the left by 75 mm at pier 3 forming a kink (see Figure 5).

**Figure 5**  
**Damage sustained to bridge No.98 viewed from rail level**

- 1.2.6 The damage to the centre span was such that it had to be removed and replaced with a similar sized span from a stock of spares held at Woburn workshops.

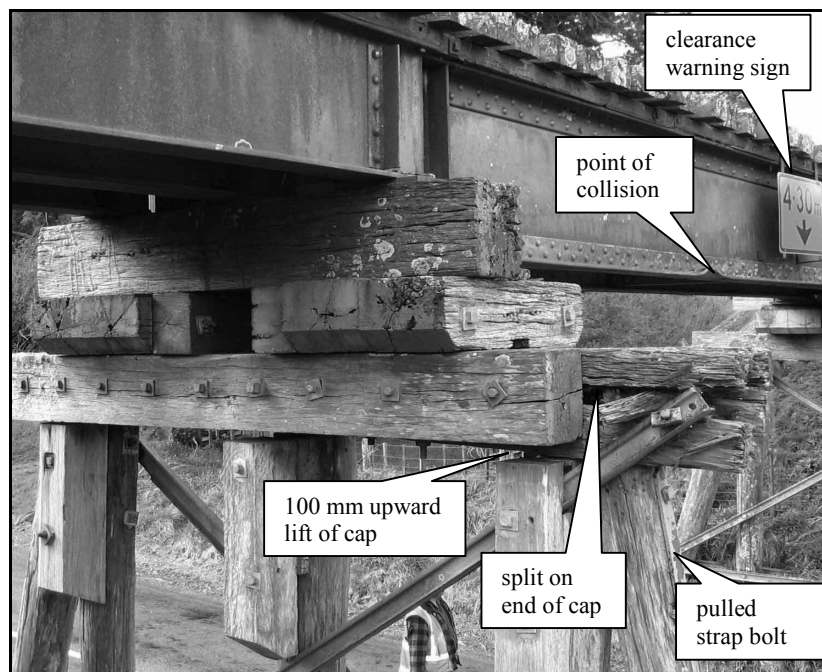
- The cap on pier 2 had been lifted approximately 100 mm and was sitting on top of the pile tenons<sup>6</sup>. The cap had been shifted to the left by 75 mm and the end of the cap where the collision occurred had been split laterally for about 1500 mm. The strap bolt holding the cap to pile No.1 had been pulled out (see Figure 6).

- The bottom flange of the plate girder had been bent up by 60 mm and inwards by 80 mm over a lateral length of 400 mm at the point of impact. The web plate of the girder was bent 100 mm towards the middle of the steel plate to a height of 600 mm above the bottom flange over a lateral length of about 2500 mm (see Figure 6).

**Figure 6**  
**Damage sustained to Bridge No.98 viewed from the south side**

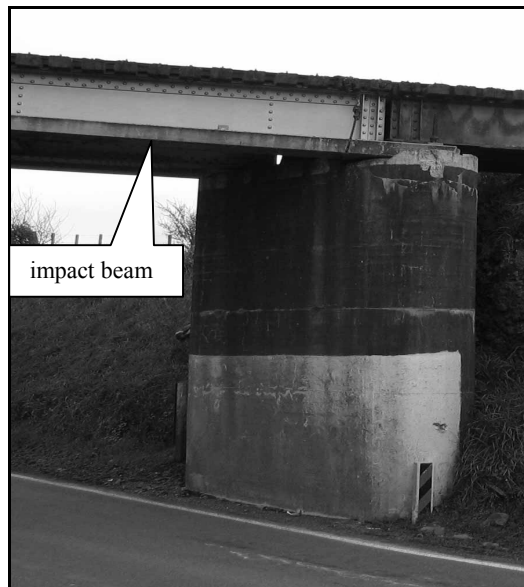
**Figure 7**

**Impact beam installed on bridge No.103 over State Highway 2, north of Eketahuna**

- 1.2.14 NZRC's Structures Code W 004 specified that rail over road bridges that were considered vulnerable to road vehicle impact damage, and those with a history of bridge strikes<sup>9</sup> were to be fitted with impact beams. Because of a history of bridge strikes on bridge No.103 over State Highway 2, impact beams were chained to the bridge piers (see Figure 7).

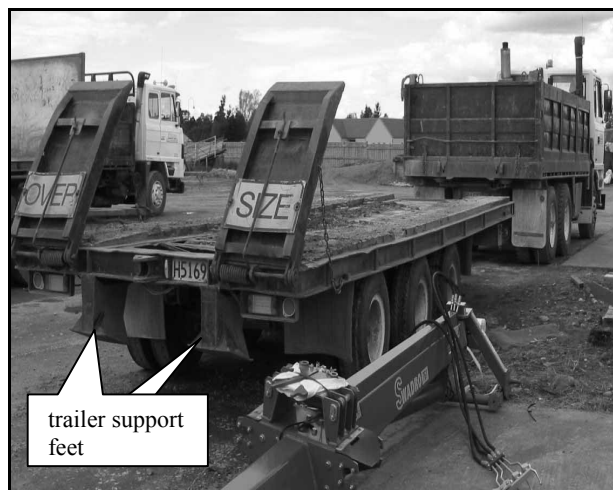
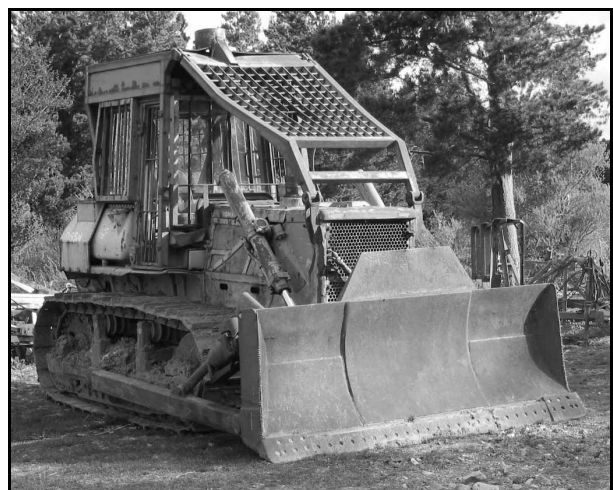
**Figure 9**  
**View of trailer and bulldozer**

- 1.5.3 The bulldozer was unregistered, so its dimensions were not held by Land Transport NZ. Industry sources calculated the overall height of the bulldozer, including the cab and the air conditioning unit would have been about 3.50 m. When loaded on the trailer, the overall height would have been about 4.50 m.

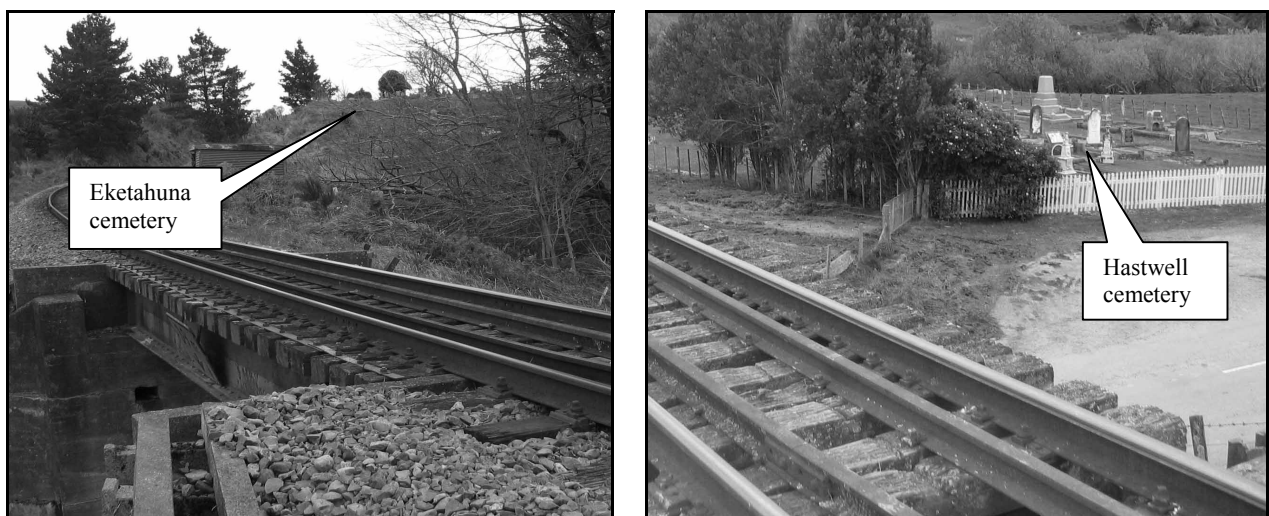
**Figure 10**  
**Bridge No.102 (left) and bridge No.98 (right) located next to cemeteries**
