RAILWAY OCCURRENCE REPORT

04-126

express freight Train 244, derailment inside Tunnel 1,
North Island Main Trunk, near Wellington

11 October 2004

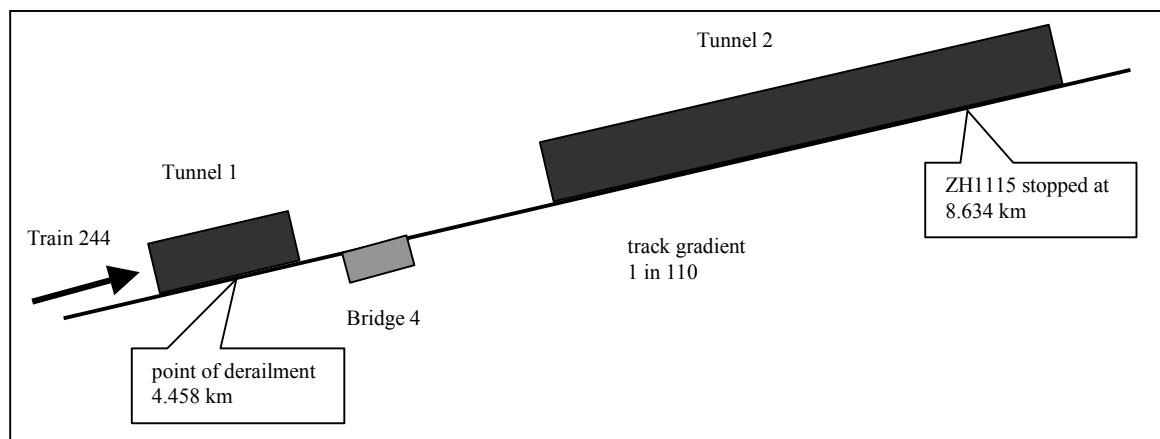
Figure 1
Derailement site plan (not to scale)

- 1.2.1 Train 244 started a 7 km long steady climb, at a ruling gradient of 1 in 110, about one km from Wellington Yard (see Figure 1).

- 1.2.2 Marks on the inside of the right running rail and a wheel flange mark across the rail head to the right side identified the point of derailment (POD) at 4.458 km, on straight track near the middle of Tunnel 1. There were impact marks, about 110 mm long, on the running edge of the right rail spaced equivalent to the wheel circumference for about 120 m before the POD. The first impact marks on the sleepers from the derailed wheelset were 3.7 m past the POD. A second set of impact marks on the sleepers started 9.3 m past the POD, indicating that the trailing wheelset of the leading bogie had derailed at that point.

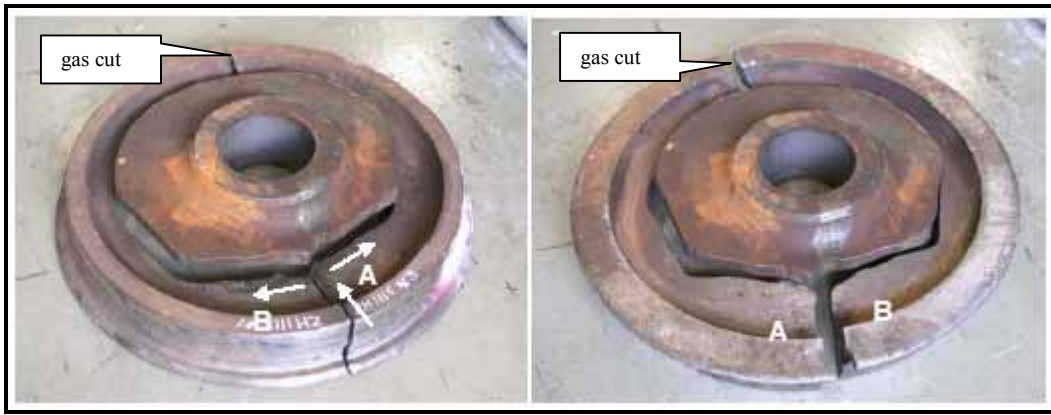
Figure 2
View of both sides of the fractured wheel

1.10.1 Three pieces of the broken wheel were examined. The 3 pieces consisted of almost equal halves of the rim, labelled A and B, with part of the outer regions of the hub attached, and the hub itself (see Figure 2). Fracturing had occurred across the rim into the hub and circumferentially around the hub.

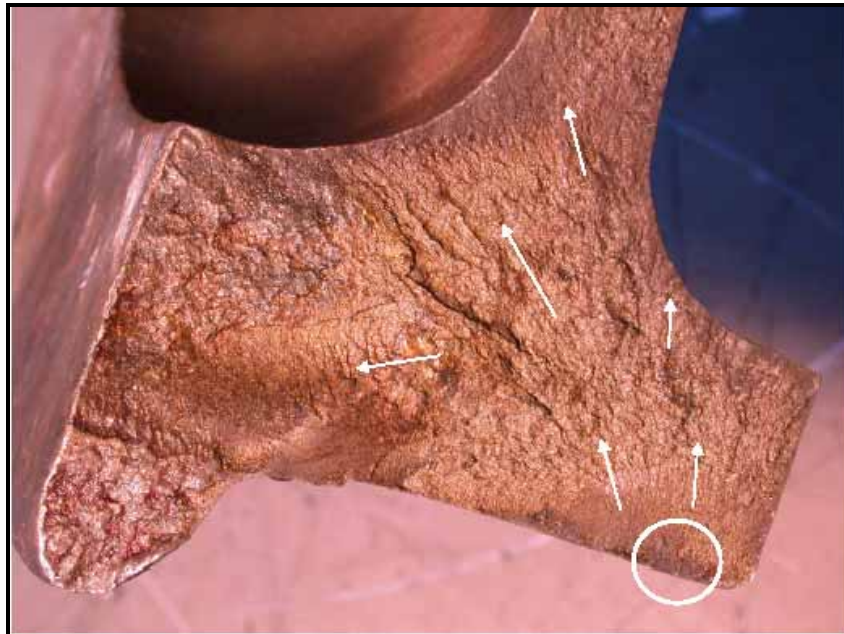
Figure 3
Fracture face of piece A showing origin of fracture and direction of propagation

1.10.2 Along the fracture, piece A exhibited a fine, fairly flat crack face, about 30 mm wide with an initiation point at the surface of the tread (see Figure 3). There was a small lip at the tread's surface. The lip was slightly impressed from the surface and appeared to have been a result of mechanical damage.

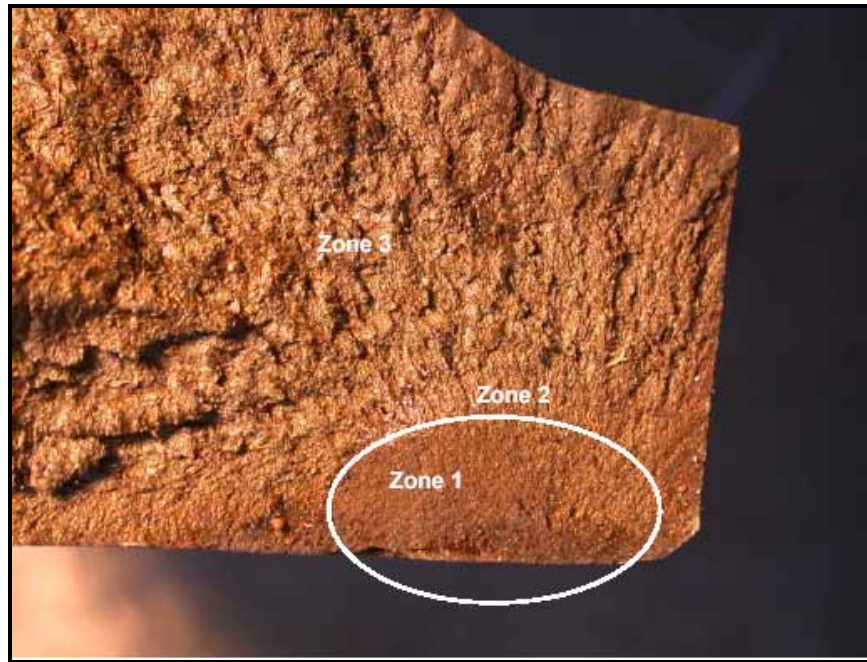
Figure 4
Close-up of crack origin showing the 3 distinct zones

1.10.3 A fine crack, labelled Zone 1, penetrated the tread approximately normal to the surface and had a depth of about 12 mm (see Figure 4). Beyond the fine crack there was evidence of coarser cracking with radiating lines orientated normal to the crack front, labelled Zone 2. This extended for about 6 mm. Beyond Zone 2, there was evidence of semi-ductile fracture with deep river lines radiating into the remainder of the rim, labelled Zone 3.

- 2.1 The wheel probably failed as a result of a small crack having been present in the hard brittle surface of the tread. The fine region of the fracture in Zone 1 was evidence of quite rapid crack propagation that extended about 12 mm into the rim. The crack in Zone 2 propagated faster and for a shorter time than in Zone 1. The remainder of the fracture, through the rim and hub occurred through semi-ductile overload.

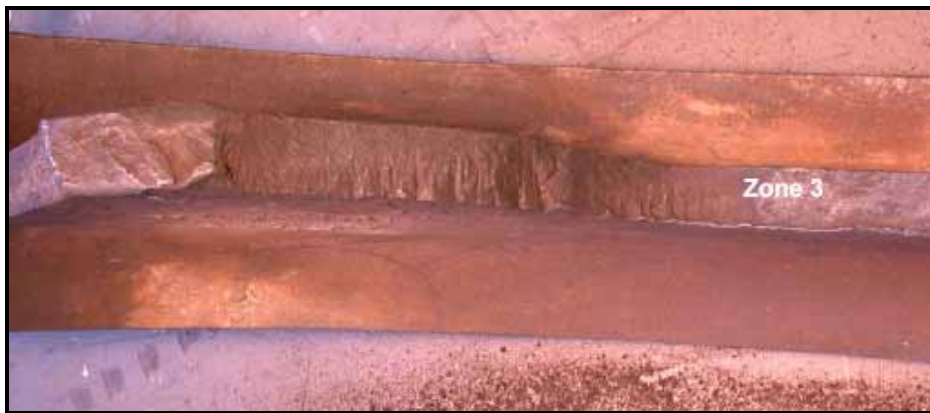
Figure 5
Semi-brittle failure in Zone 3

- 1.10.4 Zone 3 promulgated roughly normal to the surface of the tread and extended into the outer region of the hub where it changed direction and promulgated circumferentially in opposing directions around the hub to give the typical semi-brittle appearance of a sudden fracture in the material (see Figure 5).

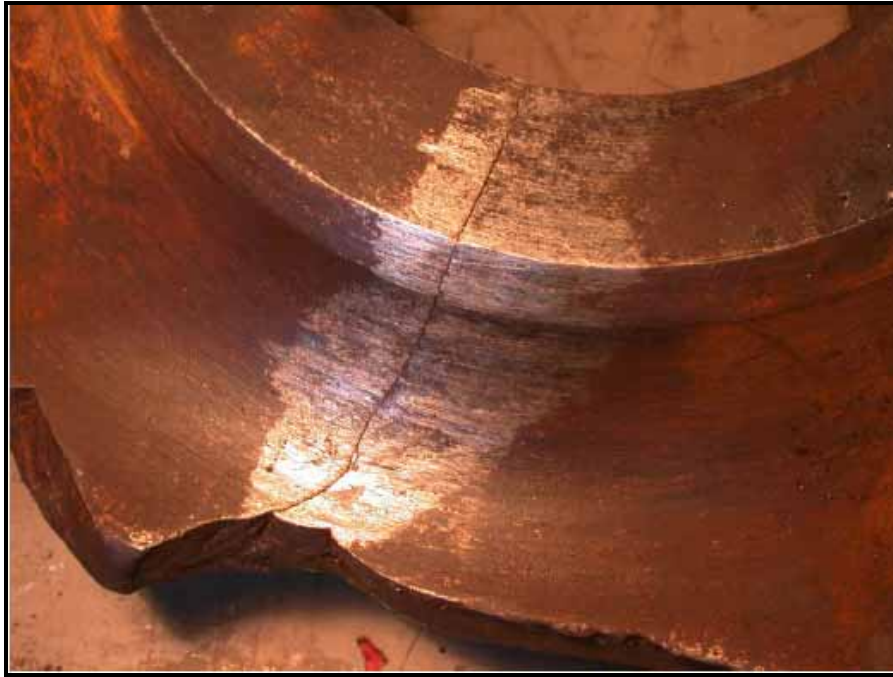
Figure 6
Crack in hub boss meeting the circumferential crack from the rim

- 1.10.5 The hub exhibited a crack through its centre boss. The hub crack met the crack from the rim (see Figure 6).

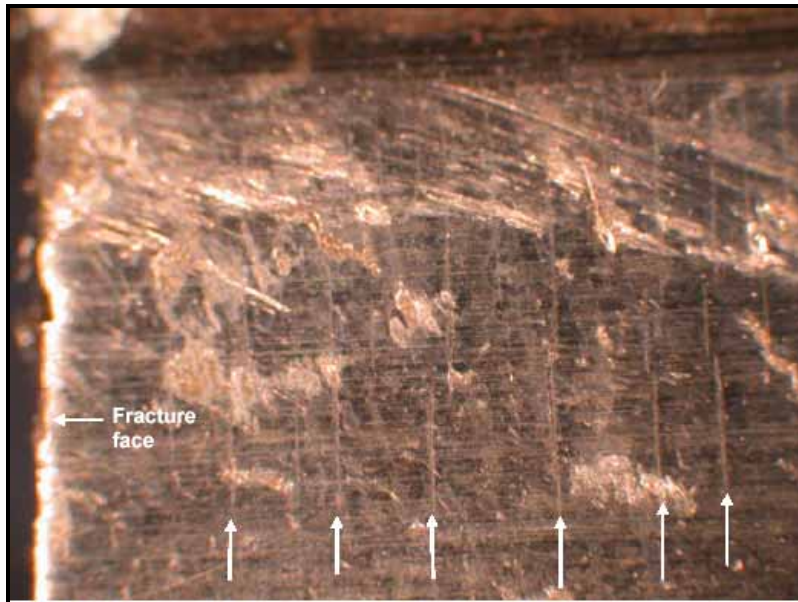
Figure 7
Transverse cracking near the outside of the tread

- 1.10.6 The surface of the tread exhibited small surface cracks. These were generally dispersed and orientated mostly across the tread (see Figure 7). There was evidence of transverse surface cracking near the failure origin. The surface of the tread was shiny, and spalling⁵ had occurred, particularly near the radius between the tread and the flange.

- No significant deformation of material was observed in the region of the crack origin.
- 1.10.8 A circumferential section was taken through the transverse cracks, shown in Figure 7, away from the fracture origin, to examine for additional evidence of material damage. This revealed the following features.

- Eleven trans-granular cracks extending normally from the surface up to about 0.415 mm into the surface of the tread. The average depth of the cracks was about 0.25 mm.

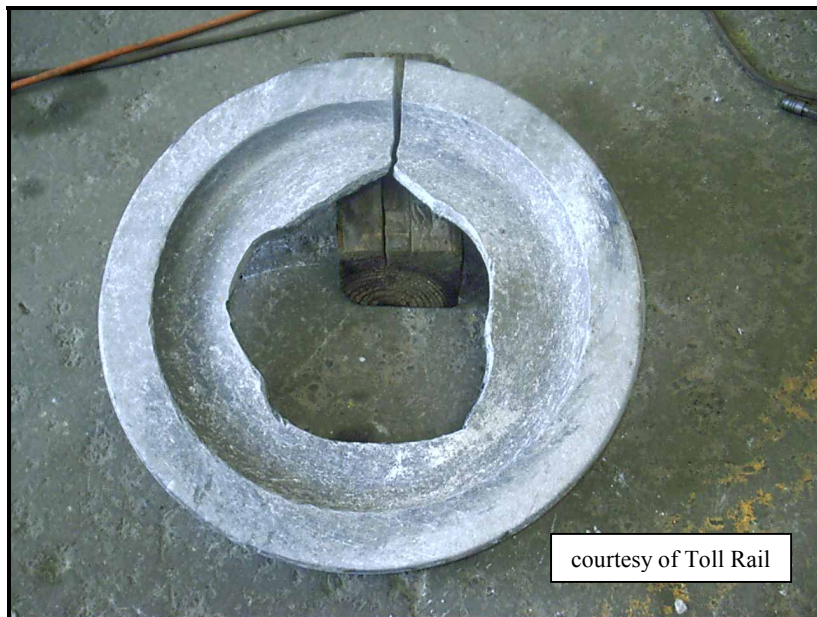
Figure 8
Outer portion of failed wheel on ZH1236

- 1.11.3 At about 1612, wagon ZH1236, derailed at 152.95 km NIMT near Feilding, about 140 km south of Waiouru, after wheel 3B fractured in a radial direction from the tread to about halfway through the plate, from where the fracture turned 90° and ran circumferentially around the wheel hub, meeting up with the radial crack (see Figure 8). The fracture initiated from an existing crack that occurred during a previous overheat that probably happened days before the event that caused the final failure. The initial crack surface showed little mechanical damage or corrosion, indicating the crack was relatively new.

- 1.11.4 Maintenance staff attending the derailment noted that all wheels on the ZH wagons were hotter than normal. However, the wheels on ZH1236 were hotter than the wheels on the other wagons.
- 1.11.5 The failed wheel was a solid wheel of a straight-plate design, manufactured from material to AAR Class C. The wheel was discoloured about 50 mm into the plate from the inner edge of the rim.
- 1.11.6 The wheel overheat was probably caused by either the brakes being overcharged by the shunt locomotive at Karioi, or by an intermittent fault in the braking system on wagon ZH1236. Given that wheels hotter than normal were reported on all wagons on the train, it was probable that the shunt locomotive caused the overheating.

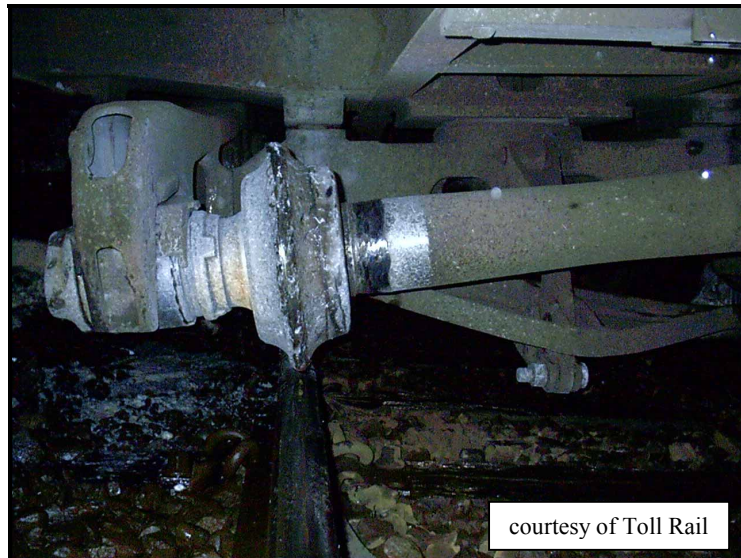
Figure 9
Derailed wheelset on wagon ZH865

- 1.11.8 The rim of the wheel had broken into 2 sections and had detached from the hub (see Figure 9). The wheel fracture appeared to have originated from small cracks at the wheel rim, followed by rapid tensile failure. The tread surface had thermal cracks more than 40 mm and numerous rim cracks in the 12 to 14 mm range. Therefore, the wheel exceeded the condition limits at the time of failure. The leading wheelset had significant thermal cracking and a worn flange. The leading bogie was undamaged, but both wheelsets showed signs of overheating with discolouration and blistering of the paint. The discolouration extended about 30 mm into the disc from the rim, somewhat less than the code limit of 100 mm.

- 1.11.10 A brake system test on ZH865 was carried out 2 days after the derailment. The test revealed that the triple valve was leaking from the vent continuously when the brakes were in the applied position. The triple valve did not respond correctly to the slow release test, occasionally the brakes would release prematurely and on other occasions the brakes would remain applied while a drop in brake pipe pressure was observed when a slow increase would normally be expected. A replacement triple valve was fitted and the wagon brakes re-tested. The replacement triple valve behaved normally.
- 1.11.11 Two other sources of air leakage were also identified on ZH865:
- missing VTA valve
 - split rear hose.

The protracted and unintentional brake application caused the wheel to overheat, the wheel was probably already highly stressed due to previous overheating incidents and with existing cracks in the tread and rim, it failed.

A lack of lubrication and subsequent seizing of a valve stem caused the leak in the triple valve. The lack of lubrication appeared to be the result of age and wear rather than due to incorrect assembly.

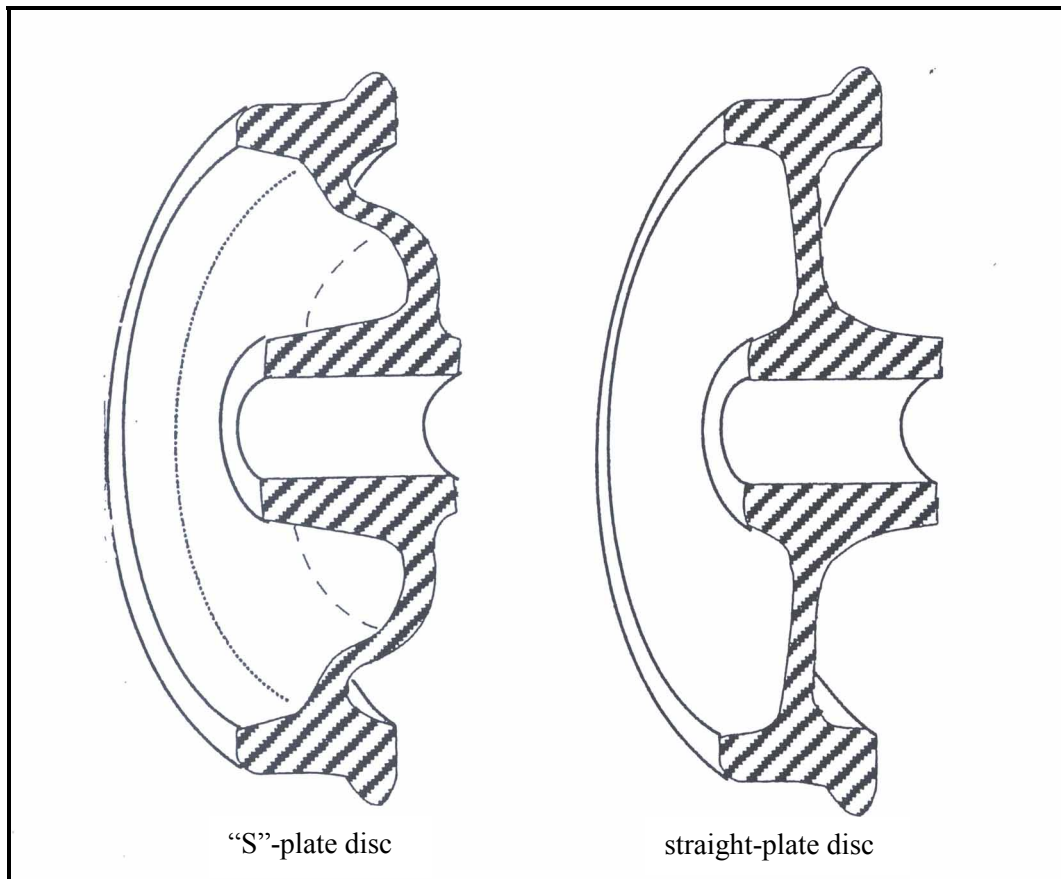
Figure 10
Wheel types

- 3.5 The flat-plate wheel discs were less resistant to fatigue cracking than “S” plate discs with a wider tread.
- 3.6 The wheel probably failed as a result of a small crack in the surface of the tread initiating the full cracking and fracture.
- 3.7 The maintenance inspections on ZH1115 were current.
- 3.8 The actions of the locomotive engineer did not contribute to the derailment.
- 3.9 The track at the point of derailment was within maintenance tolerances and did not contribute to the derailment.

- The overheat limit for wagon wheel discolouring has been reduced from 100 mm to 30 mm.
- All new Type 14 and Type 18 wheels require an improved crack resistant design “S” plate disc and wider rim.

- All ZH wagons in the Karioi traffic have had their flat-plate disc wheels replaced.
- All Karioi ZH wagon wheels and new wheels are being painted with temperature sensitive paint.
