RAILWAY OCCURRENCE REPORT

04-127

express freight Train 952 and stock truck and trailer, collision,
Browns Road level crossing, Dunsandel

19 October 2004

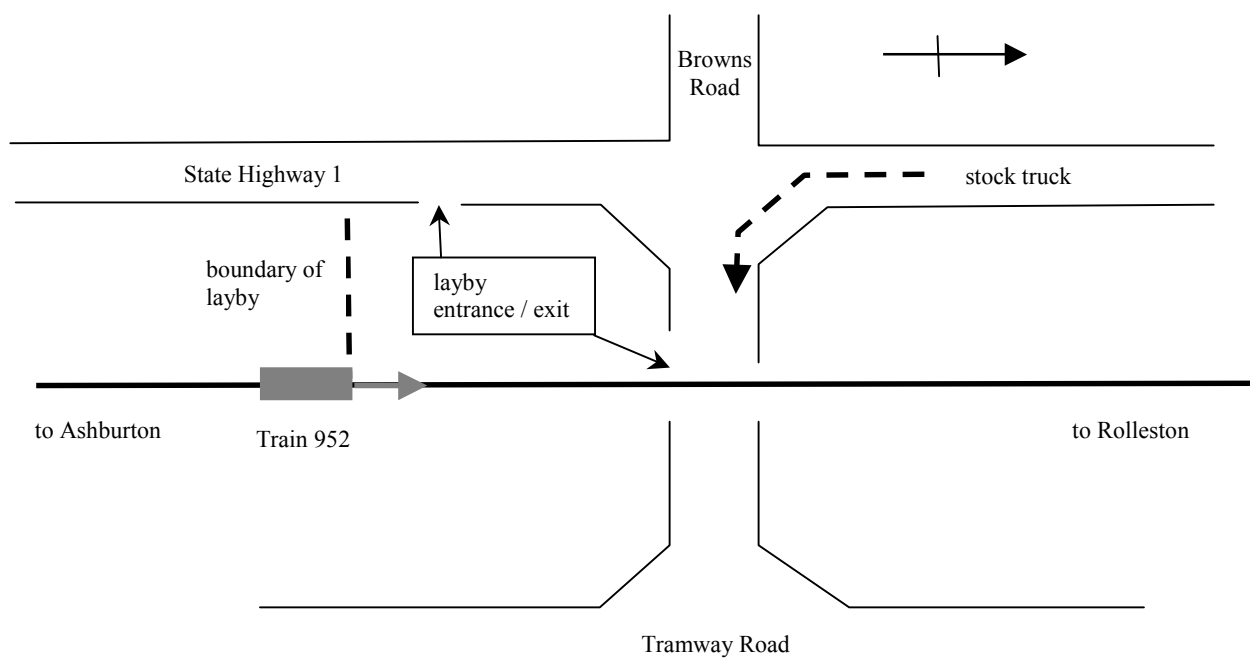
Figure 1
Site diagram of Browns Road level crossing (not to scale)

- 1.2.1 Browns Road level crossing was located at 49.97 km at Dunsandel, between Rolleston and Ashburton, on the Main South Line. Browns Road joined SH1 on the western side of the level crossing with Tramway Road on the eastern side (see Figure 1).

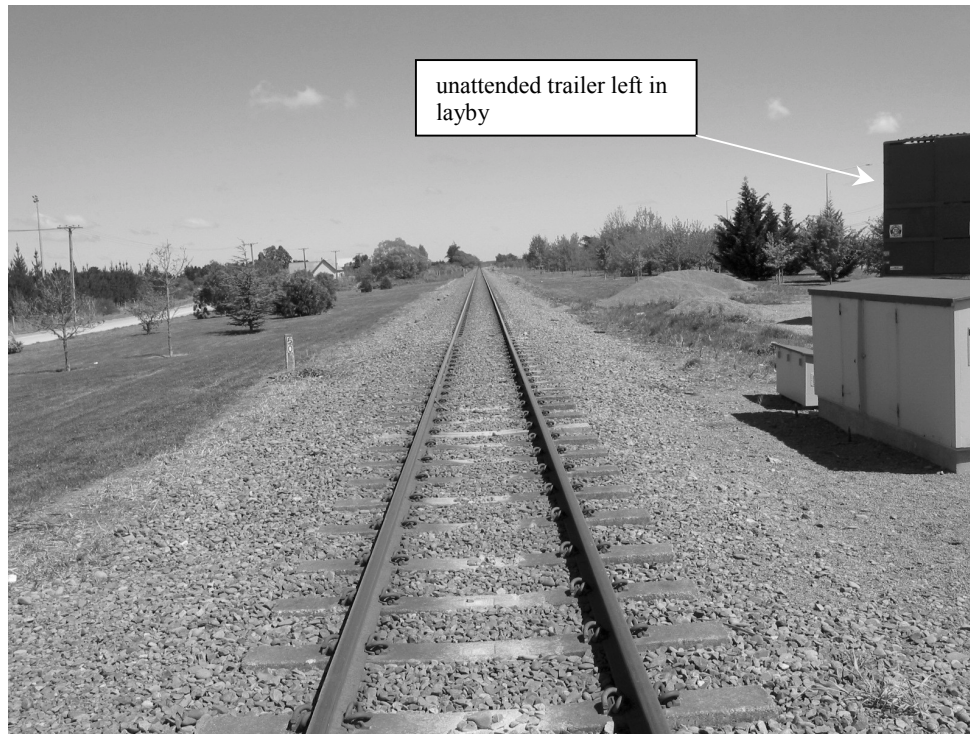
Figure 2
Looking south from the level crossing

- 1.2.2 The level crossing offered good visibility for locomotive engineers and for road users approaching the crossing. The road approach from SH1 was straight for about 37 m. However, this straight approach was reduced to about 20 m for vehicles turning from SH1. The approach from Tramway Road was straight for about 21 m.
- 1.2.3 The railway line to the south of the level crossing, from where Train 952 approached, was straight for about 500 m (see Figure 2). This photograph was taken several days after the collision and an unattended road trailer can be seen parked in the layby.

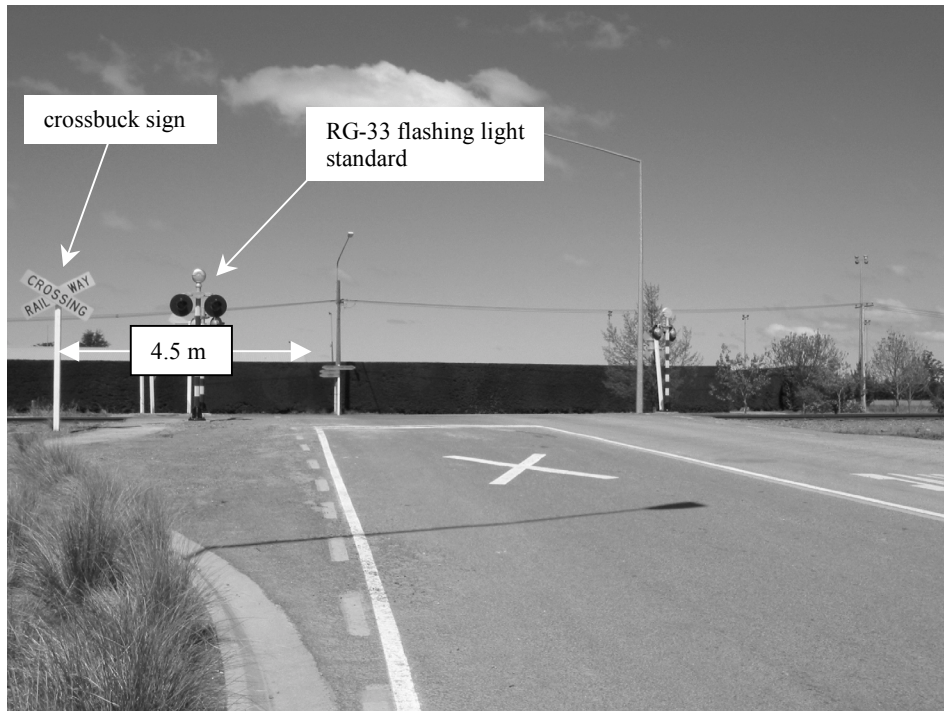
Figure 3
The level crossing approach from SH1

- 1.2.8 Flashing lights, bells, warning signage and road markings protected the level crossing. There was one RG-33 flashing light standard³ facing directly to SH1 (see Figure 3) and 2 RG-33 flashing light standards facing Tramway Road, angled towards traffic approaching from either direction (see Figure 4).

- 1.2.9 The distance between the intersection with SH1 and the crossbuck sign on the western side was about 37 m and between Tramway Road and the crossbuck sign on the eastern side was 21 m. The crossbuck sign on the SH1 side of the level crossing was 4.5 m to the left of the edge of the sealed pavement (see Figure 3).

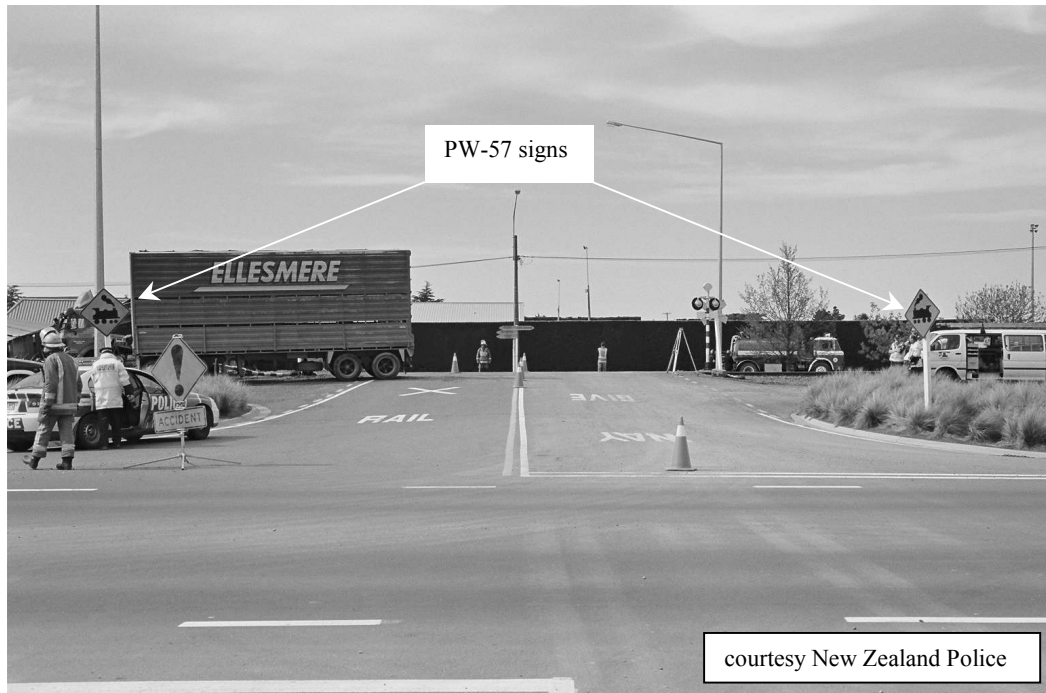
Figure 5
The PW-57 signs facing SH1

- 1.2.10 The number of RG-33 warning device standards required on each side of the level crossing was defined in Section 4 of the “Manual of Traffic Signs and Markings” Part 2 (the manual)⁴ which stated that where the distance between the intersection and the RG-33 was less than 30 m the RG-33 standard was to be duplicated on the right-hand side of the road.
- 1.2.11 A PW-57 Railway Level Crossing Warning Sign was positioned on the left-hand side of the road about 25 m from the limit lines for the level crossing. A second sign was positioned directly opposite on the right-hand side of the road. The signs were angled to face northbound or southbound traffic turning into Browns Road from SH1 (see Figure 5).

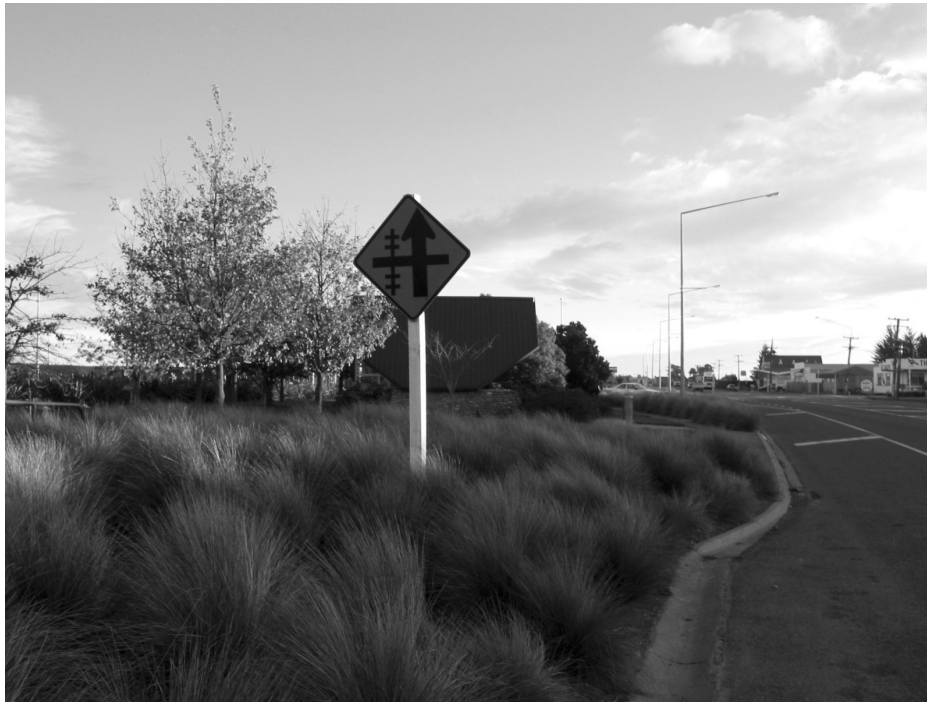
Figure 6
The PW-13 sign facing southbound traffic approaching Browns Road

- 1.2.12 The manual required that a PW-13 Railway Crossing on Side Road sign be erected on the main road approach to a controlled side road where a railway level crossing was located on the side road immediately adjacent to the main road intersection. Such a sign was positioned on the left-hand side of SH1, 101 m from the centre of the intersection with Browns Road (see Figure 6). A similar sign was positioned about 54 m south of the intersection on the left-hand side of SH1 for northbound traffic.
- 1.2.13 The maximum road speed through the area was 70 km/h and the manual required that a PW-13 sign be placed facing oncoming traffic between 100 and 160 m from the centre of the level crossing. While this was achieved for southbound traffic it was not for northbound traffic because of the presence of several access ways to shops adjacent to the highway.

- 2.1 The road signage and markings that were in place, both approaching and at the level crossing, were clearly visible and in good condition and met the guidelines included in the manual, with the exception of the southern PW-13 sign. However, the main defences, namely the warning devices at the level crossing, met the guidelines and the out-of-position southern PW-13 sign did not contribute to the collision.

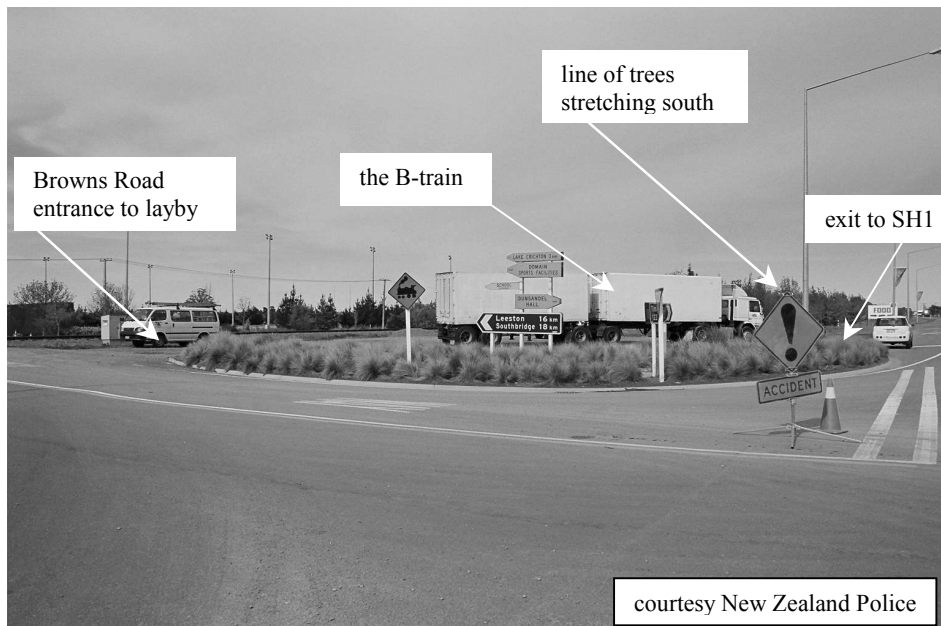
Figure 7
The B-train parked in the layby

- 1.2.14 A layby, on land owned by NZRC, extended between the highway and the railway line for about 360 m south from the intersection of Browns Road with SH1. Access to and from the layby was possible from Browns Road or SH1. Drivers of southbound vehicles stopping for meals at the surrounding facilities regularly used the layby for parking.
- 1.2.15 At some time before the collision, a southbound B-train had pulled off SH1 and entered the layby via Browns Road. The unit had parked at the south end of the layby at such an angle as to allow easy access back on to SH1 (see Figure 7). The B-train was 3.6 m high.

- 1.2.16 Measurements taken from about where the stock truck would have commenced its turn off SH1 into Browns Road showed that the truck driver's opportunity to see the approaching train would have been severely restricted by the parked B-train. Line of sight measurements established that when the train appeared from behind the B-train it would have been about 51 m from the centre line of the level crossing.
- 1.2.17 As the truck moved nearer to the level crossing, the driver's line of sight around the rear of the B-train would have been further impeded by a row of trees stretching south between the railway line and SH1 (see Figure 7).

- 2.7 The line of sight south along the railway line for the stock truck driver as he turned off SH1 into Browns Road was severely restricted by the presence of the B-train and as a result he would not have seen the train approaching. However, he had passed a sign while on SH1 which warned him of the level crossing on the side road and, as he turned into Browns Road there was another sign, a PW-57, on the right-hand side of the road and angled towards him as he turned, which warned of the presence of the level crossing. Once his vehicle had straightened up the activated warning devices were in front of him and were the principal line of defence against a collision. Why he did not stop at the warning devices could not be determined.

- 3.8 A further contributing factor was the reduced view lines on the approach to the level crossing because of the position of the B-train in the layby to the south of Browns Road.

close the entry and exit points to the land alongside the South Island Main Trunk Railway immediately south of Browns Road level crossing and State Highway 1 intersection to prevent unsafe use (003/05).

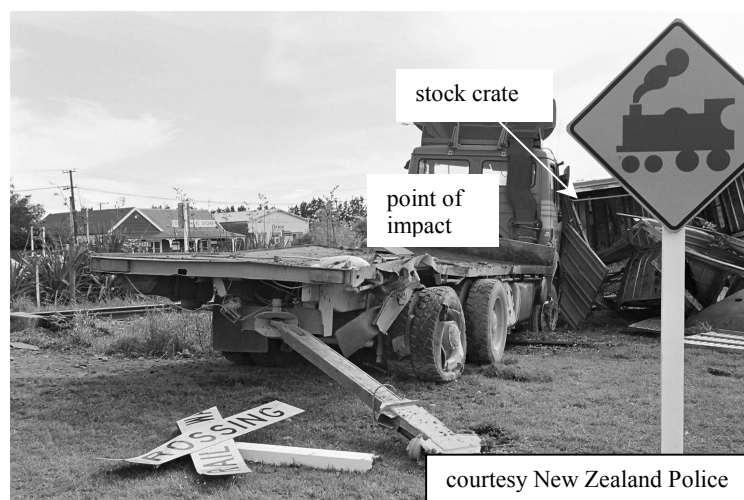
Figure 8
The truck after impact

- 1.3.1 The locomotive hit the loaded 3-axle stock truck on the rear axle. The impact separated the stock crate, which was secured to the flat deck of the truck, and threw it to the right-hand side of the track in the direction of travel of Train 952. The stock crate came to rest in front of the truck (see Figure 8).

- 1.3.2 The stock truck was turned through 90° by the force of the impact and came to rest on the Tramway Road side of the level crossing.
- 1.3.3 The trailer was separated from the truck during the impact and remained on the SH1 side of the level crossing and also turned through 90°.

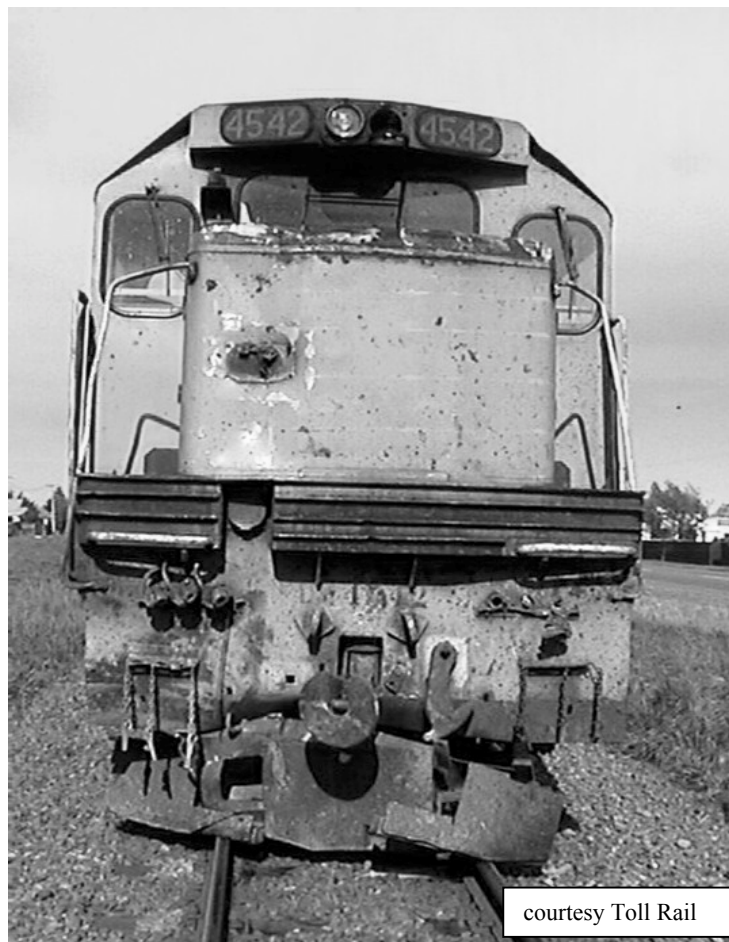
Figure 10
The front of the locomotive after the collision

- 2.4 The full force of the collision was borne by the locomotive. The truck and trailer did not come in contact with the train again after the initial contact. The fact that the locomotive remained upright and did not derail probably reduced the risk of serious injury to the locomotive engineer. In the circumstances of this collision, the crashworthiness of the locomotive met expectations.

- 3.3 The crashworthiness of the locomotive was appropriate.
- 3.4 With the exception of the positioning of the southern PW-13 sign, the existing level crossing signage and road markings were in accordance with guidelines published in the "Manual of Traffic Signs and Markings", Part 1. All signage and road markings were clearly visible and in good condition.
