RAILWAY OCCURRENCE REPORT

04-130 **express freight train derailments due to axle bearing failures, various locations**

**5 November 2004-
21 March 2005**

**TRANSPORT ACCIDENT INVESTIGATION COMMISSION
NEW ZEALAND**

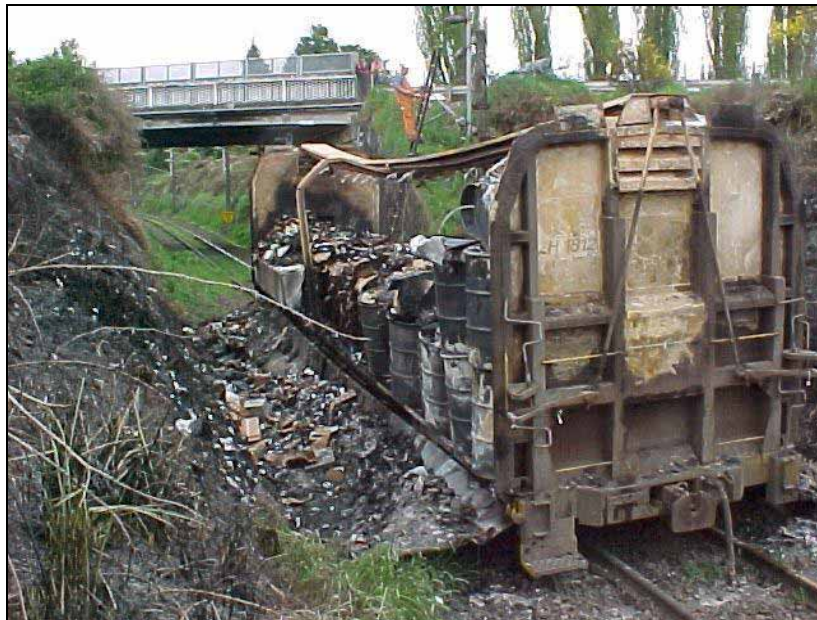
Figure 2
Fire-damaged wagon ZH1812 near Bridge 191 NIMT

- 5.1.4 The locomotive engineer looked back along his train and saw what looked like flames coming from the left side of his train. He was aware that there was an overhead bridge about 500 m ahead, so he slowed his train in order to stop near the bridge to give the Fire Service easy access to the burning wagon.

- 6.10 After the train stopped, the intensity of the fire was such that the overhead contact wire melted and fell across several wagons. When the contact wire failed, it tripped out Mananui 13 sub-feeder. The traction control computer recognised the trip out, then automatically closed again 5 seconds later. Why a further 12 minutes elapsed before the train controller operated the catenary emergency shutoff could not be determined.

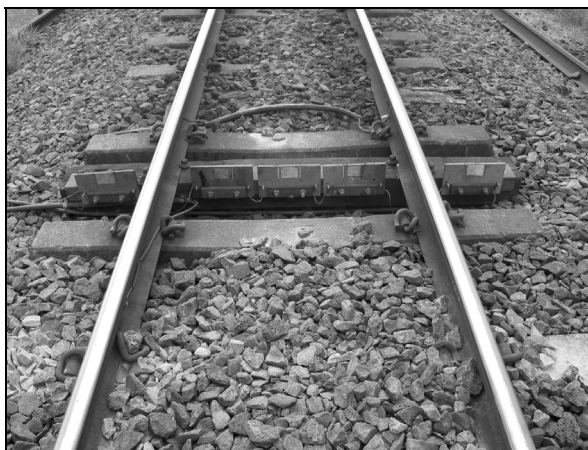
Figure 3
Combined heat/dragging equipment detection unit

5.3.4 Between Taumarunui and Owhango there were 8 DED units, of which 2 were located at 377.97 km and 374.47 km, between Kakahi and Owhango. The DED units were similar to that in Figure 3. When a DED activated, a flashing light appeared on the train controller's VDU. However, the alert indicated the track section concerned but was not capable of identifying whether either or both of the DED units between Kakahi and Owhango had activated.

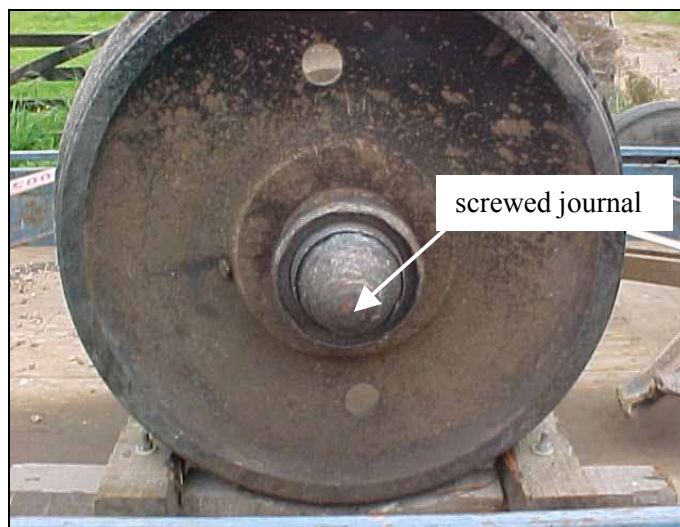
Figure 4
Recovered wheelset with failed journal

- 5.7.1 At some point, the left-hand RBU on the leading axle of the trailing bogie seized on the journal to a point where it twisted or screwed and separated from the axle (see Figure 4). The RBU was not recovered after failure, despite an extensive search of the rail corridor from Kakahi to the DED site near 378 km.

- 6.1 Because both the journal end and the failed RBU were not recovered, it was not possible to determine the cause of the bearing failure. The bearing components probably rolled down the steep embankment and away from the track towards the Whakapapa River somewhere between Kakahi and where scrape marks on the railhead were first observed
- 6.2 The wagon had been inspected to code requirements, the last B-check being 7 days before the derailment. Such inspections would not necessarily detect the defects that lead to failure.

- 6.7 The impending RBU failure made the derailment inevitable. The condition of the RBU had progressively deteriorated to a point where friction-induced heat caused the portion of the axle between the RBU and the wheel to become plastic, where upon the axle separated or "screwed off" as the axle turned. Once the axle failed, the vertically unrestrained wheel would have lifted, until it rubbed on the underside of the steel wagon deck.

- 6.3 The absence of records showing when the RBU was fitted or whether it was new or reconditioned, added to the difficulty in determining a probable cause for the failure. A safety recommendation to address this issue has been made to the Chief Executive of Toll NZ Consolidated Limited.

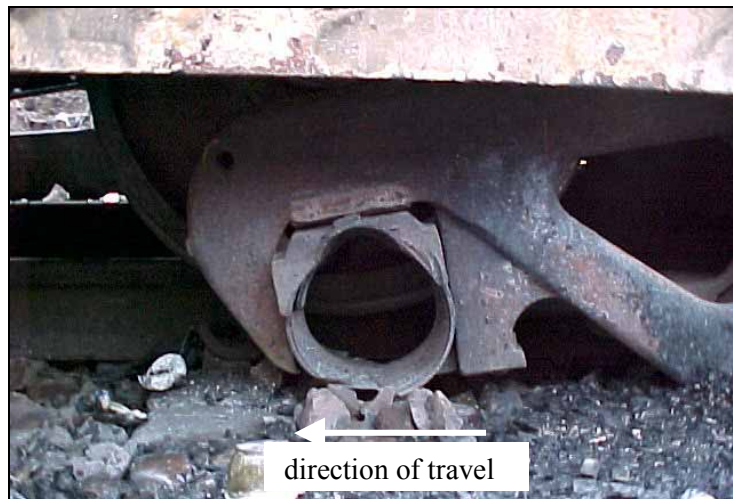
Figure 5
Bogie side frame of the derailed bogie

- 5.7.2 As the train continued, the leading end of the bogie side frame dropped and bounced, causing minor damage to the railhead and the tops of some sleepers (see Figure 5). At the same time, the left-hand wheel was in a raised attitude off the rail and lodged under the wagon floor. The left-hand wheel eventually penetrated the steel wagon deck.

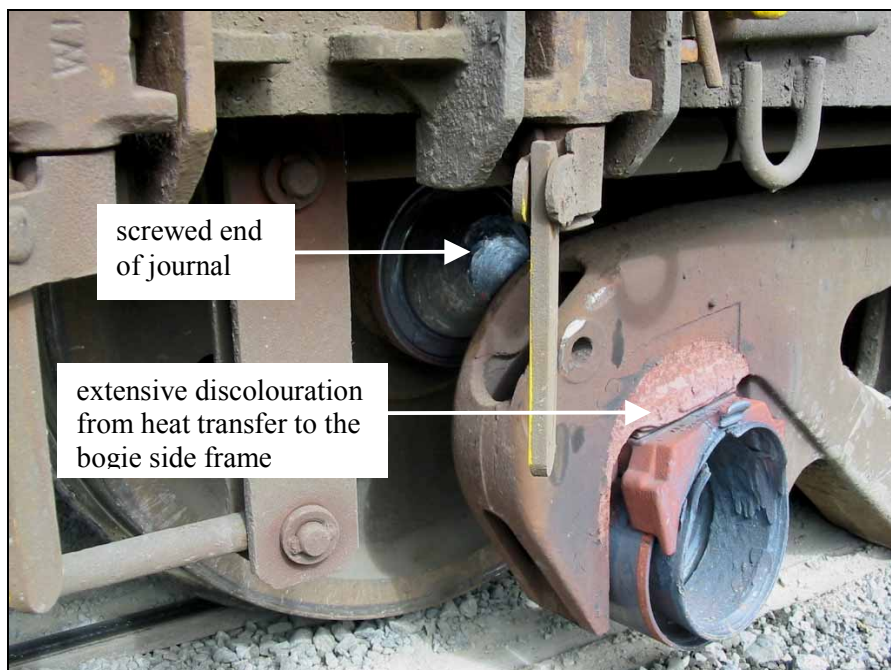
Figure 6
Screwed axle journal at A2 wheel position on wagon UKR137

- 8.1.3 The train stopped inside the limits of Wellington Freight Yard. The last 3 wagons on the train had derailed but there was evidence that the trailing bogie of the fourth wagon from the rear of the train had run derailed and then rerailed itself, possibly at a turnout. Wagon UKR137, the third last wagon had a screwed axle journal on the A2 wheel position, the right-hand side of the trailing wheelset on the leading bogie (see Figure 6). The derailed wagons were conveying refrigerated containers.

- 9.4 Extensive heat damage had been transferred to the RBU, the wear adapter and the bogie side frame. The condition of the RBU had deteriorated to a point where friction induced heat reached such a level that the bearing seized and the axle journal screwed off as the axle rotated. Once the axle failed the wheel was unrestrained and lifted. UKR137 was the first wagon to derail and the trailing 2 wagons were pulled off when they were passing over turnouts entering Wellington Yard.

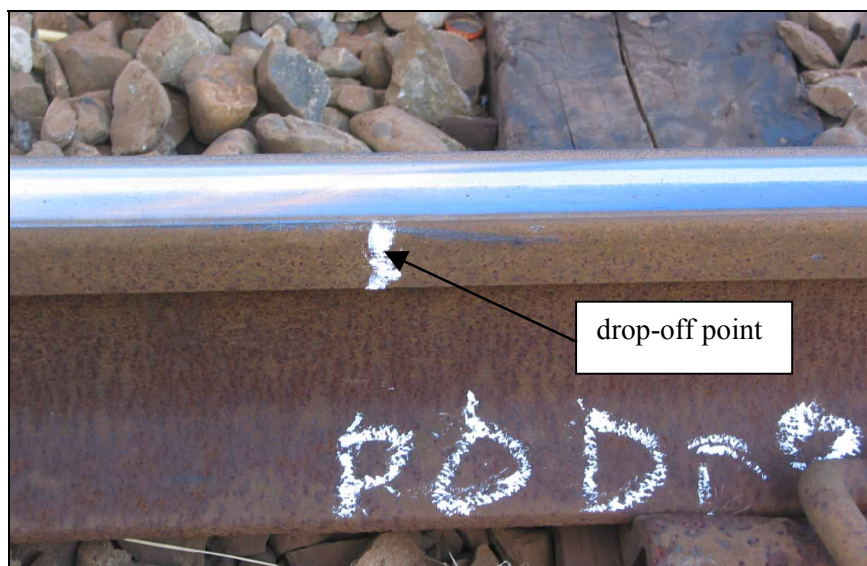
Figure 7
Drop-off point

- 8.2.1 The exact location where A2 wheel on UKR137 started to climb the right rail, the point of derailment (POD) could not be determined. However, the drop-off point for B2 wheel, the opposite wheel on the same axle, was established as 2.534 km on the Down main of the NIMT at Kaiwharawhara Station (see Figure 7).

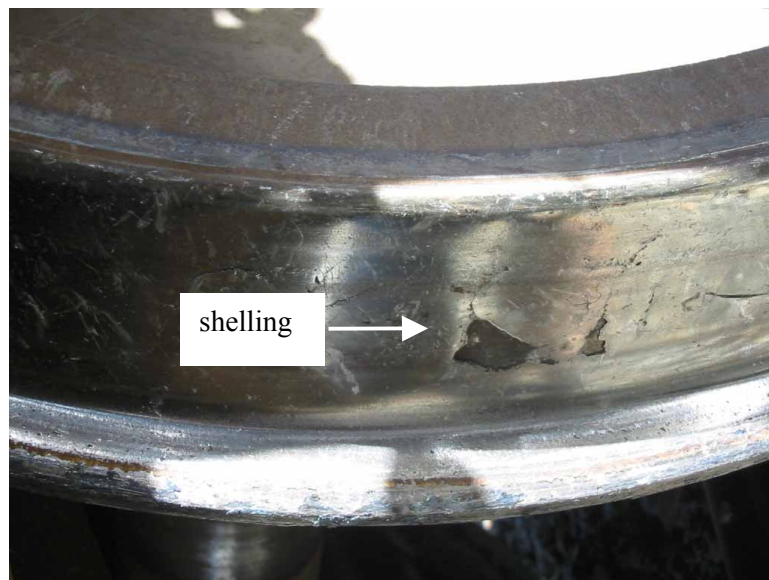
Figure 8
Shelling on the wheel tread

- 8.6.1 Clean bolts in the brake rigging were consistent with repairs having been completed a few days earlier. The end cap bolts were present on the failed wheelset. However, extensive heat damage had promulgated from the screwed-off axle journal into the bearing adapter and the bogie sideframe. The bearing end caps on the failed axle were not date-stamped as required by code.
- 8.6.2 No records were available to confirm the supplier of the failed bearing or the date that it was fitted.
- 8.6.3 The tread on the failed wheelset had multiple areas of shelling (see Figure 8).

- 9.2 Wagon UKR137 had a history of fused⁷ brake blocks before the RBU failure and derailment. However, the cause of the fused brake blocks was not addressed. The fused brake blocks were replaced and the wagon was returned to service but continued to have an abnormally high number of replacements of fused brake blocks. A recommendation to address this issue has been made to the Chief Executive of Toll NZ Consolidated Limited.

- 9.3 The failed wheelset showed multiple areas of shelling on the wheel treads, probably the result of skids that could be attributed to issues with the braking system. The hammering action caused by flat spots on the wheel tread, such as a skid or shelling, would have generated extreme shock loads into the bearing that eventually resulted in the catastrophic failure of the RBU and the subsequent derailment.

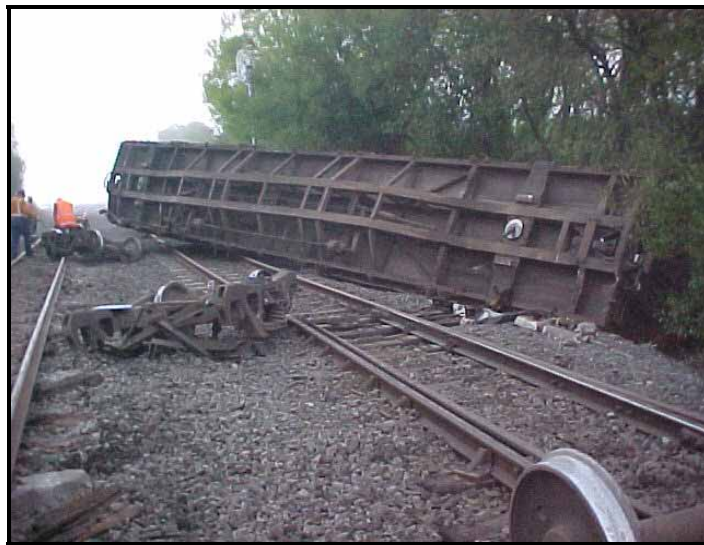
Figure 9
Derailed wagon UK18837

- 11.1.3 Wagon UK18837, the eleventh wagon on the train was on its side, foul of the Up Main line (see Figure 9) and the trailing wagon, UK7349 was derailed, although upright. The locomotive engineer put out a small scrub fire near the derailed wagons.

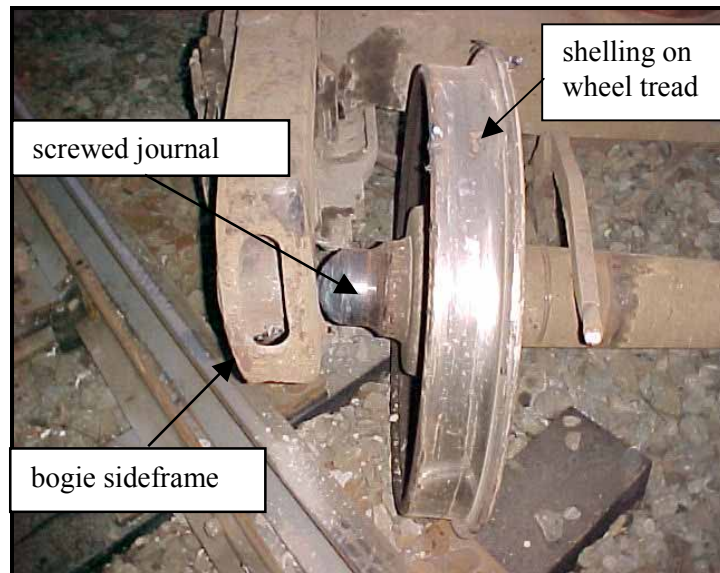
Figure 10
Screwed journal on wagon UK18837

- 11.1.4 The journal on the leading axle of the trailing bogie (A3) on wagon UK18837 had “screwed” off the axle (see Figure 10).

- 12.4 Wagon UK18837 had multiple areas of shelling and flat spots on the wheel treads probably as a result of deficiencies in the braking system. The extreme shock loads impacting on the bearing by a wheel with multiple areas of shelling probably led to the eventual failure of the RBU and subsequent derailment.

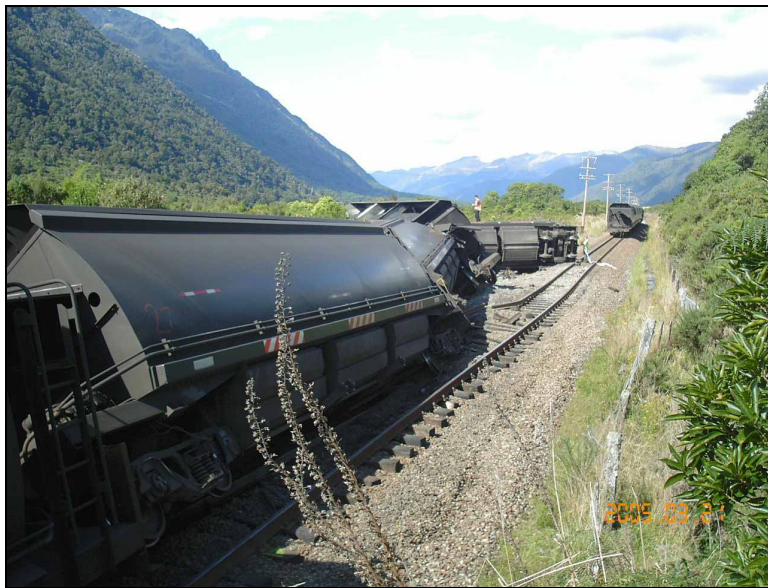
Figure 11
Some of the derailed wagons

- 14.1.5 The locomotive engineer left the locomotive cab to inspect his train. He found only 4 wagons remained coupled to the locomotives. When he reached the parted section of his train he saw that the next 7 wagons had derailed (see Figure 11) while the remaining 10 wagons at the rear remained upright and on the track.

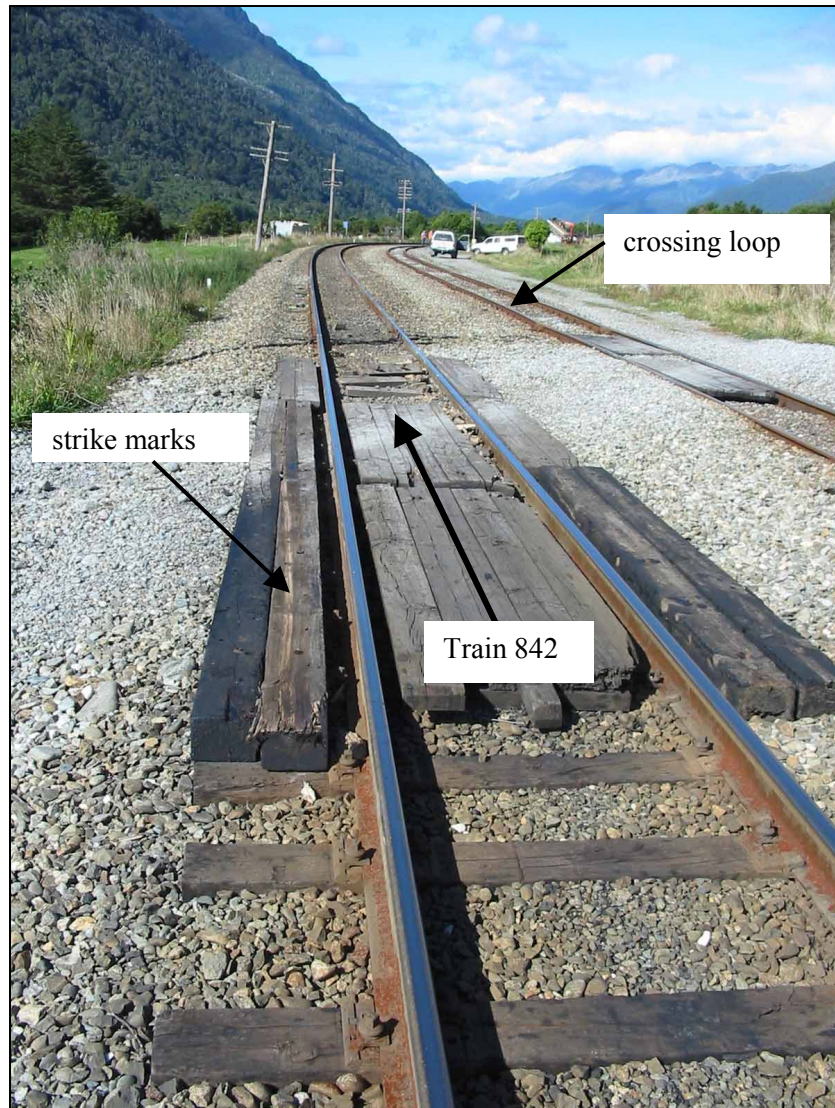
Figure 12
Point of derailment

- 14.2.1 The point of derailment was identified at 147.808 km ML, on a sleepered crossing for rail service vehicles (see Figure 12). The axle journal on the left-hand side of the trailing axle on leading bogie of CB10558, the fifth wagon on the train, had “screwed” off and the axle stub had burnt through the side frame. Strike marks indicated that when the bogie side frame impacted

with the sleepered crossing it would have lifted the wheel clear of the rail. The wagon continued a further 400 m until the derailed wheel struck the frog in the south-end main line points at Jackson, forcing the wheel and bogie clear of the track. The following 6 wagons derailed as a result of damage to the turnout.

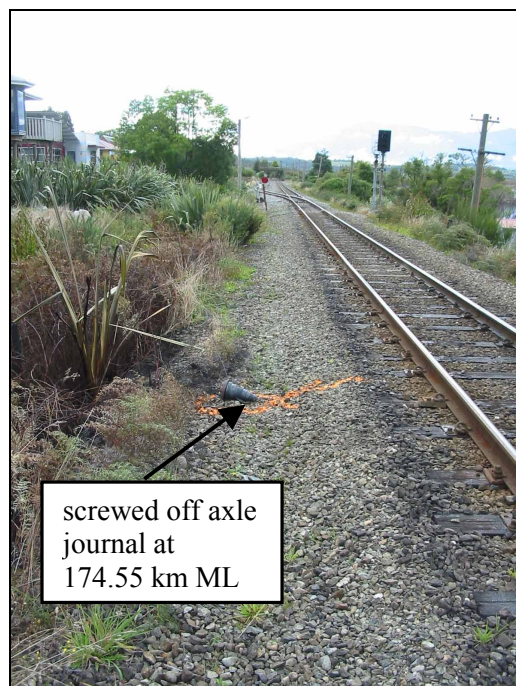
Figure 13
Burnt off axle stub from wagon CB10558

- 14.5.1 The roller bearing unit from A2 wheel had failed at least 25 km before the POD. The “screwed” off axle stub was found trackside at 174.55 km, near Moana (see Figure 13). The bearing cap locking tab was stamped “94”, indicating that RBU was last overhauled in 1994. There were several other small trackside scrub fires between Moana and Jackson caused by hot debris from the failed RBU.

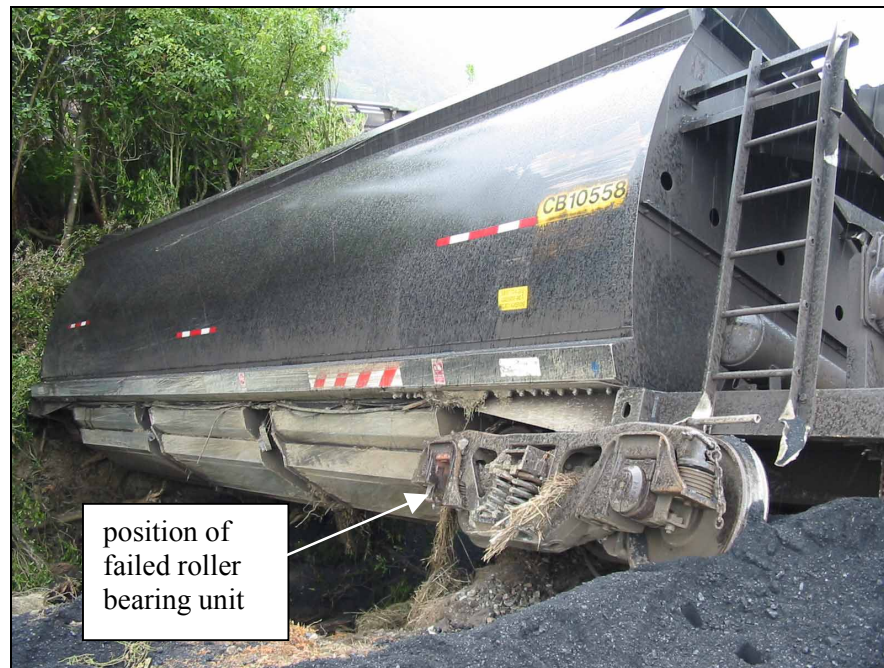
Figure 14
Derailed wagon CB10558

- 14.5.2 After the derailment, the wagon came to rest about 40 m away from the POD, straddling a creek (see Figure 14).
