RAILWAY OCCURRENCE REPORT

04-132 overhead power failures, Wellington suburban rail network

4 December 2004 –
24 January 2005

**TRANSPORT ACCIDENT INVESTIGATION COMMISSION
NEW ZEALAND**

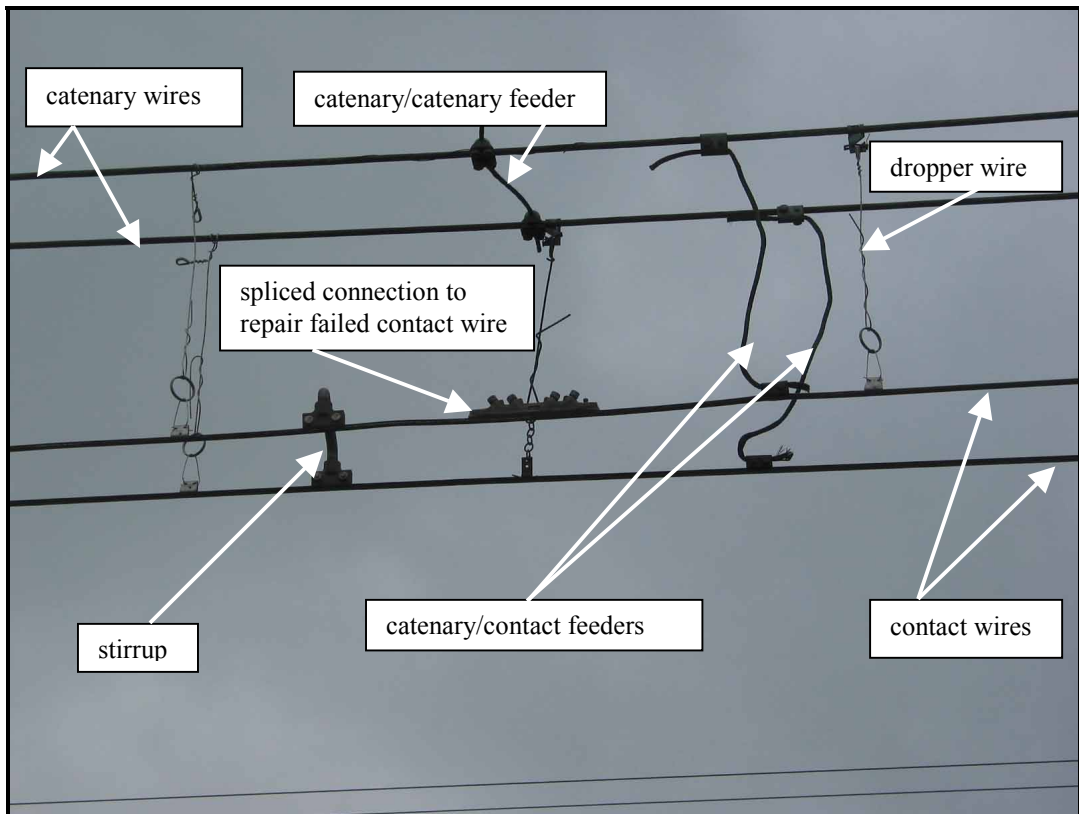
Figure 1
Overlapped contact wires and components

- 3.2.1 The initial failure on the contact wire occurred at a stirrup for an overlap³ between portal structures at 3.246 km and 3.307 km on the Up Main of the NIMT (see Figure 1). Damage to the contact wire extended from 2.821 km to 3.307 km.

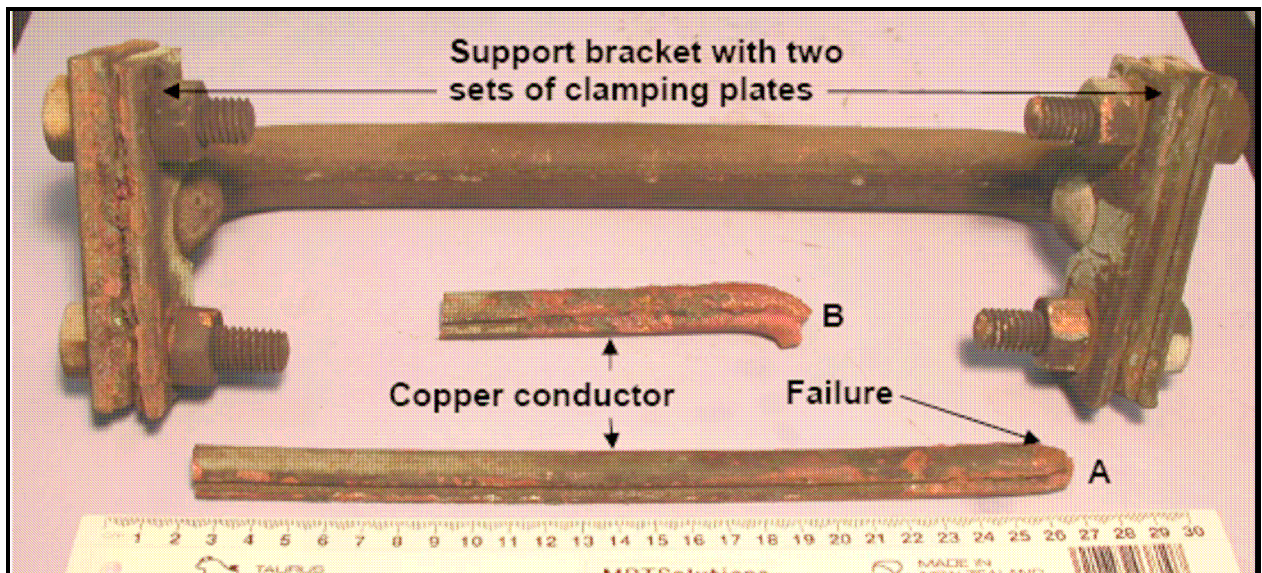
Figure 2
Stirrup assembly and copper contact wire

3.5.1 A section of the damaged copper contact wire (conductor) and the stirrup connection that included 2 sets of clamping plates were taken for independent testing and analysis (see Figure 2).

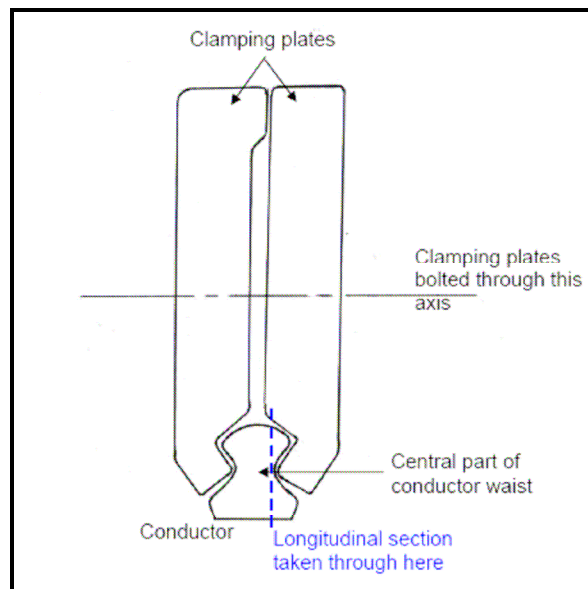
Figure 3
Conductor and clamping plates (not to scale)

3.5.2 The general arrangement before separation of the components is shown in Figure 3, and can be described as:

- the contact wire had a rough hourglass shape with a rounded top lobe and a bottom lobe that had worn flat by contact with train pantographs. The waisted central part of the conductor was held by 2 bronze clamping plates about 97 millimetres (mm) long, that have jaws shaped to fit the central part of the conductor
- the plates were bolted to close them on the conductor
- the electrical contact was made between the jaws and the central part of the conductor.

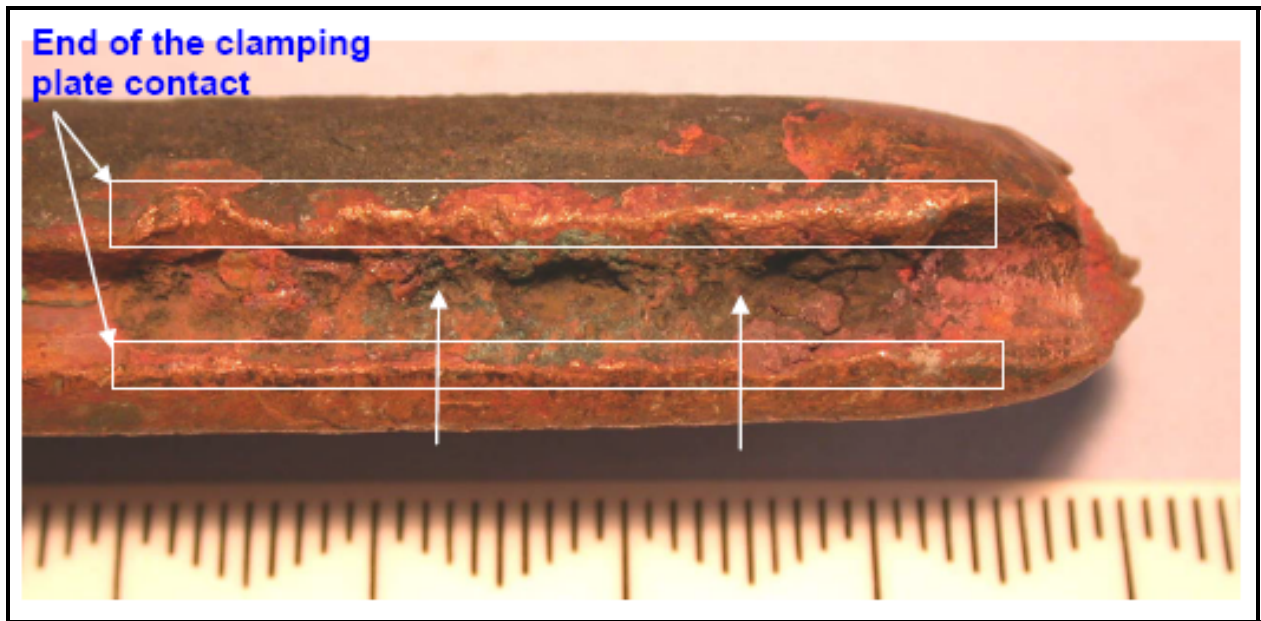
Figure 4
Failed end of the contact wire Sample A

- a fracture had occurred at one end, within the clamped portion of the conductor
- the fracture exhibited considerable necking and a clean ductile break consistent with tensile overload (see Figure 4)

- both sides of the central portion of the contact wire exhibited corrosion products within a localised section about 35 mm long (see Figure 4). There was a demarcation at the non-fractured end where the corrosion products were significantly less severe. This appeared to coincide with the end of the contact between the jaws of the clamping plates and the conductor. Red and black material that was probably copper oxides filled the narrowest part of the contact wire

- the regions just above the central part of the conductor near the top lobe exhibited deformation and loss of material in the form of an irregular surface

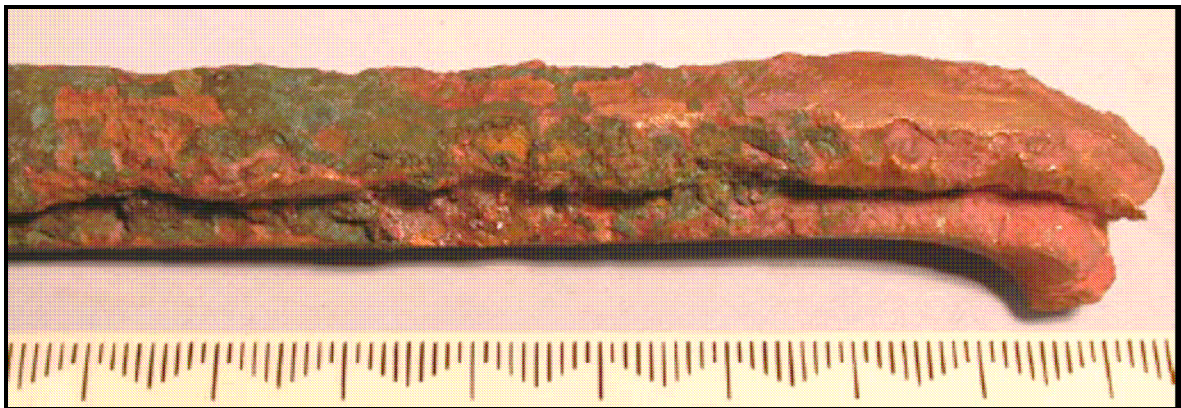
Figure 5
Deformation and degradation of contact wire labelled Sample B

- 3.5.6 Sample B exhibited severe deformation and a fracture at one end indicated failure by overload in bending and slight twisting (see Figure 5). This short length of conductor also exhibited severe corrosion and possible superficial melting.

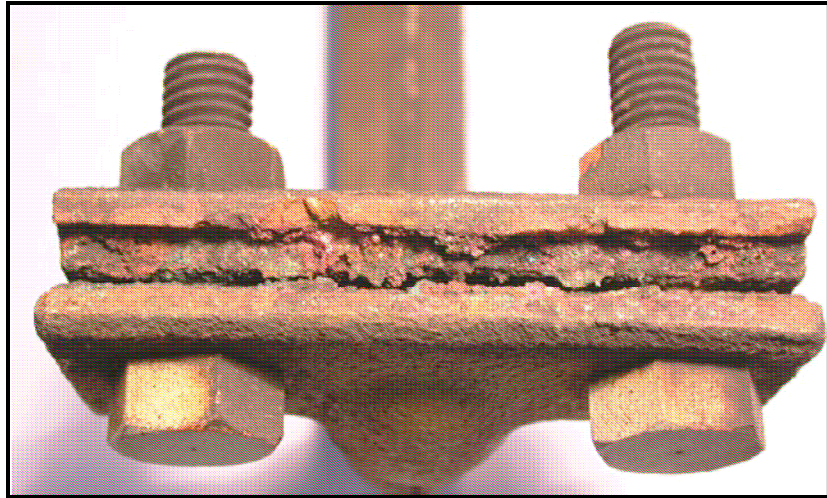
Figure 6
Clamping plate showing degradation

- 3.5.7 The following observations were made on the condition of the clamping plates:
- there were surface deposits of green and black corrosion around the outside of the plates and on the bolts. The green deposits were distributed generally away from the contact region with the contact wire, although some were present around the jaws
 - the interior surfaces of the jaws, where in contact with the contact wire, were corroded along the entire length of the jaws and the corrosion product exhibited colours typical of oxides of copper (see Figure 6)
 - corrosion product partially filled the grooves

- 4.7 Corrosion had occurred on the leaded bronze clamping plates, mostly at the jaws. The intergranular corrosion seen in the region of contact with the contact wire was typical of stress corrosion cracking and there was evidence on the surface of material having been lost. In this region, corrosion was significantly modified by the effect of arcing. The thickness of the observed corrosion products was about 0.3 mm. This figure far exceeded that of published data on corrosion rates under normal environmental conditions. Therefore, it was likely that overheating occurred as a result of the build-up of corrosion products and this may have significantly contributed to the occurrence of stress corrosion cracking within the clamps.

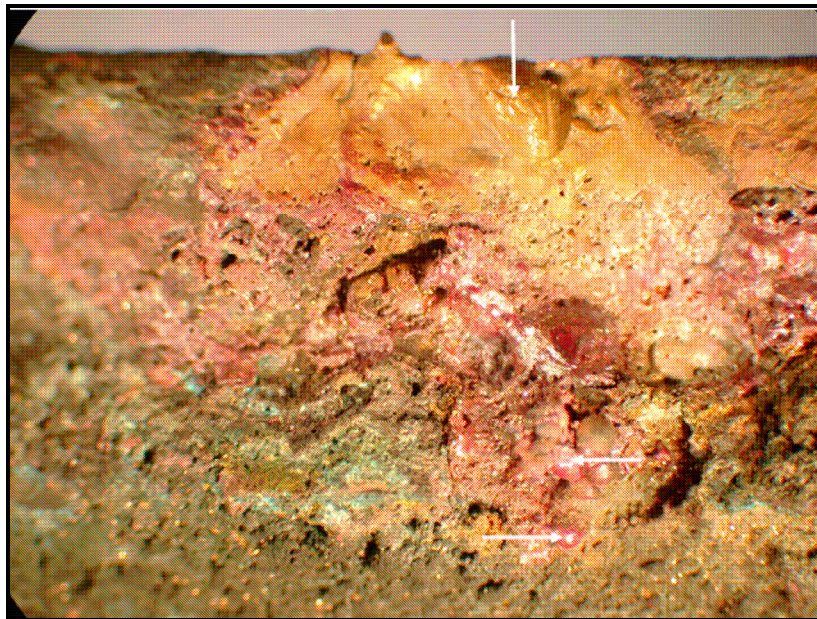
Figure 7
Melted and re-solidified and oxidised material, indicated by globules, arrowed

- melted and re-solidified material was present along the jaws and there were numerous holes in the re-solidified material, indicative of arcing (see Figure 7). When the conductor was placed against the clamping plate, and aligned such that the indication of the limit of contact on the contact wire coincided with the end of the plate, the region of most severe arcing appeared to coincide with the location of fracture A.

- 4.11 Arcing caused significant melting and holes in the bronze jaws of both sets of clamping plates, and possible indications of superficial melting on a part of contact wire sample B. The bronze alloy would have melted at temperatures in excess of 800°C. The contact wire would have melted at about 1083°C. These temperatures are more than sufficient to have caused recrystallisation and grain growth for the copper conductor.

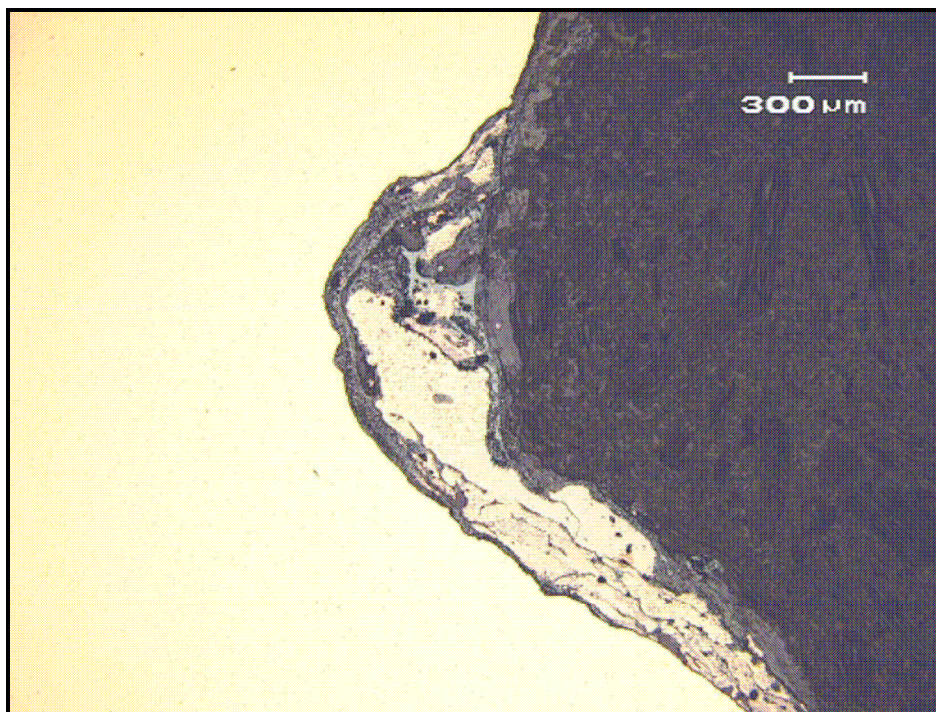
Figure 8
Copper and copper oxides in the central part of the contact wire

- copper and copper oxides on the surface of the central part were up to about 0.5 mm thick (see Figure 8)
- inclusions in the structure were consistent with electrolytic tough pitch (ETP) copper.

- 4.6 The thickness of the corrosion and copper layer on the surface in the central waisted part of the contact wire far exceeded the expected corrosion thickness under normal conditions. Therefore, additional factors had influenced the build-up of the corroded surface. These factors probably included:

- 5.4 The observed corrosion depth of 0.33 mm on the contact wire far exceeded the design average of 0.018 mm, resulting from undisturbed exposure to a marine environment for 20 years.
