MARINE OCCURRENCE REPORT

04-205

Fishing vessel *Bronny G*, grounding, Banks Peninsula

26 March 2004

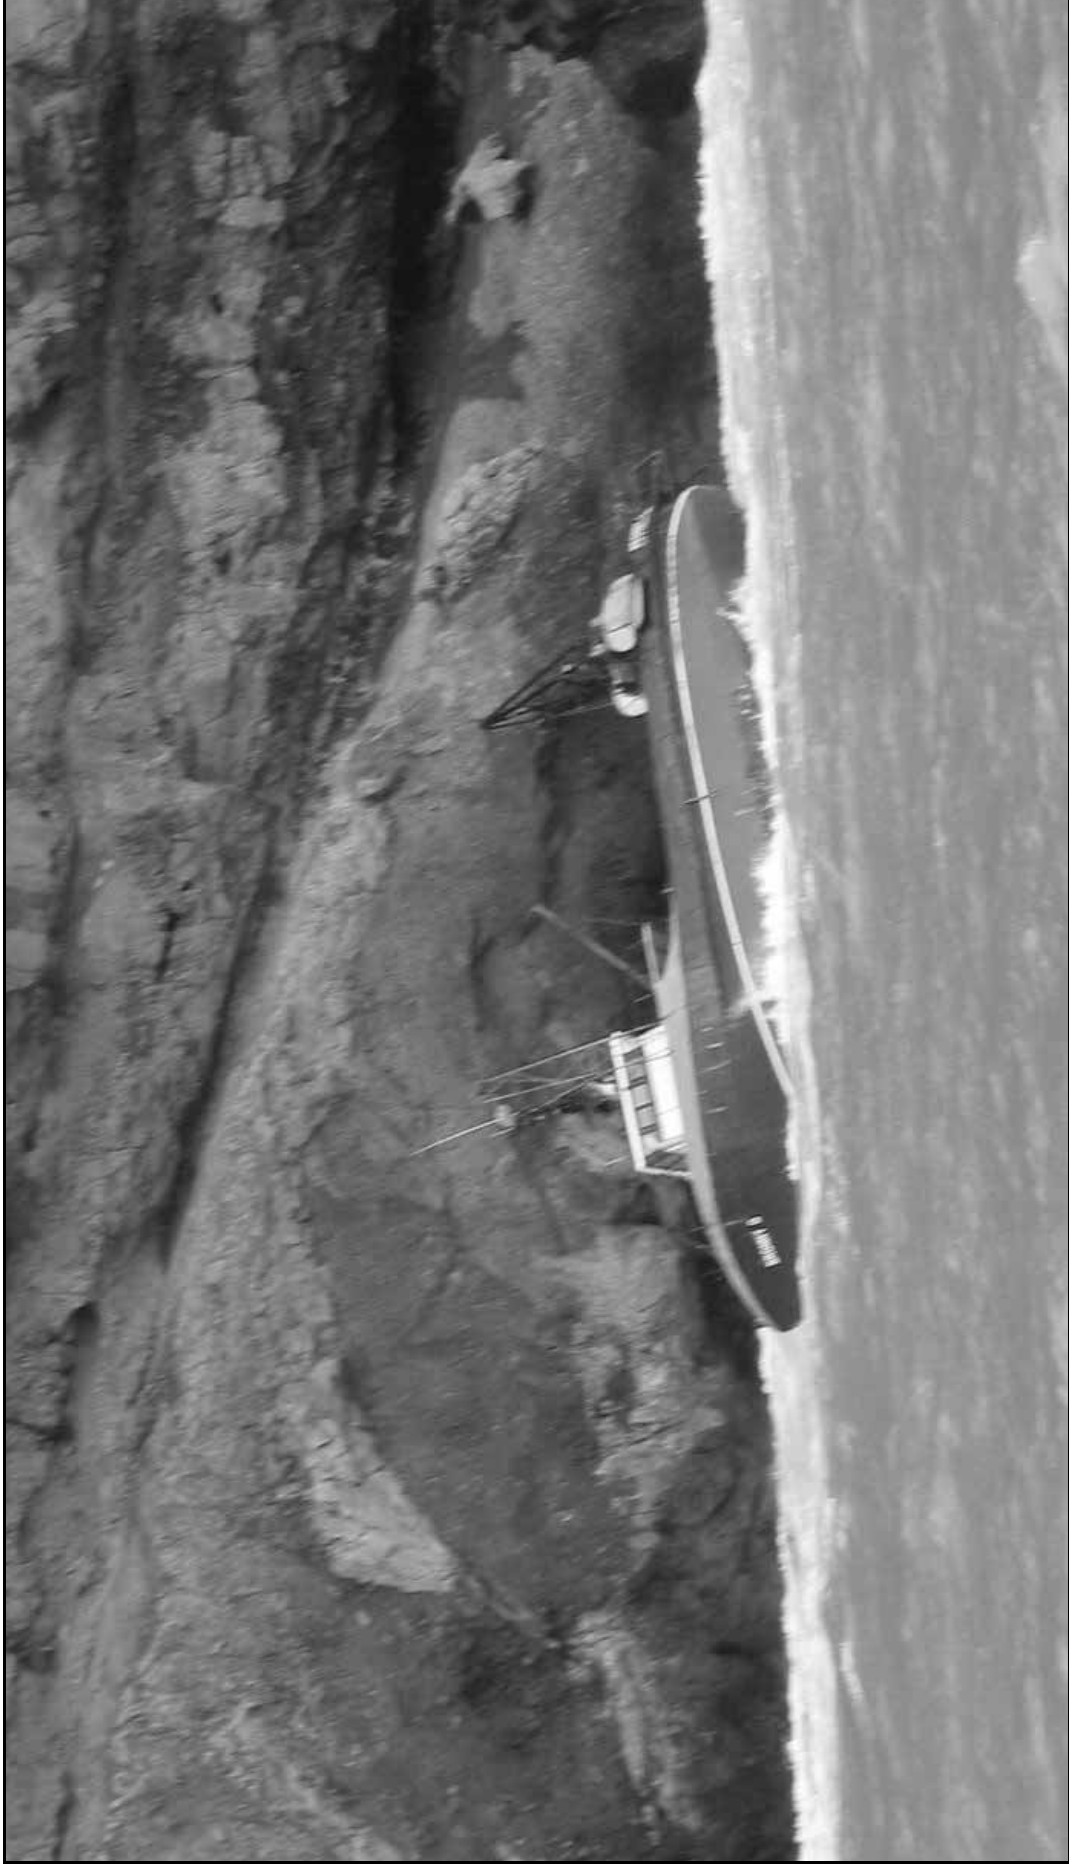
The *Bromy G* aground under the cliffs at Steep Head

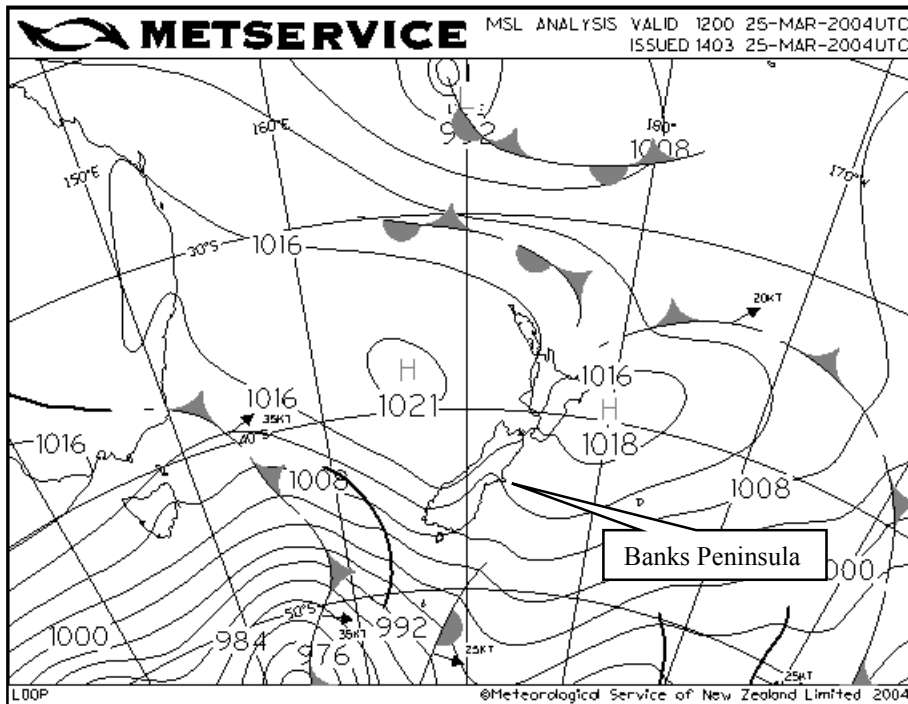
Figure 3
Mean sea level analysis synoptic chart for 0000 26 March 2004

- 1.5.1 At the time of the accident there was a high-pressure system situated over New Zealand, but a low pressure to the south of New Zealand. The associated weather systems caused a swell affecting the east coast of South Island (See Figure 3).
- 1.5.2 Banks Peninsula is situated on the boundary between 2 of the New Zealand coastal waters forecast areas, namely Conway and Rangitata. New Zealand Meteorological Service (Metservice) issued Coastal waters forecasts at well-documented regular intervals.
- 1.5.3 Coastal area forecasts are a general indication of average conditions expected in a particular coastal area. The forecasts are for open waters within 60 nm of the coast and do not apply to enclosed areas such as small bays and harbours.
- 1.5.4 The coastal waters forecast issued at 0014 26 March 2004 was as follows:

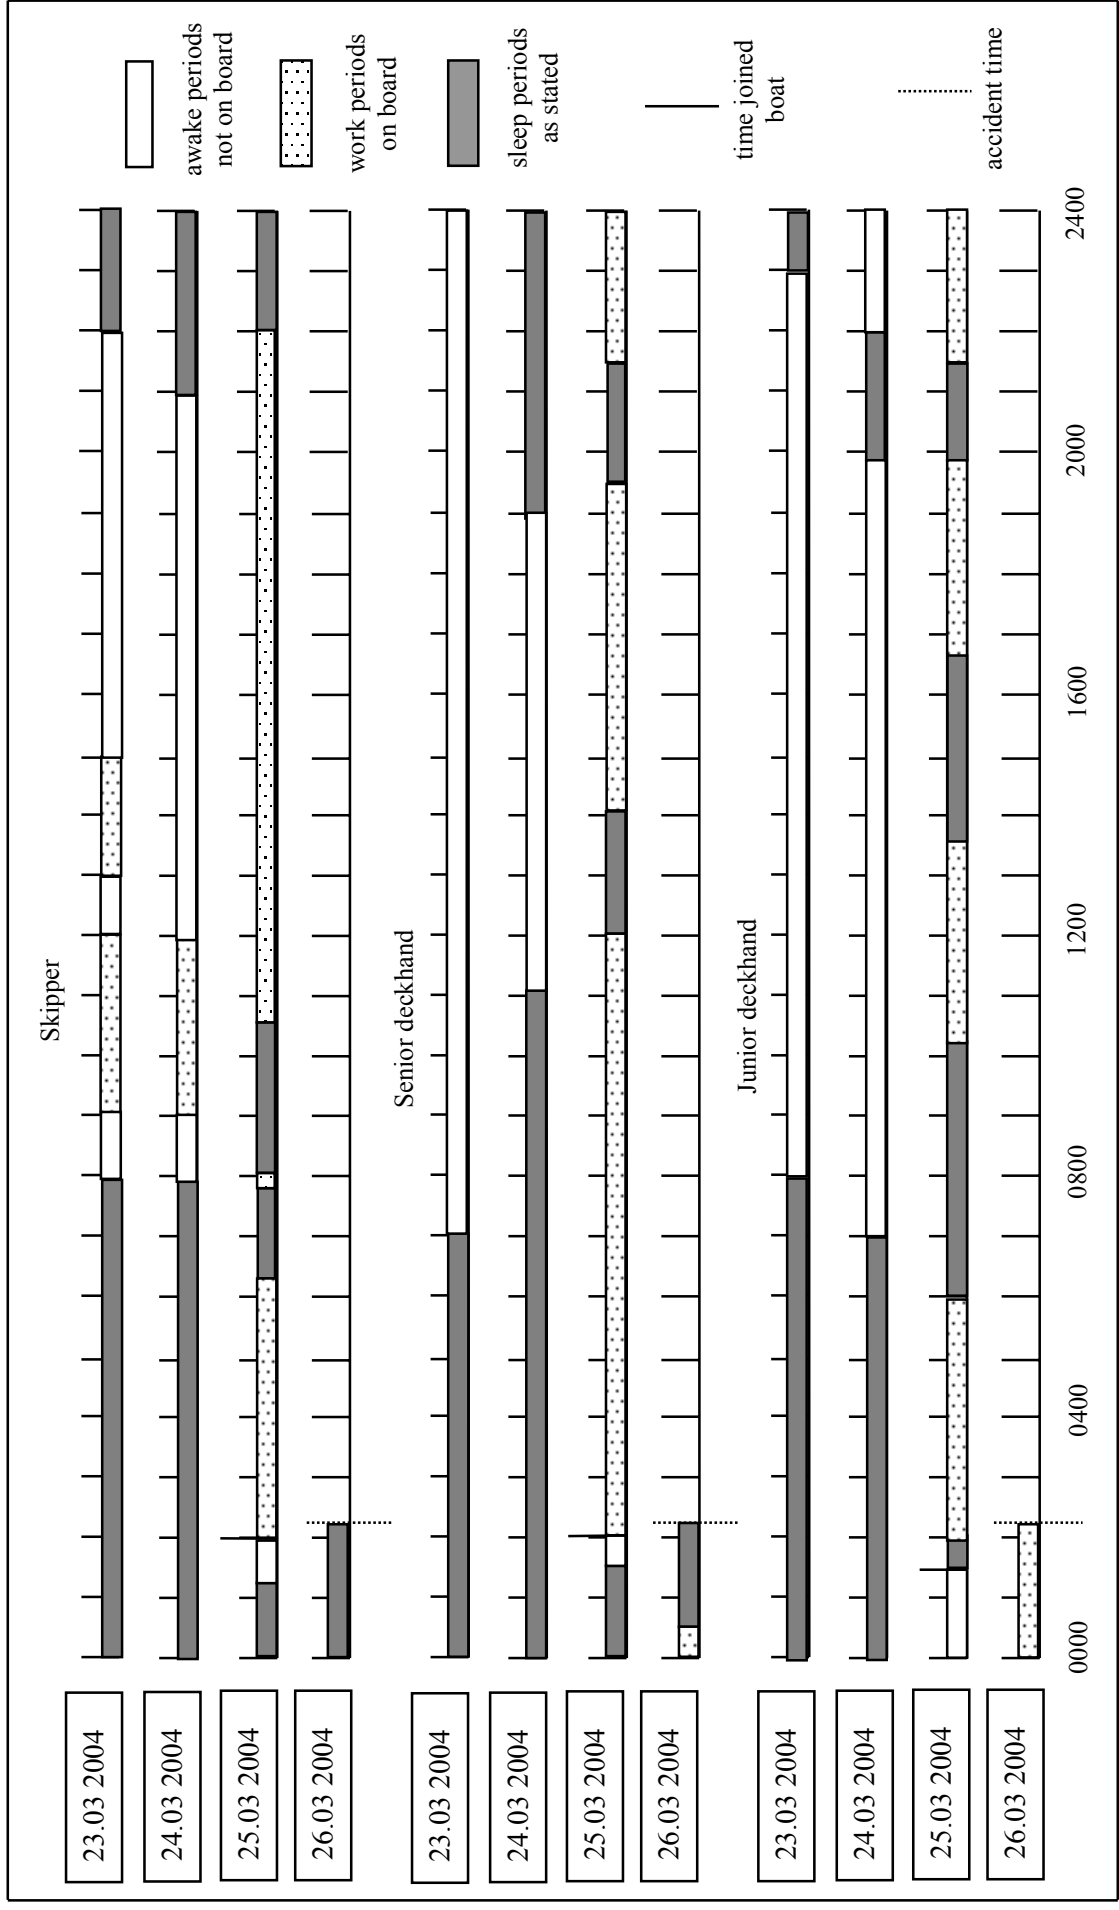
Figure 4
Crew sleep/wake information prior to accident

- 2.8 The junior deckhand had a sleep period of 2 hours about half an hour prior to starting the voyage back to port. Previously he had a rest period of about 3 hours, 3 hours before the last rest period. In the 24-hour period prior to starting the voyage back to port the junior deckhand had 3 rest periods totalling about 8 hours. He would be considered to be fatigued and be accumulating a sleep debt. In the 48 hours prior to starting the voyage back to port he had 16 hours of sleep in 5 periods, the maximum being 8 hours at the beginning of the 48-hour period, giving him a broken sleep pattern and probably poor sleep quality. From this it would appear that he was chronically fatigued.
