## MARINE OCCURRENCE REPORT

04-207

Fishing vessel *Poseidon*, grounding, north of Manukau Harbour entrance

15 April 2004

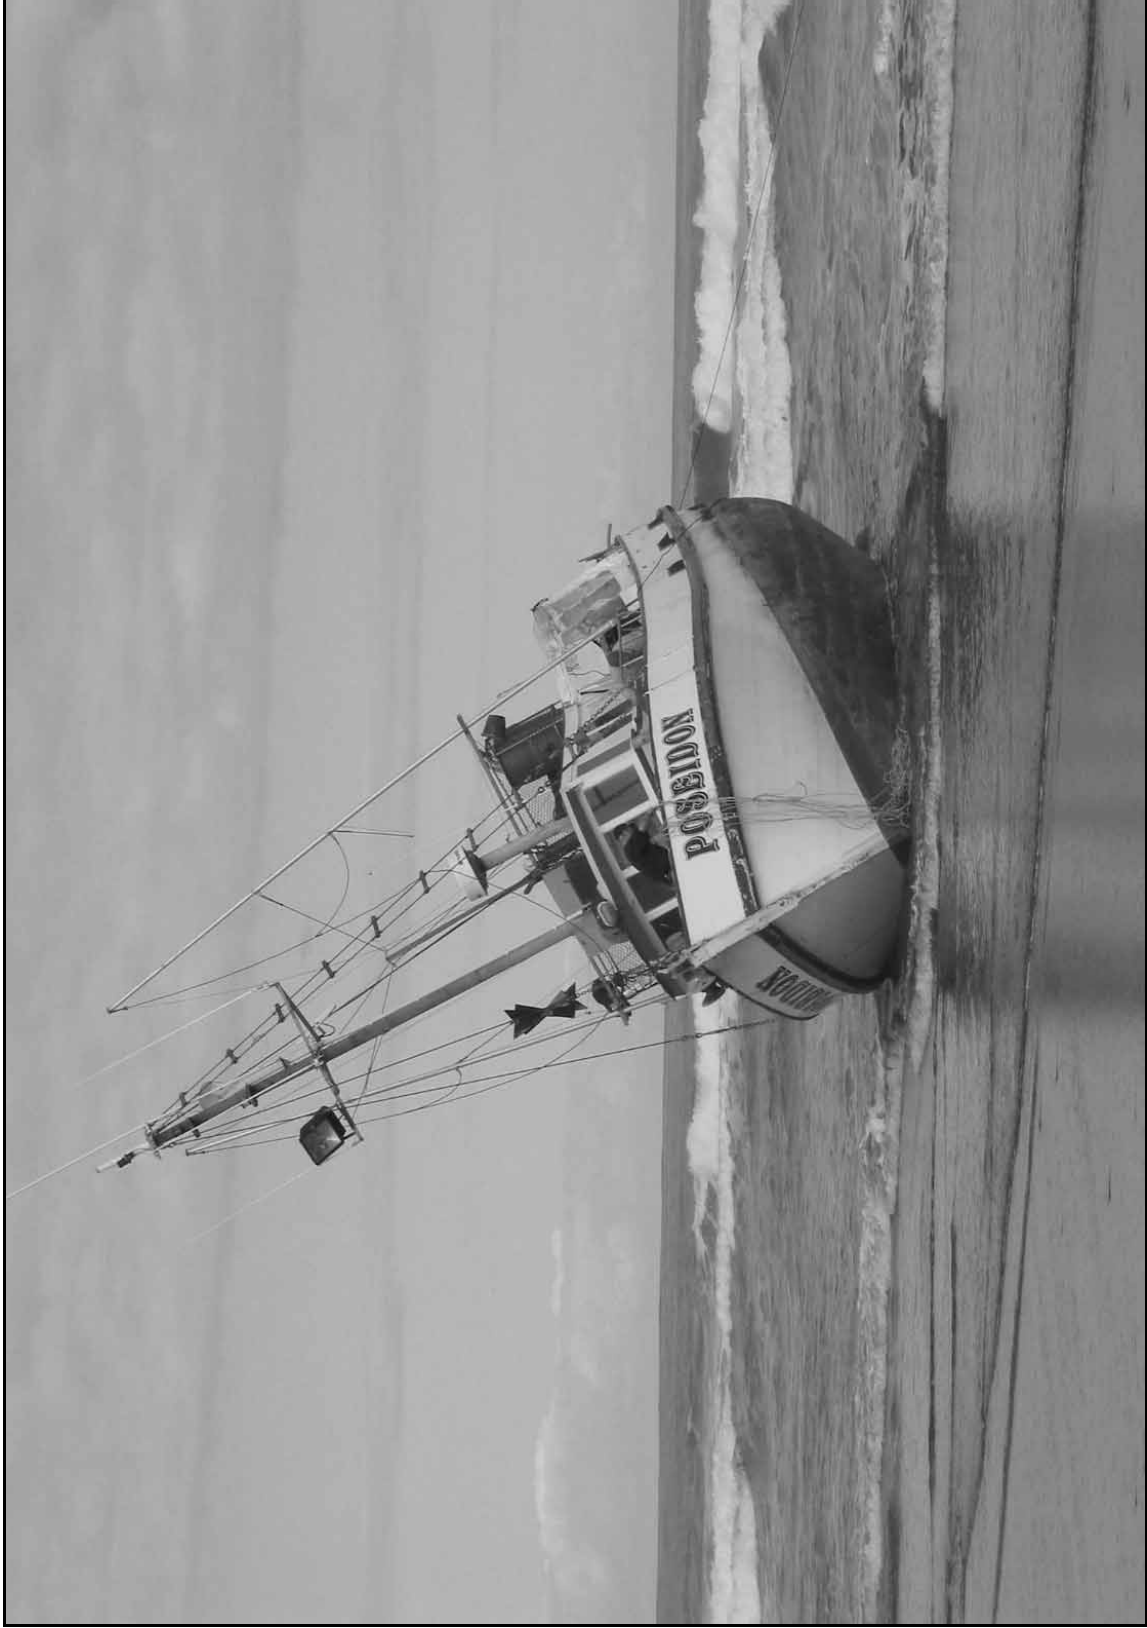
**The *Poseidon* aground on the beach north of Manukau Heads**

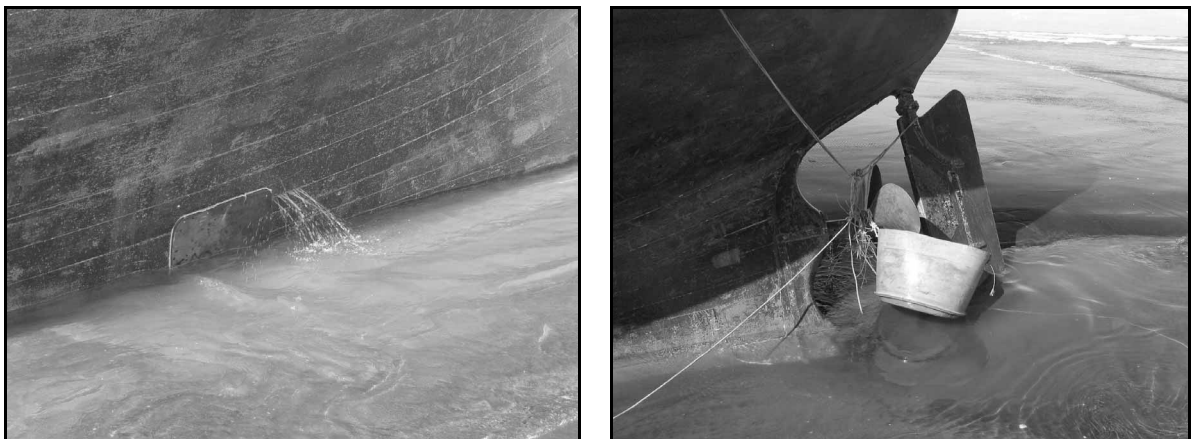
- 1.1.12 After several attempts to free the vessel something, later identified as a rope from the *Poseidon*, fouled the propeller stalling the engine. Reassessing the situation, the skipper decided to make a “Mayday” call.

**Figure 2**  
**One of the many leaks in the sprung planking, and the fouled propeller**

1.3.1 The *Poseidon* was constructed of wood planking on a wooden frame and could withstand a certain amount of flexing in the hull. However, being stranded the planking was flexed to such an extent that a number of fastenings between it and the frames sprung. Caulking between the planks of the hull was also displaced rendering the hull non-watertight (see Figure 2).
