## M A R I N E   O C C U R R E N C E   R E P O R T

04-208

jet boat *CYS*, propulsion failure and capsize, Waimakariri River

13 May 2004

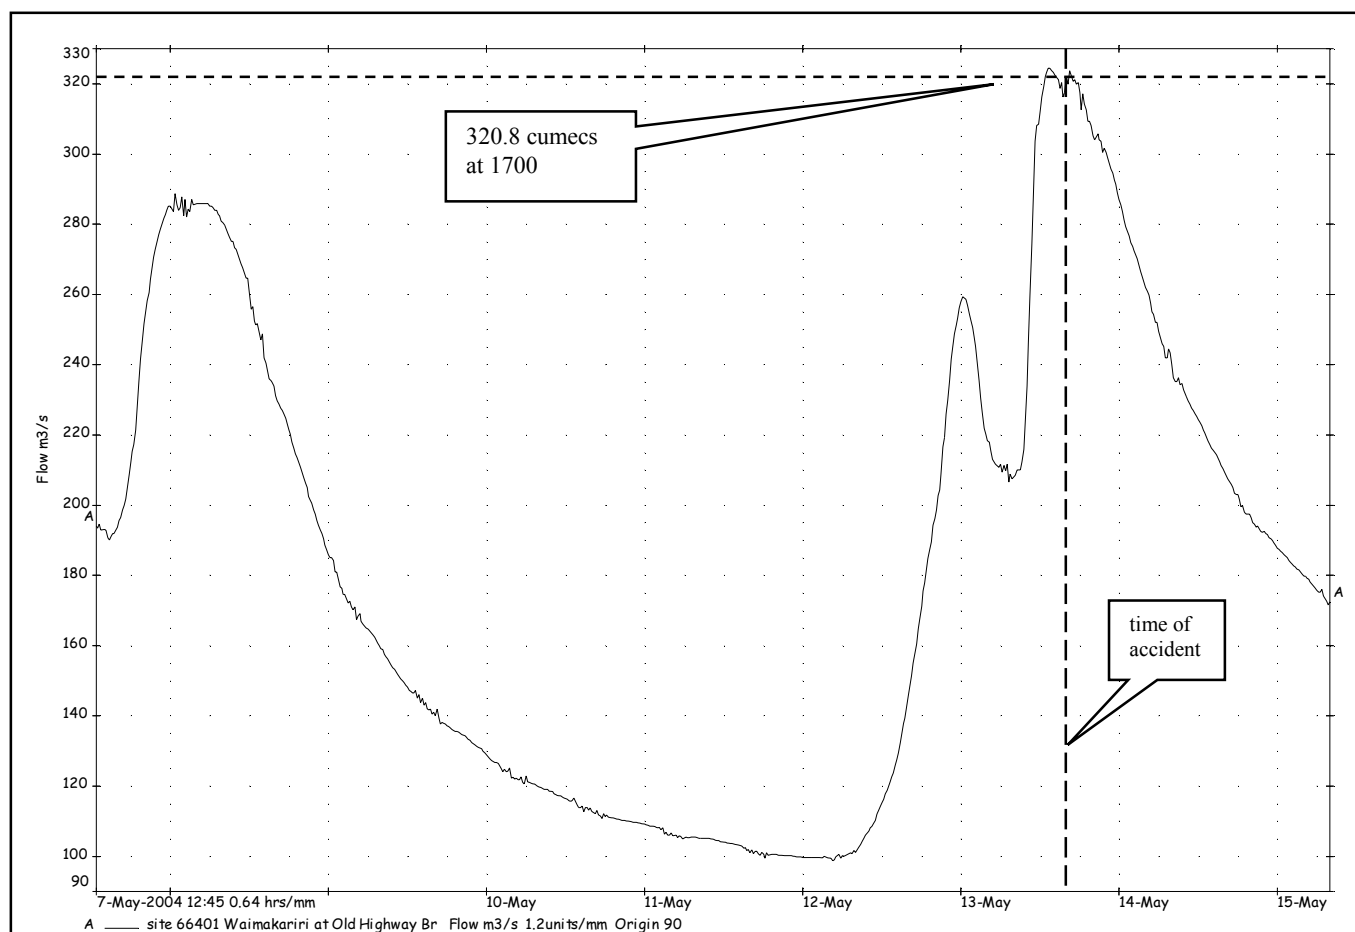
**Figure 5**  
**Smoothed and re-rated river flows at the Old Highway Bridge**

- 1.4.5 The information displayed on the ECan website was not real time but delayed by up to 6 hours.
- 1.4.6 The site at the Old Highway bridge was gauged and rated on 20 May 2004 and the data gathered since 6 May 2004 was retrospectively adjusted to include the new rating. A new graph was produced for the period of 6 May 2004 to 15 May 2004 (see Figure 5). The adjusted flows showed that on 13 May 2004 the flow was above 300 cumecs between 1115 and 2145, peaking to 324.6 cumecs at 1315. At 1700 the flow was 320.8 cumecs (see Figure 5)

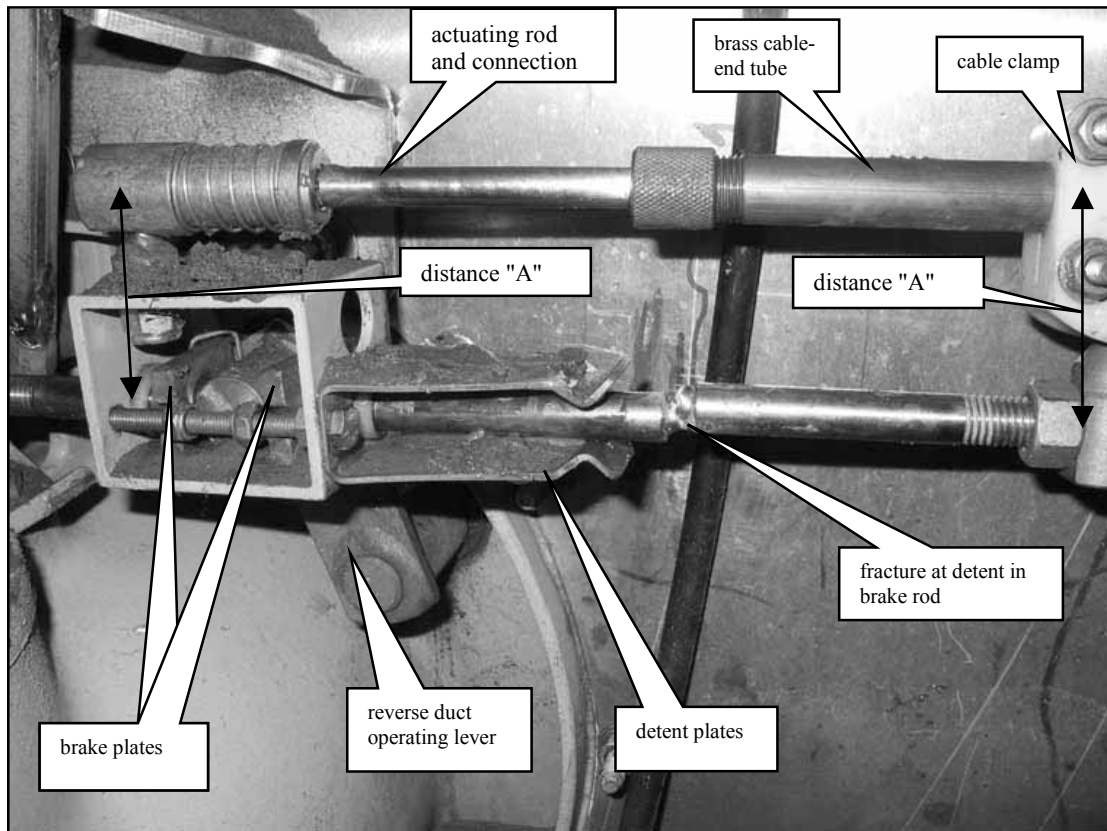
**Figure 8**  
**Reverse latch assembly as found after the accident**

- 1.7.5 Within the latch assembly were 2 brake plates, tensioned by springs and set at an oblique angle to the brake rod, which kept the reverse duct in the position set by the driver. Without the latch, the weight of the duct would cause it to drop into the reverse position. The amount of friction exerted by the brake plates could be adjusted using the adjusting rod and nuts (see Figures 9 and 11).

- 1.7.7 The smaller Morse 64C cable was designed to be fitted directly to the latch assembly through pre-drilled holes (see Figure 9) and the brass cable end tube was connected to the brake rod by a clamp with a ball and socket type joint. The larger D0499 cable was too big to be fitted in this way, instead, a connection, also with a ball and socket type joint (see Figure 8), was mounted onto the top of the reverse latch assembly and connected to the cable end rod. A larger clamp, with a ball and socket type joint was used to connect the brass cable end tube to the brake rod. The new clamp and connection increased the distance between the axis of the brake rod and the axis of the cable from 18 mm in the original design to about 50 mm (distance "A" in Figure 8).

- 2.5 The movement of the cable and the fracture of the brake rod indicate that the jam occurred at or aft of the reverse latch assembly. When the reverse latch assembly was removed from the boat it was contaminated by mud and sand but could still be slid along the brake rod. After the latch mechanism was removed the reverse duct and its control linkages moved freely without any sign of jamming. It is therefore probable that the reverse latch assembly was restrained by the reverse duct being jammed in the fully down position.

- 4.1 Prior to the accident, in response to the problems experienced by the commercial operators with the lighter Morse B71 control lever, CWF Hamilton and Co Limited had designed a more robust control lever, part number JM 1289. The new control lever was designed for use with the Morse 64C cable, thus avoiding the need to modify the cable to latch mechanism connection.
- 4.2 As part of the repairs, the operator fitted the new JM 1289 control lever and Morse 64C cable. He also fitted a brake rod that had been manufactured without the detent.

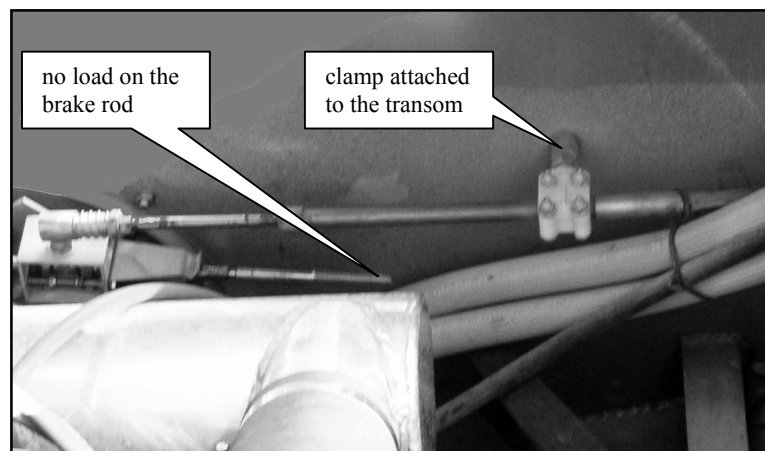
**Figure 10**  
**Reverse latch assembly as fitted to the *black boat***

- 1.7.8 CWF Hamilton and Co Ltd commented that a number of tour boats had been set up with the larger cable and control lever but the clamp at the end of the brass cable end tube was attached to the transom of the boat rather than the brake rod. In this way no load was applied to the brake rod and bending at the detent would not occur. The reverse latch assembly on the *black boat* was of this type.
- 1.7.9 The ball and socket joints on the clamp and cable end rod connection were necessary to allow for the vertical movement of the latch assembly caused by the radial movement of the reverse duct operating lever (see Figures 6 and 9).

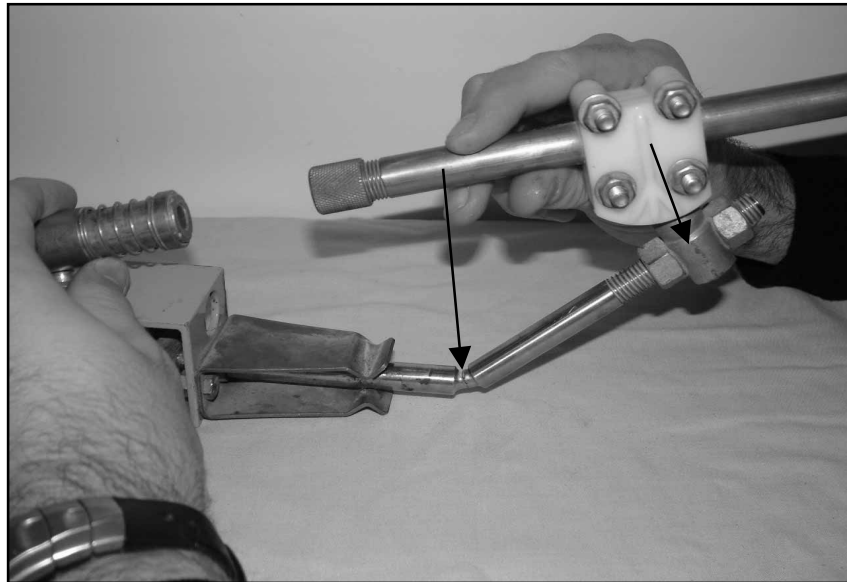
**Figure 12**  
**Reconstruction of the brake rod and cable connector at failure**

- 1.7.10 The 12 mm diameter brake rod had a 2 mm detent machined into it, reducing its diameter to 8mm. The detent gave the driver a reference point for the neutral position of the reverse duct. The detent did however reduce the cross sectional area by over 50%; (12 mm diameter rod has a cross sectional area of 113.1 mm<sup>2</sup> and 8 mm rod has an area of 50.3 mm<sup>2</sup>).
- 1.7.11 When the reverse duct was fully down, the reverse latch assembly was at the far end of its travel with the maximum length of brake rod exposed. In this configuration, the detent was subject to the maximum amount of bending moment, which increased as the brake rod deflected under the moment (see Figure 12). Note that the comparative length of the two arrows shows how the bending moment lever arm increases with rod deflection.

Clearly for the rod to fail in bending, a bending moment had to be applied to the fracture plane. Applying a force via the cable and nylon connector would impart a bending moment to the fracture plane with a lever arm equal to the distance between the cable and the fracture plane. This is the most likely source of bending moment that failed the rod.

It is important to note that because the cable connector is free to pivot on the grey box [the latch assembly], the lever arm increases as the rod deflects. The lever arm at failure would have been significantly greater than it would normally be during standard operation.

- 3.4 The fracture of the brake rod was caused by a bending moment induced by the cable and probably occurred when the driver exerted extreme pressure on the reverse duct control lever, shortly before the boat struck the bridge pier.

- 3.5 The design of the modified reverse latch assembly was deficient because it created a large bending moment on the brake rod.
- 3.6 The detent in the brake rod created a weak point, where failure was likely to occur.

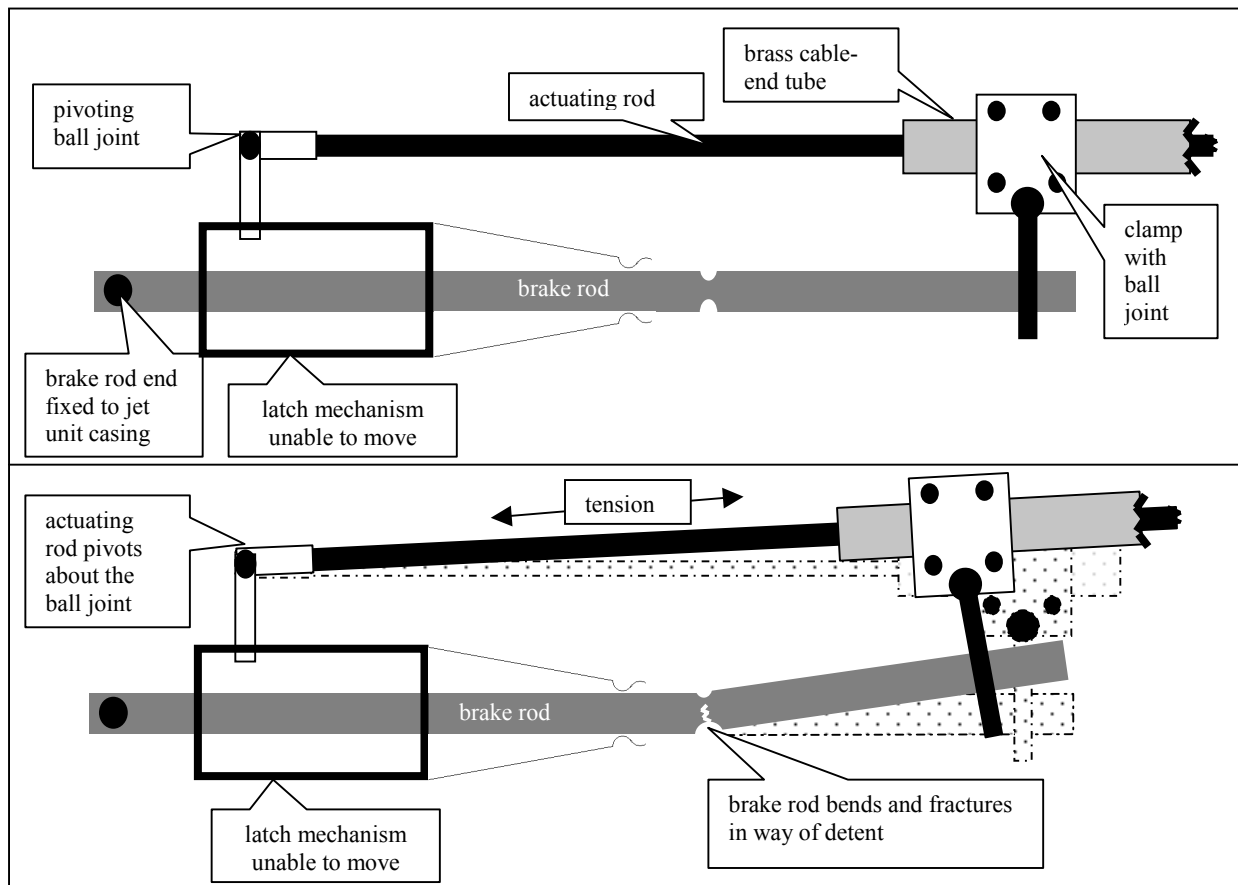
**Figure 13**  
**Effect of tension on the reverse duct operating cable should the reverse latch be unable to move**

- 1.7.12 Should the reverse duct become obstructed and jam while in the fully down position, a driver attempting to free this by actuating the lever to lift it would apply tension to the actuating cable, which would in turn apply a bending moment to the brake rod. When the actuating cable was under tension it created an inward and upward bending moment at the end of the brake rod. This bending moment would act on the weakest part, which in this case was the detent (see Figure 13). The driver indicated that shortly before the boat hit the bridge pier he pushed so hard on the reverse duct control lever that he thought that he had broken the control lever or the cable. However, during inspection the control lever and the cable were found intact.
