MARINE OCCURRENCE REPORT

04-209

fishing vessel *Joanne* and motor tanker *Hellas Constellation*,
collision, entrance to the Port of Tauranga

19 May 2004

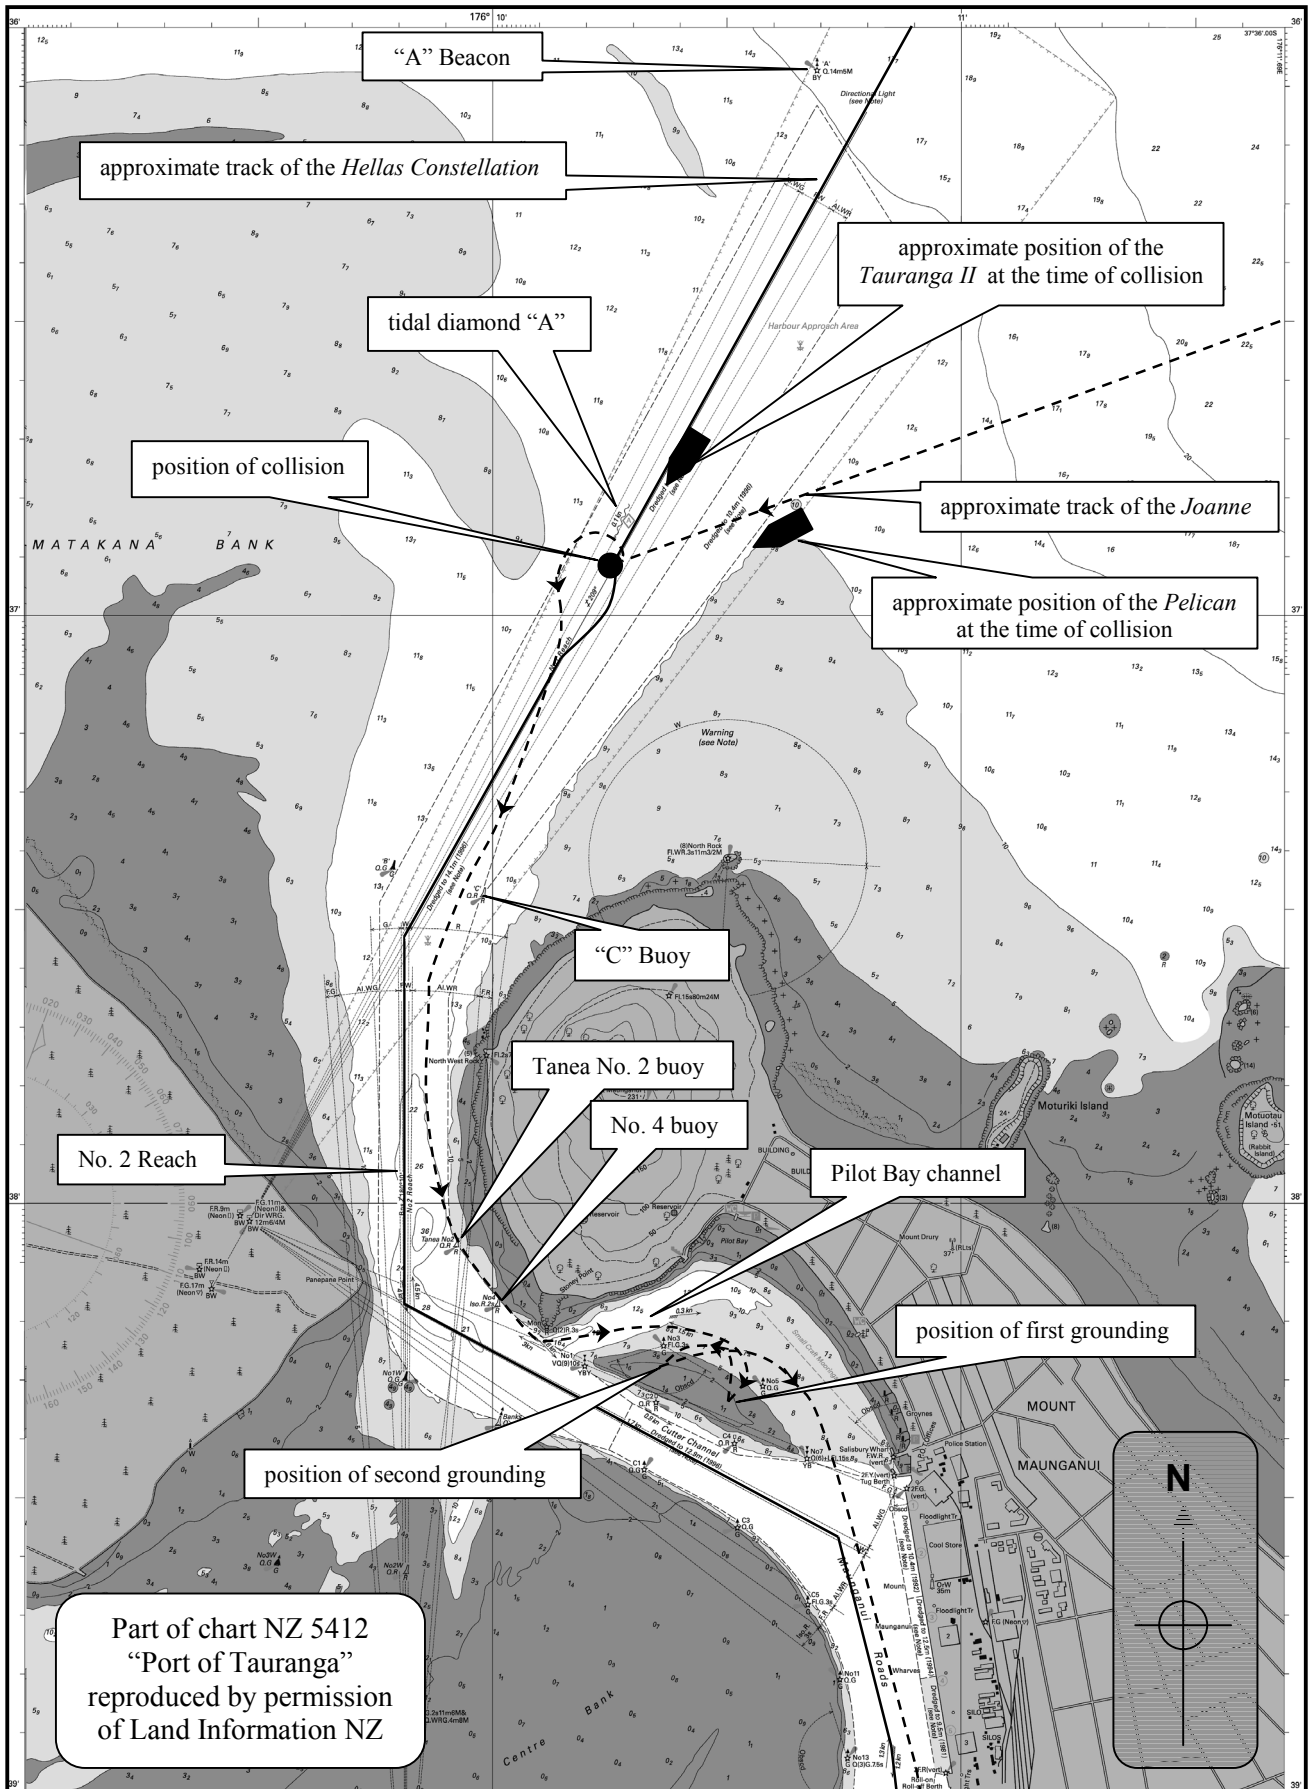
Figure 2
Accident site and tracks of respective vessels

- 1.1.7 Some time later the skipper fell asleep in the helmsman’s chair. The *Joanne* continued on course towards Tauranga. As the *Joanne* neared Tauranga approach channel, it passed astern of the dredge *Pelican* and ahead of the pilot boat *Tauranga II*, and collided with the port side of the tanker *Hellas Constellation*, which was entering port under pilotage (see Figure 2).

- 1.1.23 At about 0120, and before the *Tauranga II* could reach it, the *Joanne* collided with the port side of the *Hellas Constellation*. The pilot immediately ordered the helm to port to swing the stern away from the stricken vessel and anyone who might be in the water. However, as soon as the *Joanne*, was clear of the *Hellas Constellation* the pilot ordered helm to starboard to stop the tanker swinging out of the channel.

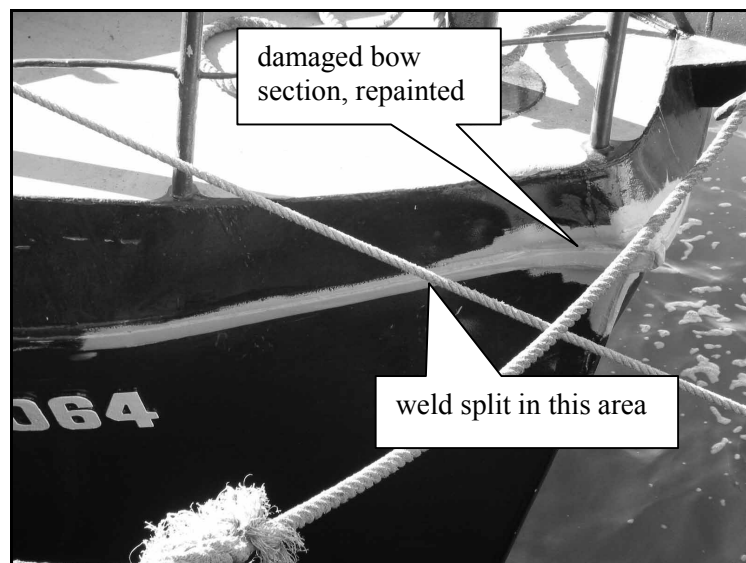
Figure 3
Damage to the bow of the *Joanne*

1.3.1 The *Joanne* sustained paint damage to the bow and a split weld in the hull just below the level of the foredeck (see Figure 3).

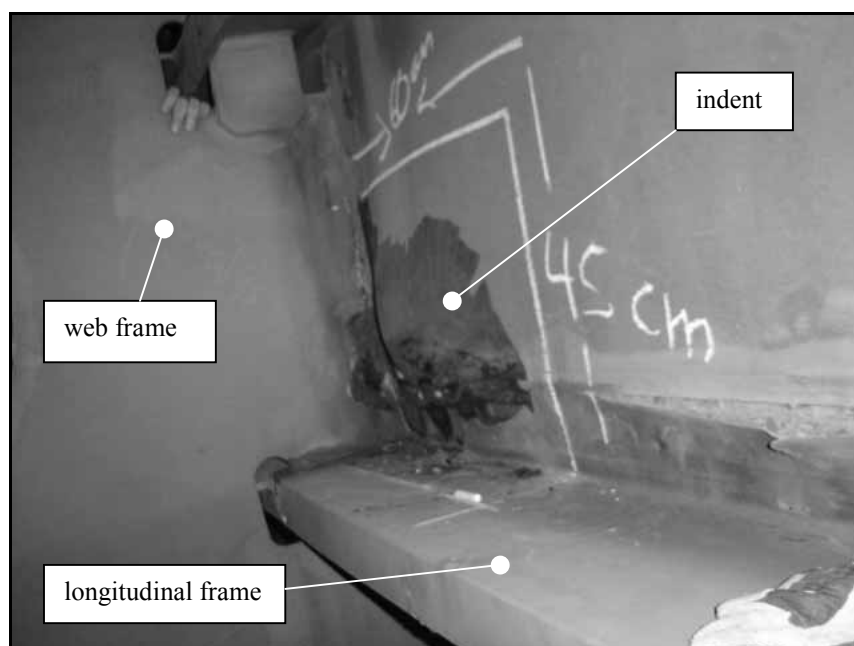
Figure 4
Internal damage to the *Hellas Constellation*

- 1.3.2 The *Hellas Constellation* sustained paint damage to the exterior and interior of the hull plating forward of amidships in way of No. 2 water ballast tank. The hull plating was indented to a depth of about 100 mm in the centre of an area of about 600 mm x 450 mm, causing deformation to a side longitudinal and a web frame.
