MARINE OCCURRENCE REPORT

04-210

restricted limit passenger vessel *Esprit de Mer*, fire,
Milford Sound

30 June 2004

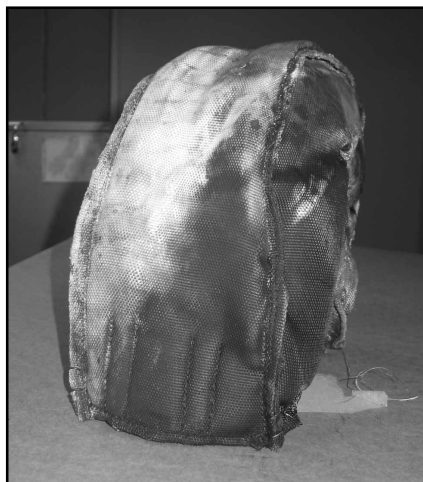
Figure 2
Turbocharger heat boot

- 1.4.5 A heat boot covered the turbine casing of the turbocharger to retain the heat and reduce the risk of people being burned if they came into contact with it. The boot had a glass fibre cover and a wire mesh inner with glass fibre wadding between the 2 (see Figure 2).
- 1.4.6 Before the photographer attended the vessel, the skipper of the boat removed the heat boot from the turbocharger so that the pipes near the turbocharger were more readily visible. Later, the heat boot was loaded onto the back of the engineers' utility vehicle with the turbocharger and ancillary pipes to be taken to Invercargill.

- 2.12 Forensic examination found that the turbocharger heat boot was contaminated by both diesel and lubricating oil, however the quantities could not be determined. Nevertheless, it can be seen from Figure 2 that black marks spread across the forward port corner of the boot. This area was very wet and oily to the touch, indicative of substantial contamination by lubricating oil.

- 2.13 The representatives of the engineering company that was responsible for maintenance on the *Esprit de Mer* suggested that the heat boot was not stained when its engineer attended the boat after the fire and that contamination was likely to have occurred when on the back of the utility vehicle on the return trip to Invercargill. Although this was possible, the Commission considered that the pattern of staining on the heat boot was more likely to be caused by lubricating oil squirting from the turbocharger lubricating oil feeder pipe.

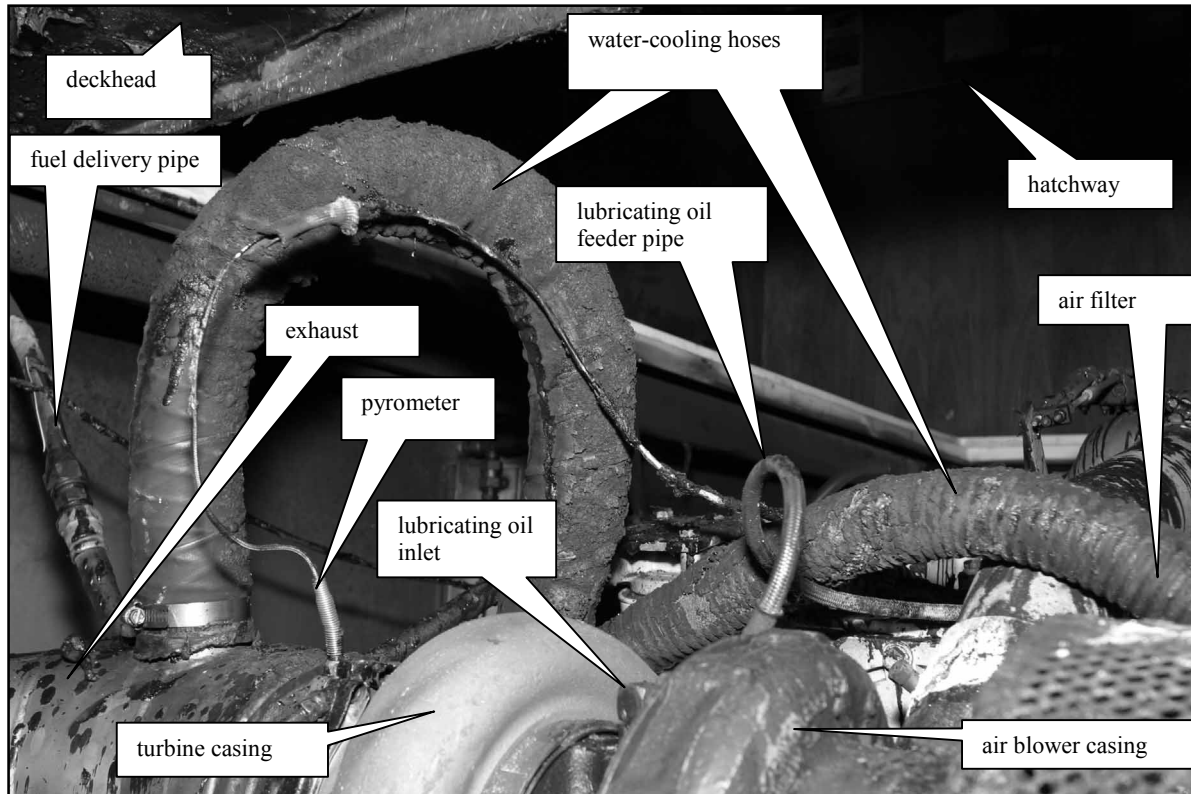
- 1.5.6 The inlet fitting on the T50 turbocharger lubrication feeder was straight, onto which the right-angle connection of the lubricating oil feeder pipe fitted. When the turbochargers were changed in 2000, the new Holset units had a right-angled inlet fitting, onto which it appears the engineer connected the right-angle connection of the lubricating oil feeder pipe. The 2 right-angles together resulted in an unnatural twist in the pipe (see Figure 3).

- 1.5.9 From the photograph in Figure 3 the hose expert observed that a water-cooling hose passed over and was bearing on the turbocharger lubricating oil feeder pipe.
- 1.5.10 No specifications for the original hose were available, but for similar braided hoses the minimum bend radius ranged between 57 mm and 89 mm. The “pig tail” bend in the turbocharger lubricating oil feeder pipe appeared to be less than this recommended minimum.

After-end of the port engine the day after the fire and before the turbocharger was dismantled; the turbocharger heat shroud having been removed

- 2.7 The photograph in Figure 3 showed that the turbocharger lubricating oil feeder pipe had an unusual “pig tail” twist just forward of the turbocharger. The way the 2 right-angle bend connections had been joined appears to have caused the pipe to be twisted into a sharper arc than was recommended for similarly constructed stainless steel braided pipe. In comparison, the new lubricating oil feeder pipe fitted after the fire had a straight connection at the end attached to the turbocharger fitting and the right-angled end attached to the oil gallery of the engine, resulting in a smooth, twist-free lead to the pipe (see Figure 8).

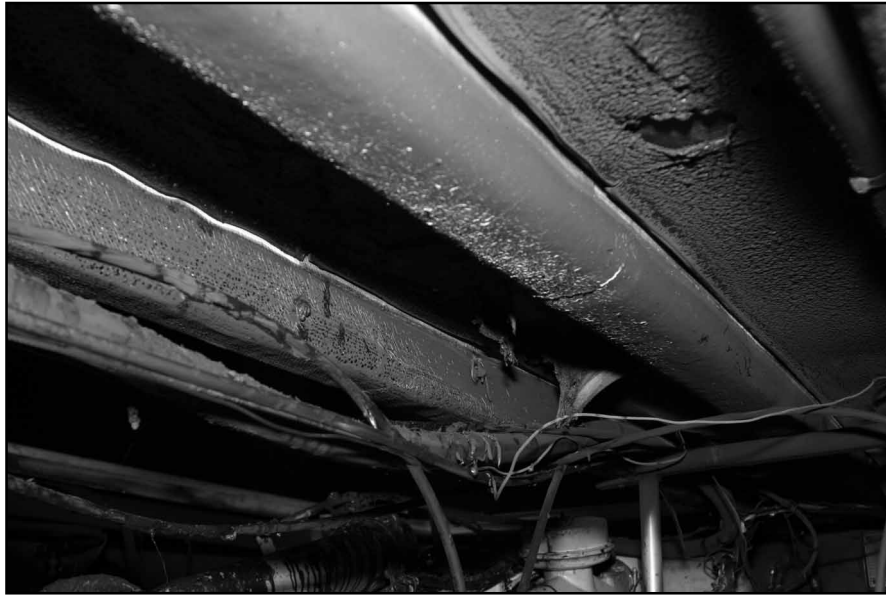
- 1.6.1 The fire damage was limited to the immediate area above and around the port turbocharger. The plastic insulation material on the deckhead, burned, melted and dripped over the port engine. Above the engine, extending forward from above the turbocharger, there was a large hatchway. The after-end of the hatch cover and the adjoining part of the deckhead showed the heaviest charring (see Figures 4 and 5). The insulation on electrical wiring and the plastic casing of the control cables running above the engine melted, causing short circuits and control failures. Rubber water-cooling hoses showed signs of fire but were still intact. Plastic lamp covers and gauge glasses on the aft bulkhead of the engine room were melted, which would indicate that the temperature had risen to about 140°C in that area.

Figure 4
Deckhead above the port engine

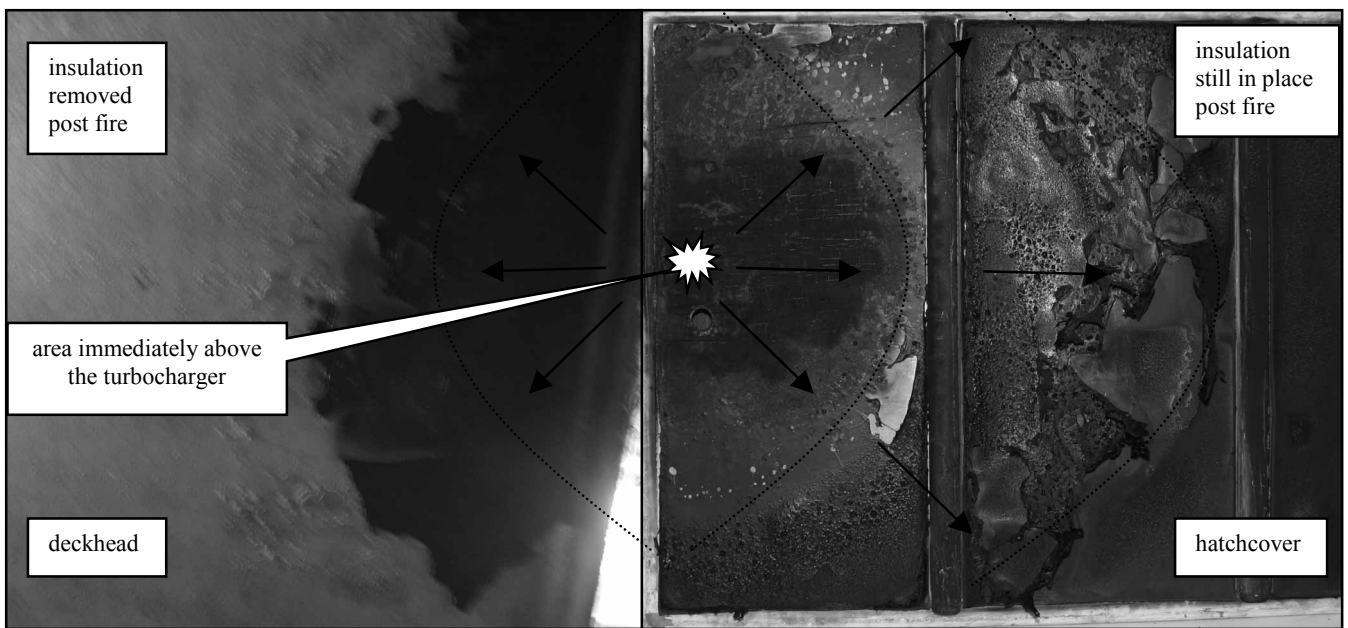
Figure 5
Composite photograph from below looking up at the deckhead and the hatch cover above the port engine. Note: charring radiating away from the position above the turbocharger

- 2.6 The burn pattern on the deckhead and hatchway above the port engine confirmed that the fire was centred in the vicinity of the port turbocharger. Turbochargers and exhaust manifolds were notorious for being the ignition sources of numerous engine room fires. Temperatures of up to 600°C, and on this engine about 450°C at service speed, could be expected at the turbocharger.

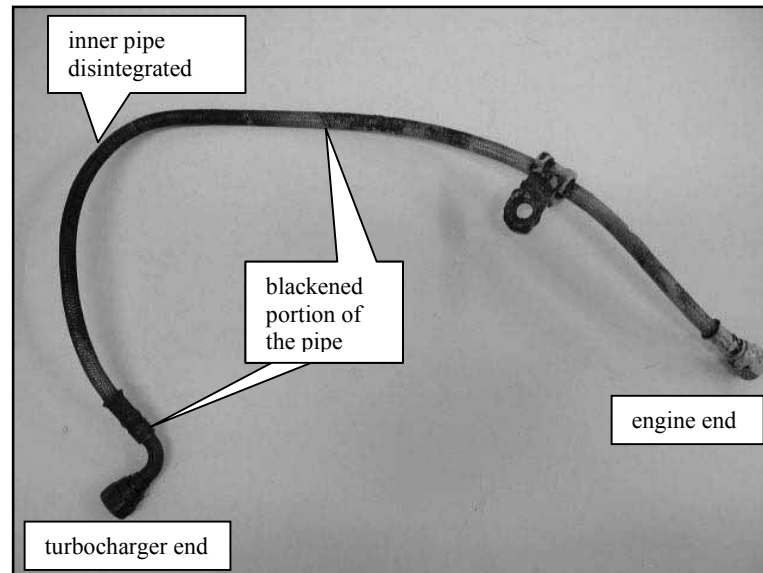
Figure 6
Lubricating oil feeder pipe for the port turbocharger

- 1.7.3 Visual inspection showed that the stainless steel braided outer casing of the lubricating oil feeder pipe was blackened over about half of its length extending from the right-angle fitting. The remainder still had a painted finish (see Figure 6). The pipe, although flexible, was relatively firm except for an area about a third of the length from the right-angled connection where it was soft and considerably more flexible. A leak test, similar to that used for the fuel delivery pipe, was carried out and on this occasion air escaped freely from the soft portion of the pipe.

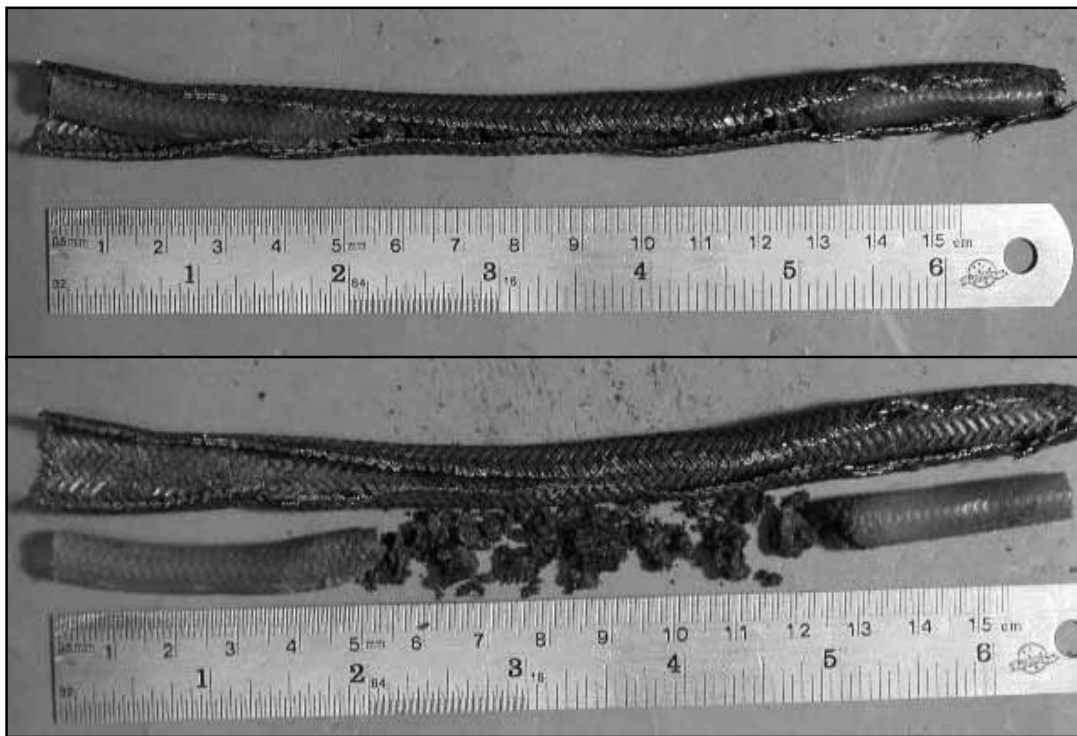
Figure 7
Turbocharger lubricating oil feeder pipe examination

- 1.7.4 The stainless steel braid was cut to expose the inner pipe, which was found to be disintegrated and charred along about 80 mm of its length in the area of the soft portion of the pipe (see Figure 7). The fragments were microscopically examined and found to be glassy with spherical pores, indicating thermal breakdown. The intact ends of the pipe on either side of the fragmented section were charred and for a further 10 mm back the pipe exhibited melting. For about 40 mm from the charred ends, the pipe was its original colour, flexible and largely in its original condition.

- 2.11 The inner pipe of the lubricating oil feeder pipe was found to be burnt about one third of the way from the right-angle end. This position corresponds with the area where the pipe had its sharpest arc. The pattern of the burning on the horseshoe-shaped water-cooling pipe (see Figure 3) suggests that the fuel for the fire sprayed from near the centre of the engine towards the after port side of the engine, further supporting the premise that lubricating oil was the fuel of the fire. When the engines were reassembled after the fire, no other components were found to be leaking, reinforcing the contention that the source of the fire was among those components removed from the engine. The only component that failed during testing was the lubricating oil feeder pipe.

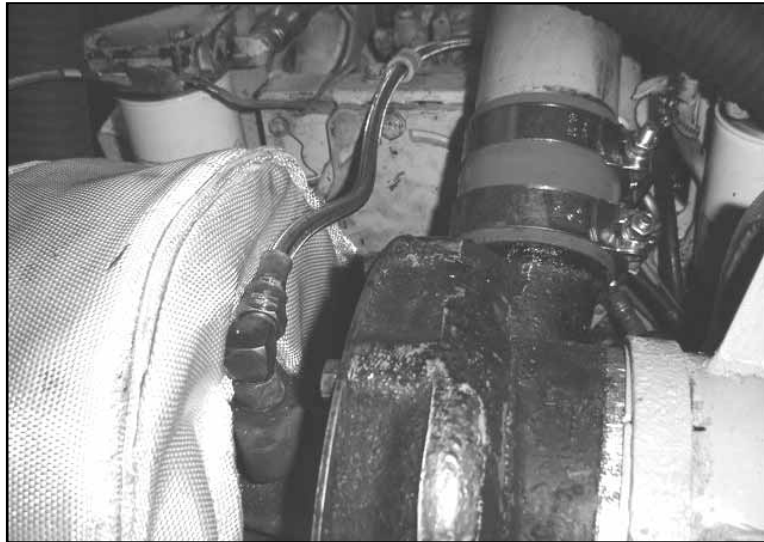
Figure 8
Turbocharger lubricating oil feeder pipe fitted following the fire

- 1.7.6 After the fire, the turbochargers were checked; they were found to be serviceable and were subsequently reinstalled on the engines by a qualified engineer from Industrial Equipment Services Limited. New lubricating oil feeder pipes and the port side fuel delivery pipe were manufactured and fitted. Electrical wiring and the engine control cables were replaced as necessary. After the engines were reassembled the engineer was requested to check all other components for leakage, including fuel filter, lubricating oil filter and high-pressure fuel pipes that could have been the source of fuel for the fire. No leaks were found.
