M A R I N E O C C U R R E N C E R E P O R T

04-215 restricted limit passenger vessel *Southern Winds*, grounding,
Charles Sound, Fiordland

15 October 2004

**TRANSPORT ACCIDENT INVESTIGATION COMMISSION
NEW ZEALAND**

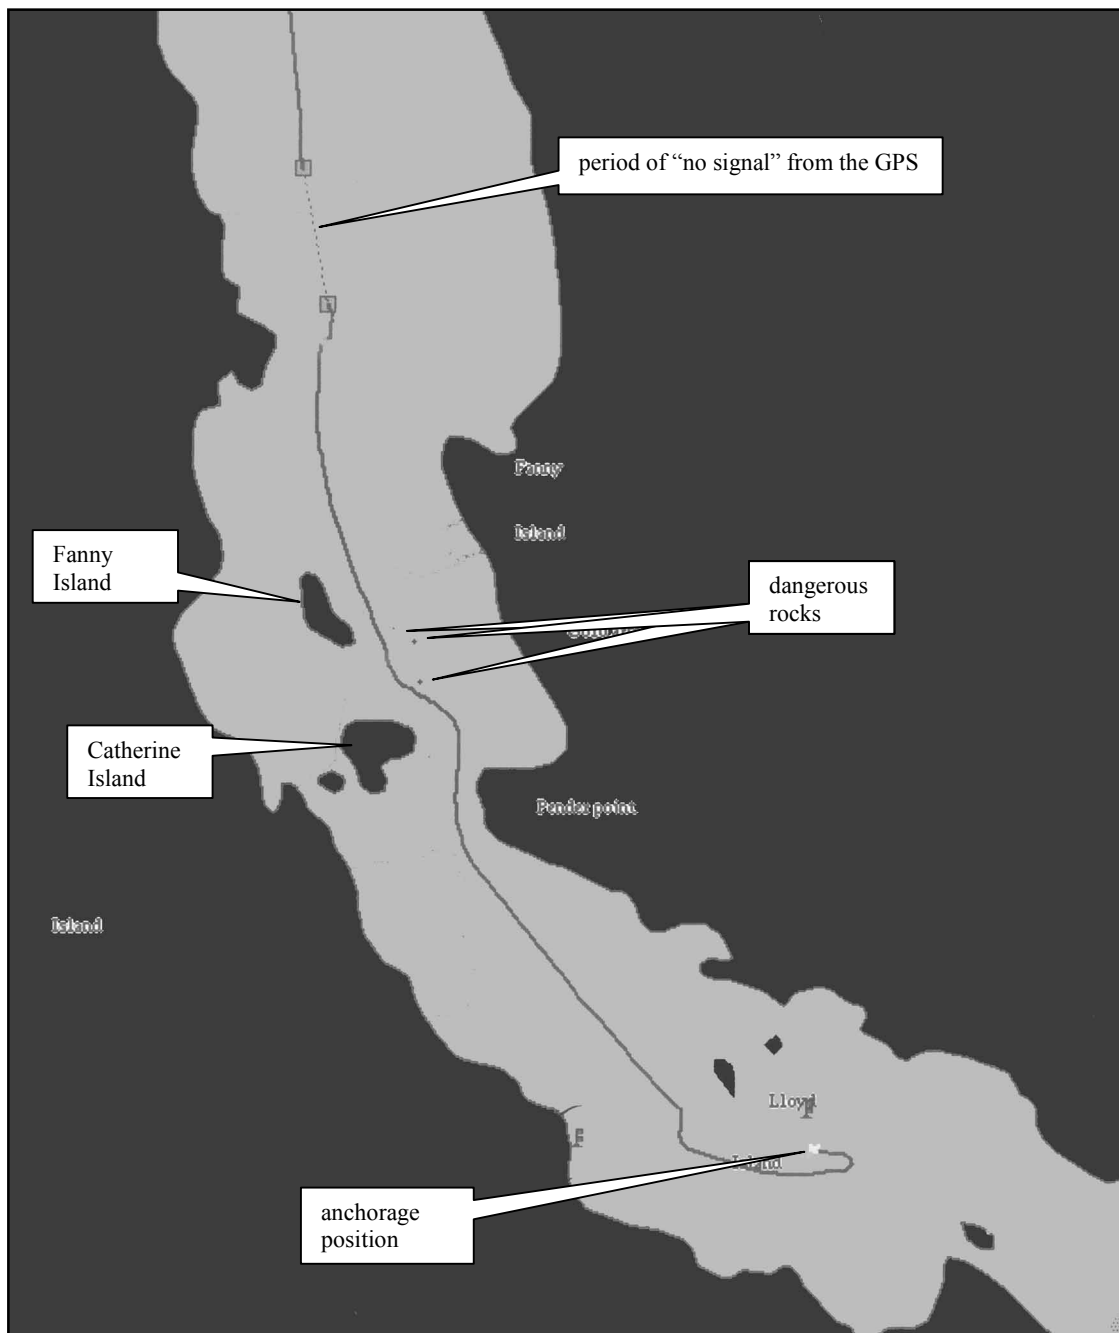
- 1.1.5 The following day they carried out work in Thompson, Nancy and Charles Sounds before going to anchor in Gold Arm, the more southerly of the 2 arms of Charles Sound. The Master said that he mainly navigated the boat by eye but he also used the radar and the track plotter. In heading into the inner part of Gold Arm he passed down the middle of the sound, leaving Fanny Island to starboard, passing close to the shoal ground before altering course to port and then starboard around Catherine Island. He then continued past Pender Point and brought the boat to anchor behind Lloyd Island in 9 fathoms [16.5m] of water (see Figures 1, 2 and 3).

Figure 3
Inward track as recorded on the Olex track plotter

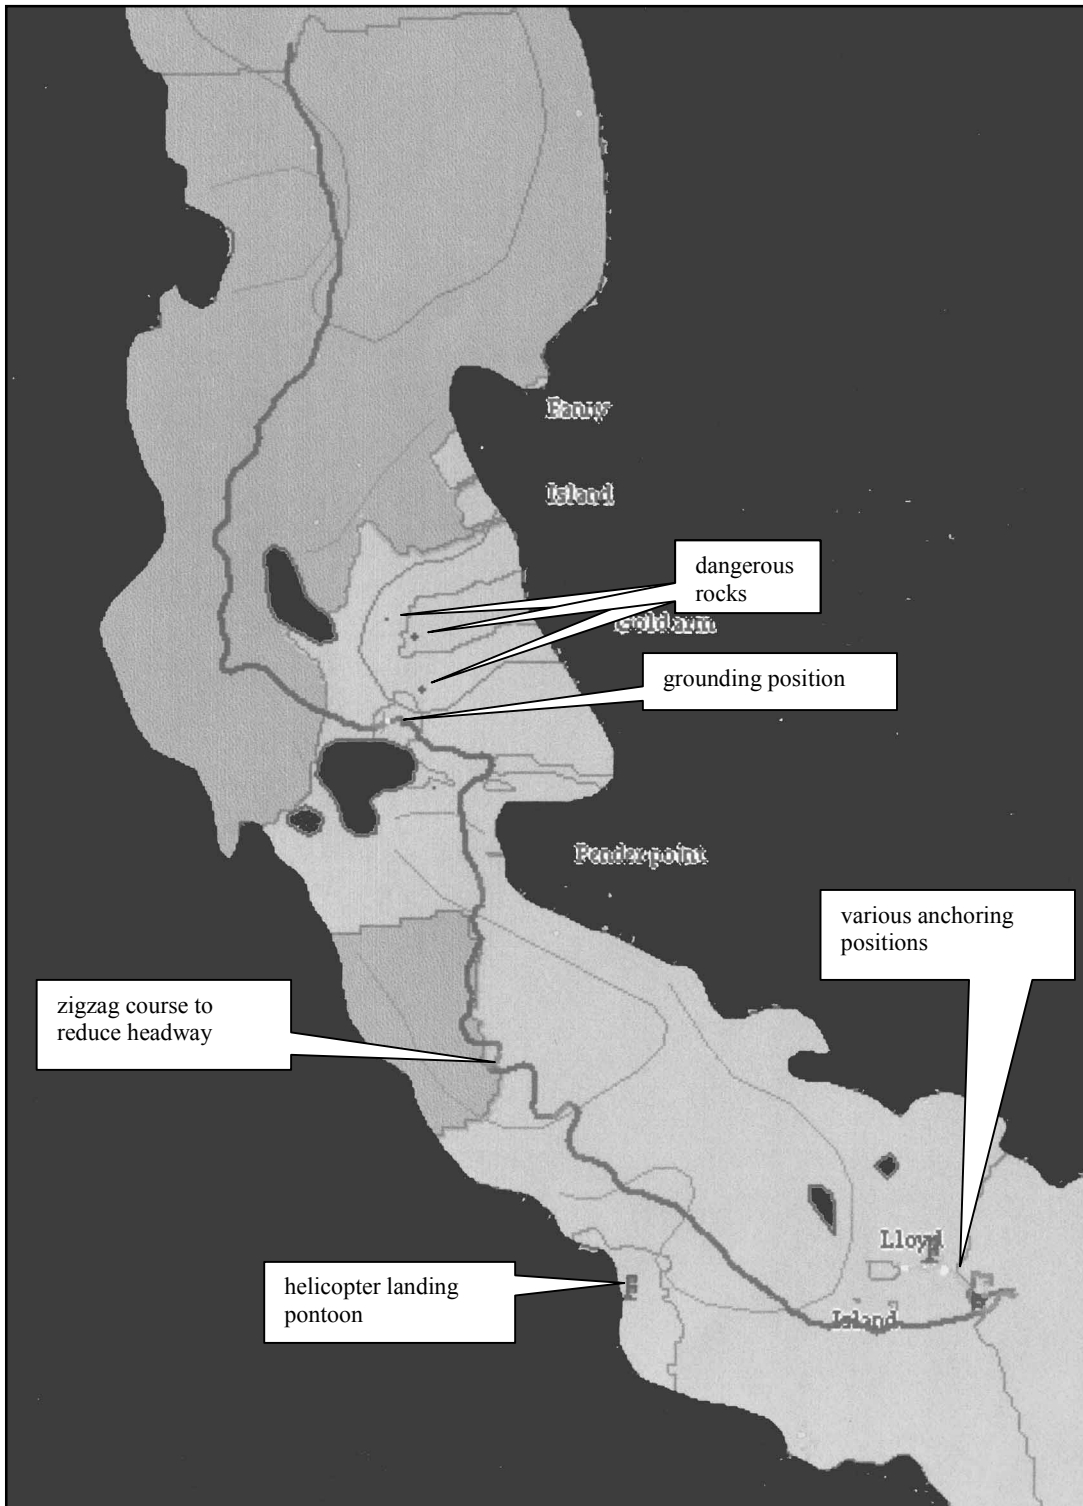
moving up and down the sound. Initially, he tried to manoeuvre in the portion of the sound between Catherine and Lloyd Islands, a distance of about 0.6 nm. However, he soon determined that the speed necessary to maintain steerage was too high for that confined area. So he decided to head into the outer part of the sound (see Figure 4).

Figure 4
Outward track as recorded on the Olex track plotter

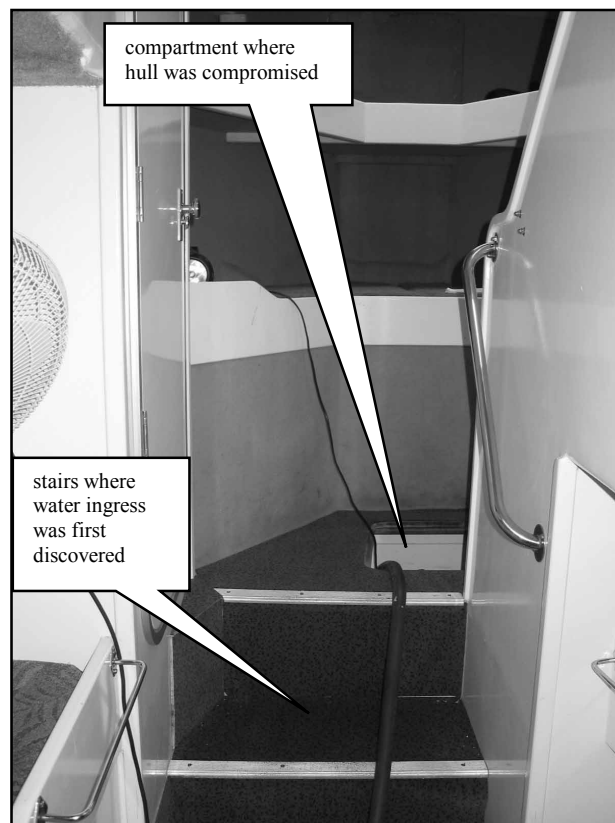
Figure 5
Looking forward towards the stairs from the accommodation to the bridge

- 1.1.11 The breached compartment was not watertight but the lightening holes between it and the space immediately abaft of it were blocked. This caused the water to build up in the breached compartment until it leaked through the stairs where it was noticed.

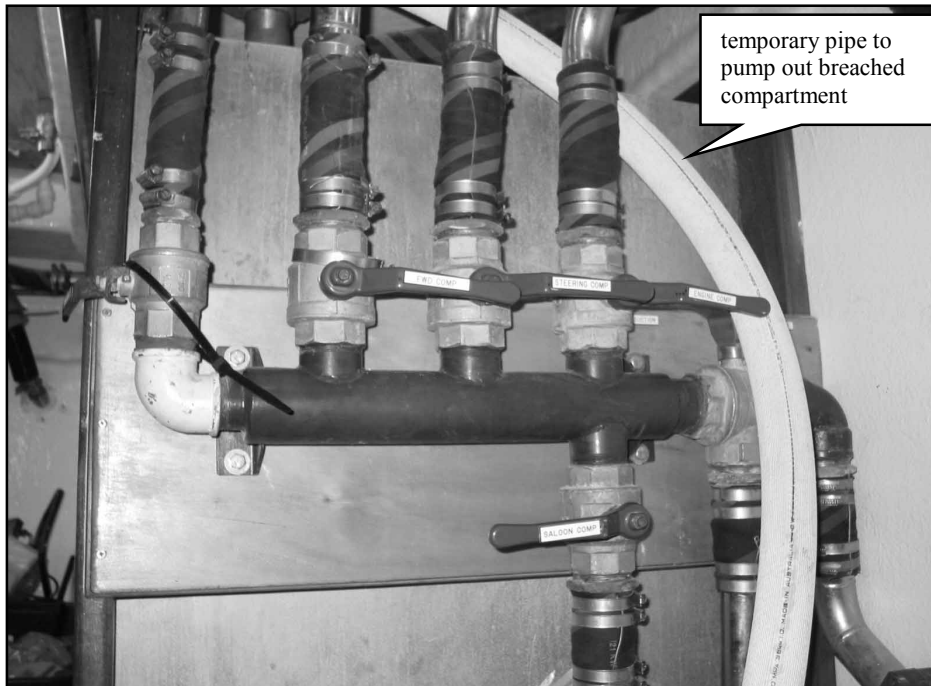
- 1.1.12 While the Master continued conning the boat, the others ripped up the carpets in the lower accommodation and started bailing the water out of the breached compartment. Initially they formed a chain, passing buckets up the chain into the cabin and throwing the water over the side. Later, they changed to bailing the water into a compartment further aft where the bilge pump could be used to eject it. Eventually, a flexible hose was rigged onto a spare bilge suction and the main bilge pump was used to eject water directly from the breached compartment (see Figure 6).

Figure 6
Bilge valve chest

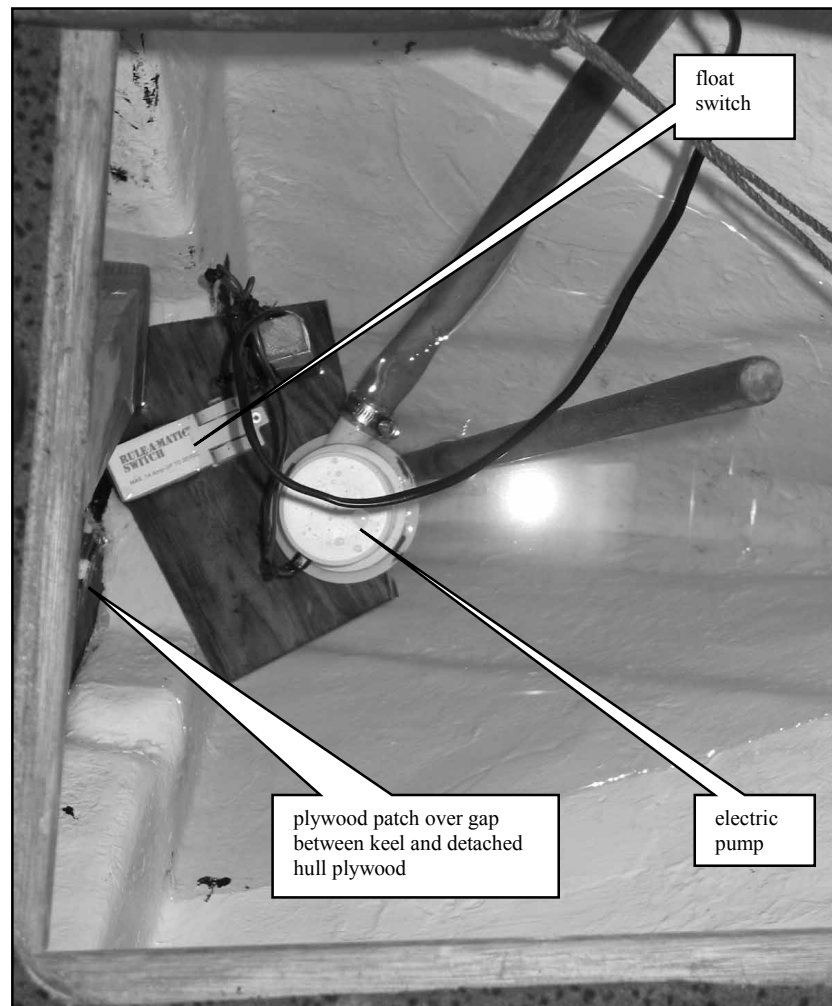
- 1.1.16 A helicopter landing pontoon was situated in inner Gold Arm, on the western shore across from Lloyd Island. This necessitated the Master again negotiating the area where he had grounded. The helicopter pilot, who could see the rocks and shoal areas from the air, assisted him and guided him down the eastern shore, close to Pender Point.
- 1.1.17 The search and rescue team included a diver, who found that on the forward starboard side of the forefoot, the hull was detached from the keel, allowing water to enter the boat. A small bilge pump with a float switch was fitted in the breached compartment and this was able to handle the ingress of water, without further use of the main bilge pump (see Figure 7).

Figure 7
Breached compartment showing the jury-rigged electric pump

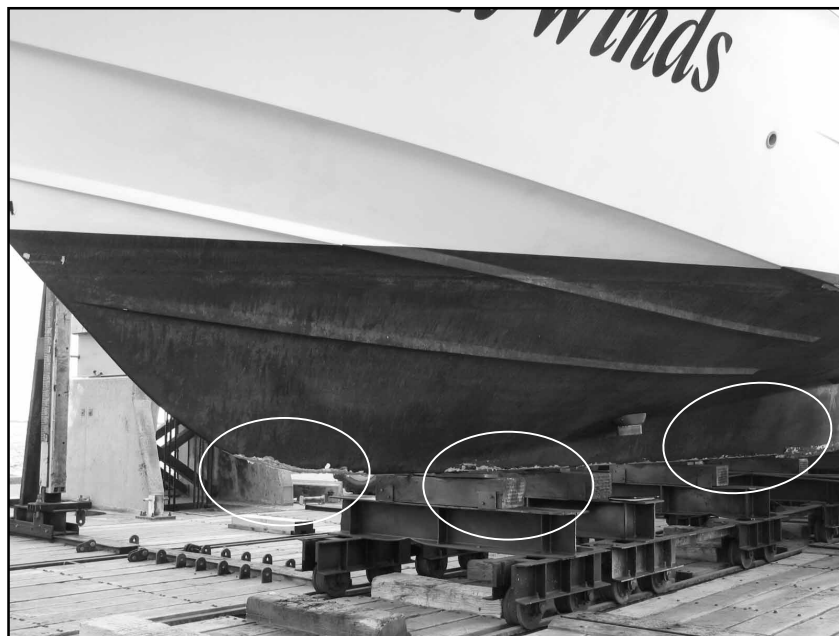
Figure 10
Areas of damage to the hull of the *Southern Winds*

- 1.4.1 The principal damage to the boat was at the forefoot and along the port side of the keel where it made contact with the rock (see Figures 10, 11 and 12).

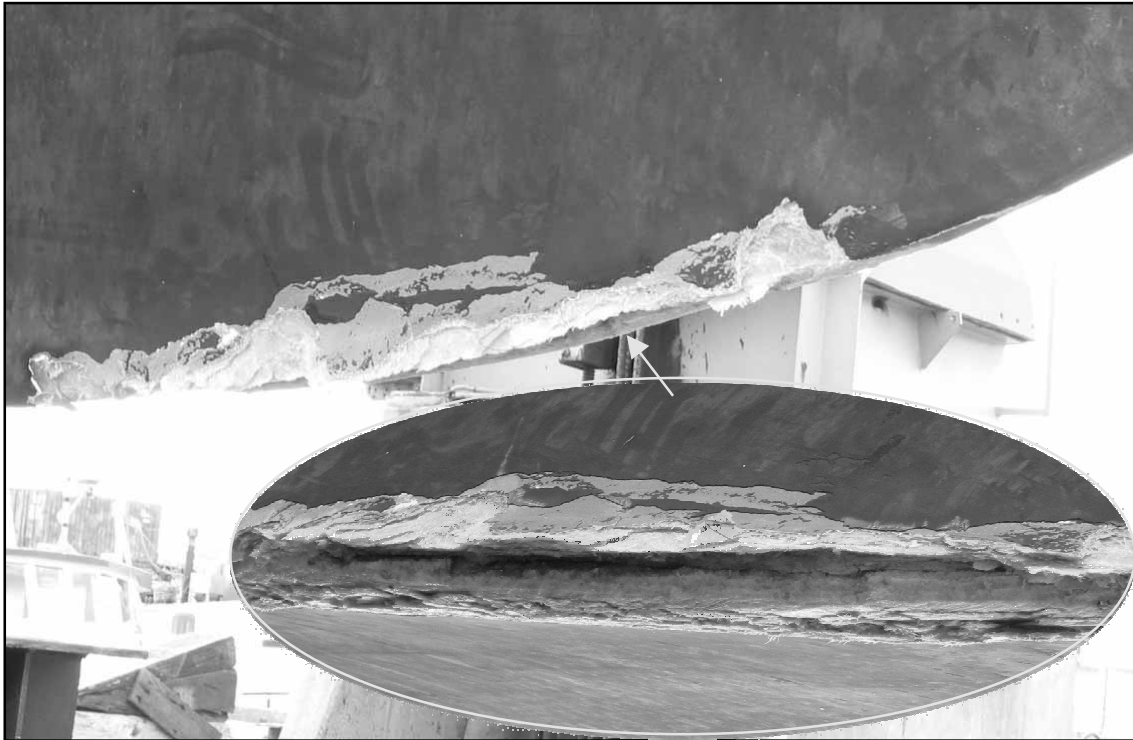
Figure 11
Damage to the bow of the *Southern Winds*

- 1.4.2 The bow hit with sufficient force to spring the hull away from the keel in way of the space immediately behind the forward collision bulkhead (see Figure 11). This space was small and had drainage holes through its after bulkhead into the next compartment, but they had collapsed, thus blocking the holes and making the space almost watertight. The collision bulkhead was not breached. Once the breached compartment began to fill, the water seeped through the wooden panels that formed the stairs and into the alleyway leading aft into the accommodation. It was here that the water ingress was first discovered.

- 2.32 Because the point of impact was on the keel rather than the hull itself, the damage was restricted to that area. Had the hull taken the full force of the contact, the resultant damage would most probably have been much more severe.

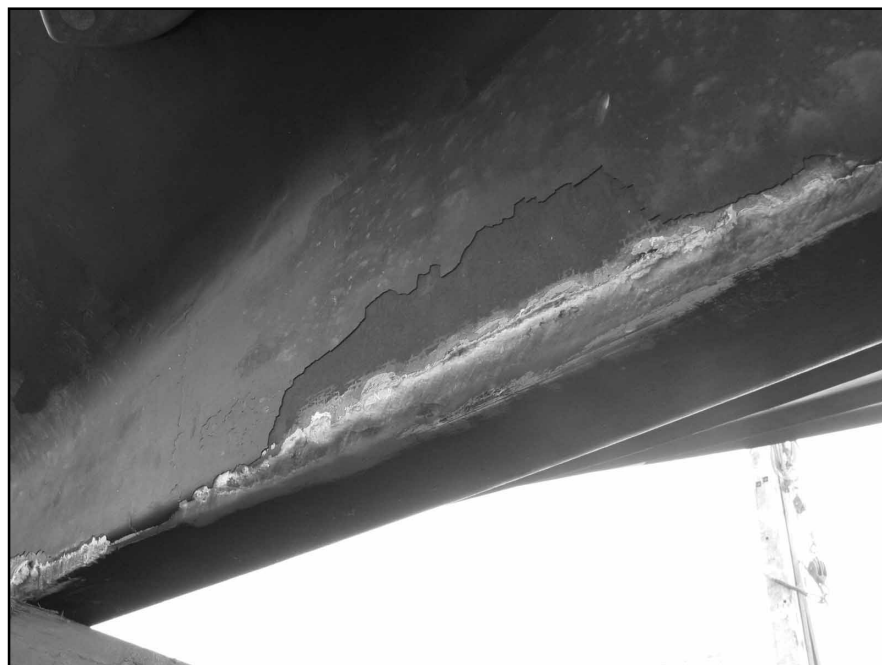
Figure 12
Damage to keel

- 1.4.3 After the initial impact on the forefoot, the port side of the keel appears to have scraped along the rock, damaging the fibreglass sheathing, but without penetrating the hull further (see Figure 12). Repairs, consisting of reinstating the damaged fibreglass resin and the extension of the sole

plate to protect and reinforce the damaged areas, were undertaken in Bluff under the supervision of the SGS M&I surveyor. The rudders and the propellers, which were about 400 mm above the keel, showed no sign of having made contact with the rock.

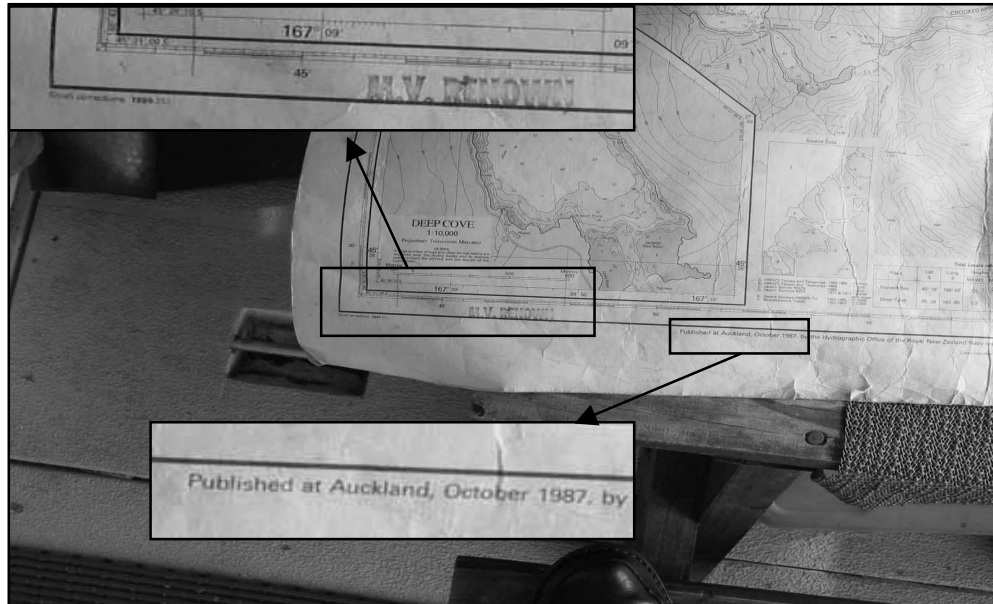
Figure 15
Paper chart carried on the *Southern Winds*

- 2.11 At the time of the grounding, there had been no new corrections to Chart NZ 7624 since it had been published, so the electronic charts were far more up to date than the superseded NZ 7522 paper chart on the *Southern Winds*. The electronic chart was still susceptible to numerous errors and as such could not be used with any certainty while navigating in such close proximity to hazards.
