MARINE OCCURRENCE REPORT

Report 04-216, passenger freight ferry *Aratere*, power failure,
Queen Charlotte Sound

TRANSPORT ACCIDENT INVESTIGATION COMMISSION
NEW ZEALAND

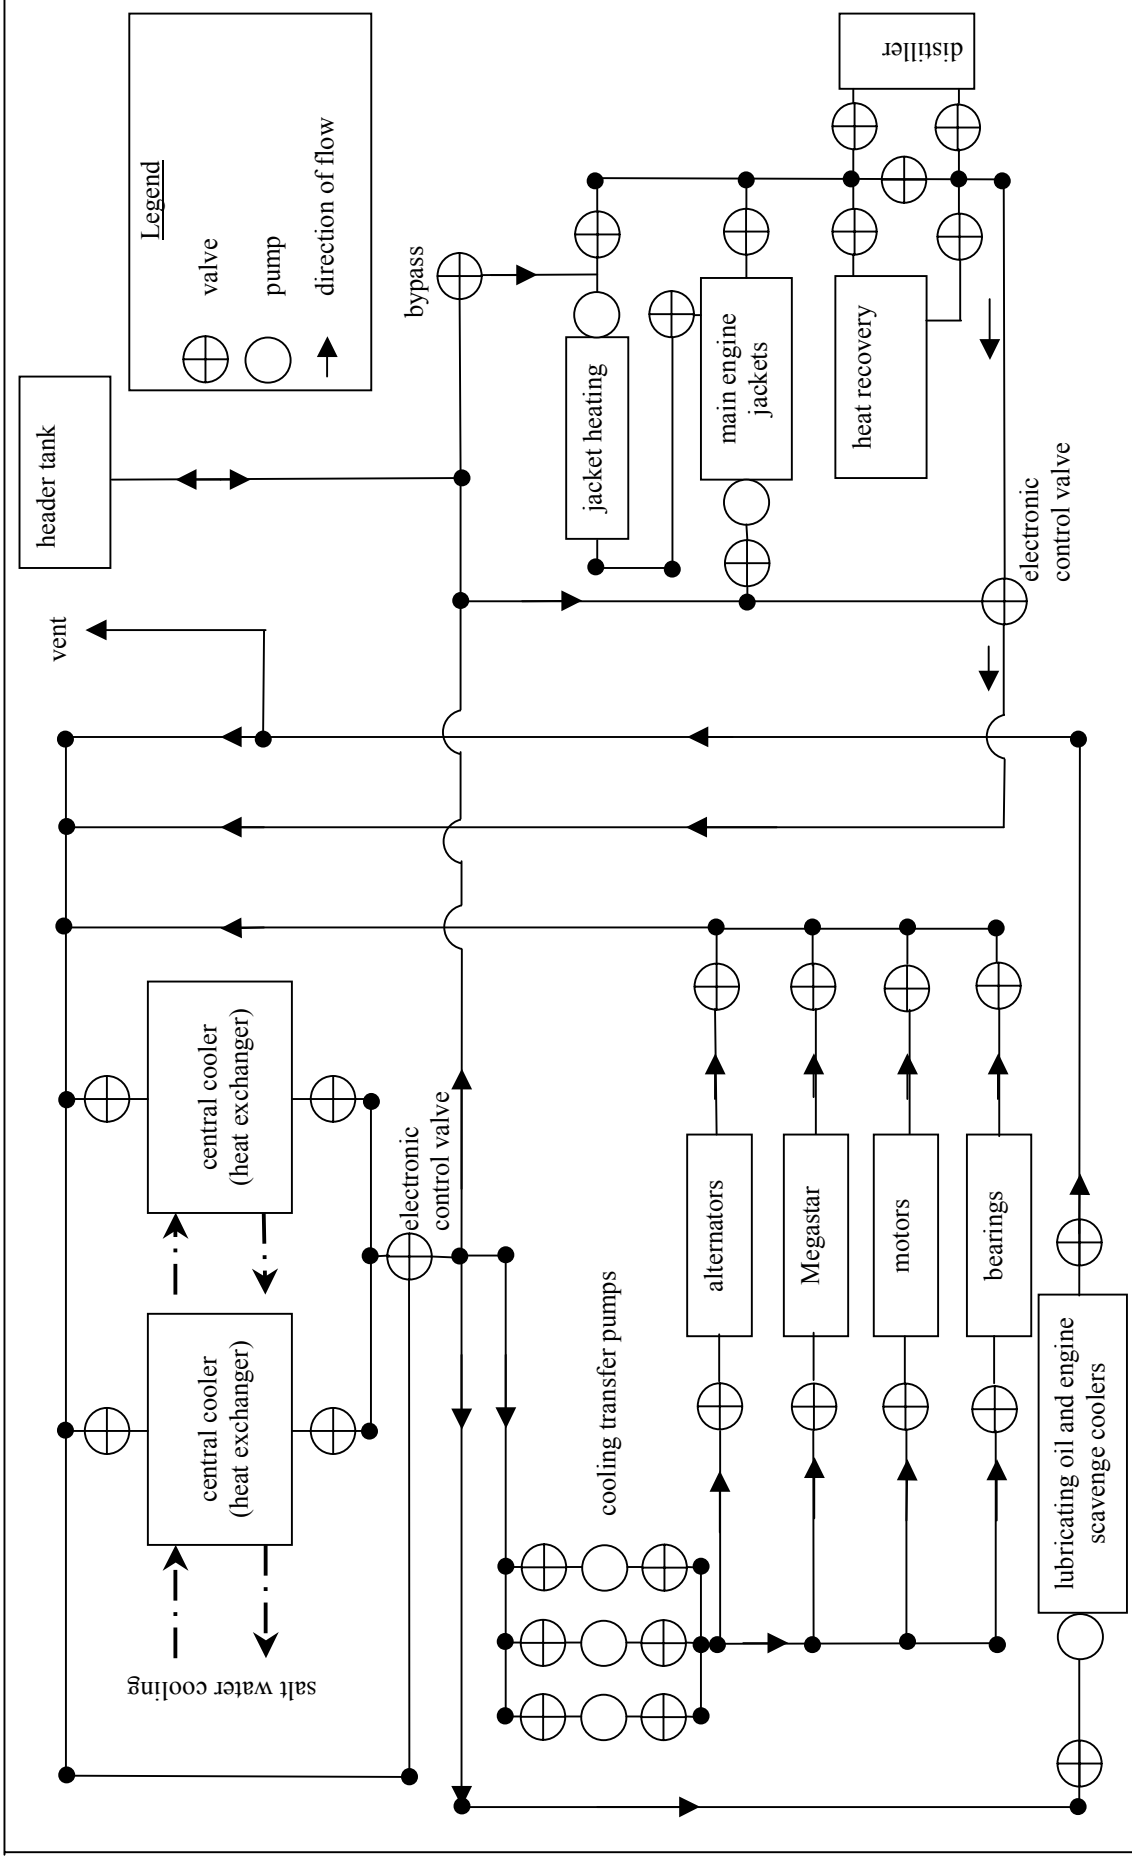
Figure 2
Diagram of the Aratere's engine cooling system

- 1.4.4 The cooling system for the machinery and equipment in the engine room, as with many of the world's merchant ships, used fresh water passing through a common system to the machinery. The fresh water then passed through heat exchangers that were cooled by salt water (see Figure 2). All 4 diesel generators, the Megastar, alternators and bearings were cooled by a common fresh water system such that if one part of the cooling system was compromised the whole system was affected.

- a consultant was engaged to review the cooling water system with a view to modifying it to cope better with air entering the system
- a decision was made to implement whatever recommendations were agreed to for fixing the problem of air entering the system during the vessel's drydock around August 2005
- Caterpillar's New Zealand agents amended the wiring of the emergency diesel generator and added a "latching internal relay shutdown output" to the software controls for low oil pressure, high coolant temperature, overspeed and emergency stop. Updated drawings were also supplied to cover the modifications.

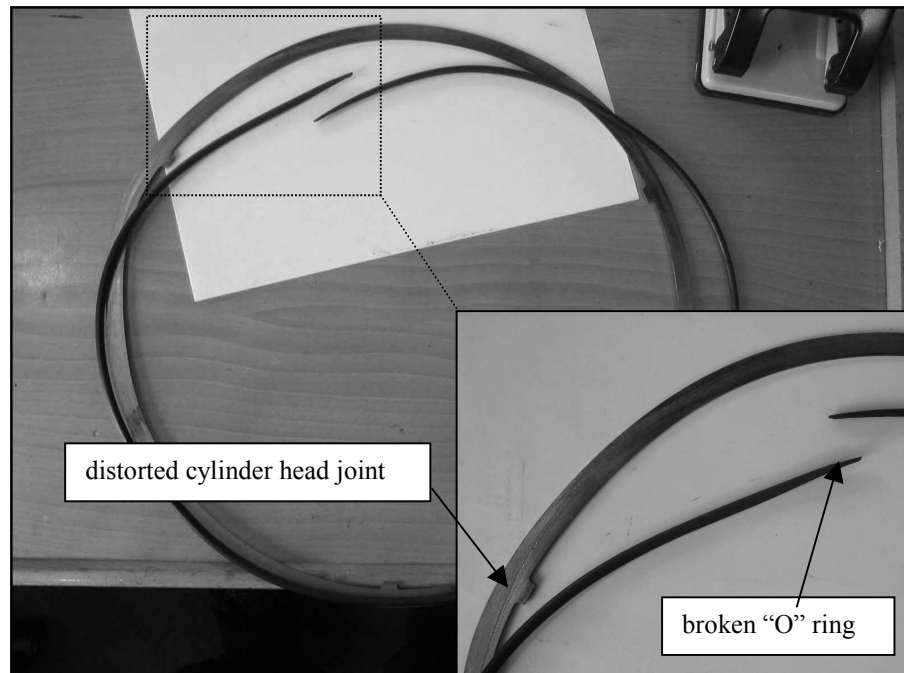
Figure 3
Broken "O" ring and distorted cylinder head joint after removal

- 1.5.1 When the number 8 cylinder head on number 4 diesel generator was removed after the incident, a broken "O" ring and a distorted cylinder head joint were found (see Figure 3).

- 3.4 The diesel generator cylinder head that leaked had just undergone emergency maintenance for leaking coolant. When the cylinder head had been replaced an “O” ring seal became caught between the cylinder head and cylinder head joint, thus preventing a good seal forming.

- 4.1 Since the incident, Toll NZ Consolidated Limited has implemented the following actions:
 - a new procedure was instigated for the replacement of cylinder heads
 - a new procedure was instigated requiring engines to be commissioned after major maintenance only when the vessel was in certain low-risk locations during a passage. This procedure was designed to identify any problems before the engine was actually required. The engine was to be run on light load in parallel with another engine before progressively higher loadings were applied
