M A R I N E O C C U R R E N C E R E P O R T

04-217 fishing vessel *San Rochelle*, fire and foundering, about 96 nm 27 October 2004
north-north-west of Cape Reinga

Report 04-217

**fishing vessel
*San Rochelle***

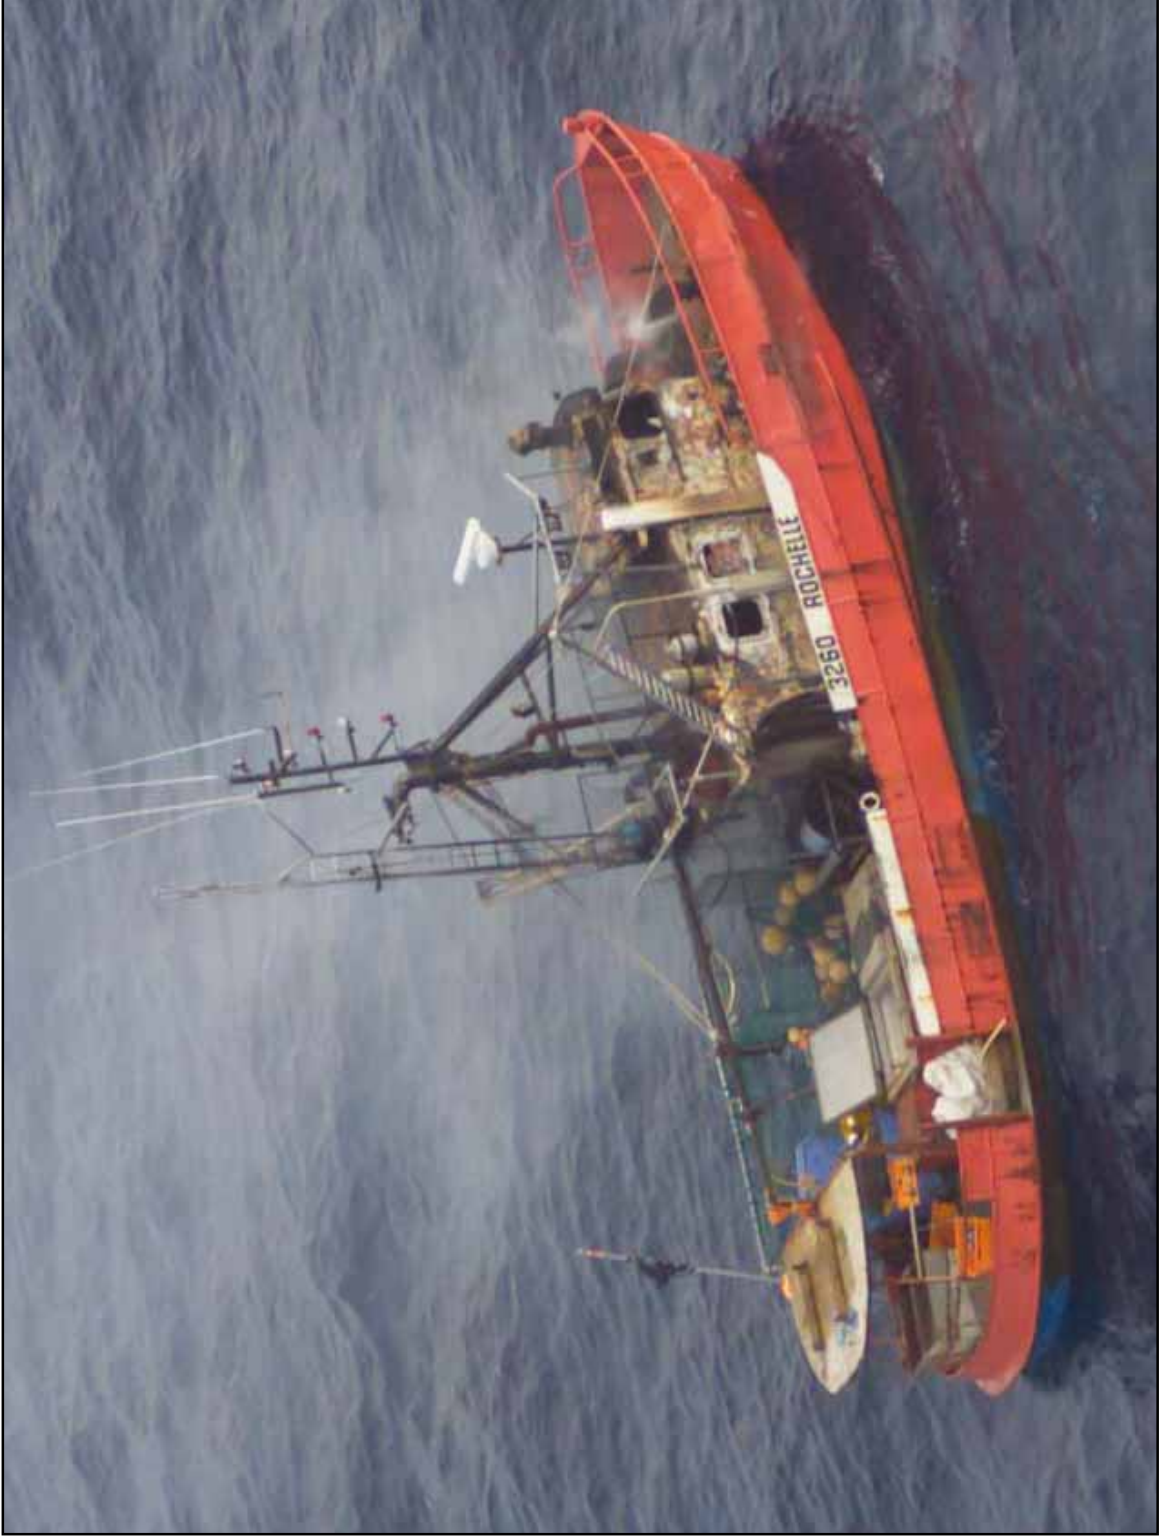
The *San Rochelle* adrift and on fire

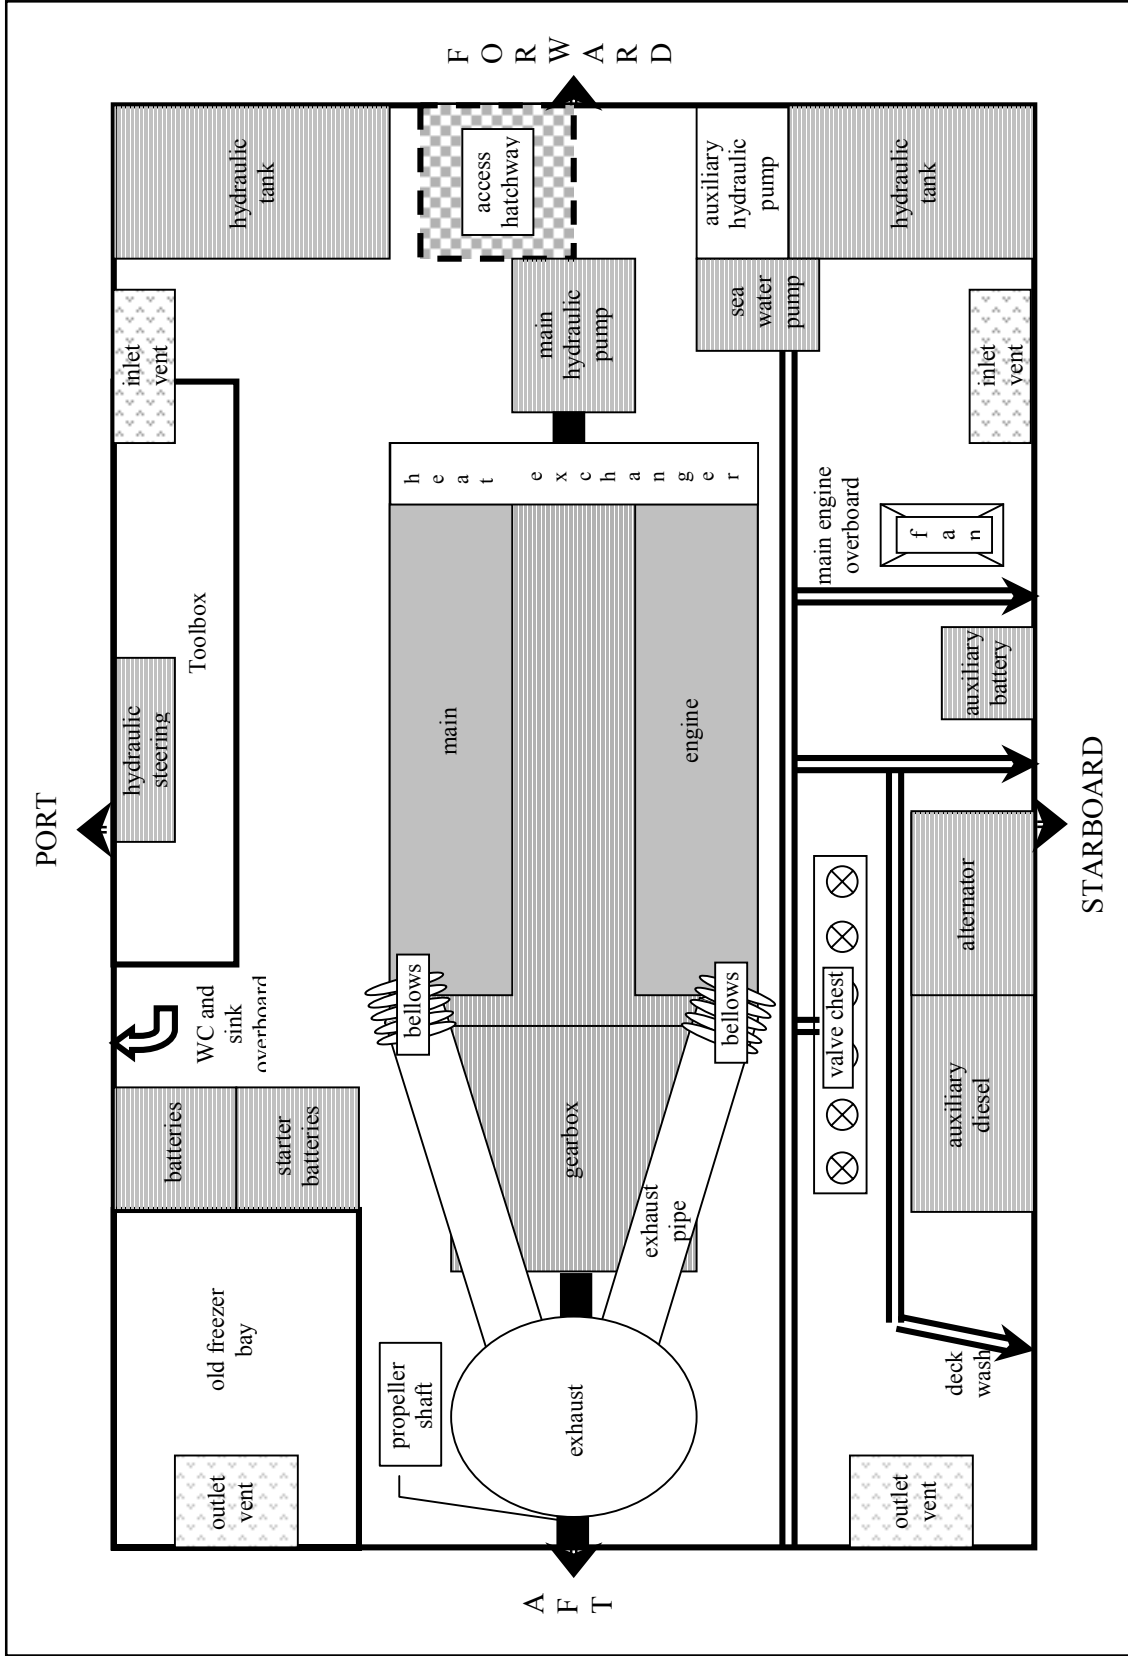
Figure 4
Plan of the engine room of the *San Rochelle*

- 1.2.8 The hydraulic system had a history of problems. In 2002, a variable delivery hydraulic pump connected to the crankshaft at the front of the main engine had caused the crankshaft and a number of main bearings to fracture. The owner thought that this had occurred on at least 2 other occasions, but there were no records to support this. In an attempt to prevent a further recurrence of the engine damage, 2 Brevini gearboxes had been interposed between the crankshaft and the hydraulic pump, but this modification was unsuccessful with the gearboxes failing on the engagement of the pump. Recently, a further modification had been made with a fixed displacement hydraulic pump being directly mounted onto the front of the engine. The hydraulic system operated at 2500 pounds per square inch [172 hPa] and was available whenever the engine was running. There were 2 common hydraulic oil tanks, one on each side of the engine room on the forward bulkhead. The port tank held 180 litres and the starboard one 150 litres (see Figure 4).

1.5.2 In early September 2004 a crack had developed in the starboard stainless steel expansion bellows between the main engine and the exhaust system (see Figure 4). The crack had allowed hot exhaust gases to escape into the engine room. Soot marks were evident on the insulation on the exhaust pipe some distance above the bellows (see Figure 5). The crack had been temporarily repaired during the maintenance period by removing the insulation, wrapping thin steel plate around the bellows and securing it with jubilee clips before the insulation was replaced. The exhaust bellows had cracked in this area twice previously. A permanent repair was due to be carried out when a different type of bellows could be sourced from Australia.

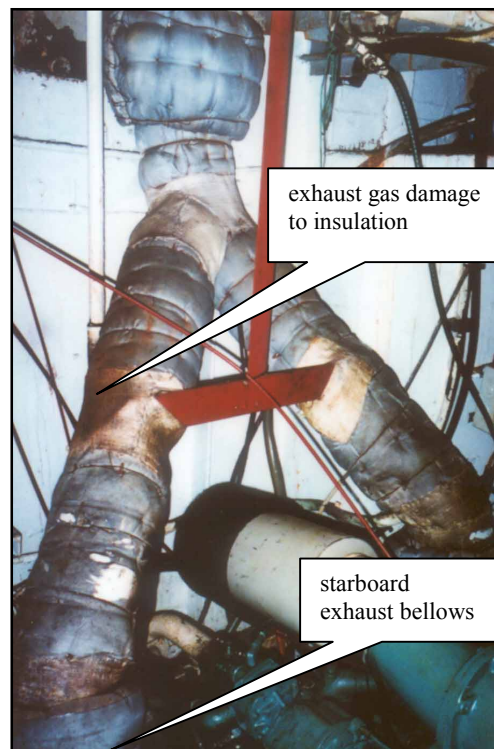
Figure 5
Photograph showing the exhaust system

- 2.3 The auto-ignition point of hydraulic oil at below 370° C and diesel oil at 260° C was below 387° C, the exhaust temperature, making the exhaust manifold or exhaust pipe the most likely ignition source of the fire.

- 2.4 The crew noticed that the deck wash hose stopped soon after the fire was discovered; this would indicate that the hydraulic system suffered a malfunction, possibly a loss of hydraulic pressure, as would be expected if the system had developed a leak. That leak may have sprayed hydraulic oil over the hot exhaust pipe or exhaust manifold.

- 3.1 The *San Rochelle* sank and was not available for inspection. Consequently, the exact cause of the fire could not be determined. A number of possibilities have been considered, with the conclusion being that the fire was probably caused by a burst pipe in the hydraulic system, allowing oil to be sprayed onto the hot exhaust pipe or exhaust manifold.
