AVIATION OCCURRENCE REPORT

05-003

Piper PA34-200T Seneca II, ZK-FMW, controlled flight into terrain, 8 km north-east of Taupo Aerodrome

2 February 2005

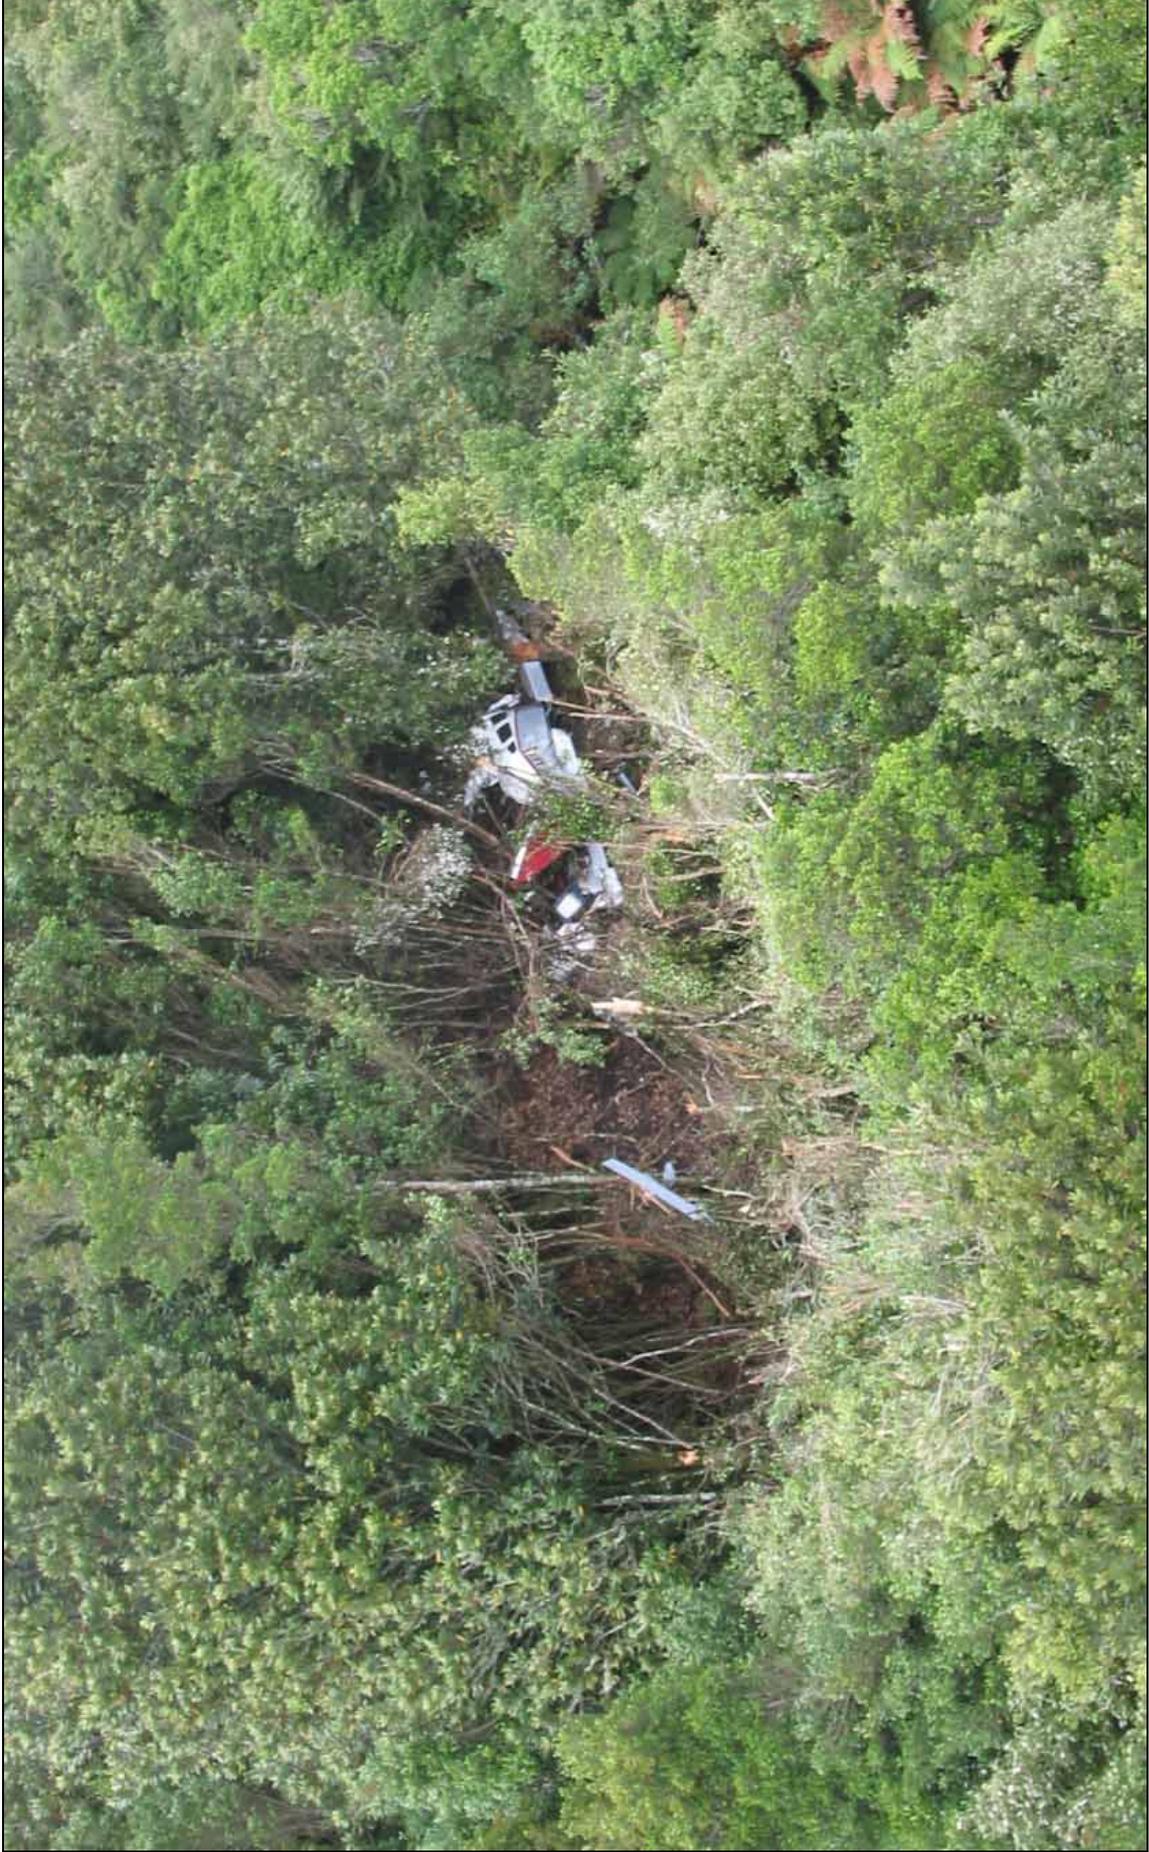
Accident Site, Mount Tauhara

- 1.12.2 ZK-FMW had struck the steep bush and tree-clad slope on a heading of between 160° M and 170° M, upright and in about a wings-level attitude. Damage to the vegetation indicated the aircraft was in about level flight when it struck the bush. As the aircraft progressed some 25 m through the bush and trees it was pulled slightly left and downwards before impacting the ground. The aircraft had struck several larger trees before coming to a sudden halt, causing the left wing to separate and the right wing to swing forward but remain attached to the fuselage. A smell of aviation fuel was noted around the accident site.

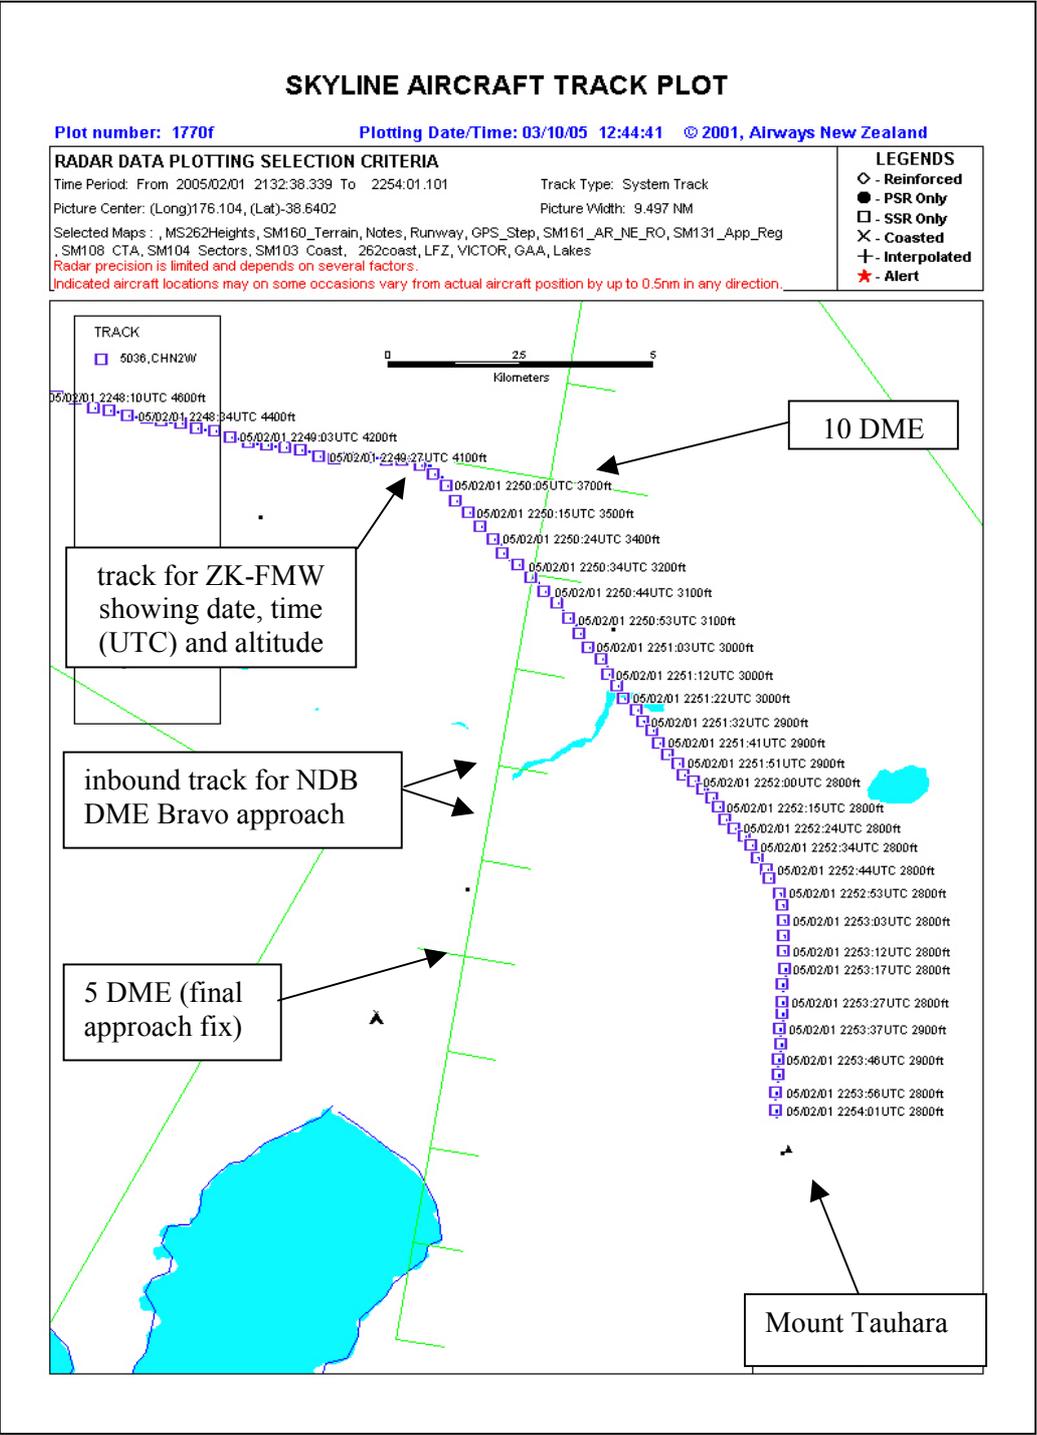
Figure 2
Radar track plot for ZK-FMW
(Courtesy of Airways Corporation of New Zealand)

- 1.8.4 ATS radar recorded most of the flight of ZK-FMW on the day of the accident. After departing from Ardmore, ZK-FMW was observed on the radar to intercept the Auckland to Kerikeri track at an altitude of 9100 ft.⁷ The aircraft was labelled CHN2W on the radar presentation. Radar information for ZK-FMW was lost at 1002 as the aircraft passed about 20 nautical miles (nm) north of Whangarei descending through 3700 ft. At 1032 radar re-identified ZK-FMW as it was climbing to 10 000 ft and flying the Kerikeri to Auckland track. After overflying Auckland, ZK-FMW continued overhead Hamilton towards Taupo.

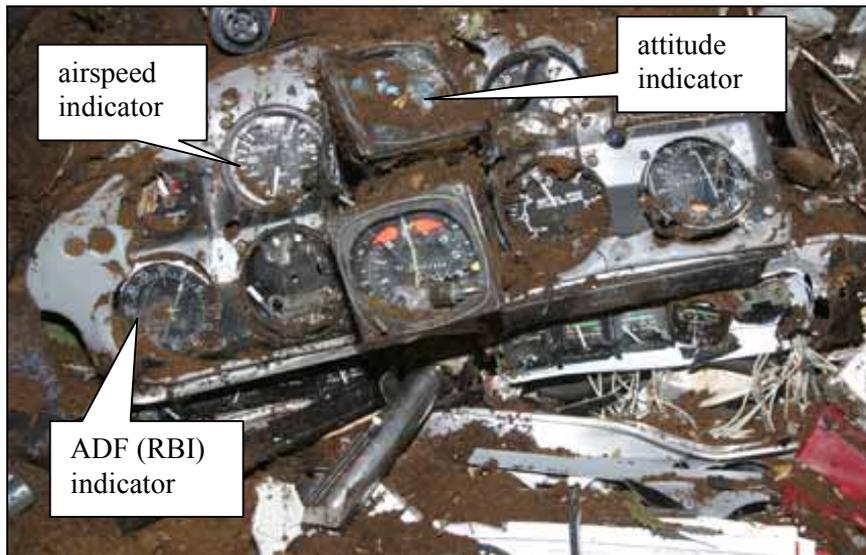
Figure 3
Pilot's instrument panel ZK-FMW

1.12.5 The following trapped instrument readings or information were noted (see Figures 3 and 4):

Airspeed indicator	124 kt
Altimeter	QNH set to 1014, needle broken
Horizontal situation indicator (heading indicator)	
heading	155
heading selector ¹¹ set to	158
course deviation bar set to	170
heading and navigation flags were displayed	
ADF(RBI) indicator	pointing 32° right of aircraft heading
Left engine cylinder temperature gauge	about 230° F
Right engine cylinder temperature gauge	about 250° F

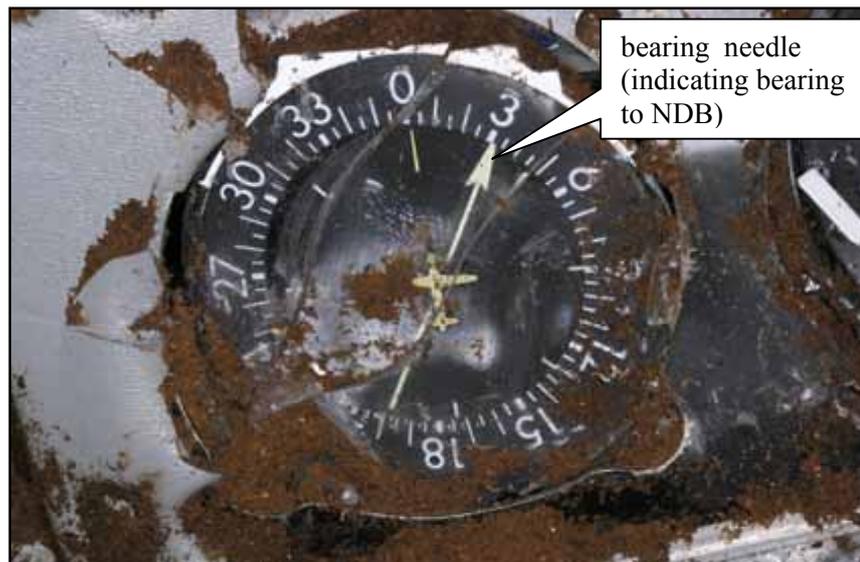
Figure 4
ADF (RBI) Indicator ZK-FMW

- 2.22 The ADF installation in the aircraft was found to be satisfactory. The condition of the "Y" channel connector cable probably resulted from the sudden and very forceful impact. Had the circuitry been compromised before the impact the pilot should have seen the ADF pointer align itself with the fore and aft axis of the aircraft – in this case probably pointing directly forward as the beacon was to the front of the aircraft. However, the pilot was likely receiving correct ADF information as he was able to fly around the arc and start the turn inbound at about the right position. Also the ADF needle was pointing about 30° to the right of aircraft heading, towards the NDB, at the time of impact.
