AVIATION OCCURRENCE REPORT

05-010

Aerospatale-Alenia ATR 72-212A, ZK-MCJ, runway excursion
during landing, Queenstown Aerodrome

5 October 2005

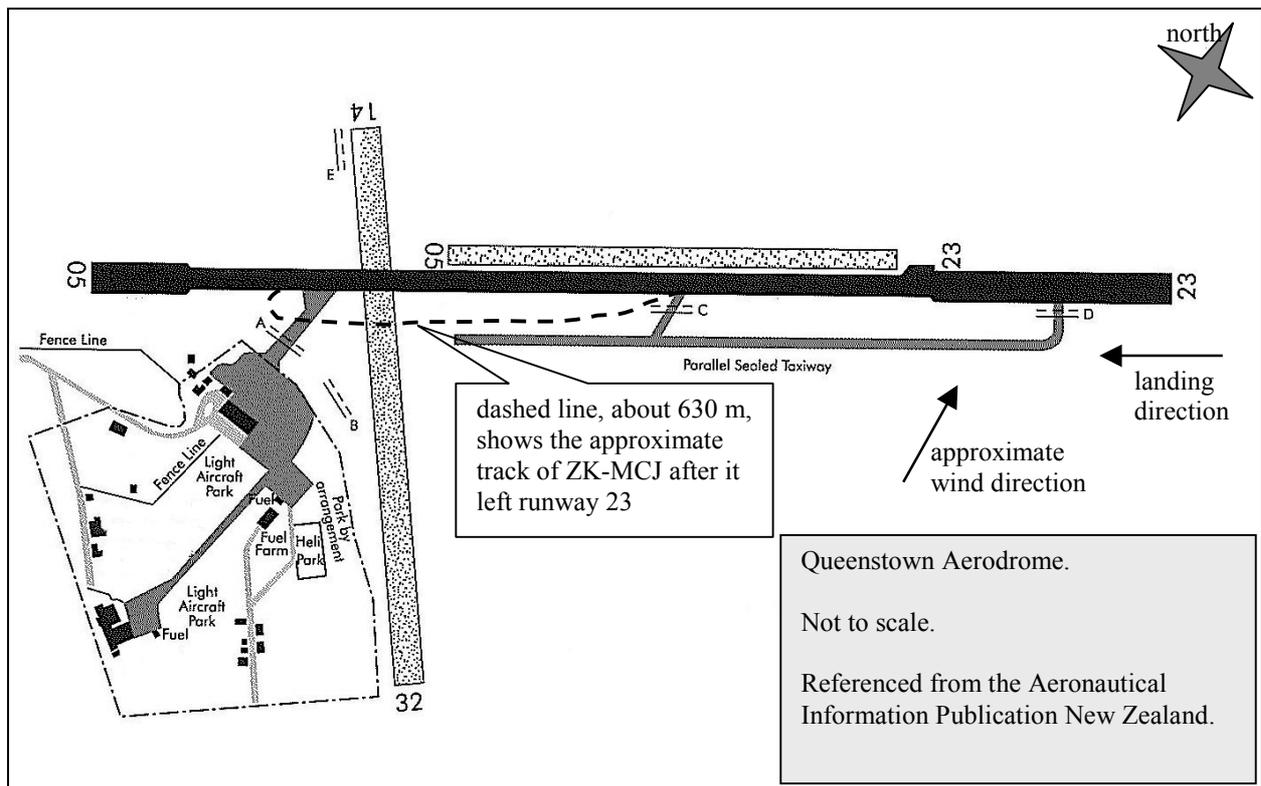
Figure 1
Queenstown Aerodrome showing approximate landing track of ZK-MCJ

- 1.1.15 After the aeroplane had left the runway it paralleled it, crossed grass runway 14 and continued to the main terminal taxiway, by which time it had slowed to normal taxi speed. The captain taxied the aeroplane across the taxiway, applied power and taxied back onto the runway abeam the control tower. He stopped the aeroplane on the runway for about 30 seconds, and using the intercom spoke to the cabin crewmember at the rear of the aeroplane, before taxiing to the terminal. Using the public address system during the taxi, the cabin crewmember reassured the passengers and advised them what had happened.

- 1.1.19 The air traffic controllers later commented that it seemed to them the nose wheels were off the runway longer than normal during the flare and landing, and that there appeared to be little weight on them after they contacted the runway. They said the aeroplane slewed in the mud alongside the runway, and that the nose wheels appeared to be pointed toward the runway. They said there was a lot of mud thrown up, and that the aeroplane had straightened and slowed by the time it crossed grass runway 14.

- 1.10.10 About 3 seconds after landing the aeroplane swung to the left. The recorded lateral and vertical acceleration suggested that the aircraft left the runway about 2 seconds later. The ailerons were deflected fully in the left wing down position at that stage. The aeroplane turned about 25° off runway heading before it turned back to parallel the runway.
