RAILWAY OCCURRENCE REPORT

05-103

express freight Train 237, derailment, 206.246km Hunterville

20 January 2005

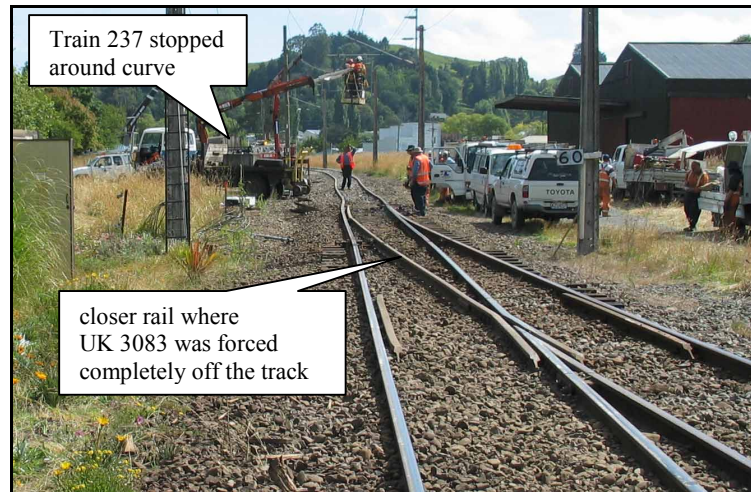
- 1.1.3 The trailing bogie ran derailed for about 1100 m until it struck the curved closer rail of No.3 points at the south end of Hunterville, where the leading bogie also derailed (see Figure 1). Both bogies of wagon UK 17124, immediately in front of UK 3083, also derailed at this point.

Figure 1
Infrastructure damage under repair at Hunterville, looking south

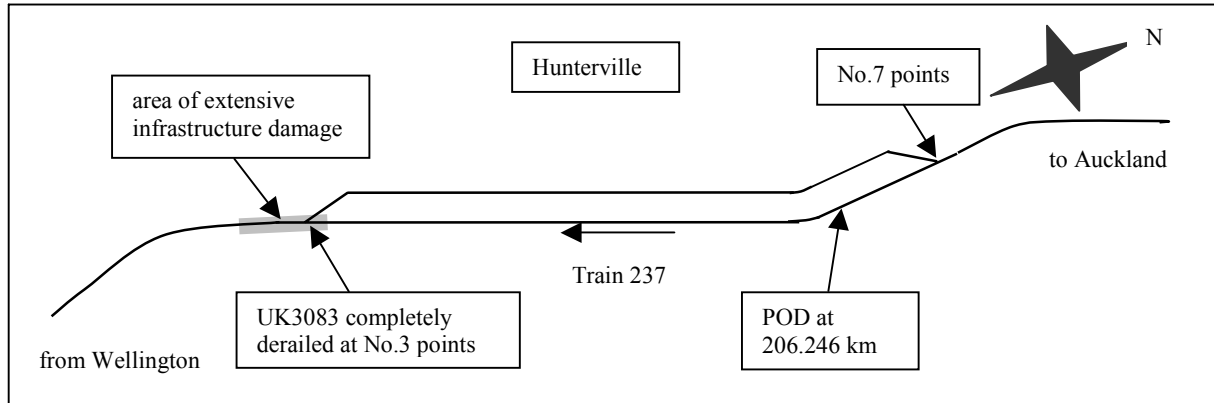
Figure 2
Site plan of derailment area (not to scale)

- 1.2.1 The derailment occurred as Train 237 was travelling along a 400 m section of straight track located between 2 reverse curves on a descending gradient of 1 in 200. The maximum authorised line speed for express freight trains was 80 km/h. No.7 points were located within the straight section of track (see Figure 2).

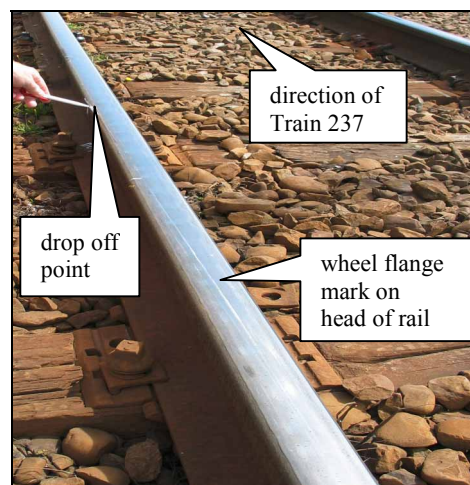
- 1.2.2 The point of derailment (POD) was identified at 206.246 km. A 3.5 m long wheel flange mark was found on the top of the left-hand rail in direction of travel. The mark became deeper as it got closer towards the drop-off point (DOP) on the outside of the rail (see Figure 3)

Figure 3
POD at 206.246 km looking south

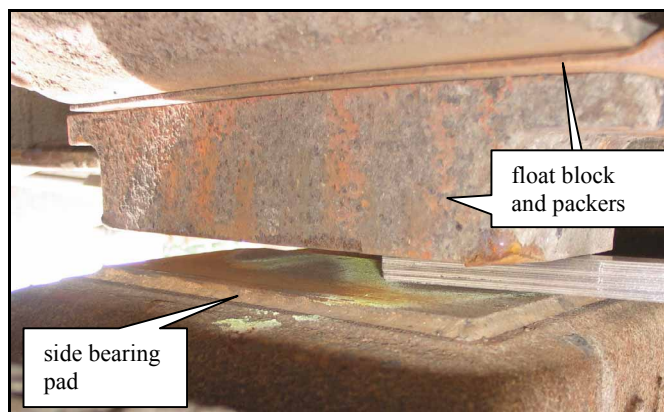
Figure 4
Float arrangement

1.4.3 Float was the measurement between the side bearing pad on the bogie bolster and the corresponding float block on the underside of the wagon body (see Figure 4). The Code stipulated that the float limit at the handbrake end was limited between 6 mm and 10 mm and between 12 mm and 16 mm at the non-handbrake end.

- 1.4.9 Derailment damage and subsequent loss of equipment precluded an accurate measurement of the float being taken on the wagon. Two float blocks and associated packers had been dislodged, one from each end of the wagon. One of the dislodged float blocks was recovered during a ground search. The second float block was not found, but fresh markings where the float block was mounted indicated that it was dislodged during the derailment.

- 1.4.10 The recovered float block and packers were identified from markings as most likely to have come from the non-handbrake end of the wagon. Bogies were refitted onto the inverted wagon body and the float measurements were taken. To allow for the missing float block at the handbrake end, an assumption was made that it was the same thickness as the adjacent intact block. Float measurements based on this assumption would have meant that the handbrake end was 26 mm in excess of code and the non-handbrake end was 6 mm in excess of code.

- 1.4.11 An internal report compiled by Alstom Transport New Zealand Limited³ (Alstom) for Toll Rail stated that it was highly unlikely that the handbrake end was 26 mm out of code and it was probable that the missing float block was a greater height than estimated. However it may have been out of code by a lesser amount. The report also noted that it was possible that the non-handbrake end had excessive float although this could not be positively confirmed, as there were inaccuracies in measurement due to derailment damage, and it was possible that additional packers from the non-handbrake end were not recovered.

- 4.1 On 25 November 2005, Toll Rail advised that they intended to ensure that float measurements are recorded as part of the C-check. Toll Rail envisaged that the check sheets would be modified by March 2006.

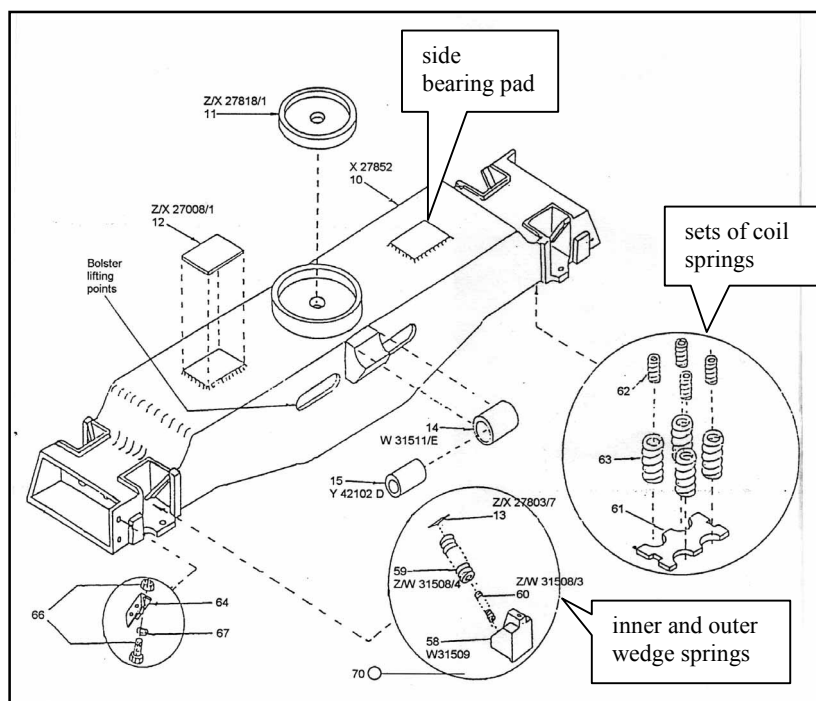
Figure 5
Diagram of bogie bolster
 Note bogie side frames omitted for clarity

1.4.6 The bogies on UK 3083 were standard 3-piece bogies as used on most freight wagons worldwide. The 3 main pieces were one bolster and 2 side frames (see Figure 5). The end of bolster was supported by 2 sets of coil springs. The larger diameter coil springs, known as primary suspension, provided vertical support. The smaller diameter coil springs, known as wedge springs, applied pressure to the friction wedge to provide damping of wagon roll oscillating movement and were positioned out of sight within the side frames.

- 1.4.7 A post-derailment examination of the bogies on UK 3083 found that 2 of the 4 inner wedge springs from each bogie were up to 2 mm less than the minimum length required for reuse, if the bogie was to be overhauled at the time. Additionally one outer wedge spring from the leading bogie was on the minimum required length required for reuse, if the bogie was to be overhauled at the time. The combined effect of the springs being below the minimum length would be the same as increasing the wedge height by 0.2 mm and the short springs did not mean either bogie was out of code, rather that the springs were out of specification for reuse.

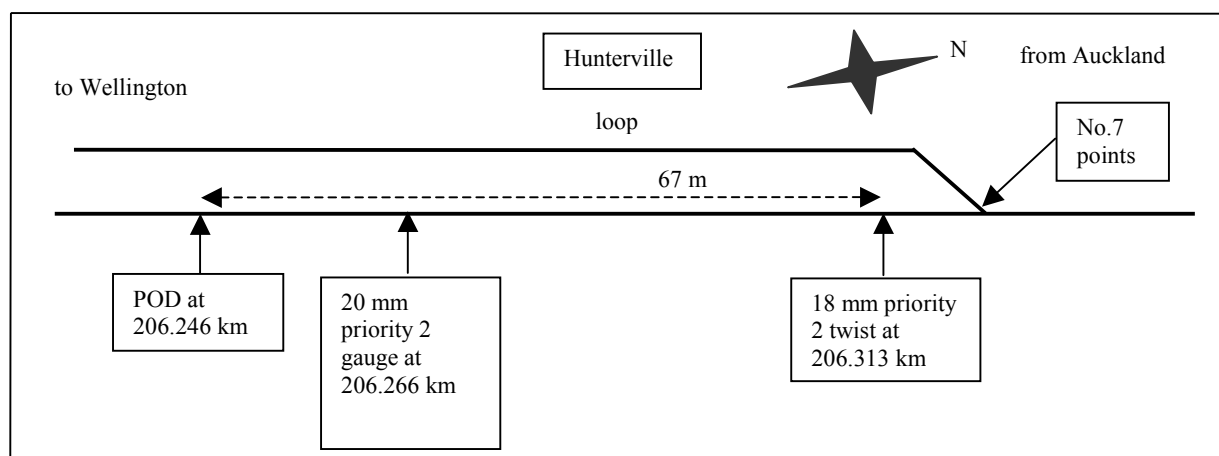
Figure 6
Location of identified track conditions (not to scale)

- 1.5.6 The measure-up of the static track geometry following the derailment identified 2 track conditions within 67 m of the POD (see Figure 6).

- 1.5.7 Both track condition sites had previously been identified as having exceedances by the EM 80 track evaluation car⁷ on 3 November 2004 as follows:

- 2.4 The track conditions were 47 and 20 m before the POD. After the wagon travelled through No.7 points, rolling oscillations on the wagon would probably have been amplified when it travelled over the track condition at 206.313 km. Then, the rolling oscillations probably continued, but slowly decreasing in severity until the wagon reached the priority 2 track condition at 206.266 km. Track marks showed that 20 m beyond this track condition, the rear bogie, which was carrying the lesser weight, lifted and the wheel flange rode along over the top of the rail. The deepening score line on the head of the rail towards the DOP was probably due to the wheel dropping back down.

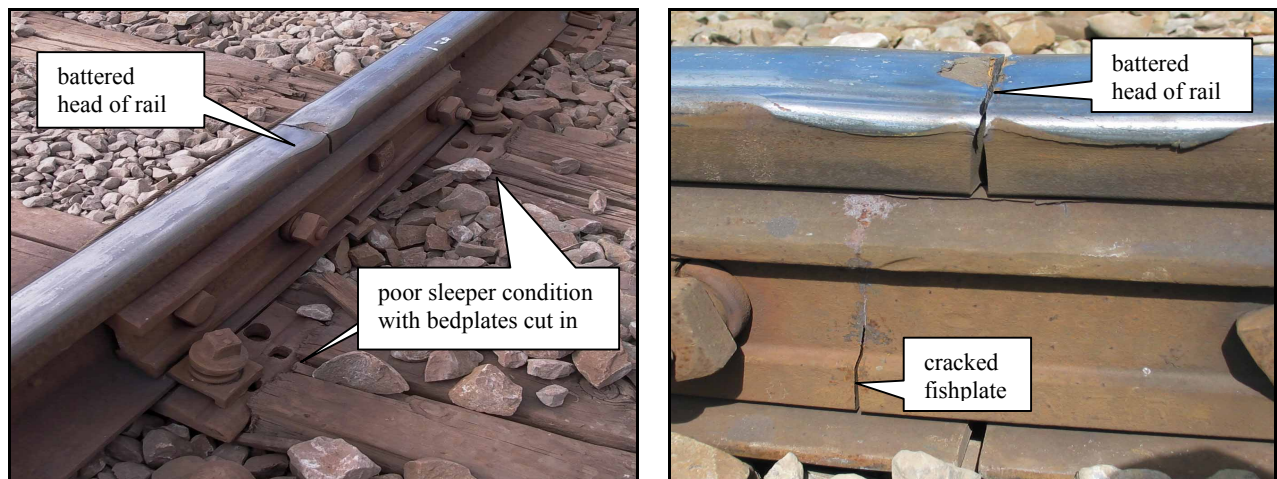
Figure 7
Rail joint at 206.266 km

- 1.5.12 The Commission's site investigation found that the rail joint at 206.266 km had a battered head of rail, and the fishplate on the field side⁹ of the right hand rail had a developing fracture (see Figure 7). The 2 halves of a discarded fishplate that had fracture in the about the same place were laying trackside close to this joint.
- 1.5.13 The 1999 annual engineering inspection noted that bedplates were digging into the sleepers between 205.25 km and 206.31 km (see Figure 7). Twice-weekly track inspections, occasional ganger run-throughs, 4-monthly EM 80 recordings and annual engineering inspections continue to monitor this area.

- 2.3 The poor sleeper and joint condition would probably not have provided resilience and strength in the track to prevent the return of the track conditions at the same locations. Having rectified the track exceedances, but without addressing the underlying sleeper and track condition problems in the area, the track was liable to relapse to the pre-existing problems more quickly with the passage of trains than would otherwise be expected. The date that the fractured fishplate had been replaced at 206.266 km was not known.
