RAILWAY OCCURRENCE REPORT

05-108

diesel multiple unit passenger Train 3334, fire, Auckland

23 February 2005

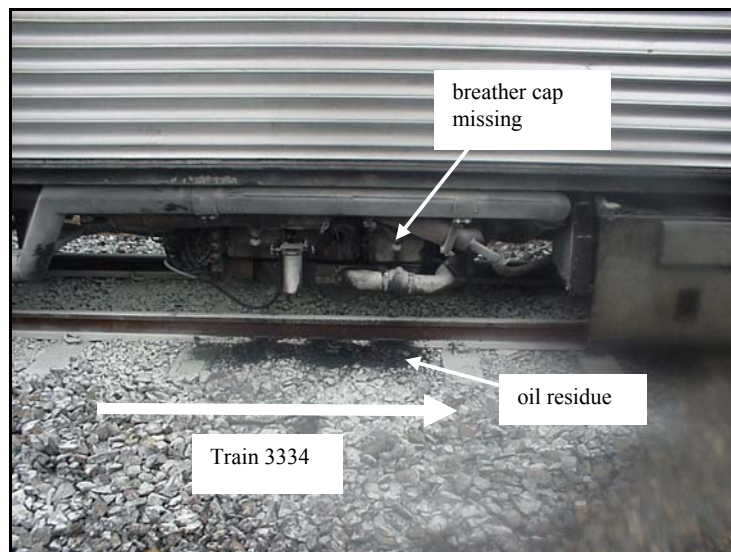
Figure 4
Oil on ballasted track

- 1.2.3 While the train was stationary at Signal 125, the breather cap from the No. 1 engine on ADK685 was projected about 1.5 m and was found between the Up Main and Down Main lines. Oil was observed on the ballasted track directly below the engine rocker covers (see Figure 4). ADK685 was towed to Toll Rail's maintenance depot at Westfield where an examination of the fire-damaged components was conducted.

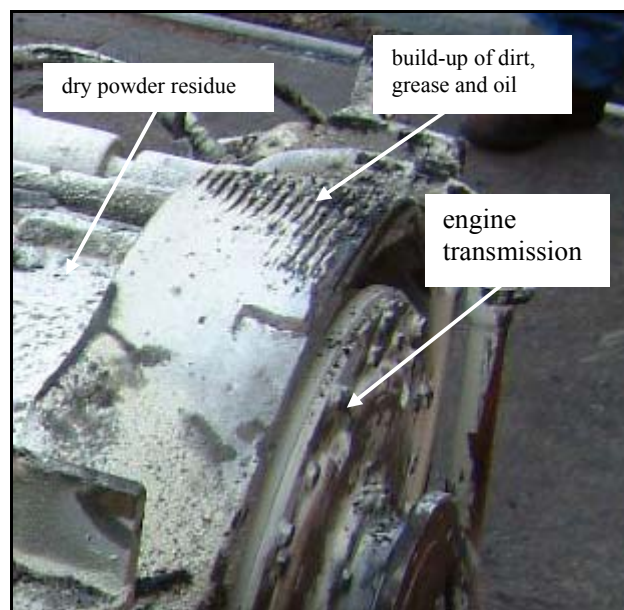
- 1.8.3 The damaged engine was sent to an independent engine refurbishment company where disassembly was carried out under the supervision of the Commission.
- 1.8.4 To determine the extent of the build-up of grease and oil and to facilitate a careful inspection of the outer casing of the engine, the dry powder, dirt, oil and grease were scraped off rather than cleaned with a water blaster. The build-up of dirt and grease around the exhaust manifold and near the engine transmission coupling was up to 25 millimetres (mm) thick in places (see Figure 6).

Figure 6
Build-up of dirt, oil and grease on top of the engine transmission housing

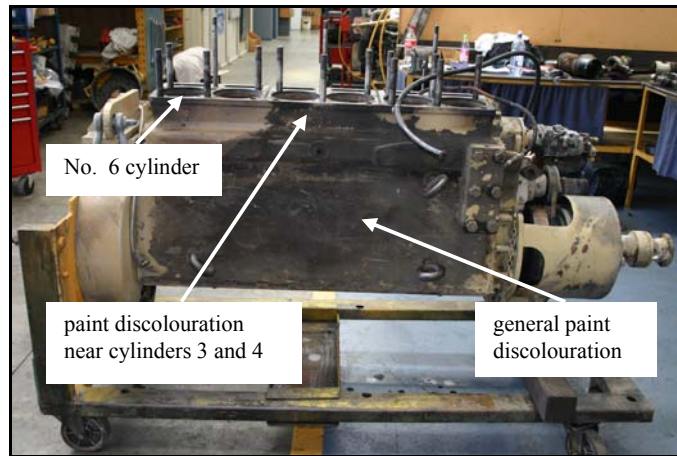
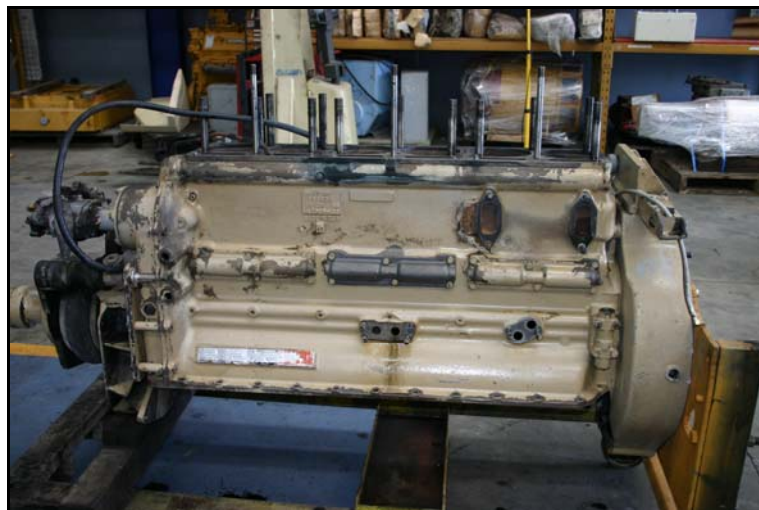
- 1.8.5 After the engine was cleaned, the paintwork was examined and it was found that on the underside of the engine the paintwork was intact, while on the topside the paintwork had suffered some discolouration, consistent with being subjected to excessive heat. The paint discolouration appeared to emanate from the exhaust manifold area of cylinders 3 and 4. Figures 7 and 8 show the paint condition on the top and undersides of the engine.

Figure 7
Topside of engine after cleaning

Figure 8
Underside of engine after cleaning

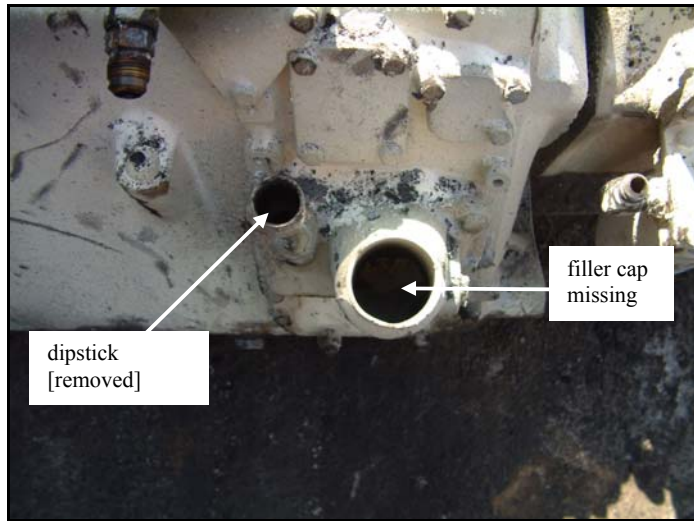
- 1.8.6 Figure 9 shows the oil filler cap opening. The dipstick had been in place but was removed before the sump was drained. About 5 litres of water were discharged from the sump together with the oil. The water had not emulsified with the sump oil.
- 1.8.7 A representative of the engine manufacturer advised that the dipstick would normally dislodge before the breather cap when blow-by⁸ was excessive because the breather cap was usually adequately vented and screwed on.

Figure 9
Filler cap opening and dipstick

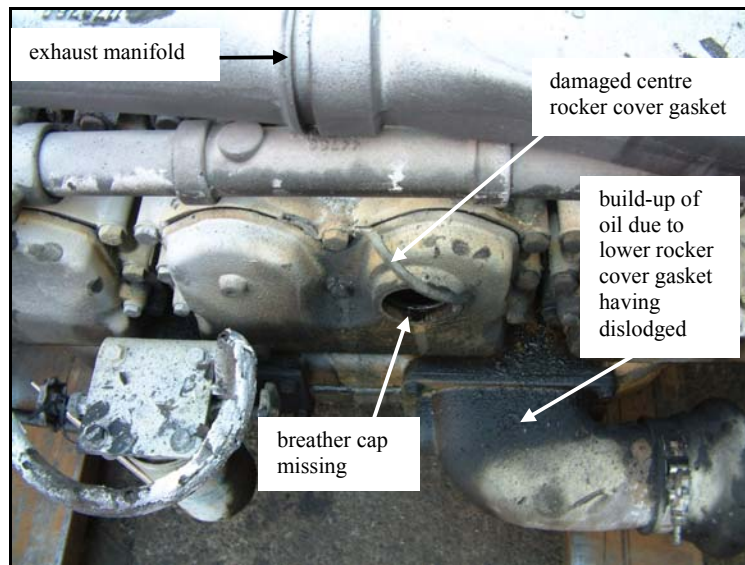
- 1.8.8 Figure 10 shows the breather cap opening and the damaged rocker cover gaskets above the breather cap opening. The un-insulated exhaust manifold was close to the breather cap and damaged rocker cover gasket. Oil had leaked from the bottom rocker cover gasket and accumulated on the air intake manifold.

Figure 10
Breather cap opening and displaced centre rocker cover gasket

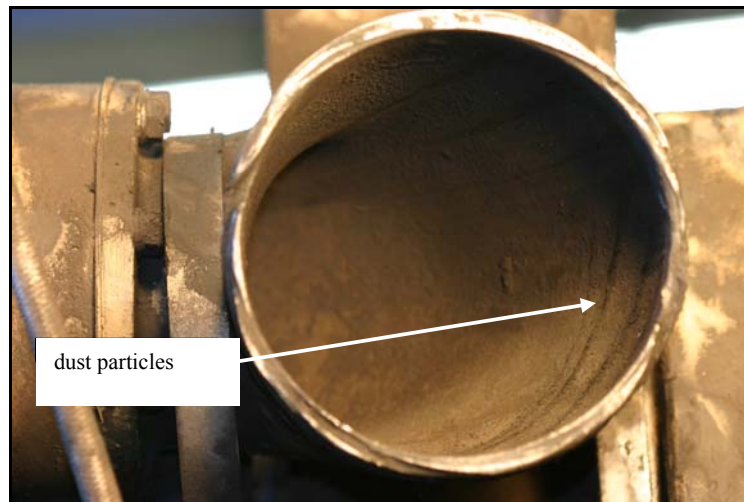
- 1.8.9 The air inlet to the turbocharger, downstream of the air cleaner, was lined with dust, indicating the extent to which dust had entered the engine (see Figure 11).

Figure 11
Dust layer on the lining of the air intake to turbocharger

- 2.13 The quantity of dust observed at the intake of the turbocharger was excessive and could have contributed to the wear on the piston rings and the failure of the rings on pistons 1 and 6. The non-availability of historical maintenance records meant that it was not possible to determine the service life of the engine and its components and therefore discount the possibility that excessive service life could have contributed to the failure of the rings.

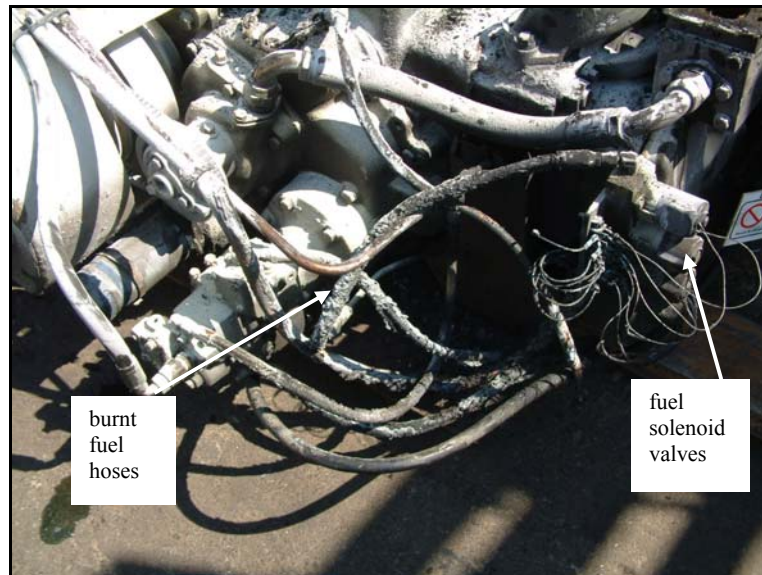
1.8.10 A number of electrical cables and fuel hoses were burnt (see Figure 12).

Figure 12
Burnt electrical cables and fuel hoses

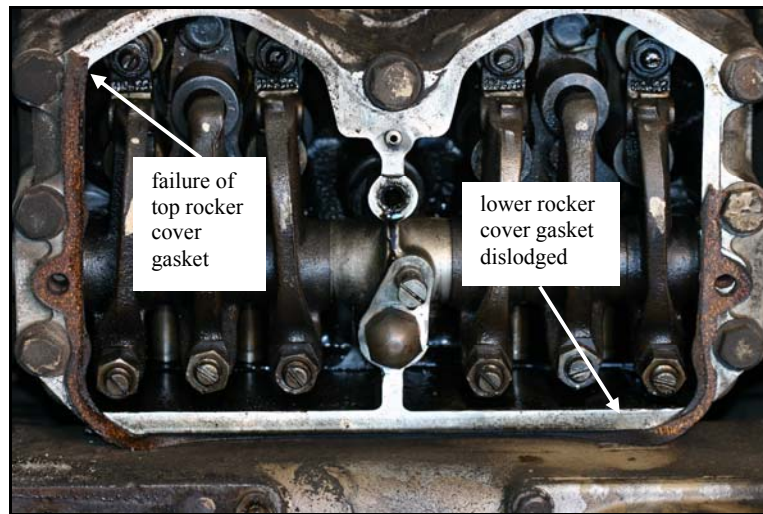
1.8.11 After removing the rocker cover over cylinders 2 and 3, it was apparent that the lower rocker cover gasket had been dislodged from its sealing position (see Figure 13). The witness marks on the gasket from the edge of the rocker casing show that this section of the gasket had probably been dislodged for some time (see Figure 14).

Figure 13
Failure of centre rocker cover gasket

- 2.19 The failure of the centre rocker cover gasket at the top and the witness marks at the bottom indicated that it had been dislodged from its sealing position for some time. The dislodgement could have been due to over-pressurisation caused by excessive blow-by, poor fitting during maintenance or a combination of both.

- 2.23 The fact that the top section of the rocker cover gasket over cylinder heads 3 and 4 was draped loosely over the rocker cover suggested that it possibly came loose just before the fire. The discolouration of the paint that emanated from the centre rocker cover and spread over the entire top engine surface indicated the starting point of the fire.

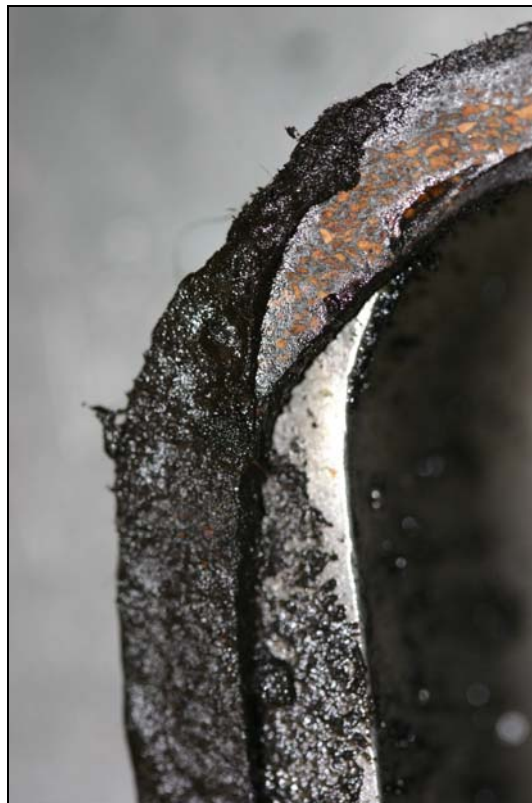
Figure 14
Witness marks of lower gasket on centre rocker cover

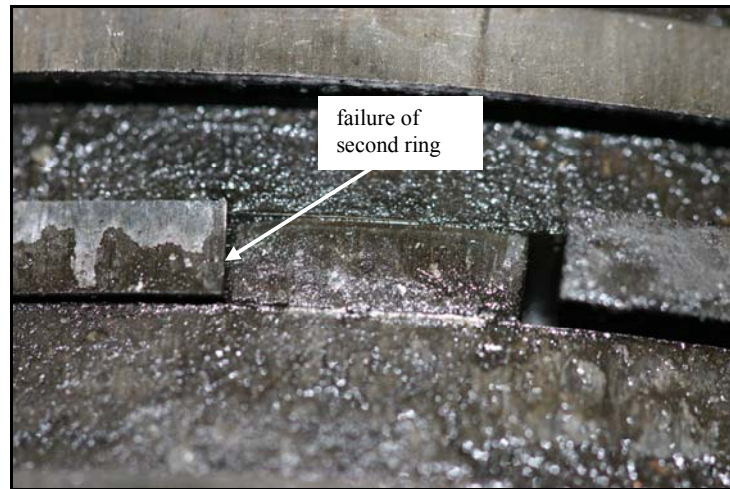
- 1.8.13 When the cylinder head and cylinder liners were removed, the following observations were made:
- the middle piston rings on No. 1 and No. 6 pistons had failed
 - the seals on liners 1, 3, 4 and 6 had failed
 - liners 1, 3, 4 and 6 had heavy pitting. This is referred to in the industry as electrolysis, with liner 4 being the most severely pitted
 - the side of No. 6 piston above the top ring was severely scored and deposits of aluminium melt were on the underside of the cylinder head.
- 1.8.14 All piston rings, liners and piston skirts had evidence of heavy wear. In particular the middle rings of No. 1 piston and No. 6 piston had failed. Figure 15 shows the failed second ring on No. 6 piston.

Figure 15
Failed second ring of No. 6 piston

- 2.14 Failure of the piston rings on pistons 1 and 6 would have led to excessive blow-by as hot combustion gases passed between the pistons and their bores into the sump below. Blow-by burns the lubricating oil coating between the piston and its bore, exacerbating wear, increasing friction and raising the local heat load on the coolant retained by its liner and seal. Blow-by would also have contributed to the failure of the liner seals observed on liners 1, 3, 4 and 6.

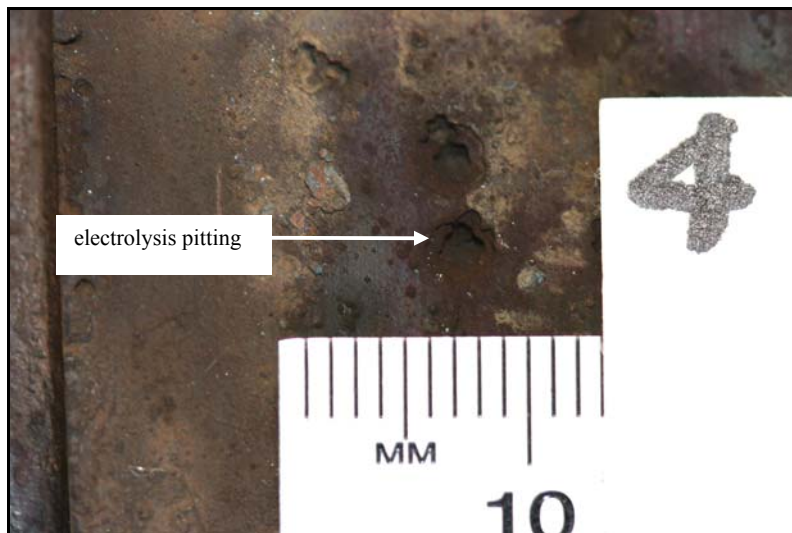
- 1.8.15 The liner of No. 4 piston had pitting marks with a diameter of about 2 mm (see Figure 16). The pitting marks or electrolysis resulted from the implosion of steam.

Figure 16
Electrolysis on liner of No. 4 cylinder

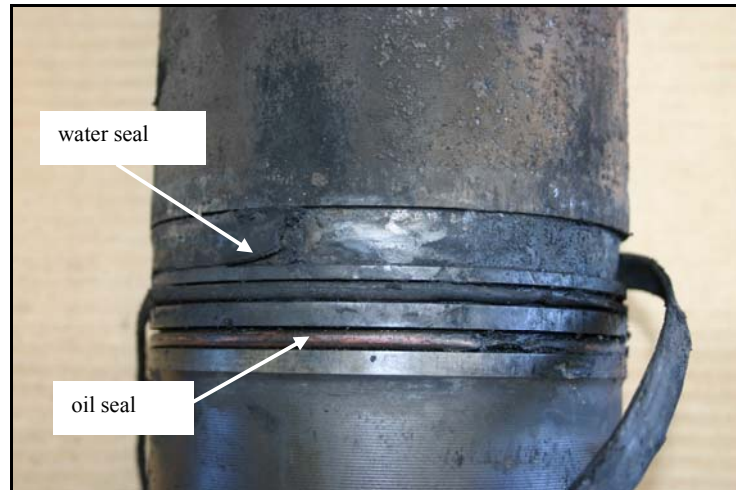
1.8.16 The seals of liners 1, 3, 4 and 6 had failed to similar extents (see Figure 17).

Figure 17
Failed seals on No. 6 liner

- 2.16 As the cylinder liner seals degraded progressively, the engine would have continuously lost cooling water into the sump below, thereby lowering the coolant tank water level and activating the low water alert. The scale observed on the liner seals would also have degraded the heat-transfer performance of the liner walls and contributed to local overheating.

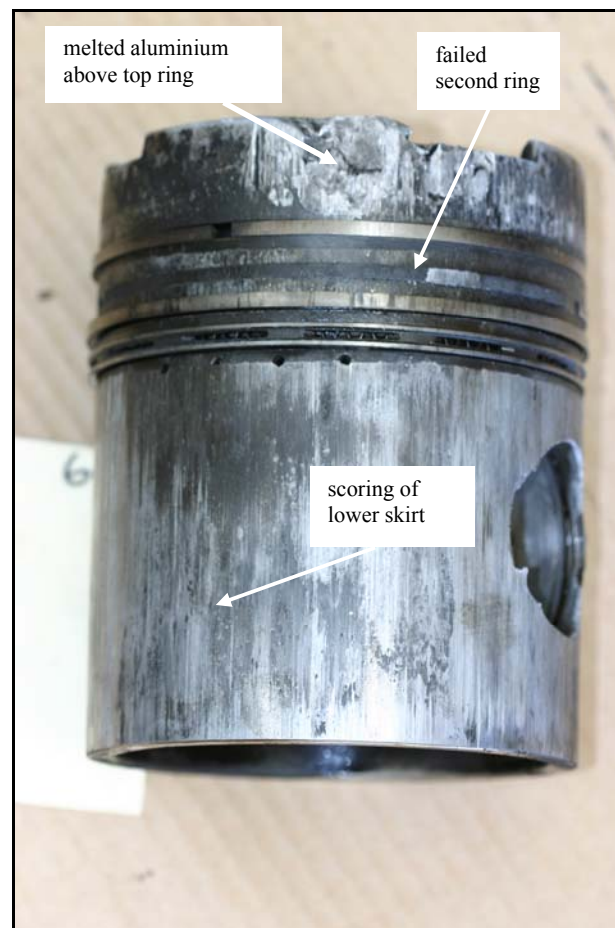
1.8.17 No. 6 piston and its skirt had evidence of aluminium melt that was caused by excessive friction developed between the cylinder and the piston. Some of the melt was deposited on the underside of the cylinder head (see Figure 18).

Figure 18
Scoring on No. 6 piston skirt
