RAILWAY OCCURRENCE REPORT

05-109

tourist Trains *Linx* and *Snake*, derailments, Driving
Creek Railway, Coromandel

20 February 2005 -
3 March 2005

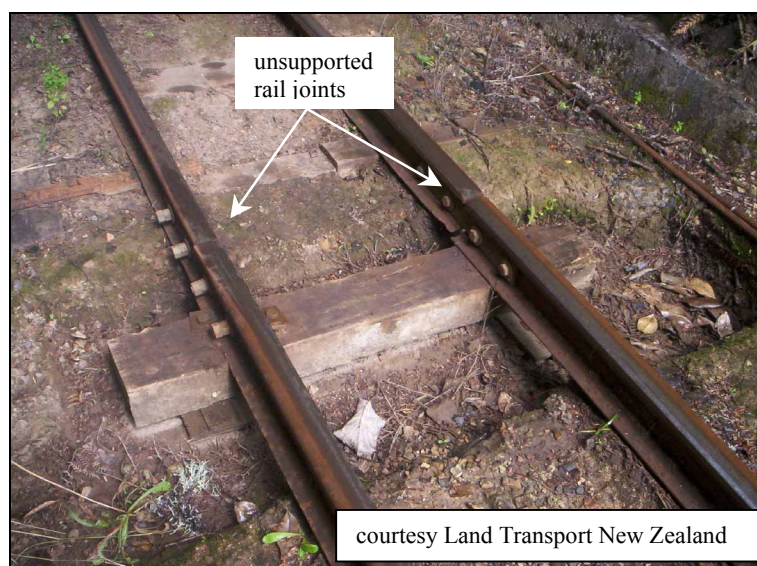
- 1.3.8 The purpose of a rail joint was to provide a connection between the rails to provide a continuous girder with uniform surface and alignment. At many rail joints there was one sleeper beneath one rail and the rail joint was directly above the edge of the sleeper (see Figure 2). This gave different support conditions at each side of the joint and put additional stress on the fishplate.

Figure 2
Sleeper under one side of joint only

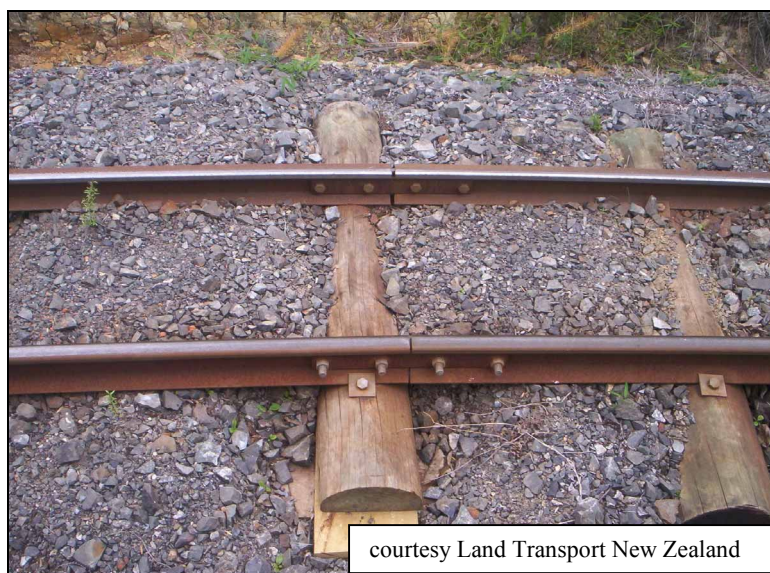
Figure 3
Half-round sleeper under one side of joint (also note packing)

- 1.3.10 Extensive use had been made of pieces of timber of all shapes, sizes and thicknesses to pack under sleepers where settlement had occurred (see Figure 3). While sleeper support had been restored by this means most were not fastened in position and required regular maintenance.

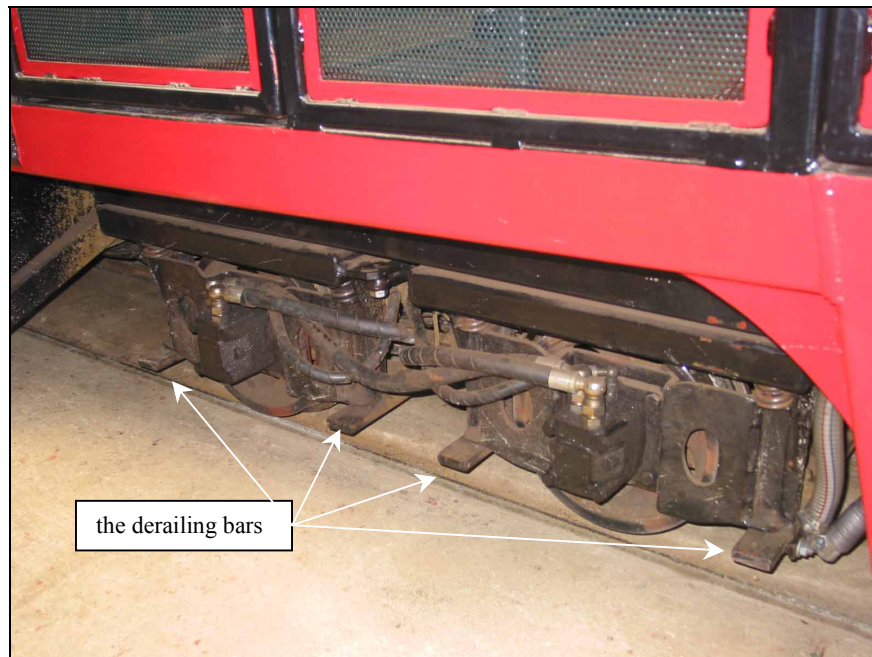
Figure 4
The derailing bars on the bogie

- 1.4.3 As the *Linx* exited the curve the derailed bogie straightened up but the projecting end on the first derailing bar on the rear bogie lodged under the right-hand railhead where it slid along for about 17 m until it struck a fishplate. On impact, the bogie was jerked further to the left-hand side.
- 1.4.4 When the bogie jerked, the carriage jack-knifed and a passenger was thrown from her seat, receiving moderate injuries as a result. The driver was alerted to the derailment by the sound of the bar striking the fishplate, and he stopped the train within about 3 m.

- 2.4 The derailing bars had been installed to prevent any derailed wheels from digging in to the ballast, and at the time of the derailment this was achieved. However, after the bogie had derailed there was nothing to alert the driver that the derailing bar was resting on the railhead. Had there been a warning device attached to the derailing bars, it is likely that the driver would have stopped the train before the rear bogie jackknifed and the passenger was injured. Following the derailments the operator addressed this issue, and no safety recommendation has been made.

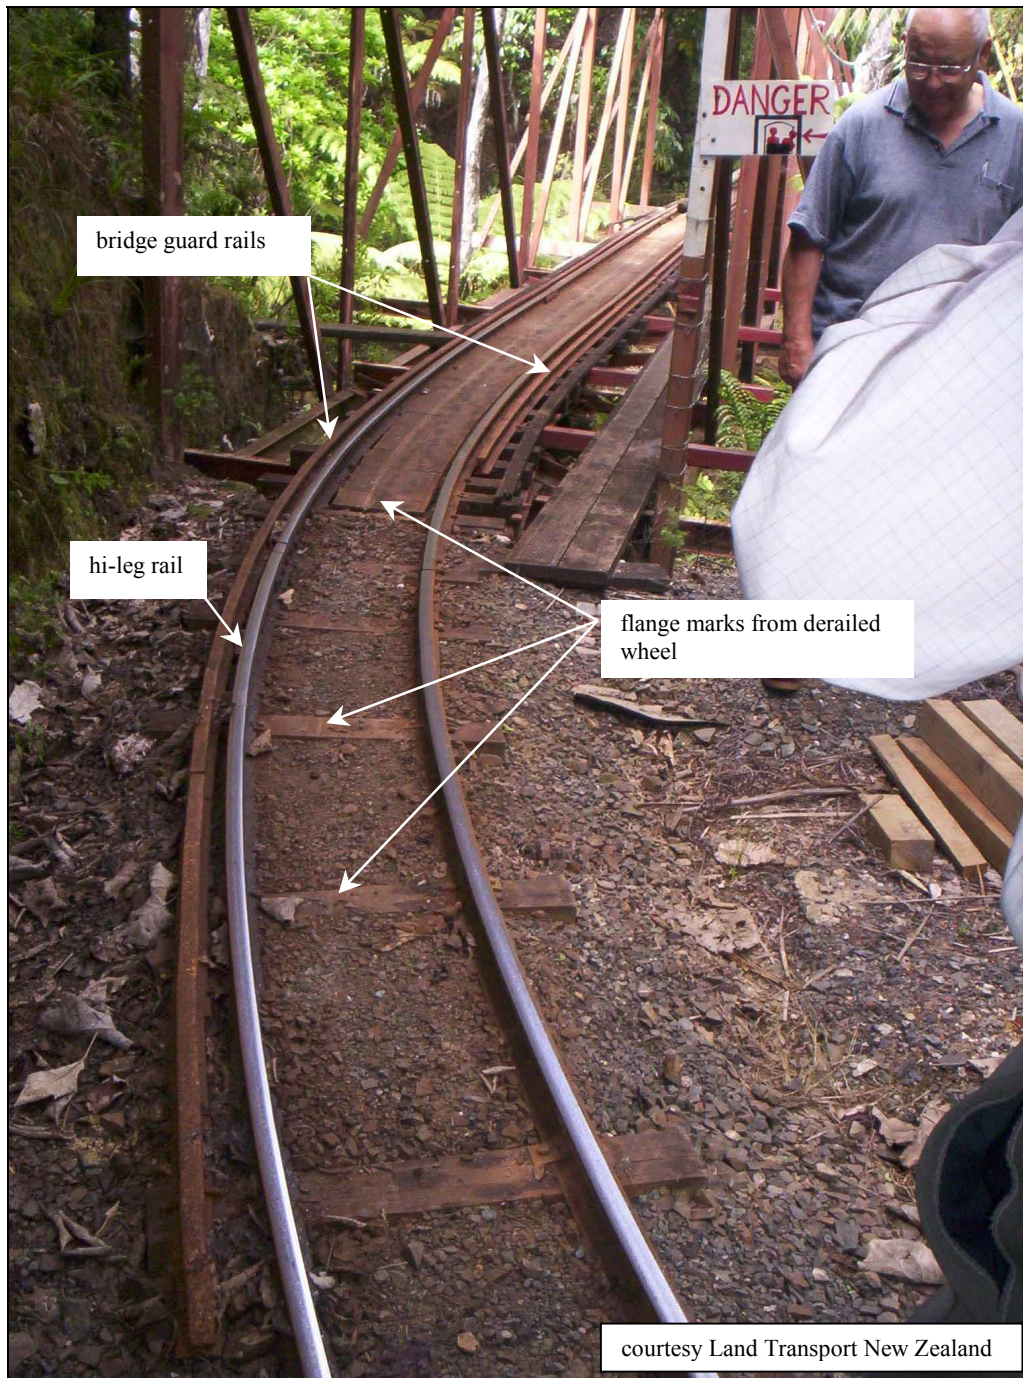
- 1.4.14 A track measure-up at the POD showed that the gauge and top were good and that the cant was a constant 10 - 15 mm.
- 1.4.15 There were no marks on the sleepers to suggest that the track had been regauged following the derailment, or that the track had been out of gauge prior to the derailment, although there were marks where the derailed wheel flange had made contact with the sleepers.

Figure 5
Track immediately beyond the POD at Peg 1270

- 1.4.16 There was no evidence to suggest any weakness in the rail to sleeper fastenings that could have contributed to the derailment.
- 1.4.17 Bridge guide rails were fitted to the outside of, and parallel to, the running rails on the approaches to and across the bridge (see Figure 5) to prevent derailed wagons from moving beyond the edge of the bridge sleepers.

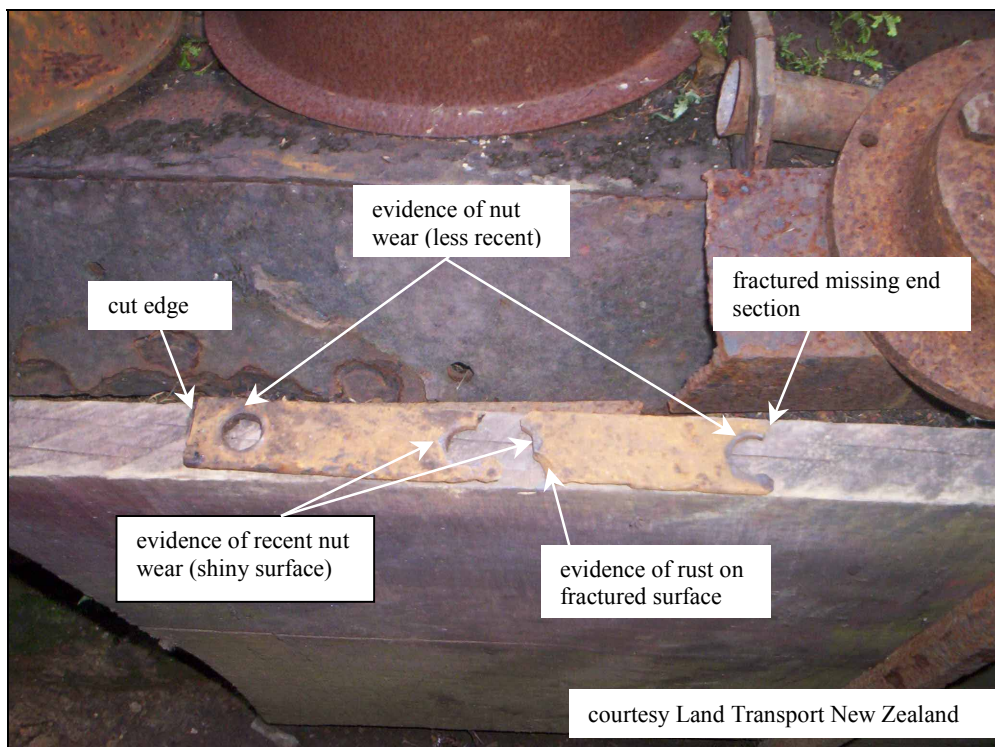
- 1.4.22 A heavily corroded and fractured fishplate measuring 32 mm wide x 6 mm thick was recovered from the derailment site. The matching surfaces were rough and rusty.
- 1.4.23 The fishplate fragments accounted for only 3 boltholes instead of the usual four. There was evidence that the end section containing the fourth hole had rusted and broken off previously.

Figure 6
The fractured fishplate

- 2.8 The fishplate had fractured through corrosion behind the bolt washer. The washer had initially been tight enough to prevent the 2 sections of the fractured fishplate from separating. The small shiny area on the face of the fishplate showed that it had until recently been in contact with the washer and had only very recently been separated. The rusty appearance of the metal on both sides of the fracture indicated that the fracture had occurred as a result of corrosion of the fishplate over some considerable time.

- 2.9 The lack of a sleeper to provide support beneath the joint meant that the fishplates securing it largely carried the weight of trains passing over the 150 mm gap between the sleepers. The fishplates would have responded to the trains passing over the gap by moving up and down and this movement would have vibrated through the corroded fishplate and hastened the ultimate fracture.

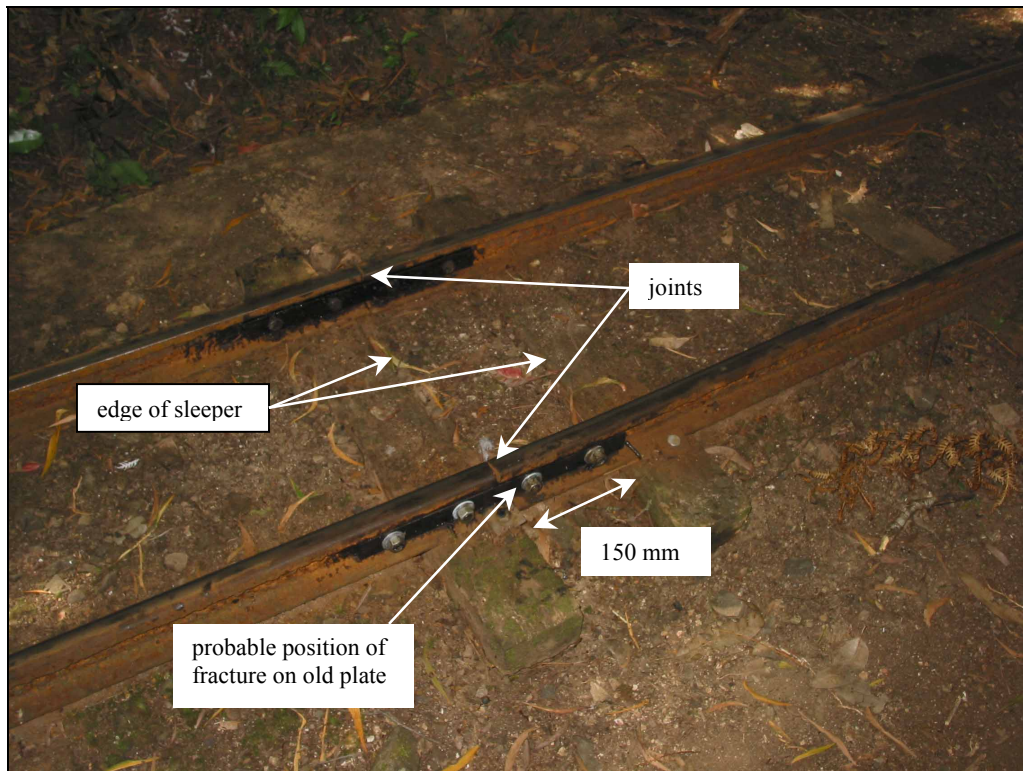
- 1.4.24 DCR staff had been aware of the fishplate problem, and only recently new supplies of 40 mm wide x 10 mm thick plates had been received for use in progressively replacing the old plates. DCR confirmed a major fishplate replacement programme had been implemented immediately following the derailment of Train *Snake* at Peg 600.
- 1.4.25 The distance between sleepers at the broken joint was about 150 mm, with the joint supported only by the fishplate across that gap. Figure 7 shows the new 40 mm x 10 mm fishplate used to replace the old fractured one.

Figure 7
The replacement joint

- 2.7 Although the corroded and broken fishplate had been replaced before investigators arrived on site this did not affect the investigation as the fishplate had been retained for inspection. The replacement, new and stronger, fishplate had been attached to the rail on both sides of the joint in exactly the same way as the replaced fishplate had been.

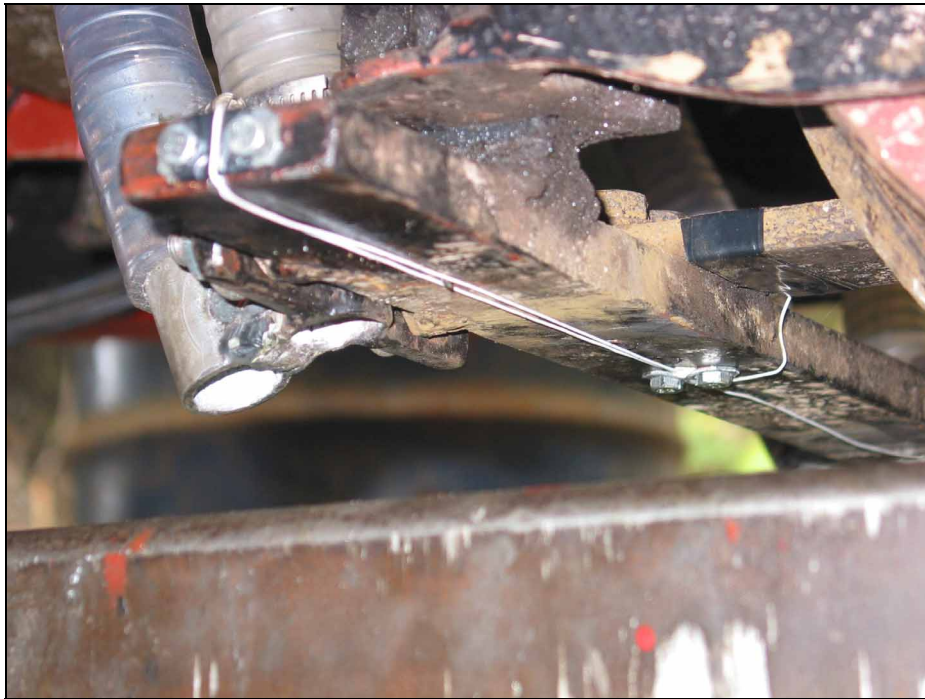
Figure 8
The derailment warning system fitted to the derailing bar

- 4.1 Following the derailments, DCR introduced a derailment warning system consisting of an insulated wire secured underneath each of the derailing bars (see Figure 8). If a bogie derailed, the wire would be trapped between the bar and the railhead and would break, triggering an alarm in the driver's cab.
- 4.2 On 9 August 2005, DCR advised that the derailment alarm warning system had been fitted to the *Linx* and tested on 18 March 2005. The system would be fitted to the *Snake* during its overhaul in September 2005.
- 4.3 On 7 March 2005 the design engineer recommended to DCR that the self-steering linkage ratio on the front and rear bogies on the *Linx* be reduced by 25%. The modifications (see Figure 9) were undertaken by DCR engineering staff and on 9 March test runs of the *Linx* were undertaken over the network under the supervision of the design engineer. The test confirmed

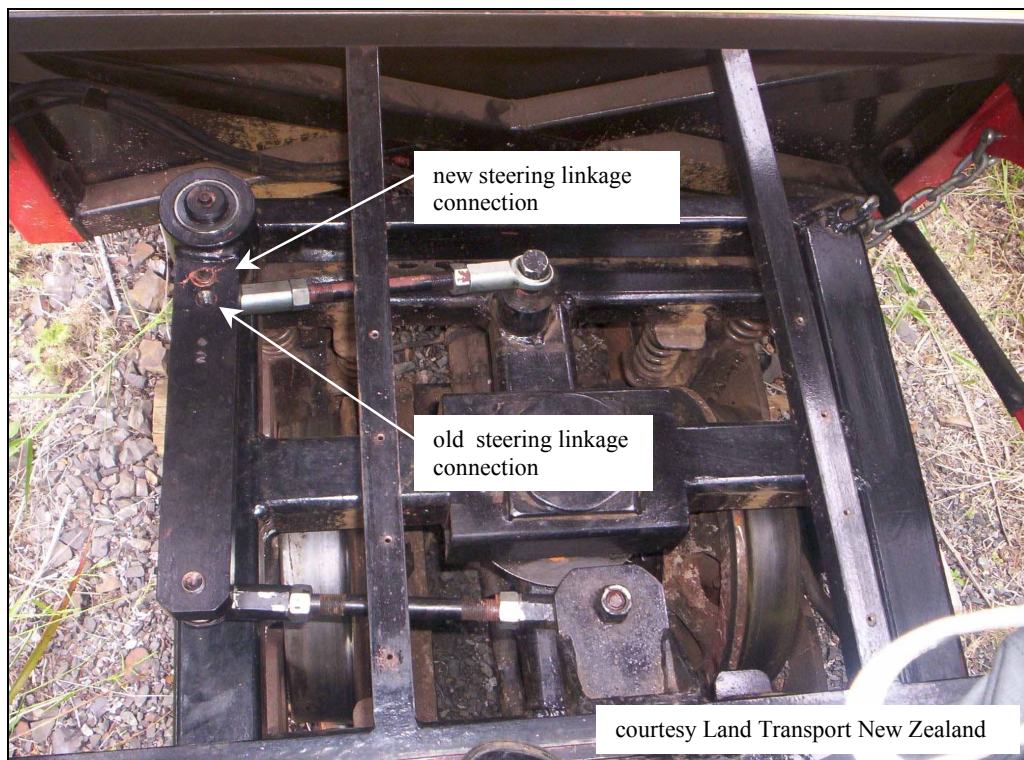
Figure 9
The adjusted steering linkage connection

that the over-steering of the rear bogie, which had previously been apparent when it entered a curve, had been eliminated and that the wheel flanges were now floating between the rails without any bias.
