## RAILWAY OCCURRENCE REPORT

05-111

express freight Train 312, school bus struck by descending barrier arm, Norton Road level crossing, Hamilton

16 February 2005

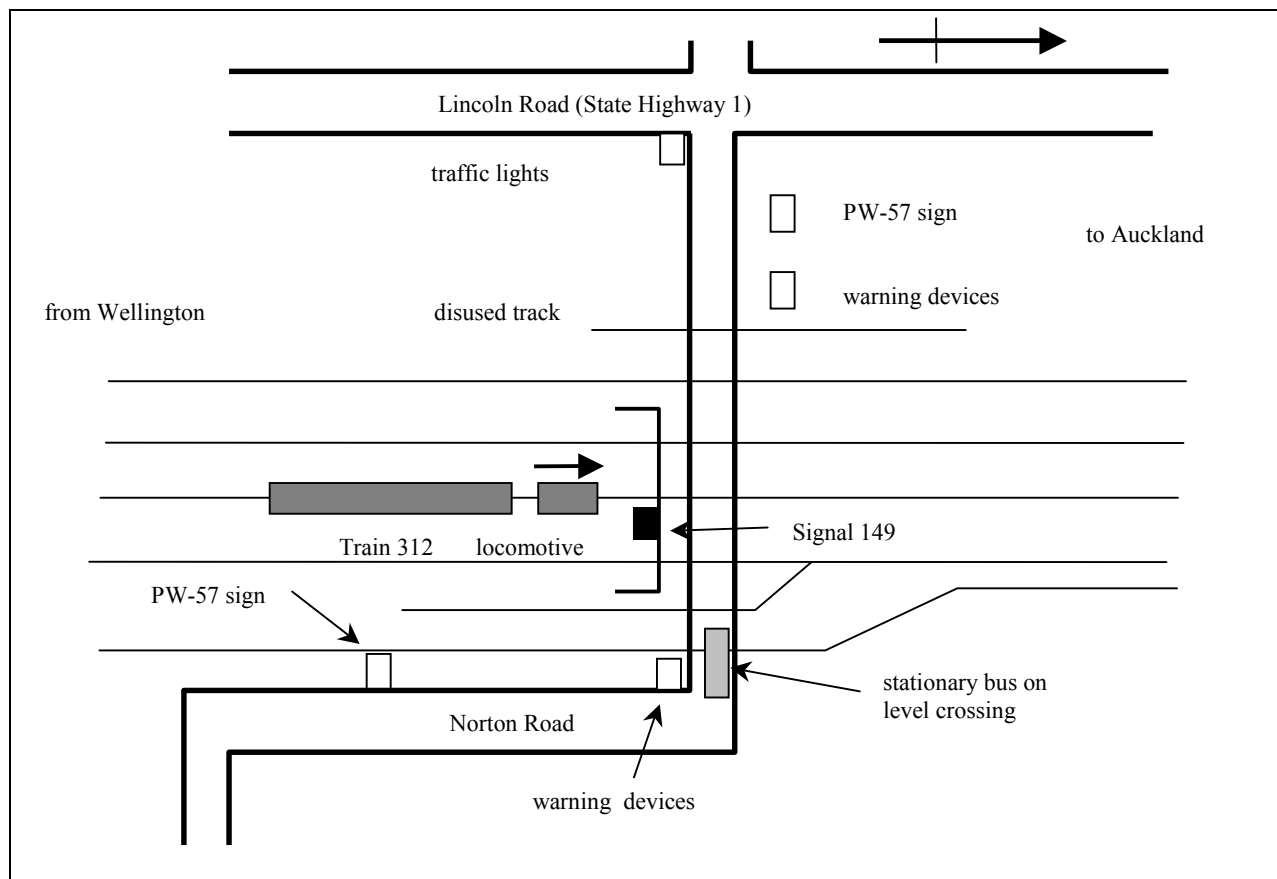
**Figure 1**  
**Site plan of Norton Road level crossing (not to scale)**

- 1.2.1 Norton Road level crossing was located at 543.23 km on the North Island Main Trunk. It was about 37 m wide and crossed 7 tracks, which included the main line, 2 loops and 3 sidings. The seventh track was disconnected and not used.

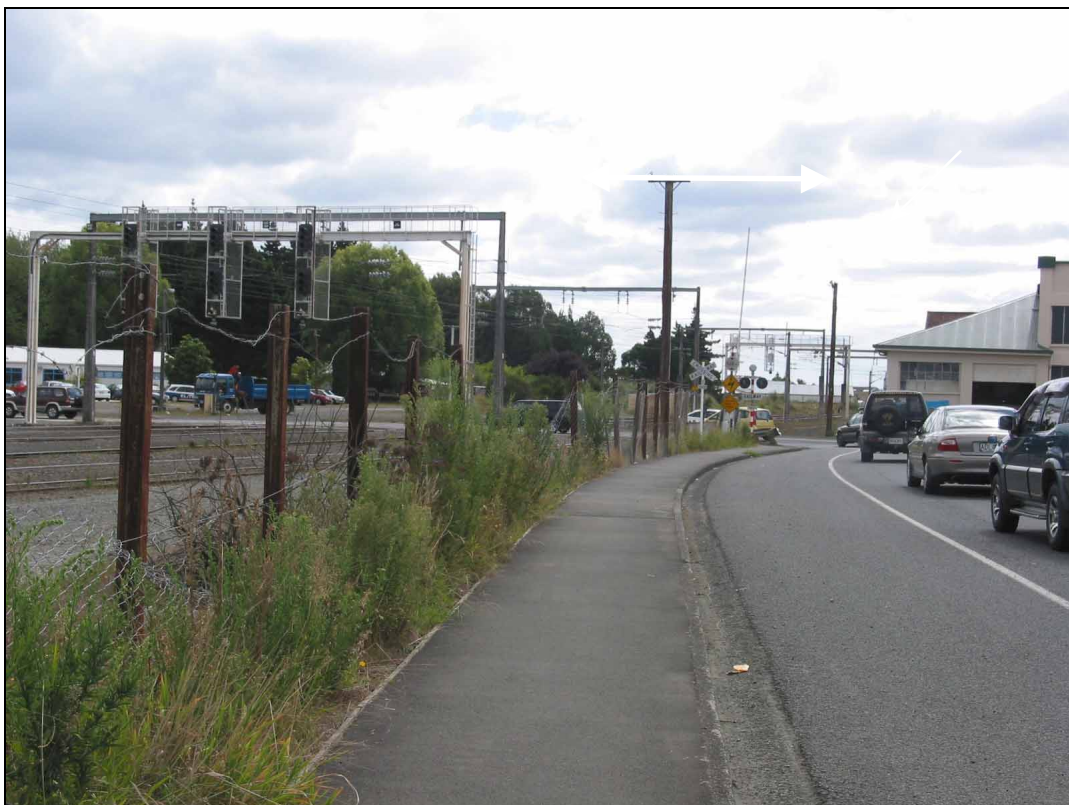
**Figure 2**  
**The eastern approach to the level crossing**

- 1.2.5 Norton Road level crossing did not offer good visibility for road traffic, particularly when approaching the crossing from the east. This approach ran parallel to the railway corridor for about 100 m before it turned sharp left on to the crossing (see Figure 2).

- 2.10 The warning devices were not operating when the bus initially entered the level crossing. The tight left-hand curved entry meant that it was not possible for the driver to approach and enter the crossing straight on. As a result, the bus was still turning on to the crossing, and by the time it had straightened up sufficiently for the driver to see straight ahead it was already under the barrier arm as it started to lower. If the bus driver had followed the traffic over the crossing he would have cleared it safely because the locomotive of Train 312 was stationary at the time. However, although he was aware of the presence of that particular train, his concern was that there might be another train approaching and his action in stopping his bus as soon as he became aware that the warning devices had activated was justified, particularly as he could not then reverse off the crossing.

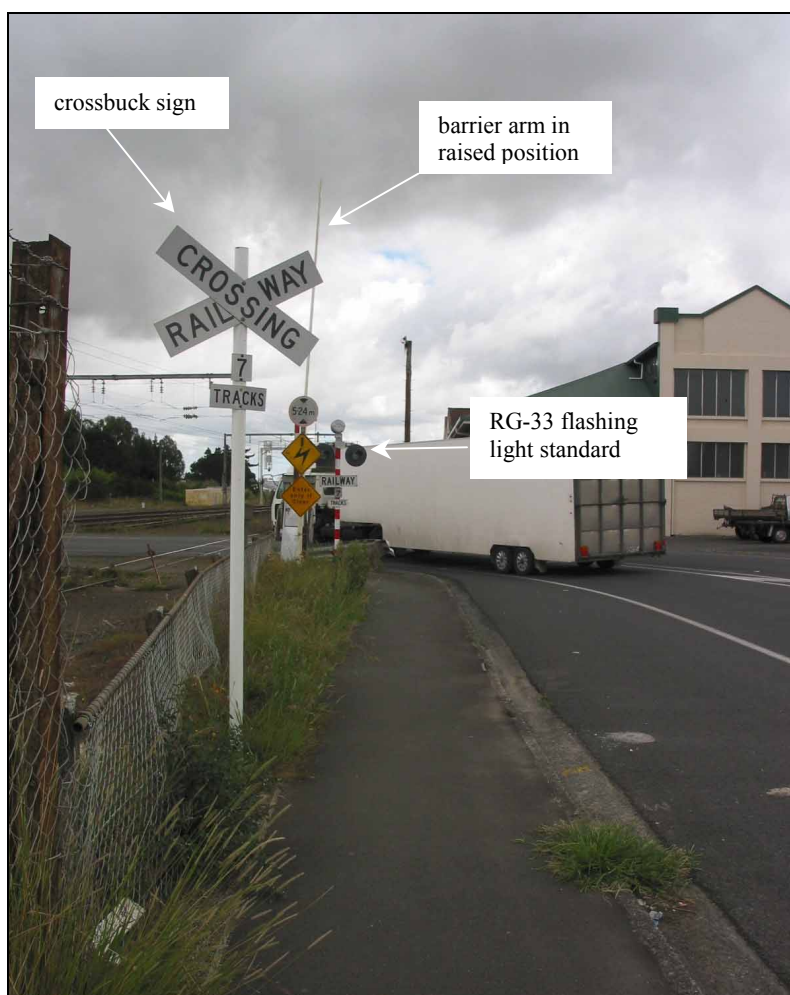
**Figure 3**  
**The eastern side of the level crossing**

- 1.2.10 There was a PW-57 sign 90 m from the level crossing on the eastern side. This was in accordance with the “Manual of Traffic Signs and Markings”<sup>5</sup> (the manual), which specified that such signs should be located on the left-hand side of the road at least 60 m from the crossing. The PW-57 sign on the western side was 57 m from the crossing (see Figure 4). This did not meet the guidelines specified in the manual, but physical limitations prevented it being further away. The manual also specified that where annual average daily traffic exceeded 2000 vehicles per day, a second PW-57 sign should be positioned on the right-hand side of the road. There were no PW-57 signs on the right-hand side of the road on either side of the crossing.

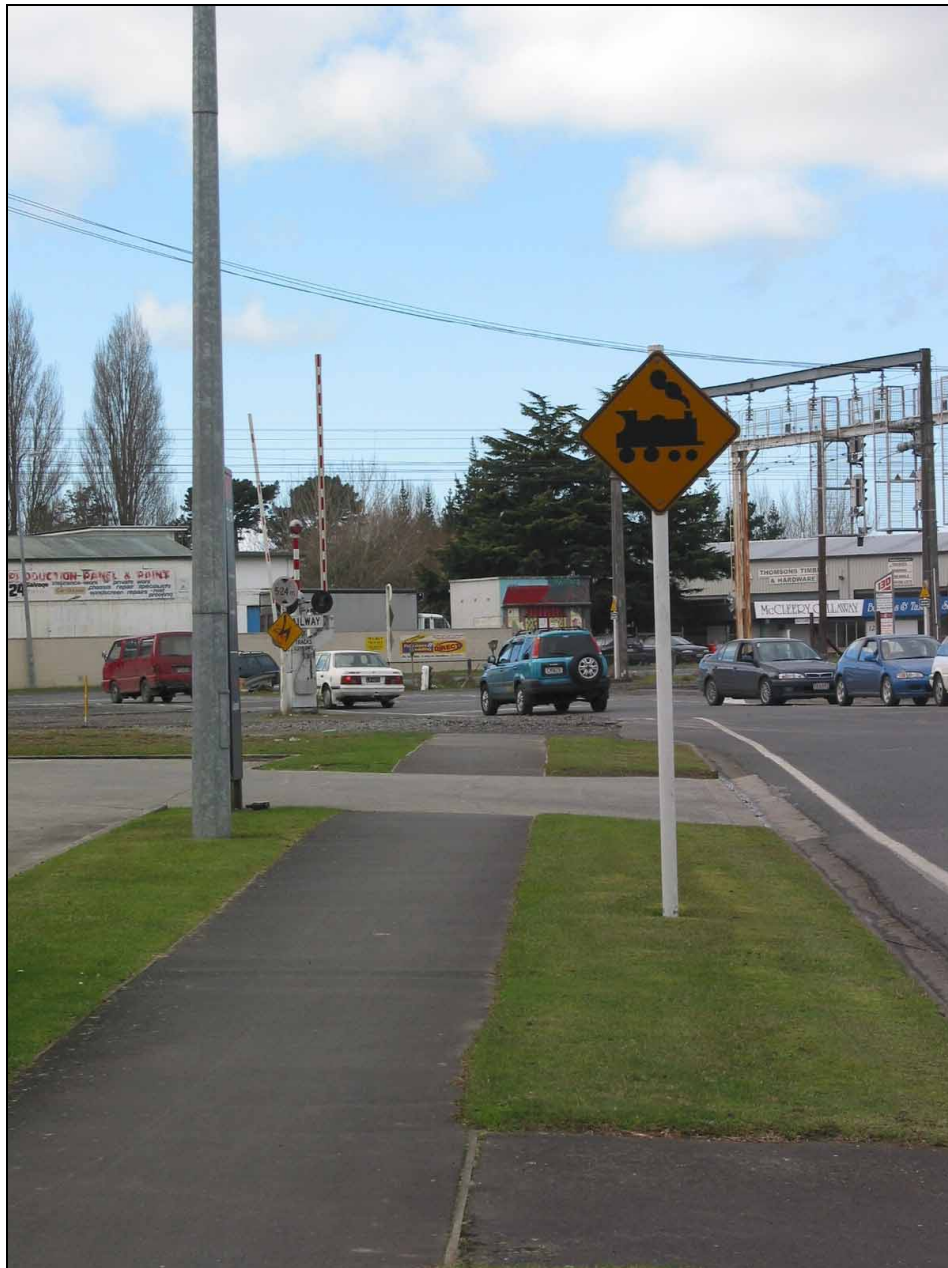
**Figure 4**  
**The PW-57 sign on the western side of the crossing**

- 2.3 The road signage and markings that were in place, both approaching and at the level crossing, were clearly visible and in good condition and met the guidelines included in the manual, except for the non-existent PW-13 sign and the incorrectly positioned PW-57 on the eastern side. The alignment of the intersection turn into Norton Road meant that it was not possible for the PW-57 to be positioned the required 60 m from the crossing but the siting of the sign did not contribute to the incident.

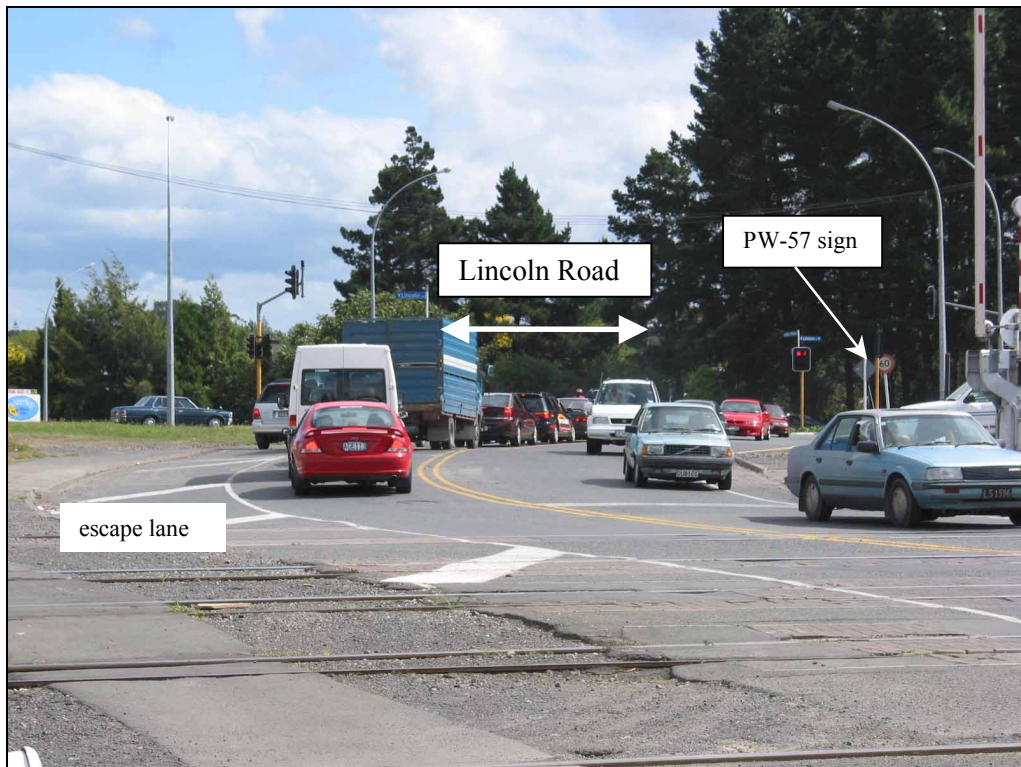
**Figure 5**  
**The Norton Road/Lincoln Street intersection**

- 1.2.11 The manual provided for a PW-13<sup>6</sup> sign to be erected on the main road approach to a side road junction where a railway level crossing was located on the side road immediately adjacent to the main road intersection. PW-13 signs were to be located where they were clearly visible to approaching drivers for a distance of at least 60 m on urban roads. There were no PW-13 signs on Lincoln Road advising traffic turning in to Norton Road.
- 1.2.12 An escape lane, identified by a painted area on the left-hand side of the road approaching the intersection, was provided for any vehicles caught on the level crossing by an approaching train because of traffic banked up at the traffic lights (see Figure 5).

- 2.7 The traffic signals at the intersection with Lincoln Road influenced traffic patterns for east-to- west motor vehicle traffic flows across the level crossing. If the signals were at stop, traffic often banked back and blocked the exit from the crossing. When approaching from the eastern side, motorists had a restricted view of traffic movements on the western side until they had completely entered the level crossing, by which time following traffic prevented them reversing and so committed them to continuing across.

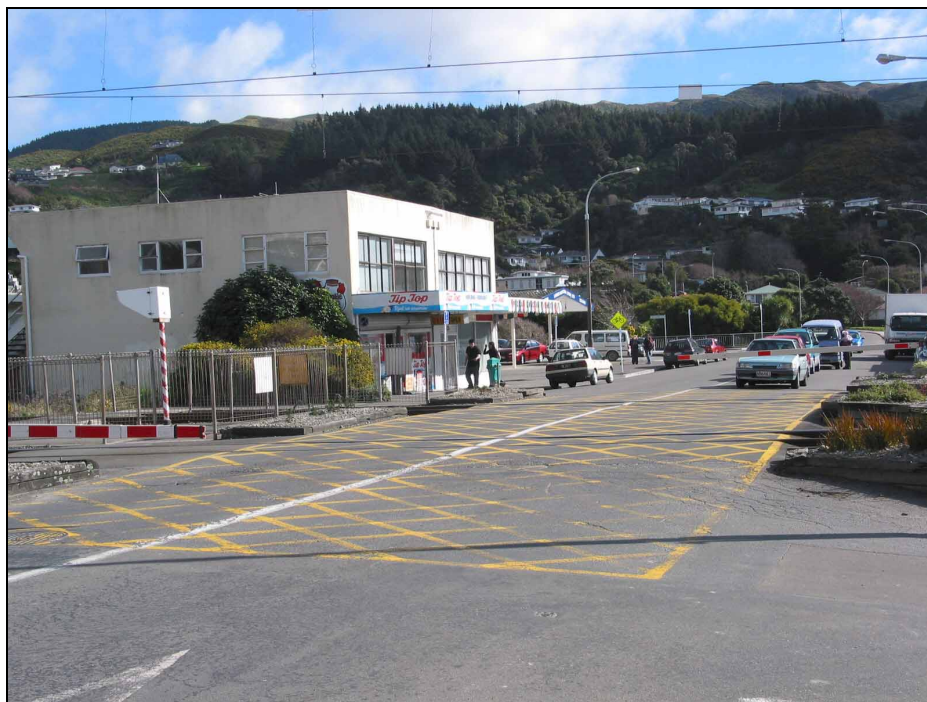
**Figure 6**  
**An example of yellow cross-hatching at a level crossing**

- 1.2.13 The manual provided that where the departure of long vehicles or queues of traffic from a level crossing may be blocked by a nearby intersection or other traffic control devices, an escape lane or clear zone should be provided. Yellow cross hatch markings could be used to define a clear zone area that drivers should not enter when their departure from the level crossing was blocked. Figure 6 shows an example of a level crossing where yellow cross-hatching was in place.

- 2.6 The bright colour of cross-hatching to indicate “enter only if clear” however, is highly visible to motorists and, together with appropriate signage, would probably have provided a more positive defence by discouraging cars from entering the level crossing, rather than relying on an escape route, when the exit was blocked. The issue of road markings at the level crossing has been included in a joint safety recommendation to the Chief Executives of ONTRACK and Hamilton City Council and no separate recommendation covering cross-hatching has been made. However, despite the compromises and possible minor improvements to signs and road markings, the crossing may be as safe for road traffic as it can be made at costs consistent with the benefits that might result from more substantial interim improvements.

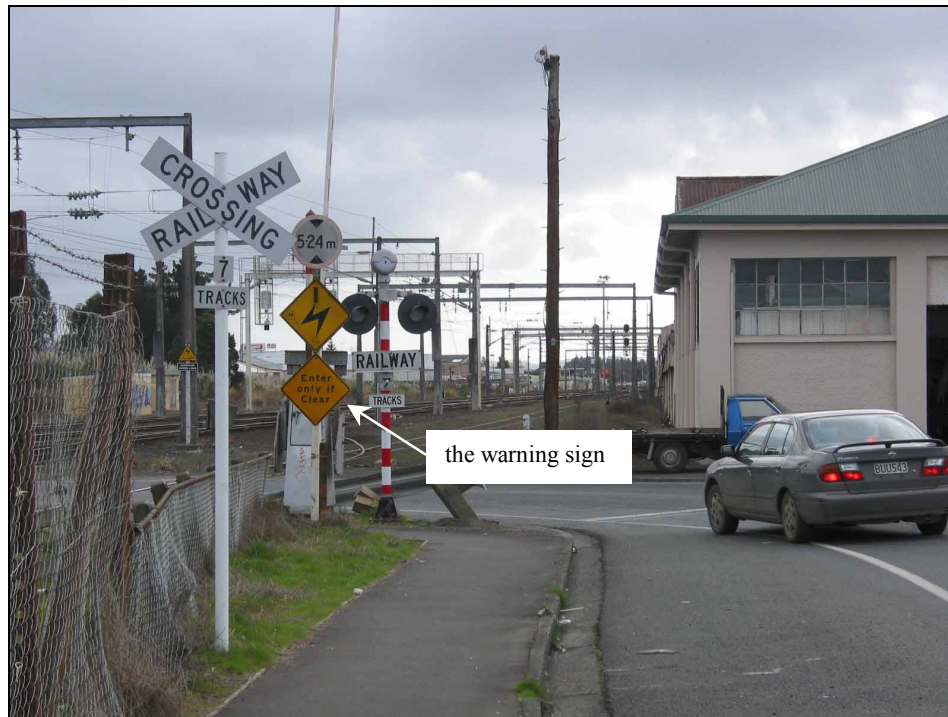
**Figure 7**  
**The overhead warning signs on the eastern side of the crossing**

- 1.2.14 There was a sign on each side of Norton Road level crossing warning approaching traffic of the presence and clearance height of the overhead catenary. An additional sign, which advised motorists to “enter only if clear”, was attached beneath the overhead warning signs on the eastern side (see Figure 7).

- 2.5 The sign, which advised drivers to “enter only if clear” was attached, with other signs, to the standard which warned of the presence of the overhead catenary. There were several signs and standards on the eastern side of the crossing, which created a clutter and this, together with the small size of the sign, would have made it difficult for motorists to see, especially as they were concentrating on approaching and entering the crossing. The issue of signage at the level crossing has been included in a joint safety recommendation to the Chief Executives of ONTRACK and Hamilton City Council.

participate with Hamilton City Council in a review of Norton Road level crossing in Hamilton to include, but not limited to, the design, layout, signage, road markings, warning devices and the alignment of the road approaches and exits to ensure these are appropriate and take steps to rectify any shortcomings identified (032/05).

participate with New Zealand Railways Corporation in a review of Norton Road level crossing in Hamilton to include, but not limited to, the design, layout, signage, road markings, warning devices and the alignment of the road approaches and exits to ensure these are appropriate and take steps to rectify any shortcomings identified (033/05)
