RAILWAY OCCURRENCE REPORT

05-115

empty passenger Train 2100, train parting and improper door opening, Ranui

1 April 2005

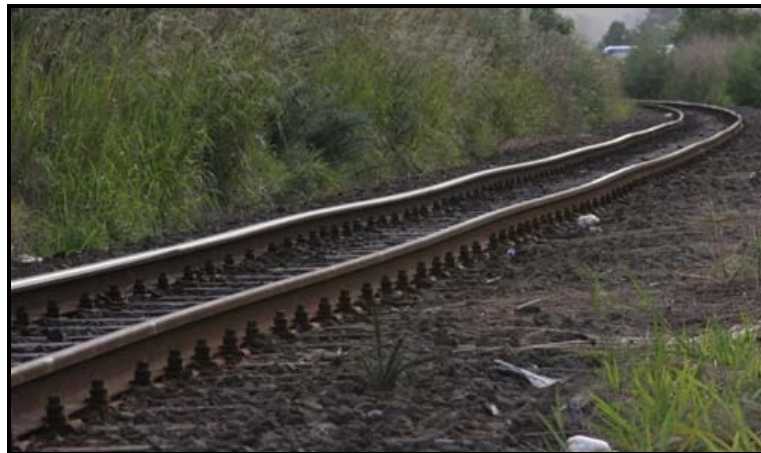
Figure 1
Track in the vicinity of the train parting location

- 1.2.1 The parting occurred at about 30.00 km on the NAL. At this position the track alignment was on a 1600 m radius left-hand curve transitioning from near level to a slightly descending gradient of 1 in 174. During its most recent run through the area on 18 November 2004, the track evaluation car³ had identified no track outside maintenance tolerances. However, the track in the area did have a wavy top (see Figure 1).

- 2.4 Although the track gauge, cant and top, when last measured by the track evaluation car in this area, were within ONTRACK's tolerance limits, there was some cyclic wavy top in the vicinity of the train parting. The wavy top may have contributed to the train parting, but it was unlikely to have caused significant movement on its own and cause the knuckles of DC 4375 and AG 55 to ride over each other, but may have caused the locomotive and guard's van to have pitched sufficiently differently to contribute to the parting.

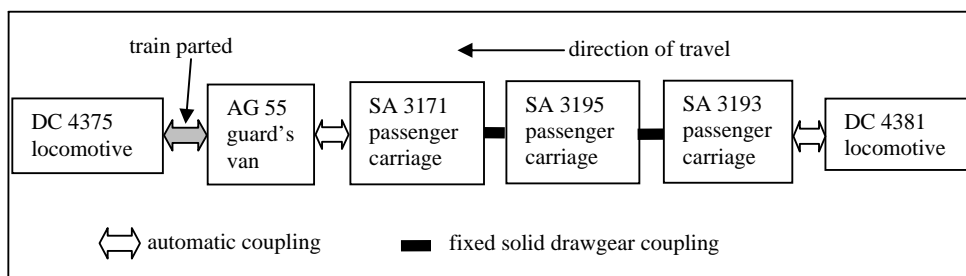
Figure 2

- 1.3.1 The Connex SA passenger train consists were made up of the requisite vehicles and generally remained made up as a unit. The vehicles on Train 2100 were connected with either automatic or fixed solid drawgear couplers (see Figure 2).

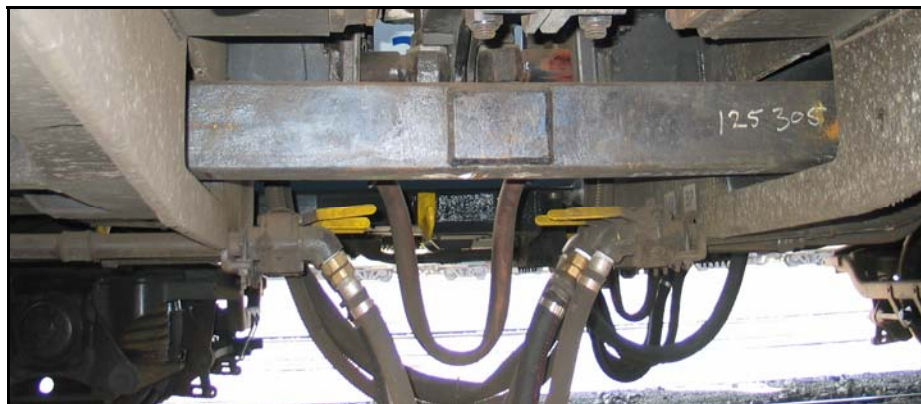
Figure 3

- 1.3.2 Fixed solid drawgear was formed of a drawbar only and provided a secure connection between 2 SA carriages (see Figure 3). Special arrangements were required to uncouple vehicles fitted with this type of drawgear.

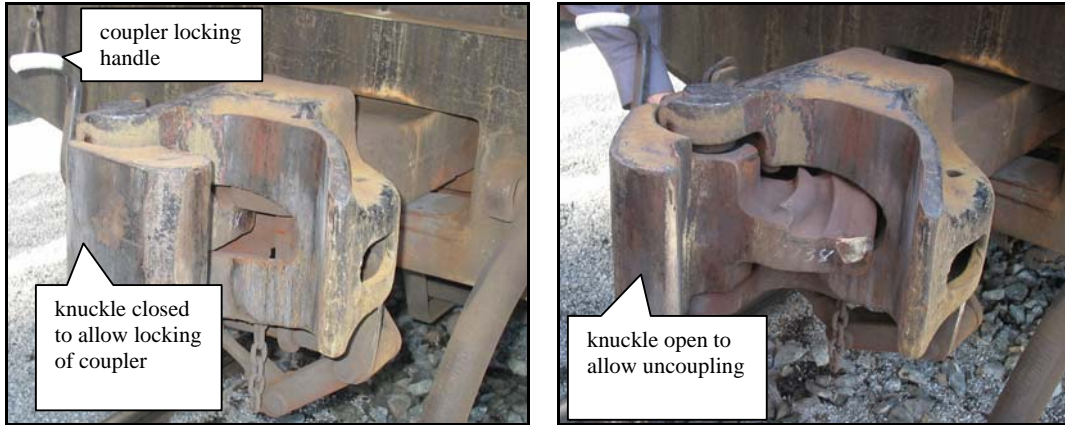
- 1.3.4 The automatic couplers between DC 4375 and AG 55 were alliance-type automatic couplers, each fitted with a positive lock assembly but with no safeguards to prevent them parting. The knuckle on each coupler was 229 millimetres (mm) high. No gouge marks were visible on the topside or underside of either of the couplers. To facilitate a coupling or uncoupling of an alliance coupler, the knuckle on at least one vehicle must be unlocked and opened (see Figure 4).

Figure 4
Automatic coupler on AG 55 with knuckle on the left, closed and on the right, open

- 2.2 The coupler on AG 55 possibly became unlocked and opened. Had this happened, it would be expected that the train manager would have found the knuckle open. However, he found the knuckle closed but as he could not recall if it was locked, this possibility could not be ruled out. The knuckle may have closed in the movement associated with the parting.

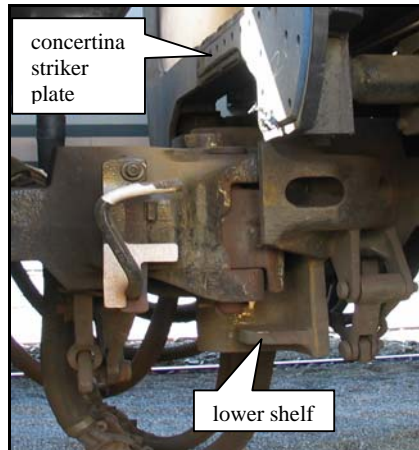
Figure 5
Coupling arrangement between AG 55 and SA 3171

- 1.3.5 The automatic couplers on the outer ends of SA 3171 and SA 3193 were specially equipped to prevent overriding, a precursor to a parting. They were fitted with a lower shelf and with the bottom edge of the concertina striker plate situated above, which limited any vertical movement so that the couplers could not part (see Figure 5).

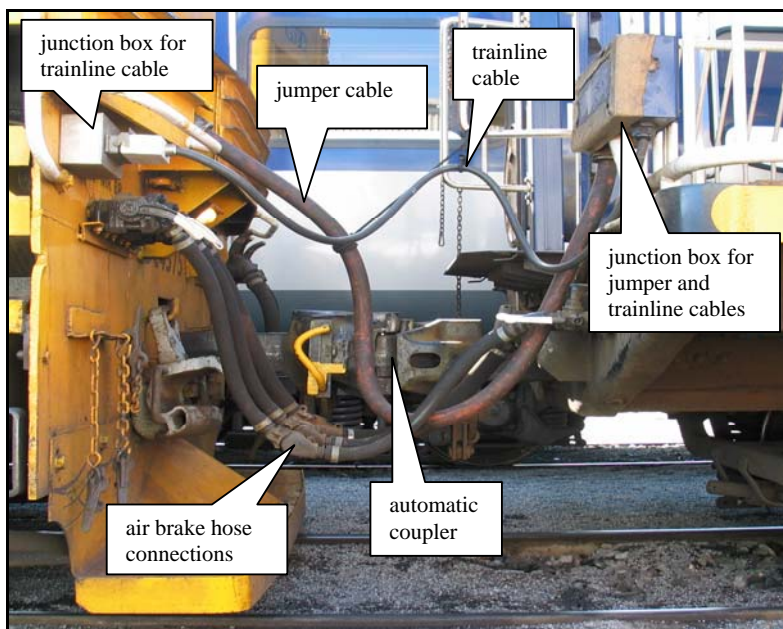
- 1.3.6 A jumper cable connection extended the length of the train, enabling the locomotive engineer to operate the locomotives at each end of the train in multiple (see Figure 6).

Figure 6
Coupling and cable arrangements between DC 4375, left and AG 55, right

- 1.7.6 On arrival at Waitakere, the locomotive engineer examined the area between DC 4375 and AG 55 in more detail. He found that all components of the jumper cable were missing, except for some bare wires hanging from the junction box on AG 55. He disconnected the jumper cable between DC 4381 and SA 3193 to enable him to drive the train from that end. He arranged for a certified Alstom member to travel in DC 4375 for the return journey to Westfield, so that he could apply the brakes on that locomotive should the train part again.
- 1.7.7 On the return journey, the locomotive engineer slowed the train in the area of the parting, but he could see no sign of the missing jumper cable and concluded that it probably had been flung off into some trackside bushes. The remains of the jumper cable were never found.

- 2.6 The severing of the trainline cable resulting in a short circuit sending commands to the carriage doors was a scenario that probably had not been considered in its design. If the consist had been conveying a full complement of passengers in this instance, any passengers standing next to the doors could have been at serious risk. Post incident tests showed that wiring arrangements had been unknowingly connected when the set had been assembled. The disconnection of the 2 wires removed the possibility of doors opening in any future train parting incident while in this particular configuration.

- 1.3.9 Tests immediately following the incident found that it was not necessary for all the wires that were connected to the locomotive event recorder on DC 4375 to be so connected. To prevent a reoccurrence that could again result in a short circuit in the trainline sending incorrect commands to the carriages to open and close the doors, Toll NZ Consolidated Limited (Toll Rail) mechanical engineers arranged for the relevant 2 wires to be disconnected between SA 3171 and AG 55.

Note that the reason that all door control trainlines were trainlined through to the locomotive was to allow these signals to be recorded on the locomotive event recorder. On 6 April 2005 (after the incident) the door open trainlines (wires 3 and 4) were disconnected from the SA car at the AG end of the train. This eliminated the possibility of the doors opening if the cable was damaged as a result of another parting between the locomotive and the AG van.

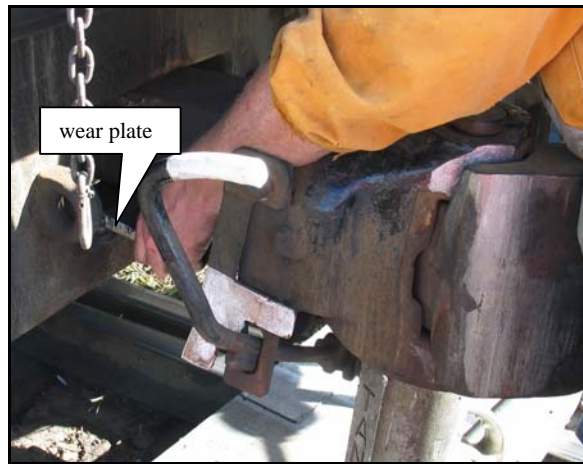
Figure 7
New drawbar wear plate being installed on AG 55

- 2.11 The train manager noted the coupling height difference when he recoupled the train after the incident. This height difference should have been obvious to dedicated mechanical personnel when the consist returned for repairs at Westfield on the day of the incident. Nevertheless, after being checked at Westfield, AG 55 was reinstated to passenger operations with a drawbar height that was out of code. Although the addition of the replacement wear plate on 5 April 2005 lifted the drawbar height to 730 mm, it was still outside code requirements when returned to service.

- 1.4.4 The buffer wear plate on AG 55 was replaced following the recordings taken on 5 April 2005. This raised the drawbar height to 730 mm (see Figure 7). Additionally, the knuckles on AG 55 and DC 4375 met code standards at that time.
- 1.4.5 A field modification instruction dated March 2000 required all couplers on AG vans to be replaced with AL-type alliance couplers when the original drop hook-type coupler was worn out. No additional measures were in place to prevent over riding and partings because maintaining drawbar height to normal code tolerances would cover this.
- 1.4.6 Locomotive(s) remained attached to the SA consists during fuelling and servicing, and were only removed if they had sustained a failure, the nature or complexity of which required them to be detached.

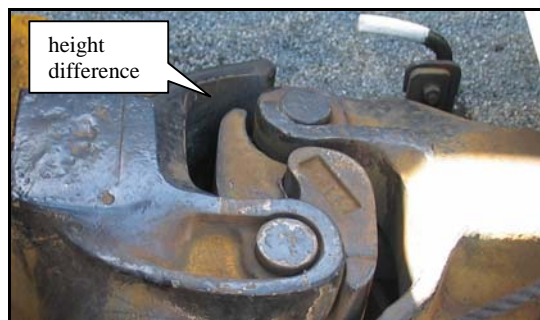
Figure 8

Locked automatic couplers between DC 4375, left and AG 55, right showing height difference

- 2.3 Another possibility was that the differing pitch and bounce between DC 4375 and AG 55 was enough that the coupler on AG 55, with its out-of-code height, slipped under the coupler on DC 4375. The height difference between the 2 drawbars was 35 mm which, when deducted from the depth of the knuckle on AG 55, meant that the amount of knuckle-to-knuckle contact between the 2 vehicles was 194 mm. Therefore, for the closed and locked knuckles to override one another, the knuckle on DC 4375 would have had to lift and the knuckle on AG 55 to drop by the combined amount of 194 mm. However, similar measurements were not taken at the knuckles to gauge the height difference at the extremity of the couplers. Because the drawbar of AG 55 would have been at a slight downward angle caused by the worn wear plate, the difference at the knuckles would have been greater and therefore the knuckle-to-knuckle contact less. Nevertheless, neither the locomotive engineer nor the train manager reported any unusual riding sensations before the train parting occurred.

- 2.12 The gradual degradation of the drawgear height on AG 55 went undetected for a lengthy period of time and there were insufficient procedures to monitor such a critical component on a fixed passenger train consist on a more frequent basis. A safety recommendation has been made to the Chief Executive of Toll Rail to address this issue.

with the trend towards fixed passenger train consists, investigate compliance with, and the robustness of, present procedures for the checking of coupled drawgear heights with a view to reinforcing existing procedures, and if need be, introducing additional or changed processes to further reduce the likelihood of passenger carrying vehicles operating in service with an out-of-code drawbar height (101/05).
