RAILWAY OCCURRENCE REPORT

05-118

express freight Train 245, derailment, Ohingaiti

27 July 2005

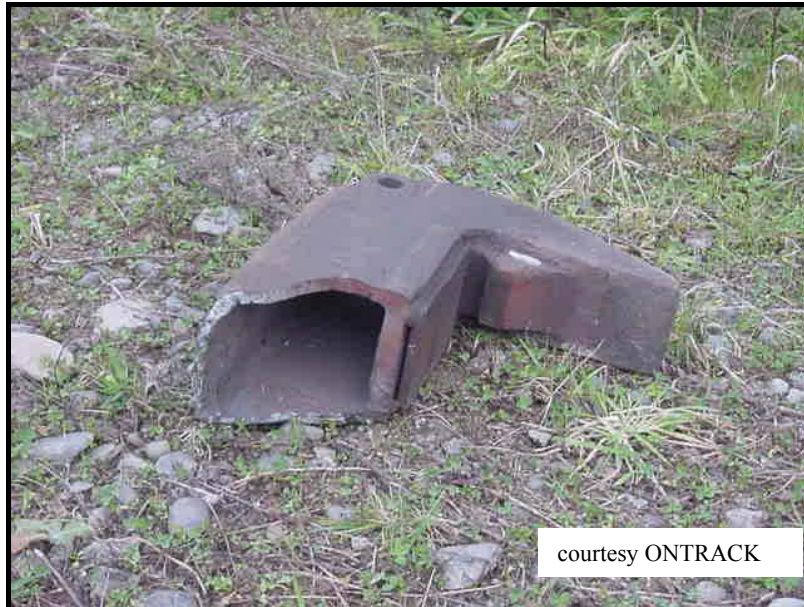
Figure 1
Fractured pedestal leg found trackside

- 1.2.4 The pedestal leg separated from the left-hand trailing bogie side frame on wagon ZH519 and was found about 3 m to the left of the track at 227.872 km (see Figure 1). When the bogie side frame fractured, the train was travelling on straight track up a 400 m long, 1 in 73 incline. The track consisted of 50 kilograms per metre g/m continuous welded rail, fastened to concrete sleepers with Pandrol fastenings and supported by clean ballast with full cribs and shoulders. The track geometry was within maintenance tolerances.

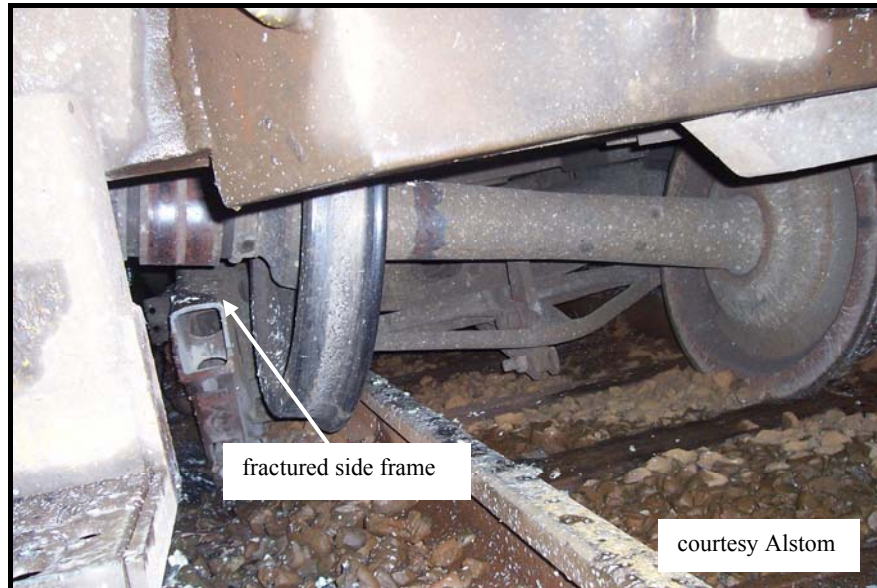
Figure 2
Derailed trailing bogie

- 1.2.5 There were light marks on the left-hand end of the sleepers (in the direction of travel), and some bent rail fastenings between 226.38 km and 225.127 km. The sleeper bruising became more pronounced from 225.127 km to where derailed wagon ZH519 stopped at 224.17 km, some 3.75 km past the point where the side frame fractured (see Figure 2).

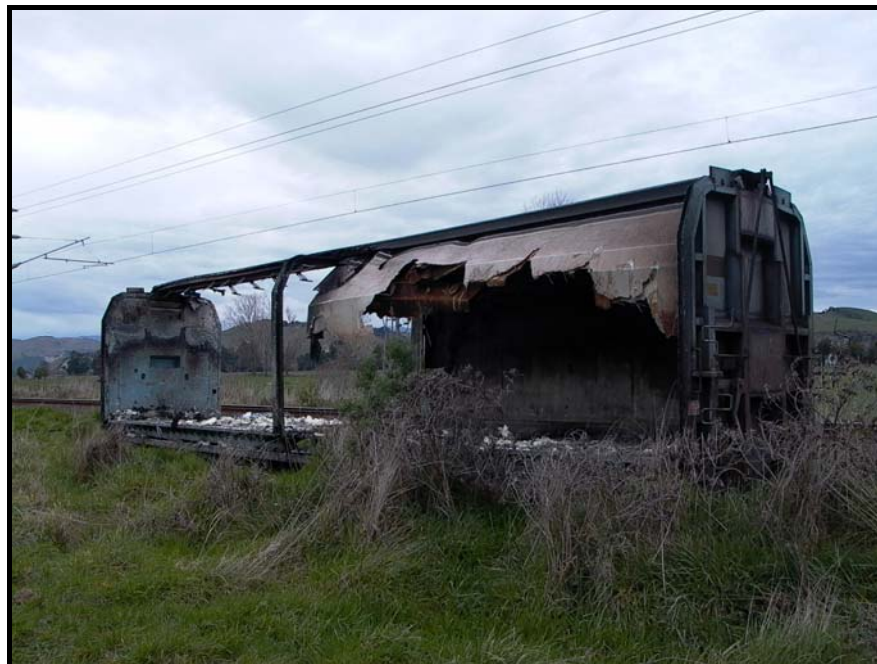
Figure 3
Wagon ZH519 placed trackside

- 1.1.5 The locomotive engineer left the locomotive cab to check his train and to determine the extent of the track damage. He saw that wagon ZH519, the 12th wagon back from the head, had derailed and that the wood pulp inside the wagon was smouldering. An off-duty fire officer who was travelling north on State Highway 1 had seen the smouldering wagon and had already called out Fire Service personnel from both Mangaweka and Taihape before the locomotive engineer reached the derailed wagon.

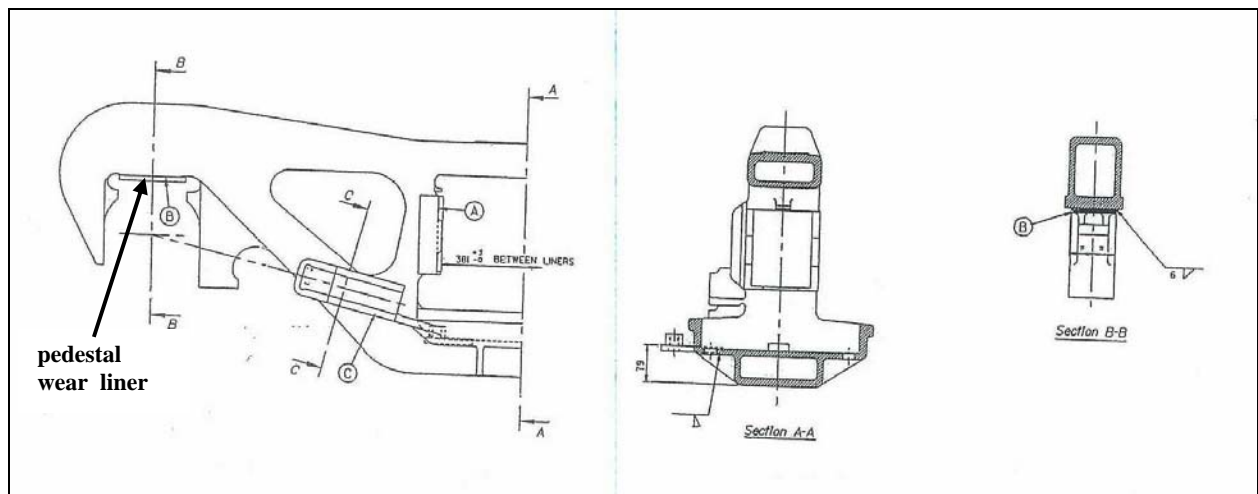
1.8.1 Toll Rail's drawing 11051499 showed the weld attaching the pedestal roof wear liner as a 6 millimetres (mm) fillet weld applied down both sides of the liner but not across the end of the liner (see Figure 6).

1.8.2 After the derailment, a number of other bogie side frames were inspected and about 20% of them had welds extending around the corner on the end of the pedestal roof liner.

Figure 6
Attaching pedestal roof wear liner

- 4.1 A survey of bogie side frames undertaken by the rolling stock maintenance provider indicated that the weld extending around the corner of the pedestal roof liner may occur on up to 20% of the bogies in service, although in general the weld size was within specification. The rolling stock maintenance provider has stated that on all future overhauls, the weld attaching the pedestal roof wear liner to the side frame is not permitted to extend beyond the thickened portion of the pedestal roof.

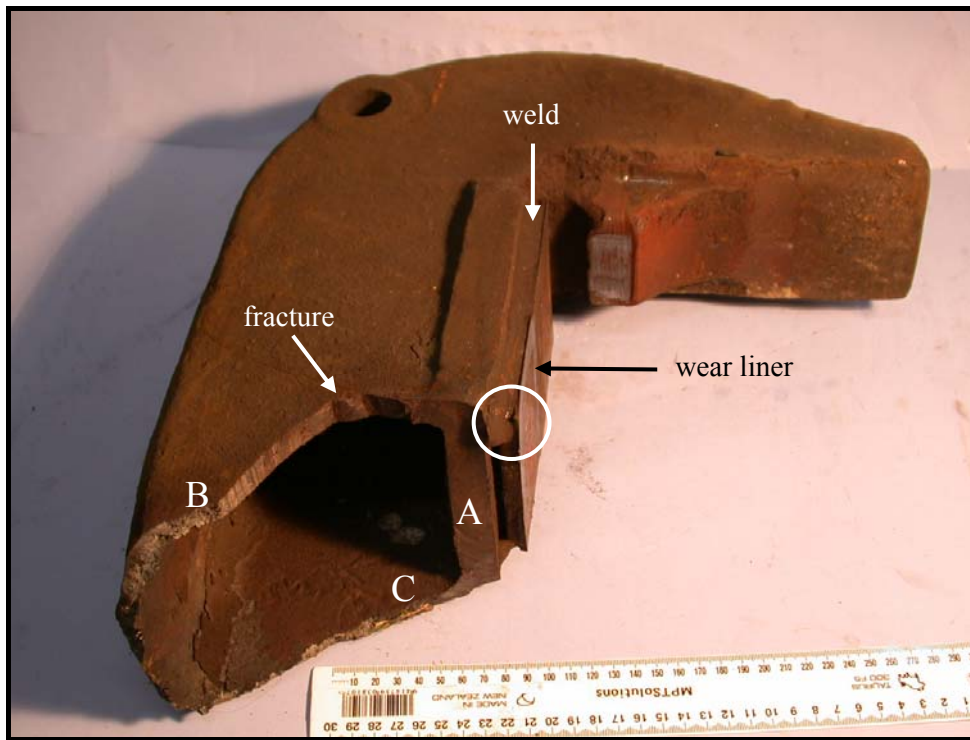
1.9.1 The separated portion of the side frame was recovered and taken to an independent metallurgy laboratory for examination. The side frame was essentially a box frame onto which a wear liner was welded (see Figure 7).

Figure 7
Failed side frame with end of fillet weld (circled)

- 1.9.2 The side frame had fractured through the box section. The fracture propagated approximately perpendicular to the axis of the box section then changed direction to about 45 degrees to the axis. The fracture was covered in a medium to dark brown corrosion product consistent with iron oxide.

- 1.9.3 The weld that attached the roof wear liner to the side frame extended about 15 mm around the end of the liner and into an area in the side frame that is highly stressed. The weld at this point was approximately 12 mm.

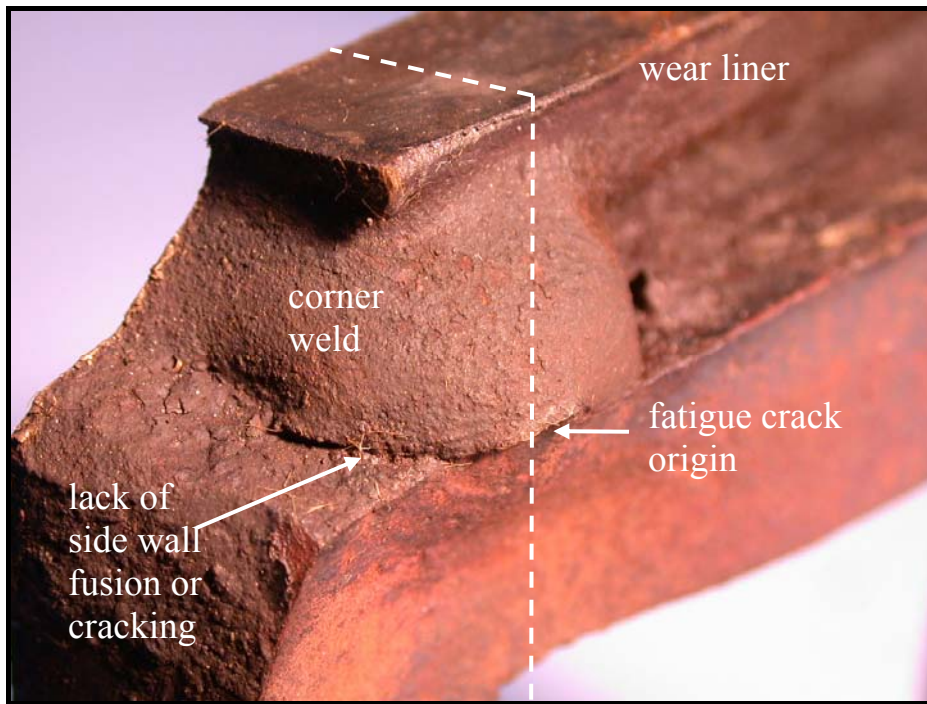
- 1.9.4 The fracture exhibited a fatigue crack that originated from the toe at the end of the fillet weld with the side frame (see Figure 8) and propagated through one side of the box section, labelled A in Figure 6, and up the 2 adjacent sides of the box section to positions labelled B and C. The dotted white line in Figure 8 indicates where the weld was sectioned for more detailed examination.

Figure 8
Close up of the corner weld

- 1.9.5 The fatigue fracture traversed about 50% of the perimeter of the box section. The fatigue crack in region A was very fine, whereas gradually broadening beach marks were present towards regions B and C. Beyond regions A, B and C the fracture exhibited overload.

- 1.9.6 The fracture was cleaned with an inhibited acid solution and the surface in region A still exhibited a dark brown corrosion product, indicative of old corrosion. The corrosion product on the fracture surface beyond region A was removed and the fracture surface was relatively clean with a metallic look, indicating that the fracture in these regions was more recent than at A.

- 1.9.7 The end of the fillet weld exhibited, at its toe, a lack of sidewall fusion with the side frame. However, there was no evidence of a defect on the fracture surface from where the fatigue crack originated.

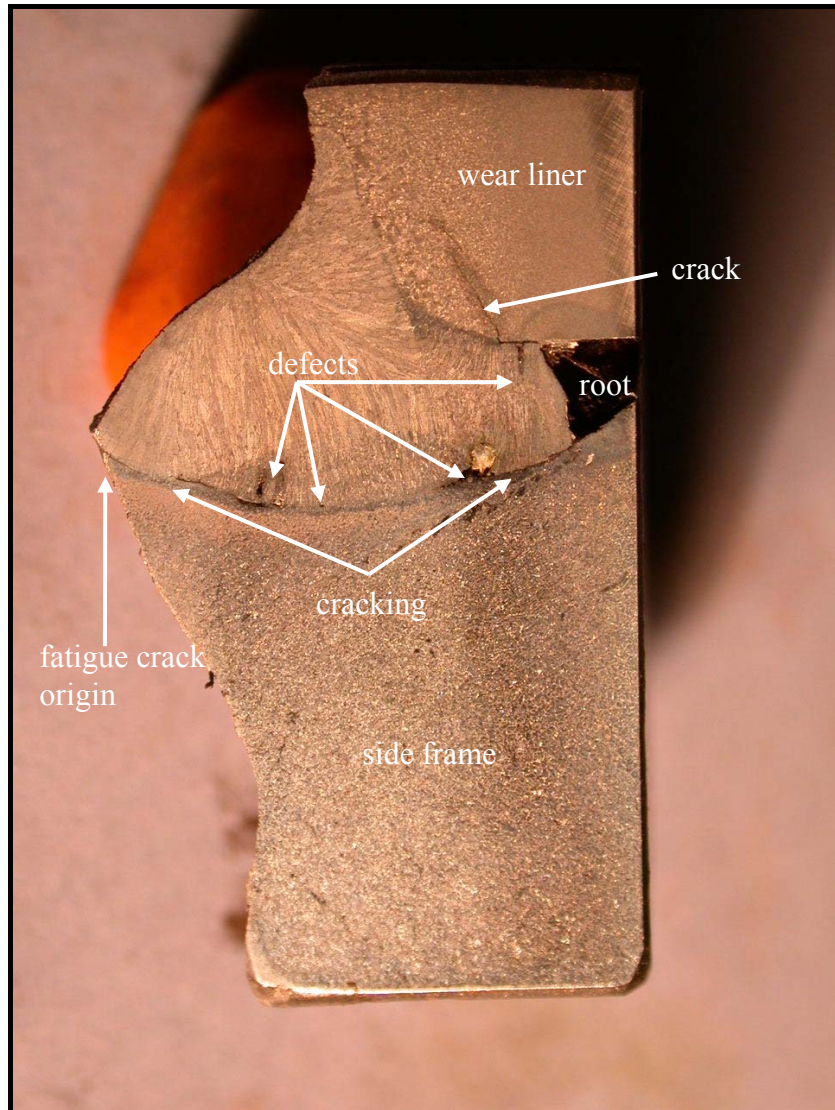
- 1.9.9 A section was cut through the wear plate, fillet weld and side frame for a more detailed examination (see Figure 9). At the end of the cutting, the box section closed on the hacksaw blade, indicating that there were circumferential compressive stresses in that region of the assembly.

Figure 9
Section showing the weld, defects and cracking

- 1.9.10 There was considerable cracking present in the following locations, as marked in Figure 9:
- at the toe of the weld in the heat-affected zone (HAZ) in the side frame at the origin of the fatigue crack (see Figure 9)
 - in the HAZ between the toe and the root of the weld
 - in the HAZ at the root of the weld on the side frame (see Figure 10).

- 1.9.11 Most of the cracks were generally open towards the surface and became narrower further into the material, indicating that the cracks were still propagating.

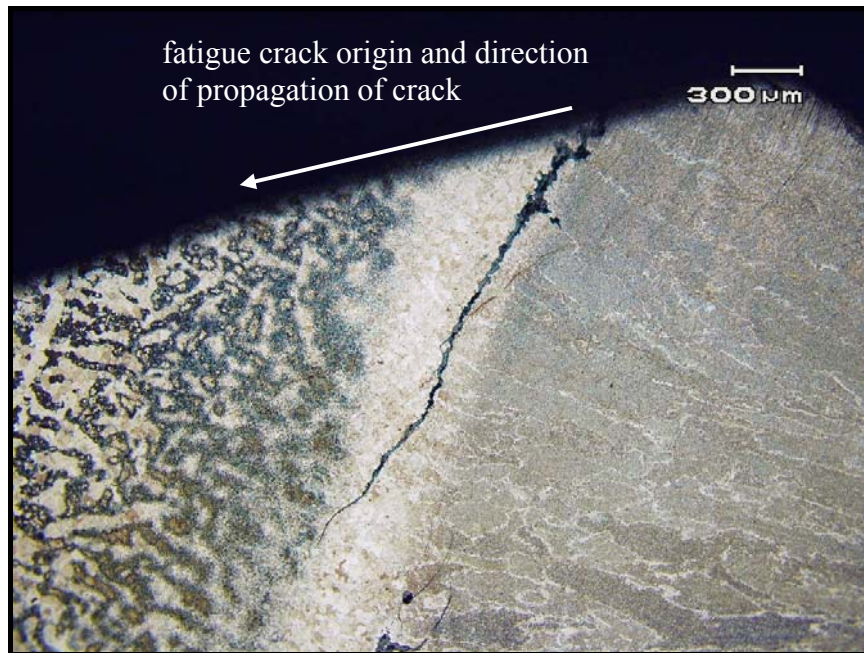
Figure 10
Origin of the fatigue crack in the HAZ

- 2.2 The fatigue crack initiated from the fillet weld at the end of the pedestal roof wear liner rather than stopping at the side. Therefore the non-compliant weld extended into an area that was highly stressed.

- 2.3 The presence of defects at the interface between the weld fillet and the side frame indicated that there was a lack of side wall fusion at the toe of the weld, and this was probably the initiator of the fatigue crack. The defects could have been introduced at the time the wear liner was replaced during the last major overhaul of the bogie, nearly 5 years before the derailment.

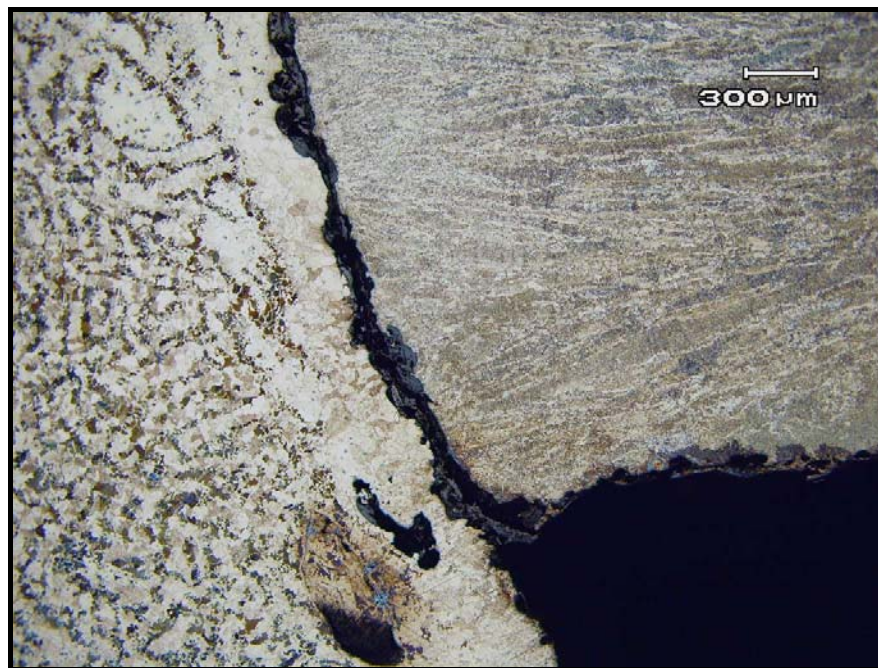
Figure 11
Lack of sidewall fusion at the weld root
