RAILWAY OCCURRENCE REPORT

05-119

runaway wagons from Waingawa and subsequent collision with motor vehicle, Hodders Road level crossing, 74.35 km between Carterton and Dalefield

29 July 2005

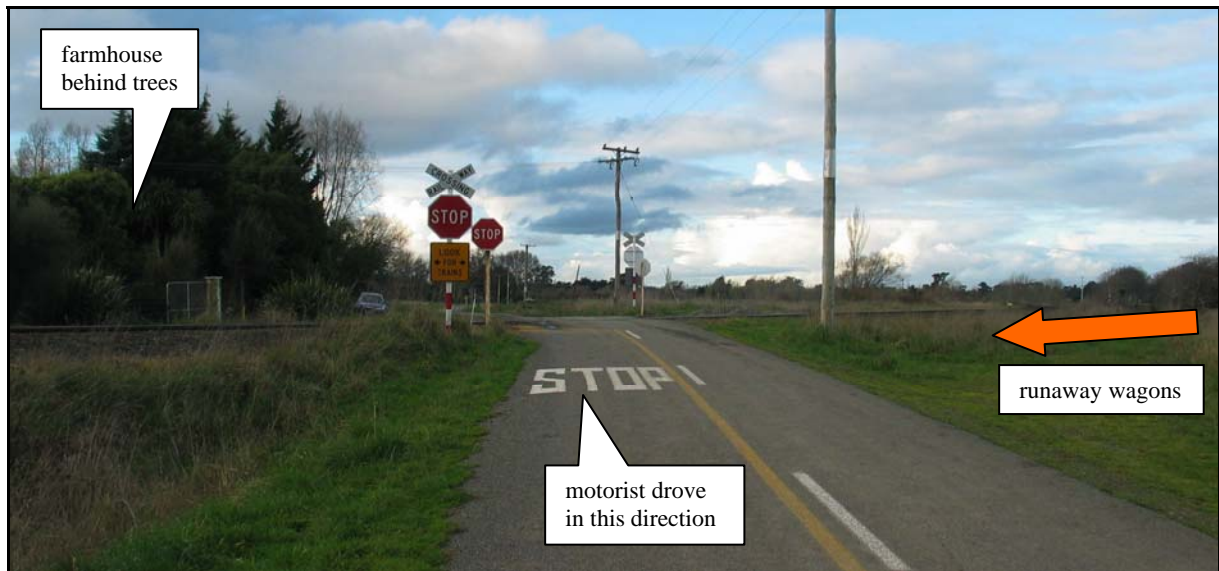
Figure 2
Hodders Road level crossing looking northwest

- 2.32 Hodders Road level crossing carried only light road traffic volumes and this, combined with the relatively light rail traffic volumes, meant that the level crossing did not meet the criteria for the installation of automatic warning devices. The signage that was installed was in good condition, clearly visible and together with view lines, met the required standard.

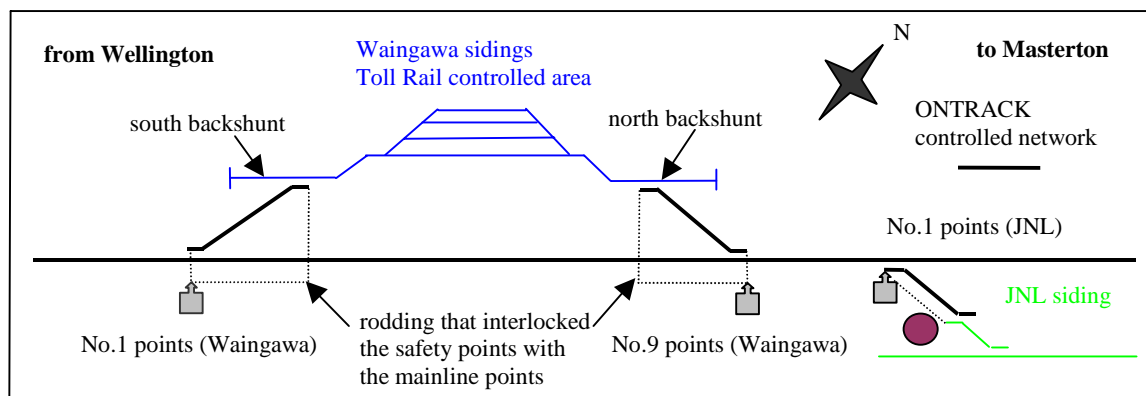
Figure 4
Interlocking arrangements at Waingawa and JNL siding (not to scale)

- 1.2.3 When Waingawa was opened, shunting was carried out with wagons separated from the locomotive's air brake system. This nationally established practice was known as loose shunting and mostly occurred on tracks where trains were made up and broken up. Occasionally, uncontrolled movements occurred during shunting operations. To prevent such movements from entering the main line, safety points interlocked with the main line points were routinely installed, such as at Waingawa. When in the normal position, the safety points would route the uncontrolled movement to backshunts where it would be stopped by obstructions placed at the end of the tracks (see Figure 4).

- 1.2.4 Beyond yards and sidings, the criterion for installing safety points on the main line was mostly limited to junction stations and other specific locations to provide operational flexibility. The rail industry in New Zealand decided at an early stage in its development to operate main line trains with a continuous air brake system. When such trains were required to shunt from the main line at specific locations, then the shunt was performed with the air pressure being retained, supported by the application of handbrakes. At these locations, safety points were not installed.

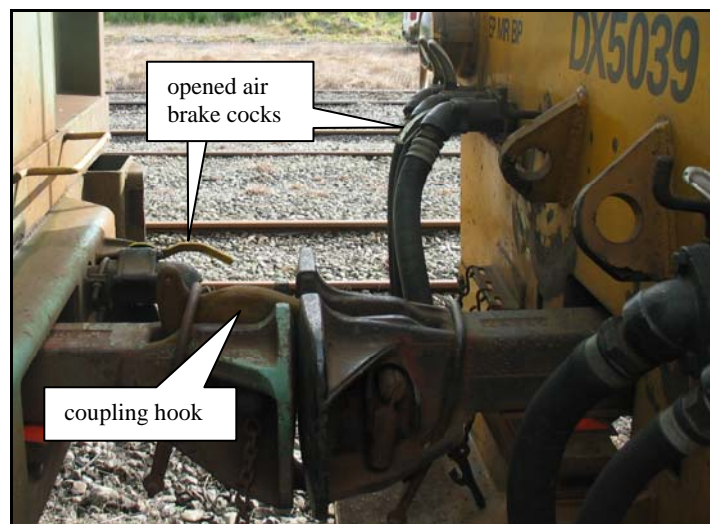
Figure 6
Coupling between DX 5039 and lead wagon

1.4.15 LE 2 said that before he alighted at Waingawa, he extracted the portable radio from its cradle and tested it with LE 1. He also obtained LE 1's track warrant key to use in conjunction with his own key to facilitate the simultaneous opening of the points at Waingawa and JNL siding. LE 2 said that he alighted from the locomotive as the train was slowing to a stop and went straight to the couplings between DX 5039 and the lead wagon.

- 1.4.16 LE 2 said that he closed the brake cocks on the locomotive and wagon simultaneously, then lifted the coupling hook as the train was “solid and the brakes were applied” (see Figure 6). LE 2 also said that he did not need an ease up⁶ to uncouple the train. He then radioed LE 1 to move the locomotives ahead while he walked alongside.

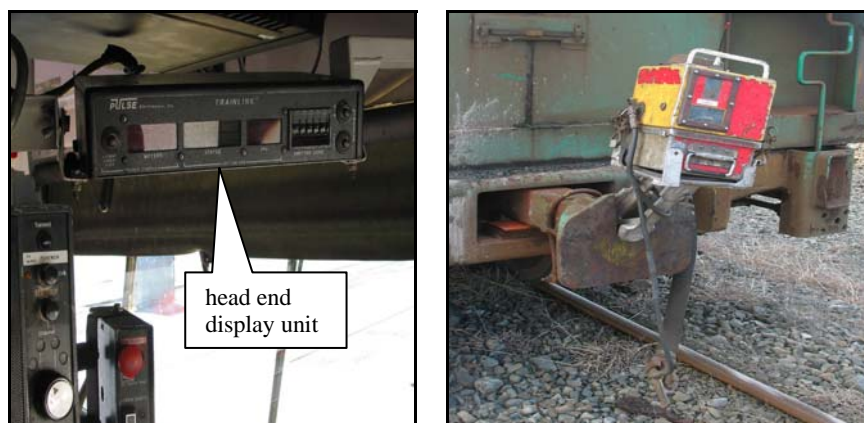
Figure 8
Head end display unit left, and TEM right

- 1.5.19 The red light on the TEM was flashing when track staff arrived on site at about 0630 but stopped flashing, as designed, at sunrise. The TEM was slightly damaged, but still functioning when examined on site at 0900 by a service manager from Alstom.

- 2.31 After the wagons had run away from Waingawa, it was not clear what caused the brakes to apply and bring the wagons to a stop at 70.50 km. When the collision occurred at Hodders Road level crossing, the TEM was slightly damaged. The air brake connection to the TEM could have been stretched or sprung, which could have then resulted in a sharp drop in air pressure, consequently triggering at least a partial brake application and causing the wagons to come to a stop gradually, assisted by the uphill gradient beyond Hodders Road level crossing. As the 10 kPa per minute air leaks on the wagon were insufficient to apply the brakes, and based on the visible damage to the TEM, this scenario probably best described what occurred. After the wagons had come to a stop, air would have continued to leak at a rate of about 10 kPa per minute from the wagons. Because no handbrakes had been applied, when all air pressure had bled away, potentially the wagons could have run back downhill to the level track in the vicinity towards Hodders Road level crossing. However, by the time staff arrived on the scene, some braking was still applied.

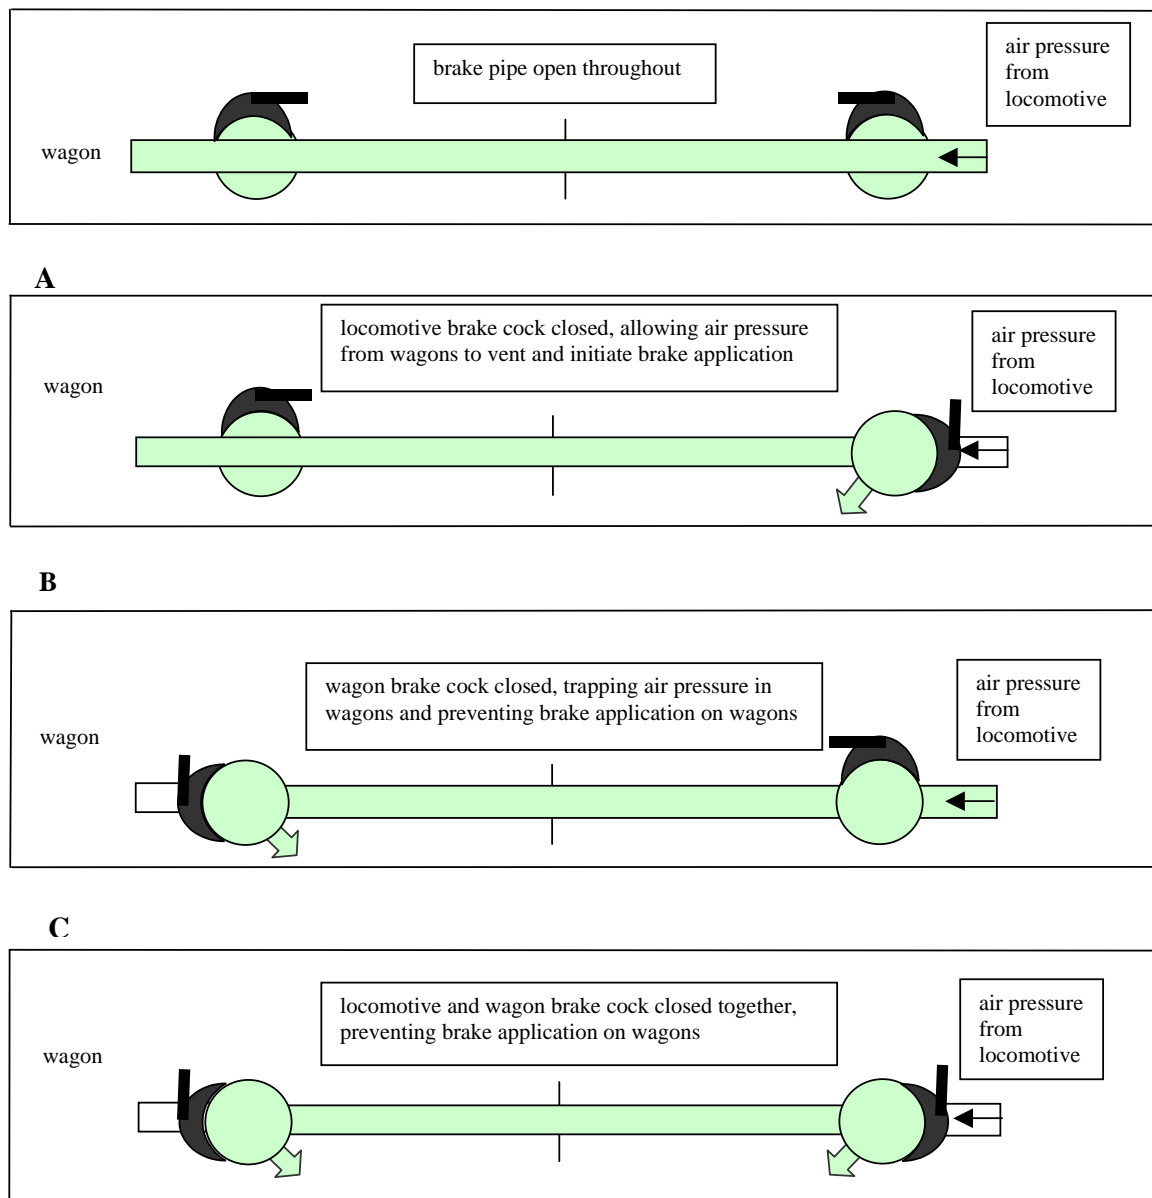
Figure 12
Schematic sequential air braking actions

- Test 4: The final test was to determine the effects of different sequential closings of the brake cocks between DX 5039 and the lead wagon, the same place where LE 2 had separated the wagons from the locomotives. This involved the brake pipe pressure being fully charged at 550 kPa but with no brake application in the locomotive cab. The results were:

Action	Result
A	close locomotive cock first, then wagon cock	after 6 seconds brakes applied on all wagons
B	close wagon cock first, then locomotive	no brakes applied
C	close both cocks simultaneously	no brakes applied
