## RAILWAY OCCURRENCE REPORT

05-120      Report 05-120, express freight Train 142, runaway wagons,      1 September 2005  
Mercer

**Report 05-120**  
**express freight Train 142**  
**runaway wagons**  
**Mercer**  
**1 September 2005**

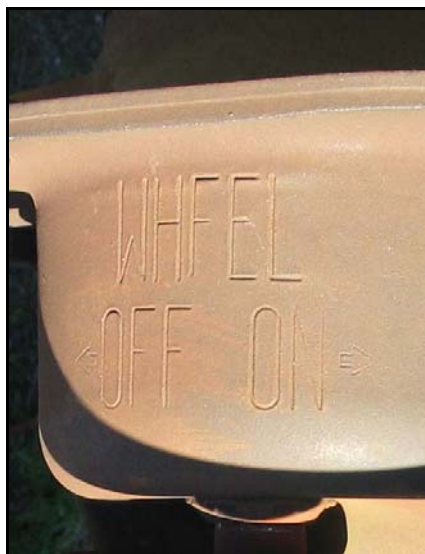
**Figure 5**  
**Inscription on AAR handbrake**

- 1.4.9 The TXO said that he had to look under the wagons to see whether the thread of the worm drive was applying or releasing the brakes. When he had established that turning the wheel anticlockwise released the brakes, he went along and turned each handbrake wheel until it could not move any more. There were no markings on the EWR wagons to show on [applied] or off [released] as opposed to the AAR handbrake on the coal wagons, which had this feature (see Figure 5).

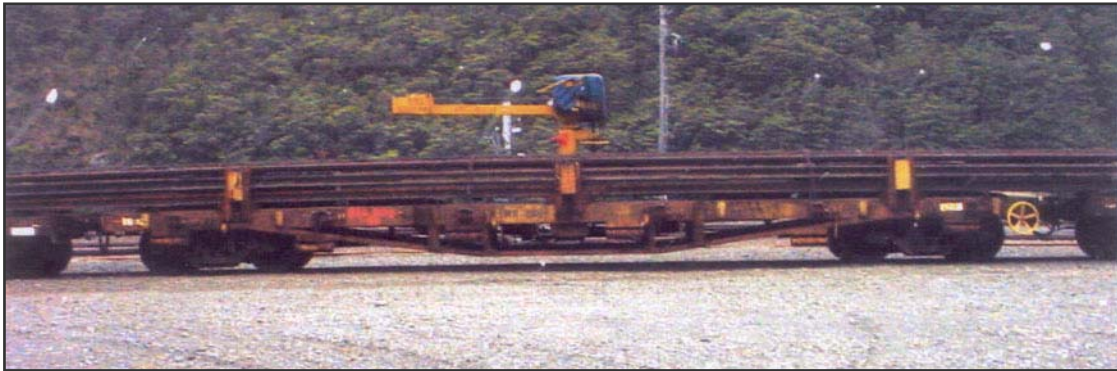
**Figure 7**  
**An EWR wagon**  
(courtesy of ONTRACK)

- 1.9.3 A post-incident on-site examination of the 6 EWR wagons found that the air brake was cut out on EWR 171. This meant that although air pressure was being supplied through the wagon, a cut-out valve had been applied to prevent air entering the wagon's triple valve to activate the brakes. This action was generally taken to allow a wagon with defective air brakes to remain in a train consist until it could be scheduled for repair.

- 1.9.4 It was later established that EWR 293 also had its brakes cut out, but the TXO had reinstated the air brakes on this wagon during subsequent shunting movements after the incident.

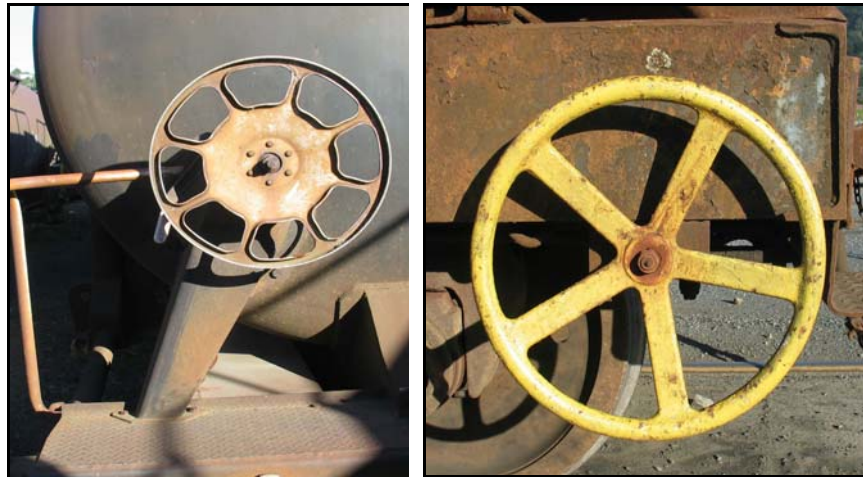
**Figure 8**  
**The 2 wheel-type handbrakes**

1.12.3 The old wheel-type handbrake was fitted to a small number of service wagons such as the EWR and other classes owned by ONTRACK, and to some of Toll Rail's log wagon fleet operating in the Bay of Plenty. Braking force was applied by turning the wheel clockwise about 10 to 15 revolutions. The handbrake mechanism was located out of sight behind the wagon side frame. Release was achieved by turning the wheel anticlockwise (see right-hand picture in Figure 8). The TXO had not operated this type of handbrake previously.

- 2.7 Having agreed to do the shunt, the TXO was then confronted with the old wheel-type handbrake on the EWR wagons, with which he was unfamiliar. If the Amicus system had been accessed and enquiries made, it would have been seen there was no warning regarding the braking condition of EWR 171 and EWR 293 because they were not bad ordered. It was not known if the TXO saw the position of the brake cut-out cocks on the 2 wagons during his pre-shunt inspection and it was also not known if either wagon had been visually identified to show that its brakes had been cut out.
