RAILWAY OCCURRENCE REPORT

05-121

express freight Train 354, near collision with school bus,
Caverhill Road level crossing, Awakaponga

2 September 2005

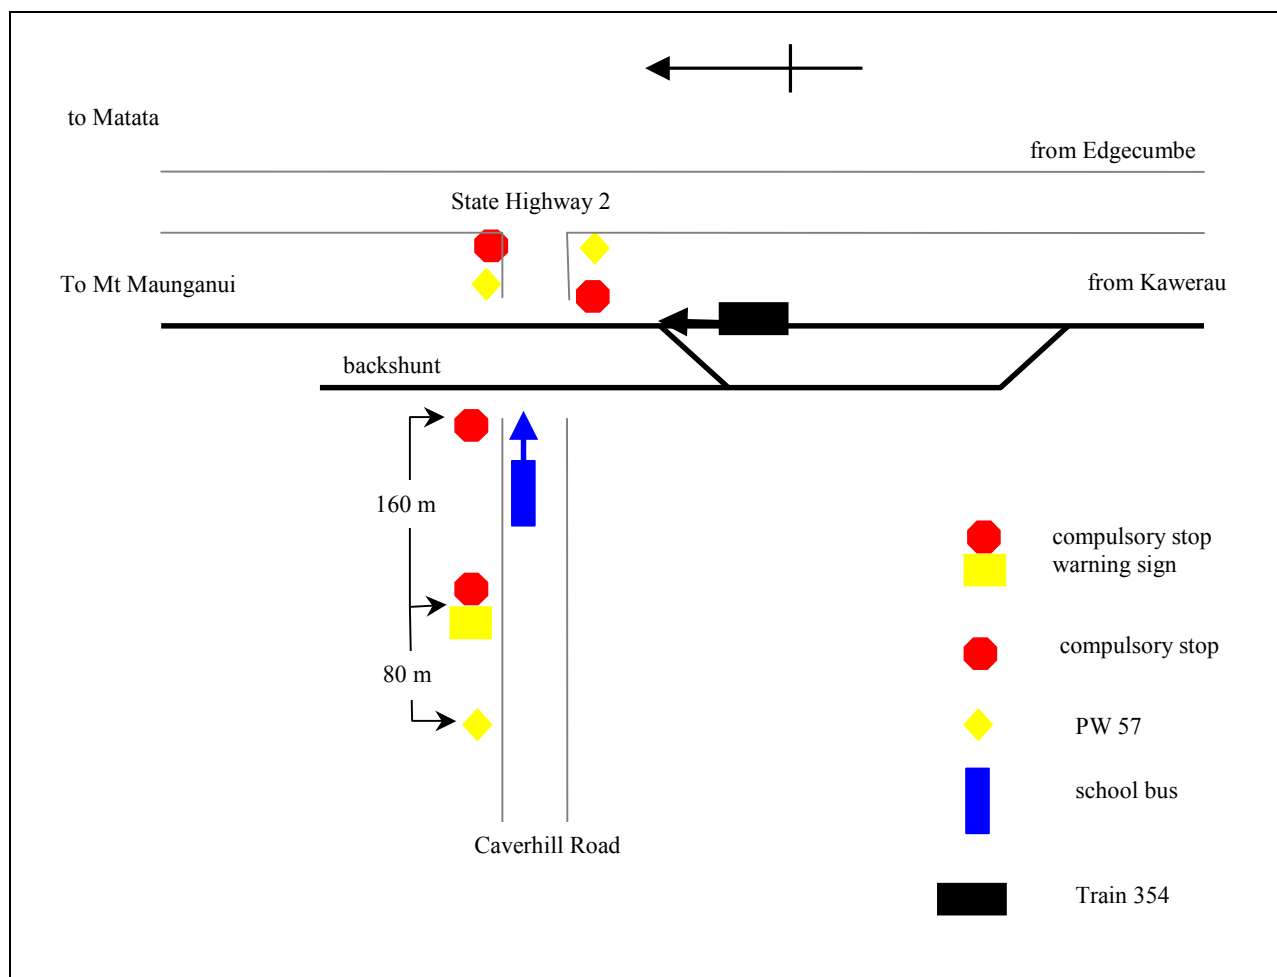
Figure 1
Site diagram of Caverhill Road level crossing (not to scale)

1.2.1 Caverhill Road level crossing was located at 165.300 km on the East Coast Main Trunk and crossed 2 tracks, the main line and a backshunt, or loop extension (see Figure 1). The backshunt was not used, except for the occasional stabling of mobile track maintenance vehicles (MTMV) when working in the area.

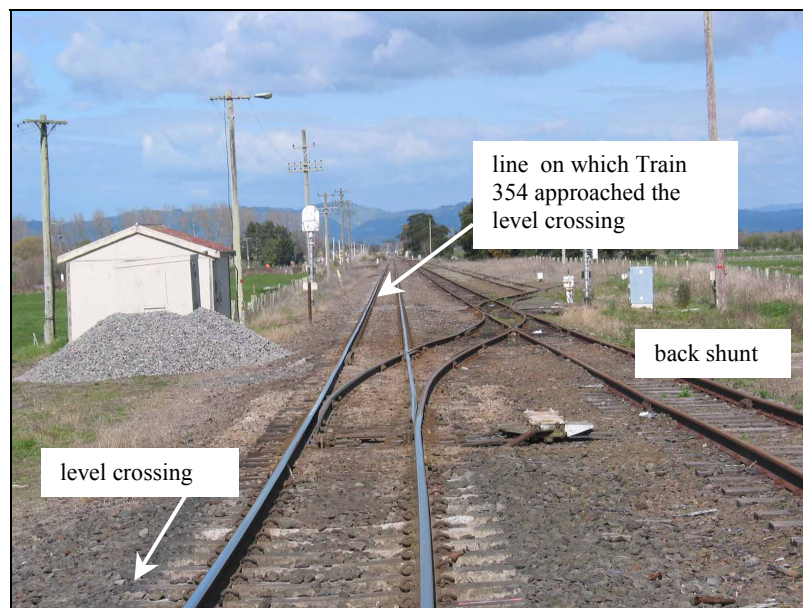
Figure 2
Looking south from the level crossing

- 1.2.4 The level crossing offered excellent visibility for locomotive engineers approaching from Kawerau (south) as the line approached the crossing on a straight of at least 1200 m. (see Figure 2).

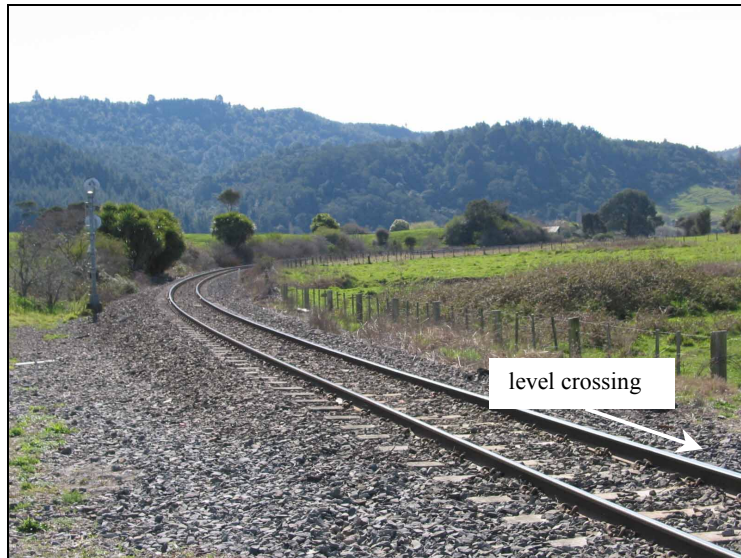
Figure 3
Looking north from the level crossing

- 1.2.5 The line approached the crossing from the north around a 420 m radius left-hand curve (see Figure 3). Because a locomotive engineer sat on the right-hand side of the locomotive in the direction of travel his view line of the level crossing was reduced.

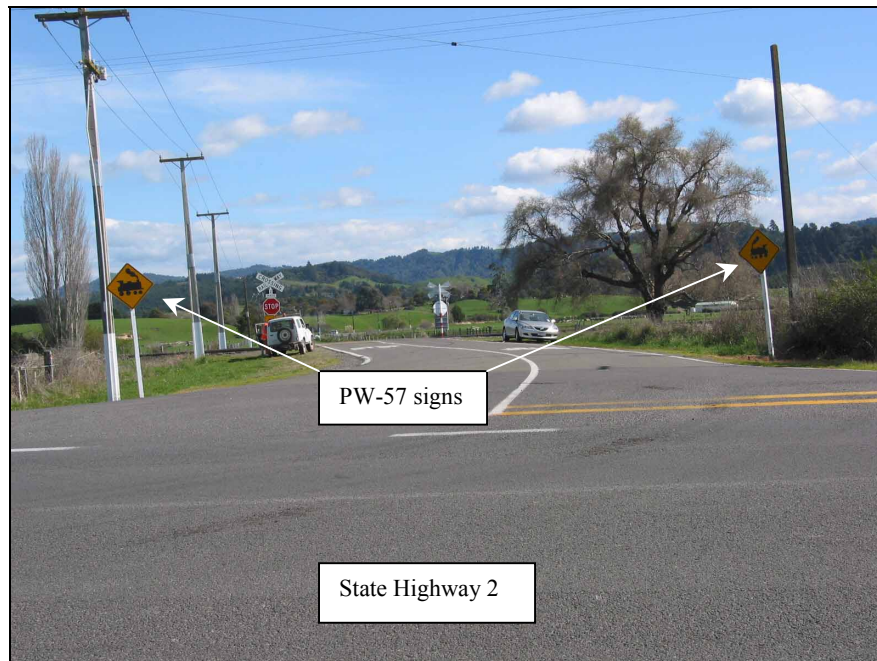
Figure 4
Looking west to the Caverhill Road intersection with State Highway 2

- 1.2.6 A vehicle count, taken several days after the incident, showed that between 0730 and 0800, 36 motor vehicles, including cars, heavy trucks and buses, used the crossing. Of that number, 20 vehicles, or 55%, had stopped at the compulsory stops on either side of the crossing. Of those that didn't stop, some reduced speed as they approached the crossing, but the majority continued across without slowing down.
- 1.2.7 On the eastern side of the railway, Caverhill Road connected to State Highway 2 by means of an intersection controlled by a compulsory stop. The intersection was about 50 m beyond the crossing (see Figure 4). The same traffic count showed that of those vehicles that did not stop at the compulsory stop at the western side of the level crossing, a significant number also did not stop at the compulsory stop before entering State Highway 2.

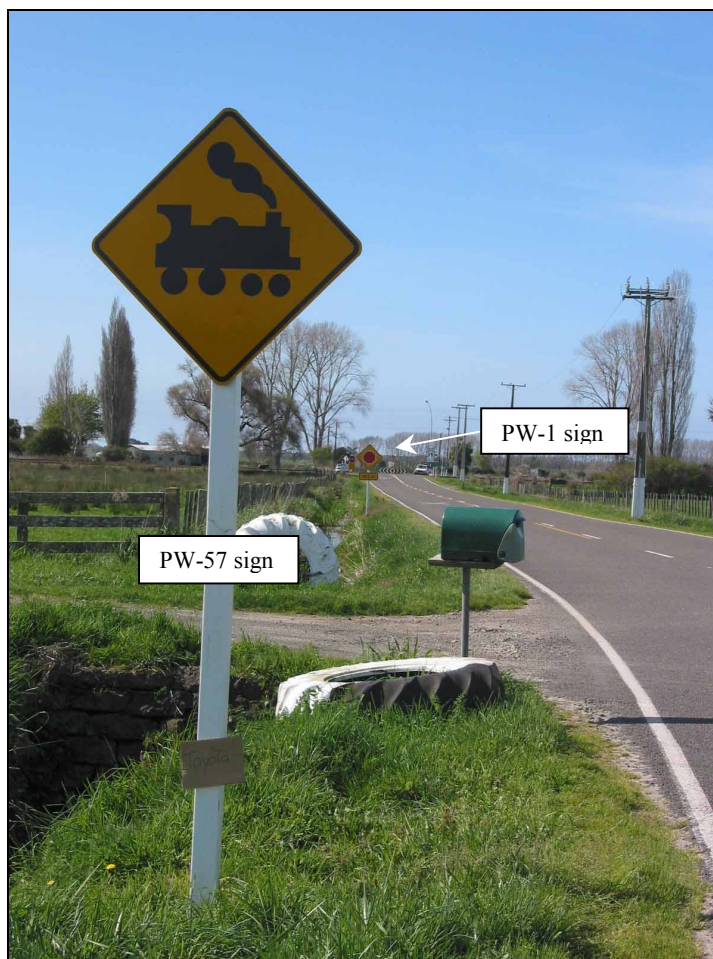
Figure 5
The PW-57 and PW-1 signs on the western approach to the crossing

- 1.2.8 A PW-57 sign warning motorists of the level crossing was located about 240 m from the level crossing on the western side. This was in accordance with the “Manual of Traffic Signs and Markings”² (the manual), which specified that such signs should be located on the left-hand side of the road at least 60 m from the crossing. The PW-57 signs on the eastern side were about 50 m from the crossing, but physical constraints prevented them being positioned further away. Figure 4 shows the positions of the PW-57 signs on the eastern side of the crossing, and Figure 5 shows the PW-57 sign on the western side.

- 1.2.9 A PW-1 sign, warning motorists of the impending compulsory stop, was positioned 160 m from the level crossing on the western side of the crossing (see Figure 5). PW-1 signs were erected in advance of an RG-32 Railway Level Crossing Stop sign combination³ (see Figure 6) where the sign was not clearly visible to approaching drivers over a distance of at least 120 m in a rural area. There was no PW-1 sign on the eastern side because of physical constraints. The manual required that in areas with 100 km/h speed restrictions such signs should be positioned 160 m before the RG-32 sign.

- 2.2 The road signage and markings that were in place, both approaching and at the level crossing, were clearly visible and in good condition and met the signage guidelines in the manual, except for the absence of PW-13 signs on State Highway 2 and the closeness of the PW-57 signs on the eastern side. However, the main defences, namely the RG-32 Railway Level Crossing Stop sign combinations on either side of the crossing, together with the advance warning signs, met the guidelines and the absence of the PW-13 signs did not contribute to the incident. The bus had approached from the western side of the level crossing anyway.

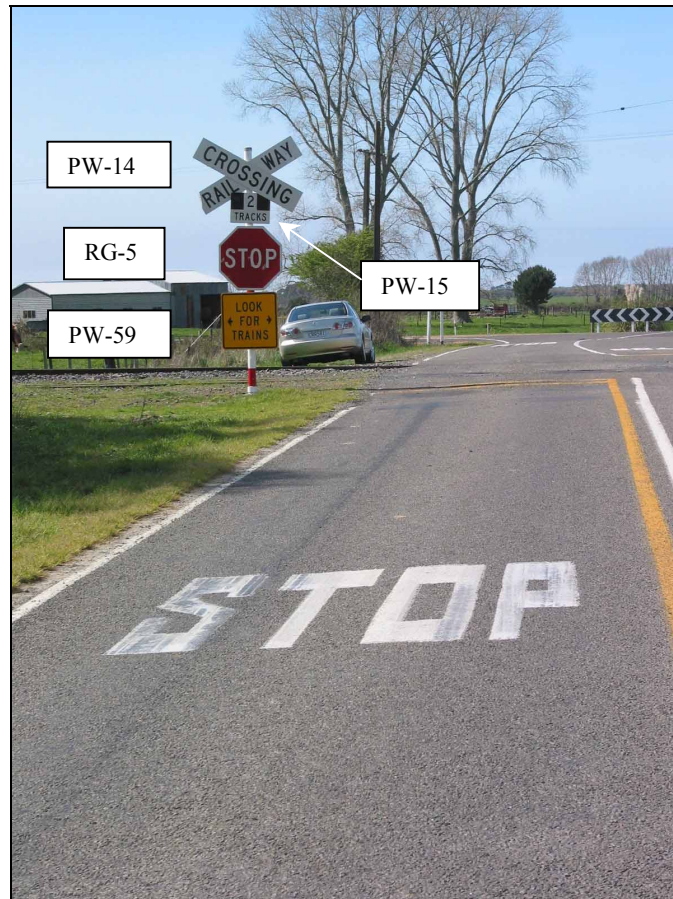
Figure 6
The RG-32 Railway Level Crossing Stop sign combination

1.2.10 RG-32 signs were positioned on both sides of the level crossing in accordance with the manual.

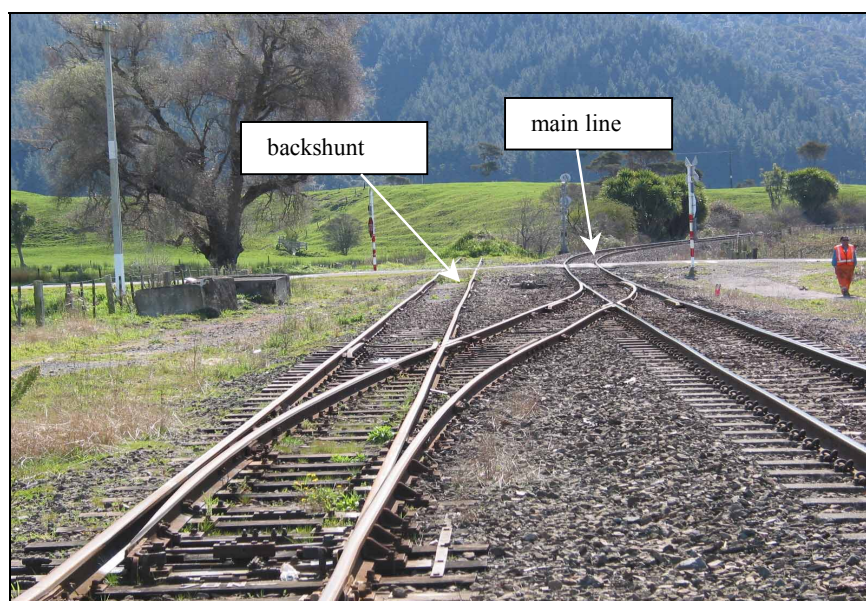
Figure 7
Looking north of the level crossing

- 1.4.22 Witness 3 also expressed concerns about the practice of stabling MTMVs on the back shunt at the level crossing as this significantly reduced visibility to the north for motor vehicles stopped at the compulsory stop at the level crossing. while moving towards State Highway 2. This was because the track curved away behind the stabled vehicles and motorists had to edge on to the crossing to be able to see around the vehicles to see if a train was approaching from that direction (see Figure 7).

- 2.8 Although not a contributing factor to this incident, the stabling of MTMVs on the backshunt at the north end of the Awakaponga crossing loop was raised during the investigation. This only happens when work is being undertaken in the area, but the presence of these, or any rail vehicles stored on the backshunt, restricts the north view for motorists on the western side of the crossing. Motorists were then forced to edge out onto the crossing to be able to see around the vehicles when looking for trains approaching from that direction. Any degradation in lines of sight at level crossings is viewed with concern and a safety recommendation covering this issue is made to the Chief Executive of ONTRACK.

ensure that the northern view lines from the western side of Caverhill Road level crossing for traffic heading east are preserved by prohibiting the storage of rail vehicles on the backshunt at the north end of the crossing loop at Awakaponga (107/05).
