05-123

empty passenger Train 4356, overrun of conditional stop board without authority, following an automatic air brake valve irregularity, Meadowbank

6 October 2005

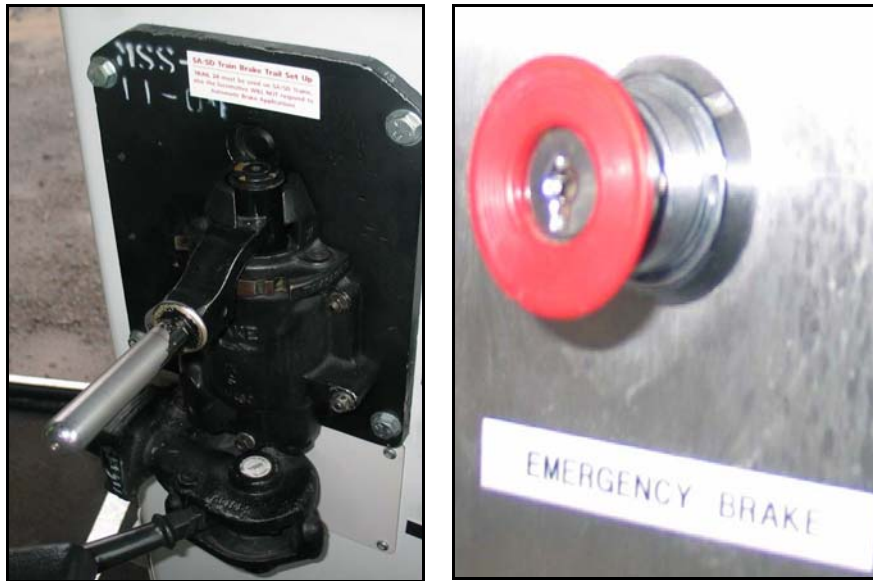
Figure 2
Air brake controls in the driving cab of SD5811

- 1.1.6 Shortly afterwards, and in preparation to stop the train at the conditional stop board, the locomotive engineer motioned the auto brake valve handle to the service position, but it would not move. He then repeatedly attempted to move the handle in a series of punches with the open palm of his hand. While in the cab, the train manager saw the locomotive engineer forcibly “bang” the handle a few times.

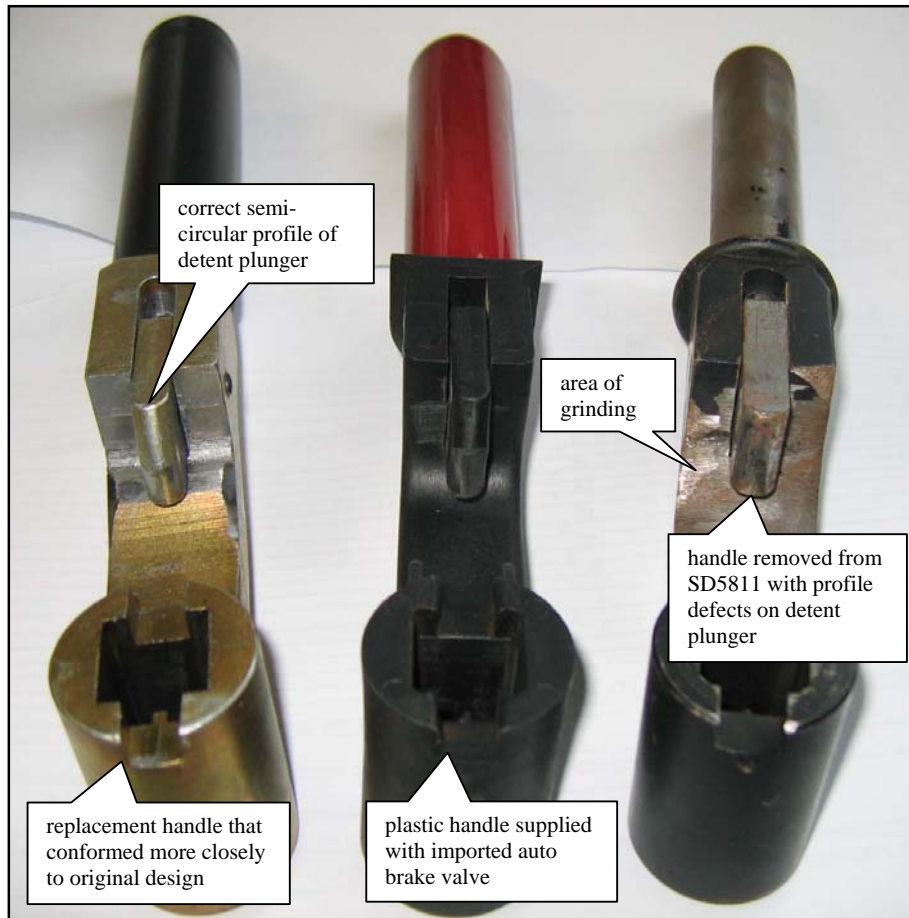
Figure 8
Brake handles (end view)

1.7.3 The front of the auto brake valve was removed and, with the original handle still attached, the main spindle, cams and shuttle valves were seen to move freely throughout their full range with no signs of interference between any of the moving parts. The front cover was replaced and the auto brake valve underwent a full automatic brake code test, again with the original handle, but the fault could not be replicated. There were some signs of wear on the detent plunger of the brake handle (see Figure 8).

- 1.7.4 It was noticed that the profile of the detent plunger was out of phase with the detents on the quadrant and there were a few worn/flat spots on the head of the plunger. Instead of being of semi-circular profile, it was irregular in shape and had a non-conforming radius on one side, making the plunger jam rather than ride over the quadrant as it was designed to.
