## RAILWAY OCCURRENCE REPORT

05-125

Taieri Gorge Railway passenger Train 1910, train parting,  
Dunedin

28 October 2005

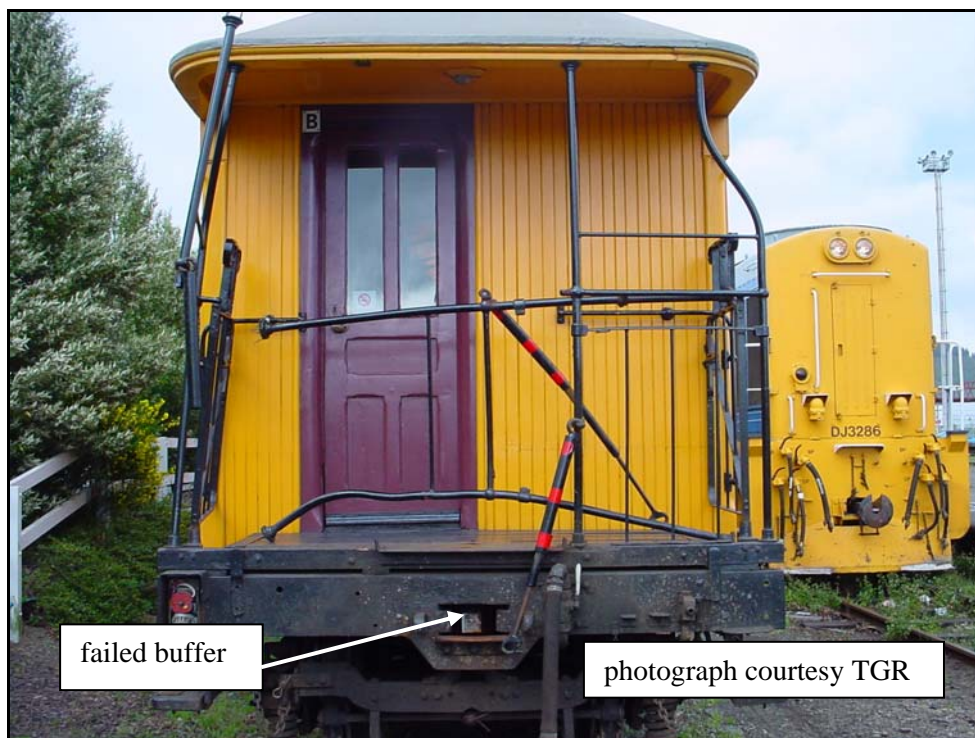
**Figure 1**  
**Passenger car XPC412**

- 1.1.4 The guard inspected the train, then radioed the locomotive engineer to inform him that the train had parted between the first and second passenger cars, because of a broken buffer (see Figure 1). The 2 sections of the train were about 40 m apart.

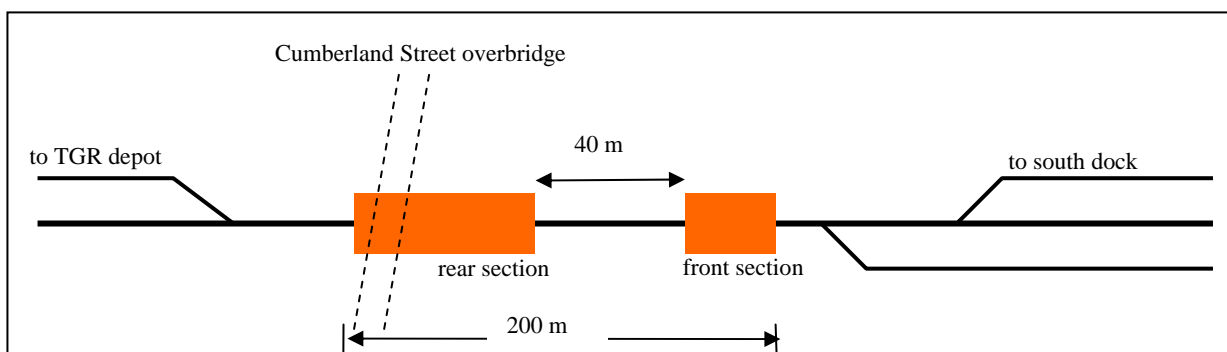
**Figure 3**  
**Site plan showing where Train 1910 stopped (not to scale)**

- 1.3.1 Train 1910 parted when the locomotive was at about 379.5 km on the MSL. The brakes applied automatically and the locomotive stopped, with the lead passenger car still attached, at about 379.1 km MSL. The rear of the train stopped under the Cumberland Street road-over-rail bridge, about 200 m further back (see Figure 3).

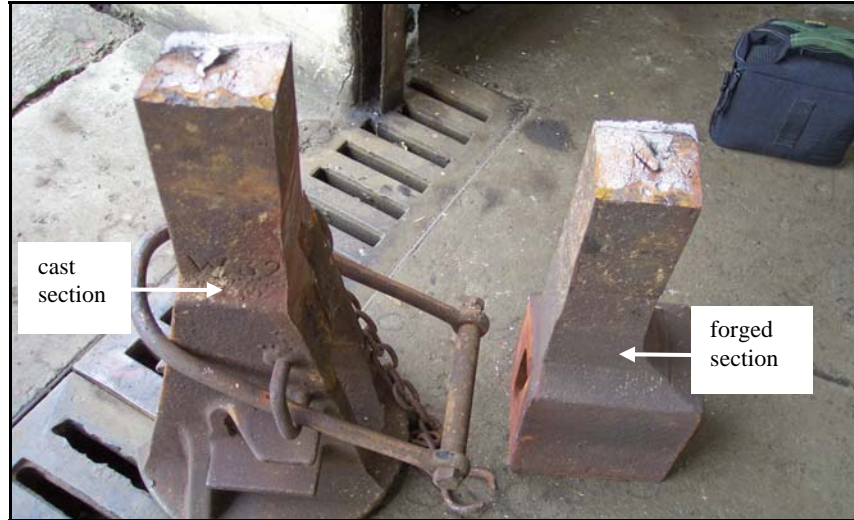
**Figure 4**  
**Fractured buffer**

- 1.8.1 The buffer was manufactured by flash butt welding a cast section and a forged section (see Figure 4). The age of the buffer was not known. However, the supplier of the buffers confirmed that the process of butt welding the cast and forged sections had ceased more than 30 years ago. Currently, all new buffers are fully cast, thus eliminating the need to butt weld a cast section to a forged section.

- 2.1 The buffer failed due to fatigue followed by tensile failure. The fatigue crack, which originated at the root of a weld deposit, followed the fusion zone through the section until there was no longer enough sectional strength remaining to sustain the stress, resulting in a catastrophic failure.

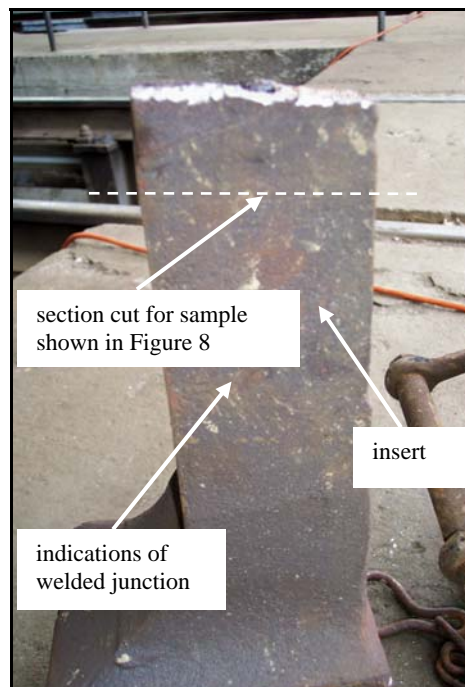
**Figure 5**  
**Forged end of buffer**

- 1.8.3 The forged end of the buffer had a 100 mm long section inserted to achieve the required buffer length (see Figure 5).

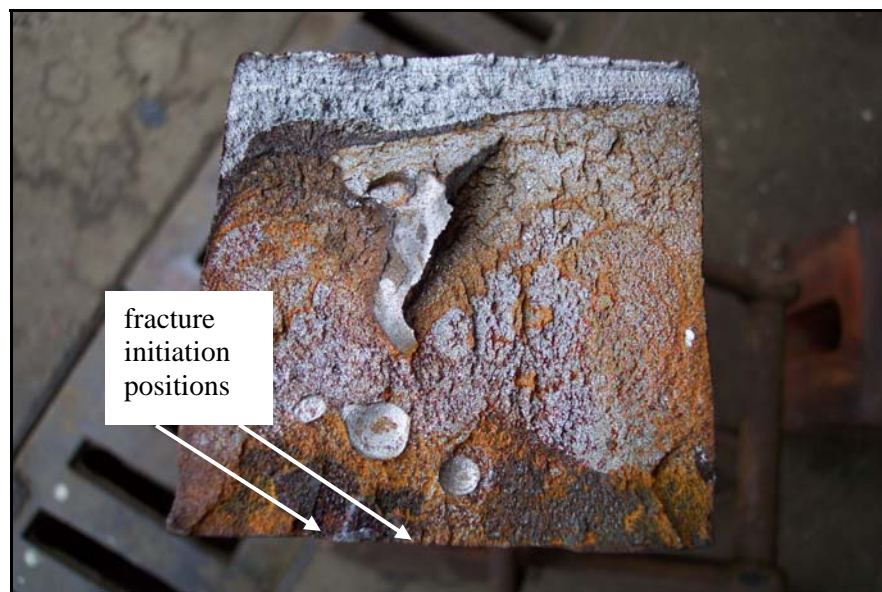
**Figure 7**  
**Fracture face of cast section**

1.8.4 The fracture initiation positions are marked in Figure 7.

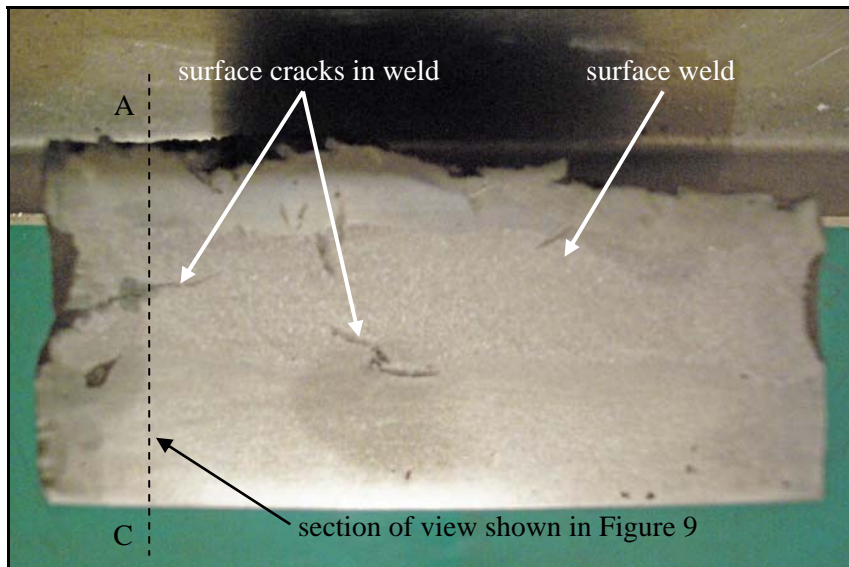
**Figure 8**  
**Surface macro of forged end**

1.8.5 Samples were cut from the fractured end to determine the material types from which the cast section, forged section and insert were made. The surface of the forged end was fine ground and etched to reveal the position of the flash butt weld and the fusion zone. This macro-etched surface revealed what appeared to be a surface weld over the junction of the flash butt weld shown in Figure 8.

1.8.7 The surface weld, shown in Figure 8, contained some cracks. One such crack originated at the edge where there was an undercut, resulting in a small void in the weld deposit. This crack had propagated from the root of the weld deposit and followed the fusion zone for about 15 mm (see Figure 9).

- 2.2 The initial flash butt weld had large areas of no or poor fusion and the surface weld deposit may have been an attempt to repair the initial lack of fusion.

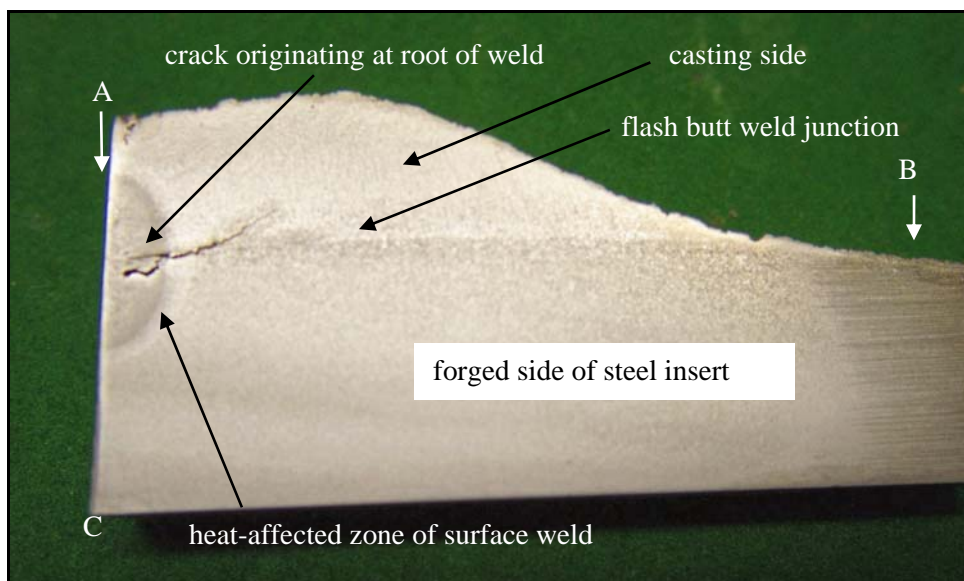
**Figure 9**  
**Micro of the section through the dotted line in Figure 8**

- 2.3 Surface cracks and areas of lack of fusion acted as stress concentrators, resulting in slow initial crack propagation. The rate of crack propagation would have accelerated as the effective cross-section of the buffer was reduced, with the catastrophic failure occurring when there was less than 15% of the original cross-sectional area remaining.
