RAILWAY OCCURRENCE REPORT

05-126

express freight Train 246, derailment, South Junction

30 October 2005

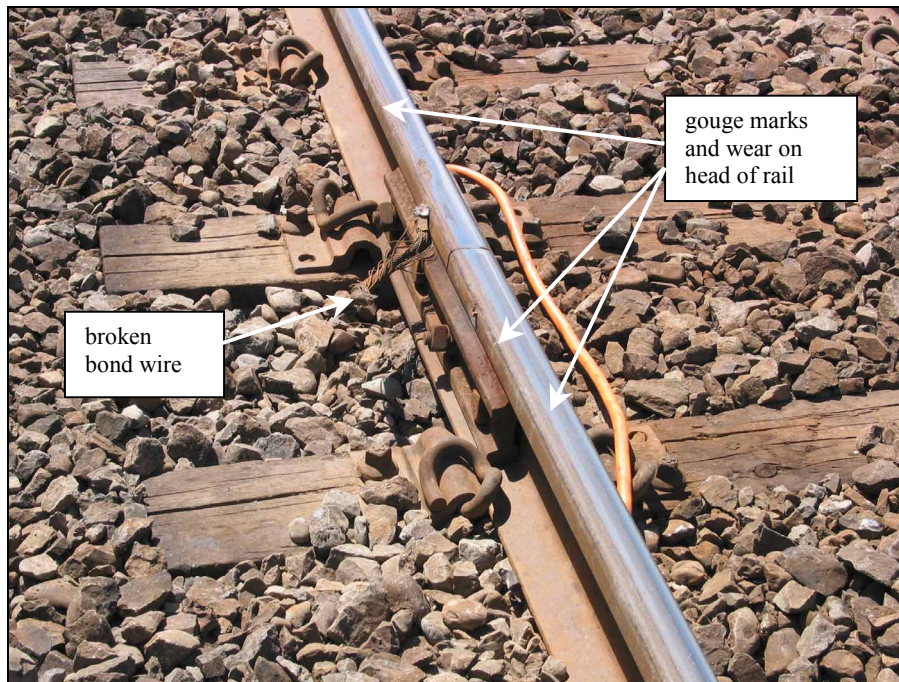
Figure 2
Broken bond wire at 28.771 km

- 1.2.5 A broken bond wire on the outside of the left-hand running rail of the Up Main line at 28.733 km, and gouge marks on the head of the rail, were the first signs of the collapsed bogie side frame contacting the head of the rail. Figure 2 shows the next broken bond wire, at 28.771 km, with gouge marks visible on the head of the rail approaching and beyond the broken bond wire.

- 2.2 The gouging on the head of the rail was probably caused by the sharp edge of the brake block shoe, which came in contact when the side frame dropped. The side frame probably broke the bond wires because it overlapped the head of the rail after the initial collapse.

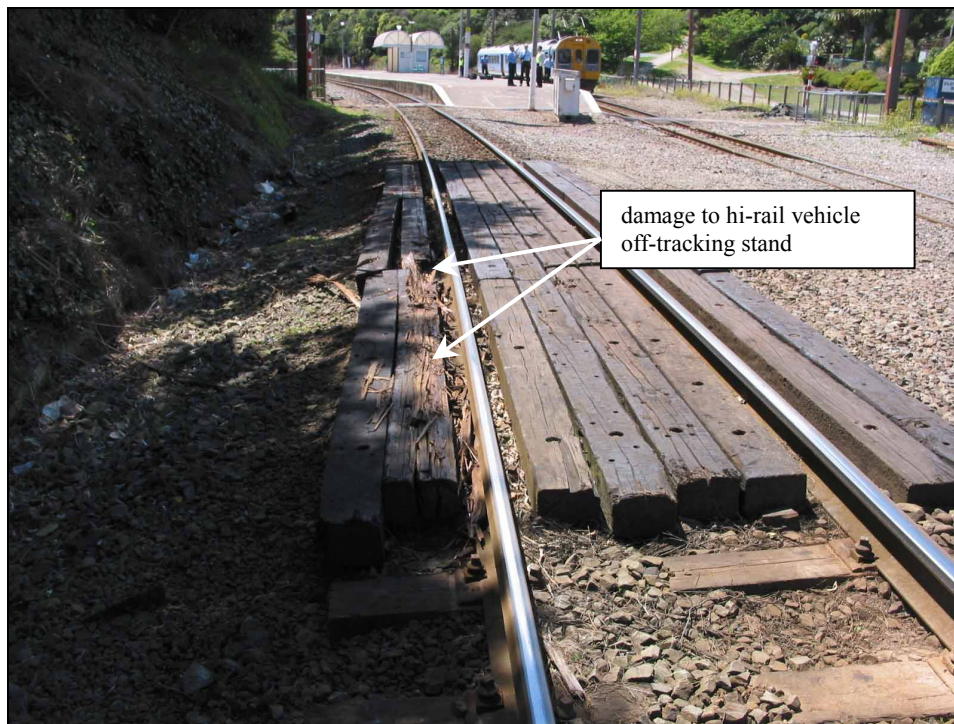
Figure 3
Hi-rail vehicle off-tracking stand at Pukerua Bay

1.2.6 A hi-rail vehicle (HRV) off-tracking stand at 30.285 km (see Figure 3) and a pedestrian level crossing at 30.300 km, both on the Up Main line at Pukerua Bay, showed evidence of strikes by the underside of the dropped bogie side frame.

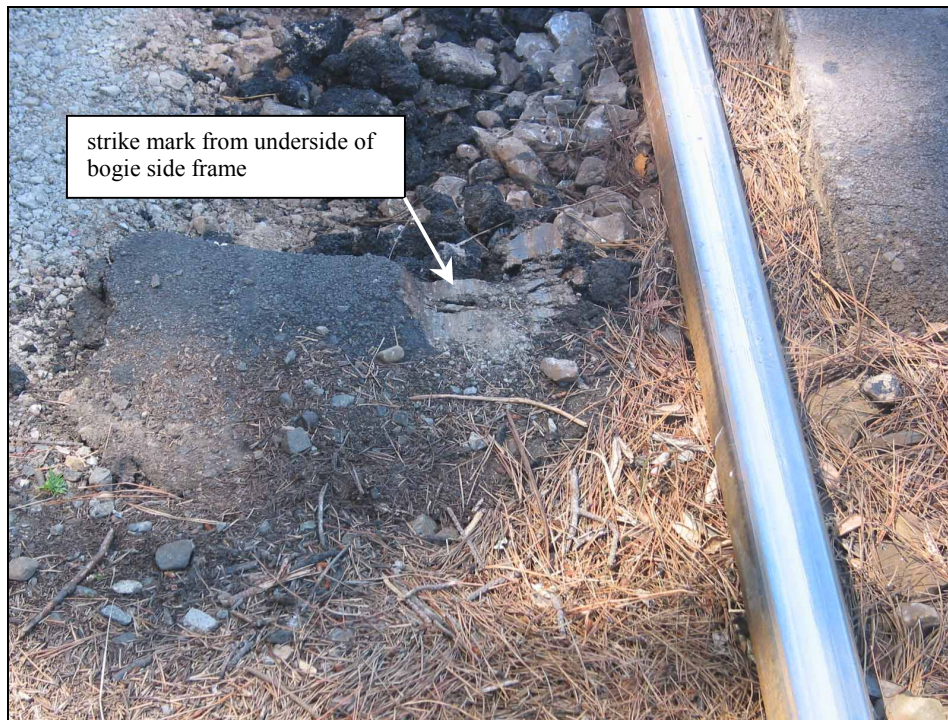
Figure 4
Pedestrian level crossing at Muri

1.2.7 The tarmac on the left-hand side of the pedestrian level crossing on the Up Main line at 31.300 km at Muri showed further evidence of a strike by the dropped bogie side frame hanging over the left running rail (see Figure 4). The width of the gouge in the seal corresponded with that of the underside of the dropped frame.

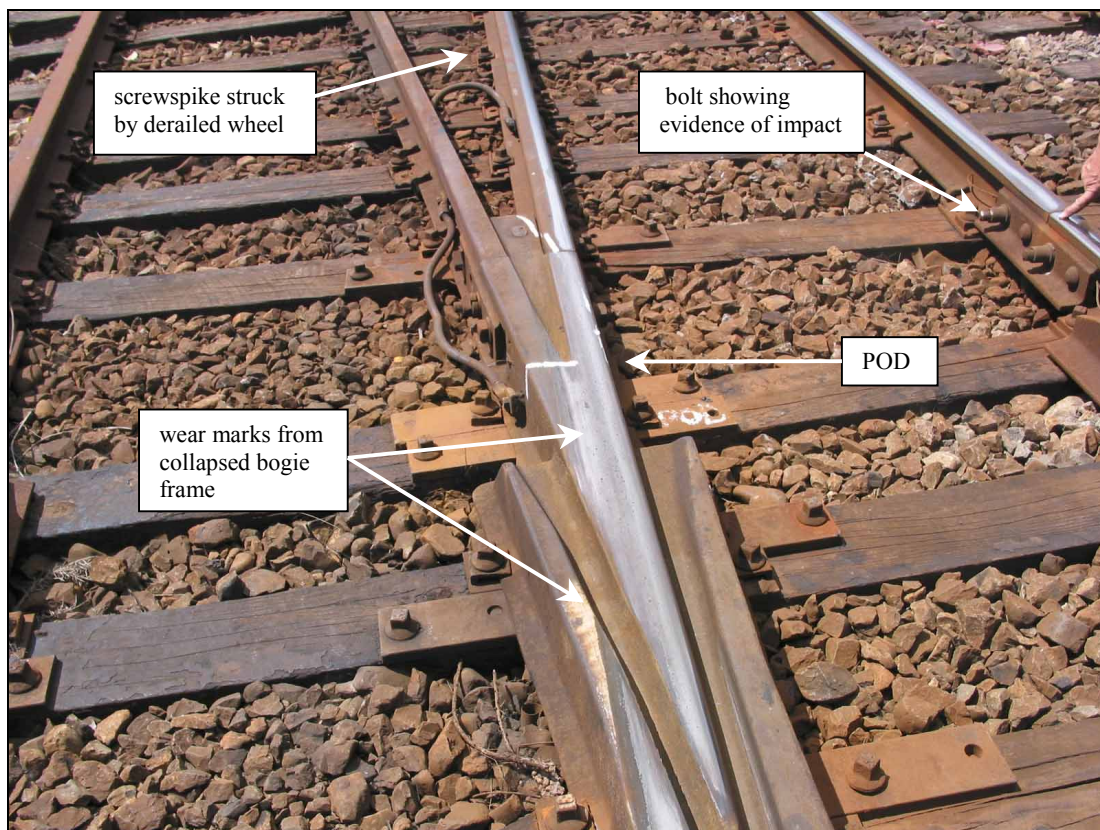
Figure 5
Point of derailment, facing points South Junction

1.2.8 The first impact mark from the derailed right-hand wheelset was on a bolt on the inside of the right-hand running rail, about 500 mm past the point of derailment (POD). The first impact mark from the derailed left-hand wheelset was on a screwspike on the outside of the left-hand running rail, about one metre beyond the POD (see Figure 5). The bearing adaptor and the broken-off portion of the side frame were found adjacent to the points.

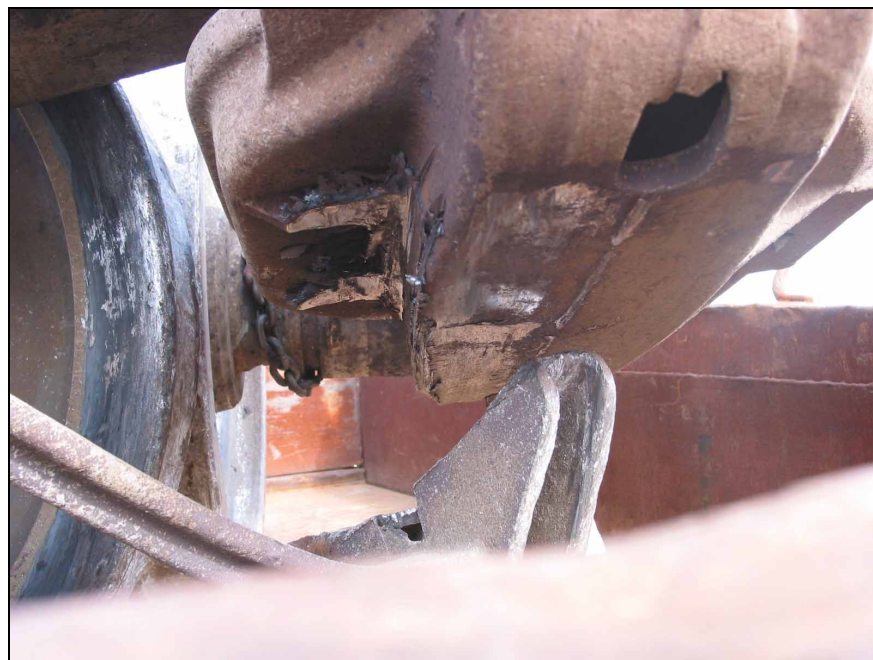
Figure 11
Worn away gussets

- 1.9.2 When the bogie side frame collapsed, it dropped until the gussets on the underside were below the head of the rail. The side frame was then overhanging the head of the rail and below rail level. Figure 10 shows an undamaged assembly, and Figure 11 shows the worn gussets and other damage to the underside of the side frame of UKR84. Figure 11 was taken from the rear of the bogie side frame; the gussets would have been outside the left-hand rail in the direction of travel, as shown in Figure 9.

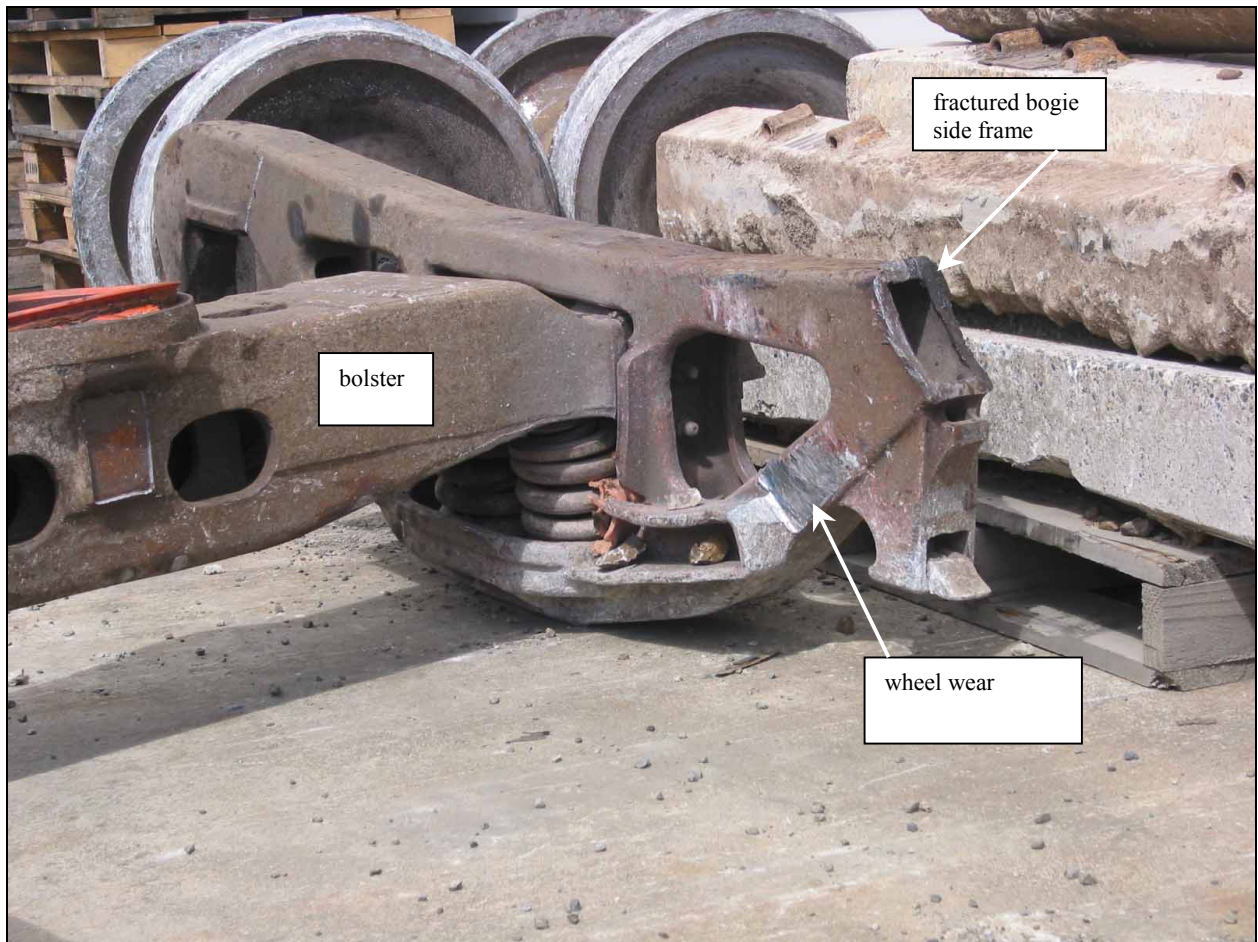
Figure 12
Failed left-hand side of the bogie side frame

- 1.10.1 The failed bogie parts were taken to the United Group Limited⁵ wagon depot in Wellington where they were examined as part of the investigation. Figure 12 shows the bogie side frame after it was recovered from the derailment site.

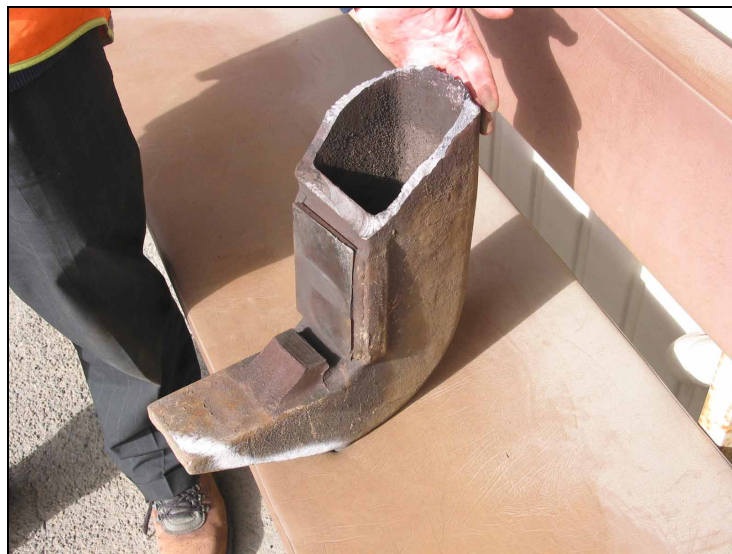
Figure 13
Fractured bogie side frame left-hand leading end

1.10.2 The fractured left-hand leading end of the bogie side frame was recovered from the POD at South Junction.

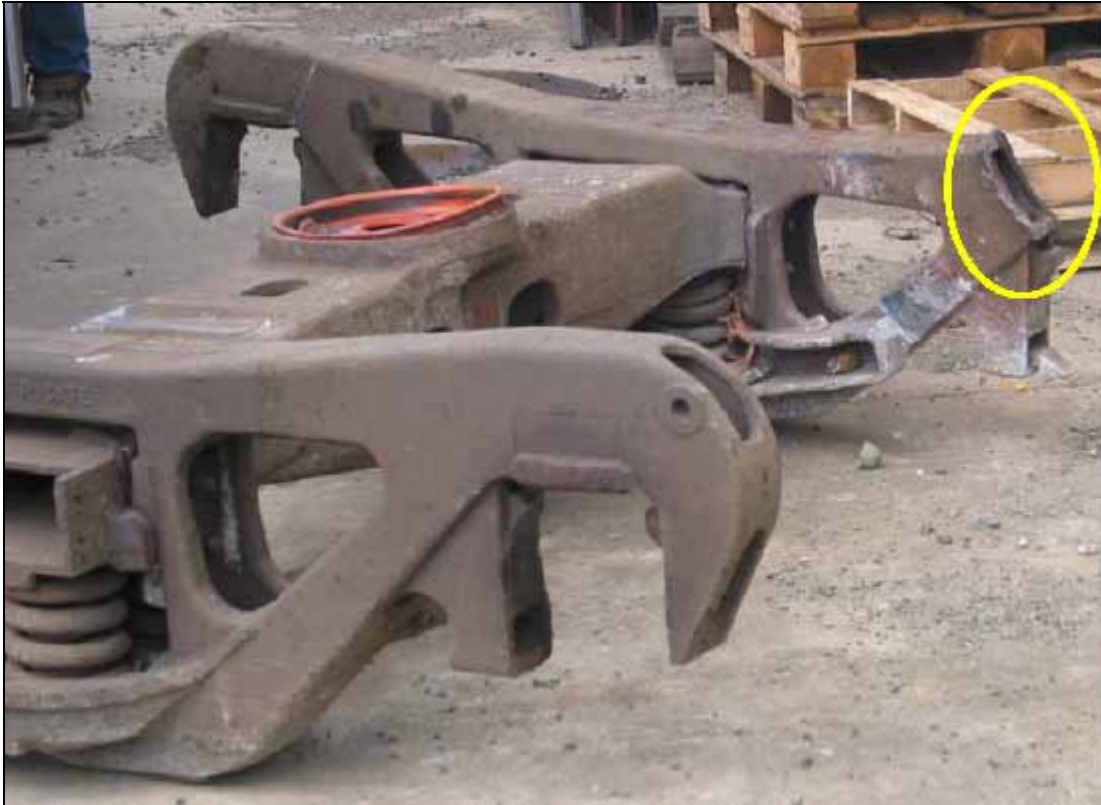
Figure 14
Failed bogie side frame

- 1.11.1 The separated portion of the front left-hand leading side of the bogie frame was taken for independent metallurgy testing and analysis. Figure 14 shows the failed bogie side frame with the fracture area circled.

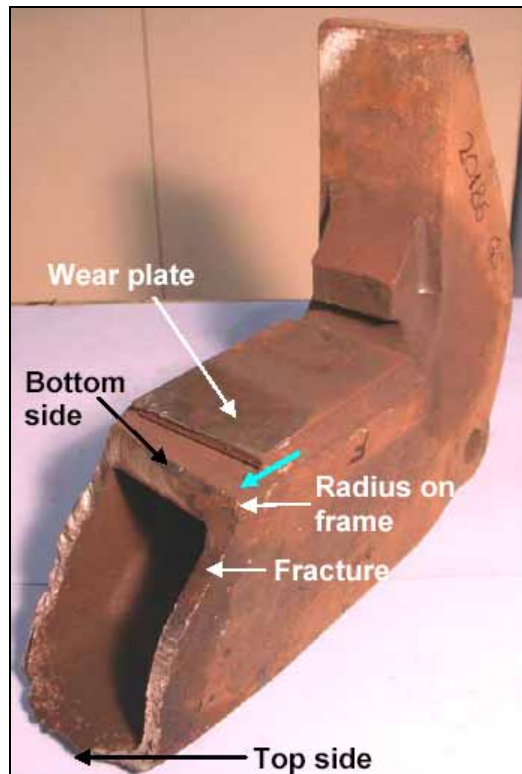
- 1.11.3 The fractured part of the bogie side frame was visually examined using a stereoscopic microscope. The side frame included a box section to which was welded a wear plate (see Figure 15). The blue arrow indicates an axial direction view of castellations in the prepared metallographic section.

Figure 15
Fractured section of bogie side frame

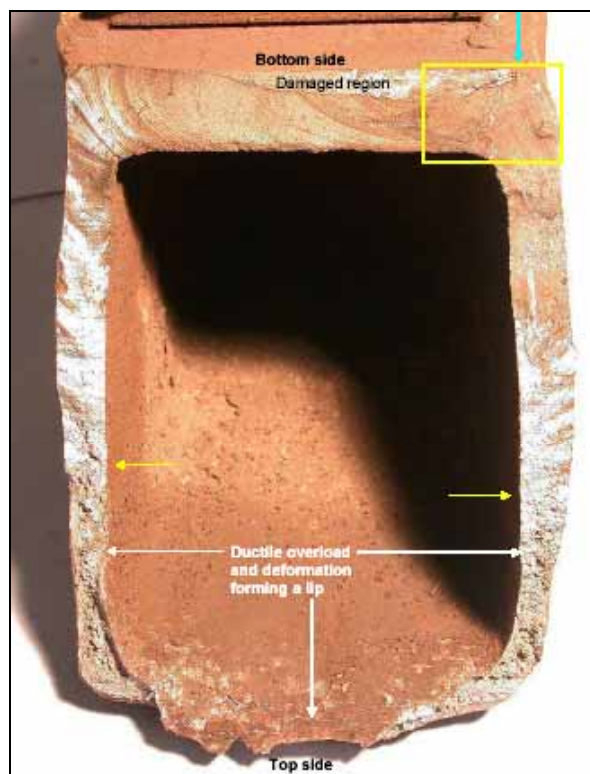
Figure 16
Box section

- 1.11.4 A fatigue fracture was present and had propagated completely through the bottom side and across about two-thirds of adjacent sides of the box section area. Ductile overload fracture was visible below the yellow arrows as was a deformation lip on the topside of the box section (see Figure 16).

- 2.8 The bogie side frame probably failed in high cycle fatigue followed by ductile overload. The presence of a relatively smooth, flat region of fracture with “arrest” marks along the bottom side of the box section indicated that the cracking had been present for some time. Each “arrest” mark indicated a significant change in the loading conditions, probably related to each time the wagon was loaded or unloaded and each time the wagon was moved.

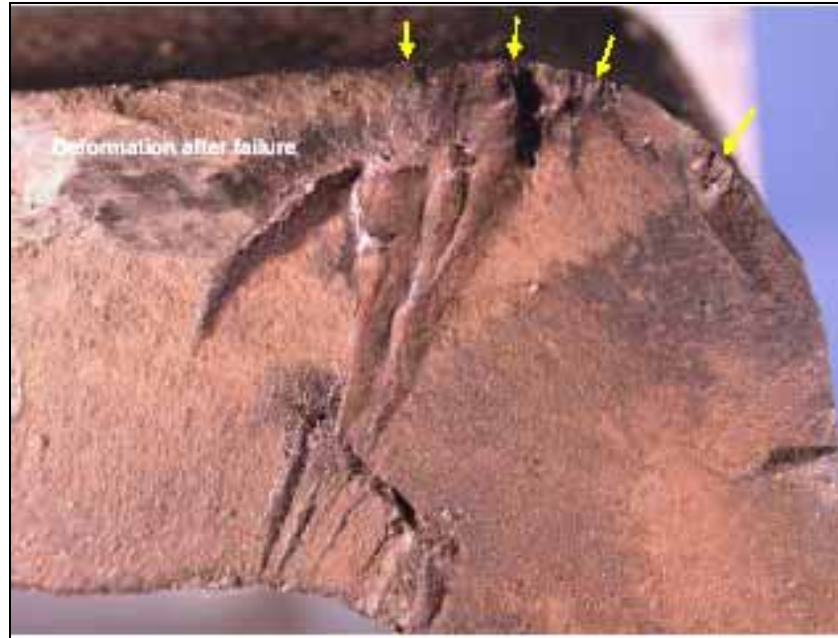
- 1.11.5 Fatigue initiation occurred at a corner in a radius on the bottom side of the box section. The radius appeared to have been part of the original frame geometry (see Figures 15 and 16). Some edge damage sustained after the failure had obliterated evidence in part of the fatigue initiation region, although considerable evidence of fatigue was present beyond this. Several fatigue cracks had initiated at significantly different positions on the radius and led to castellations with significant steps. One of these castellations appeared to have been masked by damage sustained after the failure (see Figure 17).

Figure 17
Initiation region of fatigue crack exhibiting castellations (arrowed)

- 2.9 The presence of a number of castellations showed that the fatigue cracking had occurred at a stress level well in excess of the fatigue limit, which suggested that the cracking probably occurred in thousands or tens of thousands of cycles rather than tens of millions of cycles.

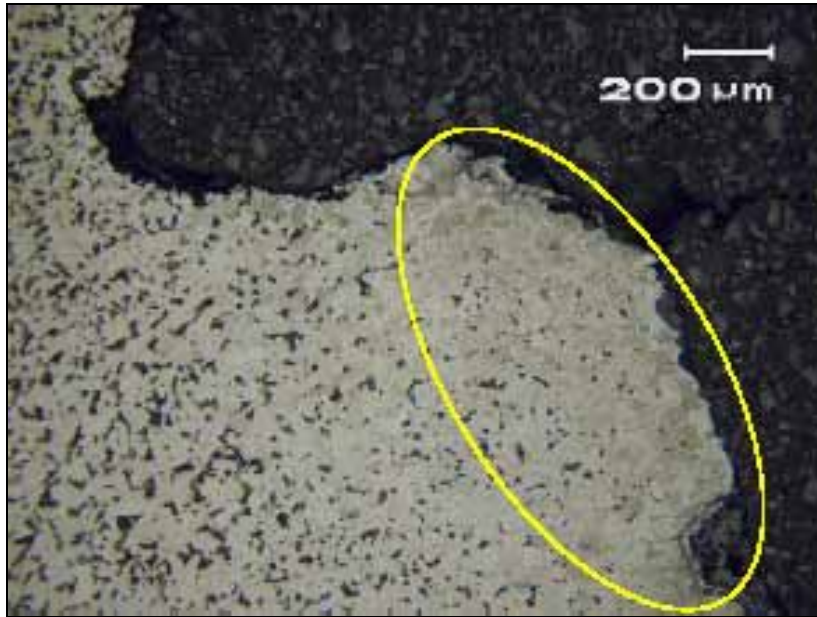
1.11.12 Decarburisation⁶ near the surface of the material was observed under the microscope in the decreasing amount of the darker phase (pearlite) in the microstructure, and can lead to a reduction in strength in the surface layer (see Figure 18). This was typical of annealed⁷ cast steel structures and was not considered to be a contributing factor.

Figure 18
Region of initiation near a castellation. Decarburisation is present (circled) near the surface of the bogie frame

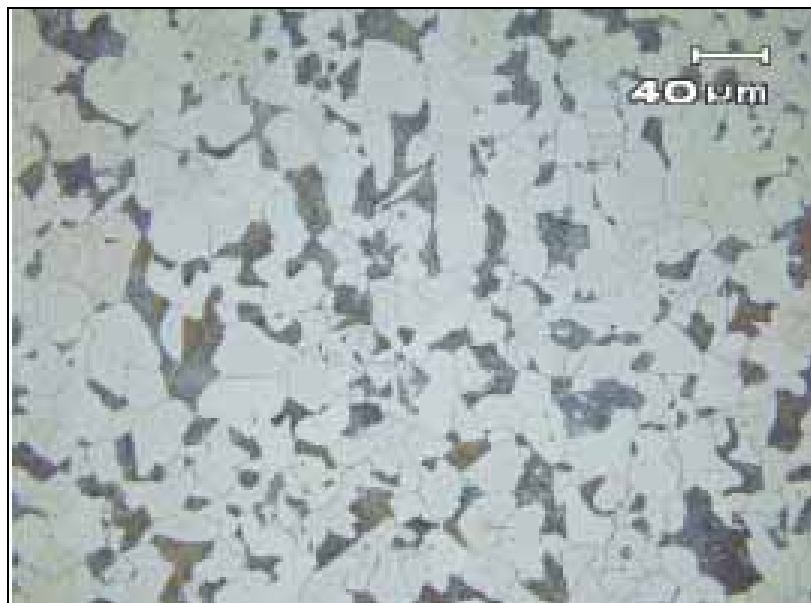
1.11.13 The structure was typical of cast steel. However, the microstructure was consistent with annealed carbon steel, indicating a typical heat treatment after casting (see Figure 19).

Figure 19
Microstructure of surface area
