RAILWAY OCCURRENCE REPORT

05-128

diesel multiple unit Train 3056, passenger injury, Papatoetoe

31 October 2005

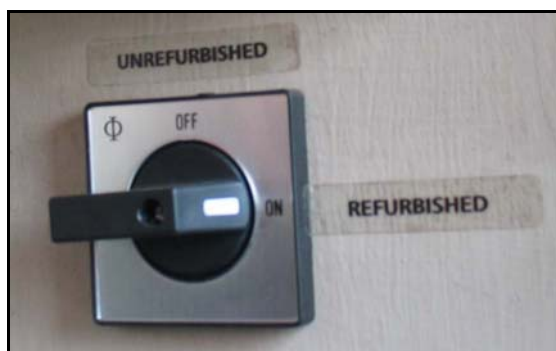
Figure 4
Selection switch in cab of ADK 687

A selection switch was mounted in the cab of ADK 687 to enable it to operate in any of the modes (see Figure 4). The switch enabled maintenance staff to choose between refurbishment and standard mode and thus synchronise door control and other electrical systems with whatever set the set was coupled to.

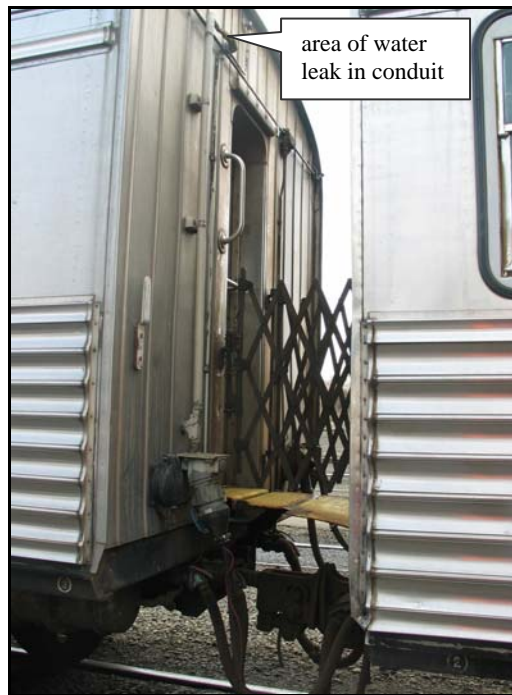
Figure 5
Conduit and jumper plug socket on ADK 687

- 2.20 The electrical and mechanical arrangements applied to the composite consist were appropriate. However, the effect that water leaking into the conduit and accumulating in the jumper plug would have had on the door operation had probably not been identified during the design phase and subsequent testing of the composite consist.

- 3.2 The bi-parting doors closed unprompted due to short circuits in the door-control trainlines. The short circuits were caused by water and dirt that had leaked into a conduit then accumulated in a jumper plug.

- the damaged conduit connecting to the 19-pin socket on ADK 687 was replaced.
- wire 27 to the tranzlog was reconnected.
- the tranzlog was downloaded after 3 days of normal operation and no faults in the door operations and other systems were noted.
- overall, the tranzlog was found to be working correctly.
- a negative earth fault introduced during repairs to the battery switch on ADK 687 was detected and repaired. This fault would have established the first part of a fault path which could then be completed by a positive earth fault elsewhere to create an unwanted circuit connection.
