## MARINE OCCURRENCE REPORT

05-205

restricted limit passenger vessel *Black Cat*, control cable failure and collision with rock wall Seal Bay, Akaroa Harbour

17 April 2005

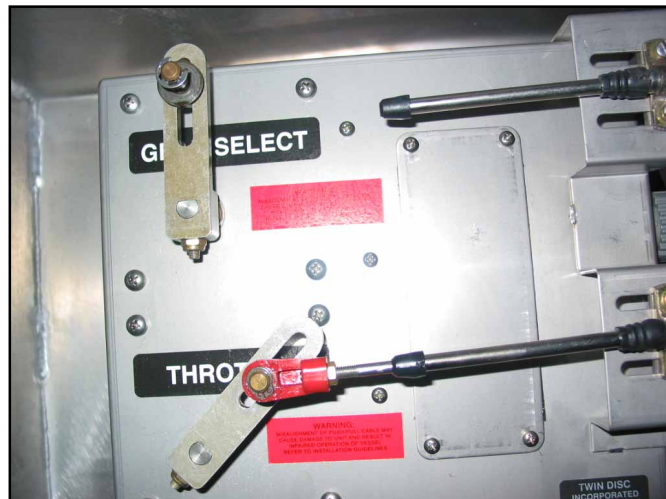
- 1.2.5 The interface between the electronic and cable controls took place in the ECUs. Each cable actuator was moved by a small servomotor, which was regulated by a potentiometer. The control system for the Yanmar engines differed from that of the Caterpillars, so the ECU part of the Twindisc control system was replaced with one that had separate throttle and transmission actuators (see Figure 4).

**Figure 4**  
**Electronic control unit with transmission cable removed**

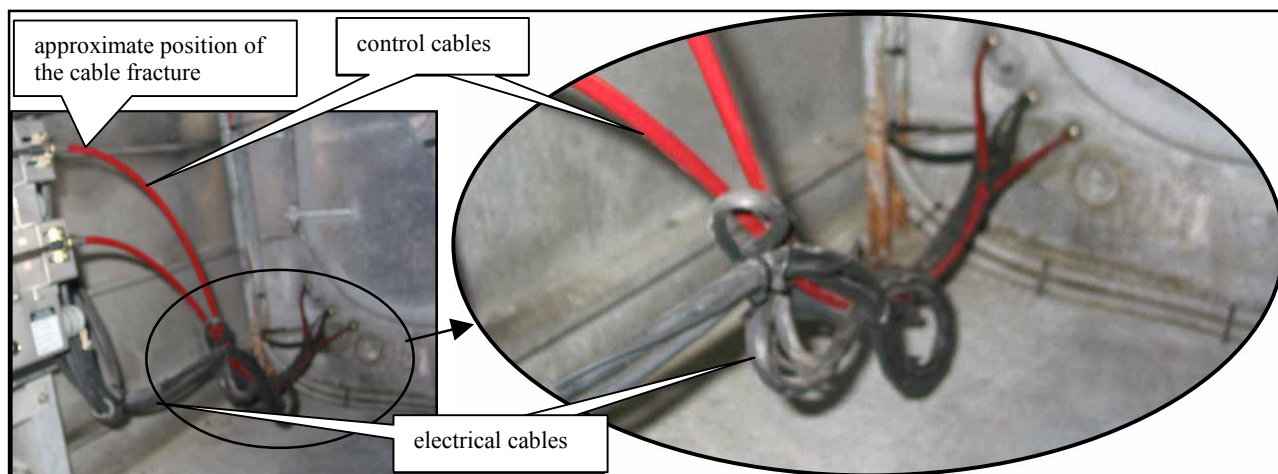
- 1.2.6 The ECUs were mounted in the port and starboard void compartments forward of the engine rooms, and watertight grommets were used where the control cables passed through the bulkhead into the engine room. The control cables in the starboard side curved downwards from the ECU before recurving upwards to pass through the bulkhead. In an attempt to improve tidiness, electrical cables passing between the void space and the engine room had been attached with cable ties to the control cables (see Figure 5).

**Figure 5**  
**Control cables with electrical wires attached**

- 2.6 No tight bends were formed in the control cables when they were installed, and the minimum bend radius of 127 mm was exceeded throughout. There was sufficient flex in the cables to allow them to move with the motion of the boat. However, once the control cables were in place, some heavy electrical cables had been attached to them at the bottom of the loop between the ECU and the engine room bulkhead. The additional weight of the electrical cables would have accentuated the stress on the control cables with the movement of the boat and probably induced a bending moment on the supporting control cables, particularly on the upper one, the transmission control cable. The permanent slight bend in the internal cable near the fracture was probably the result of the additional weight of the electrical cables on the control cable.

- 2.7 Attaching the electrical cables to the control cable, while almost certainly responsible for its failure, was understandable of someone wishing to maintain a tidy boat, and a mistake that many mariners or installers of machinery could and do make.

- 3.3 Bending fatigue failure was caused by the additional weight of electrical cables that were attached to the control cable.
- 3.4 It is probable that the control cable failed in less than a third of its expected minimum life due to the stress caused by the additional weight of the electrical cables.

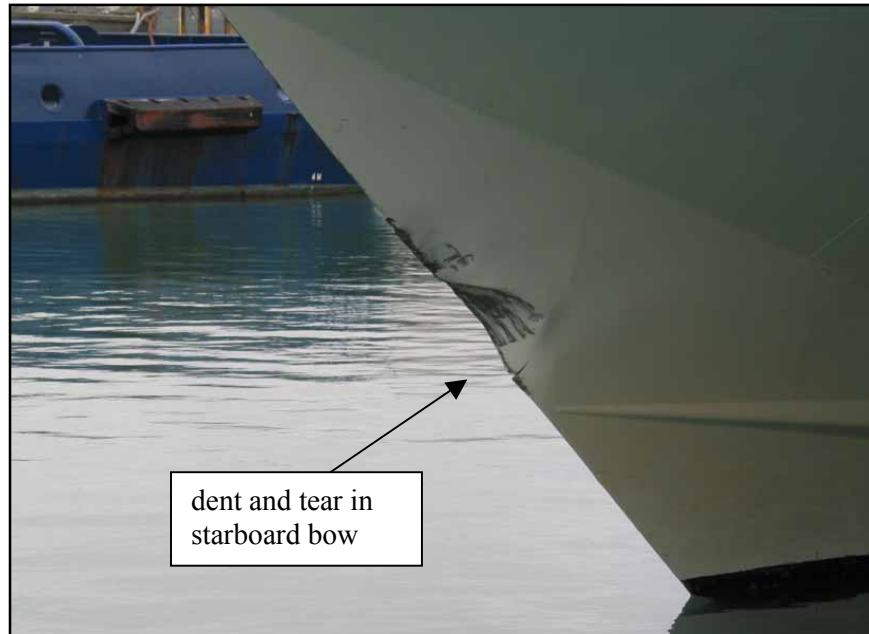
- 1.5.2 The bow of the starboard hull was dented and there was a small tear in the hull plating in way of the stem (see Figure 6). Although above the waterline, the tear allowed the slow ingress of water into the forward void space when the boat was moving. However, the bilge pumps were capable of handling the amount of water entering the space. The starboard side of the hull had scrapes along its length, but none of those penetrated the hull. There was a crack in the hull above the starboard propeller. Two of the blades on the starboard propeller had lost about 25 mm off their tips; a third blade had a small nick out of its outer edge (see Figure 7).

**Figure 6**  
**Damage to the starboard bow**

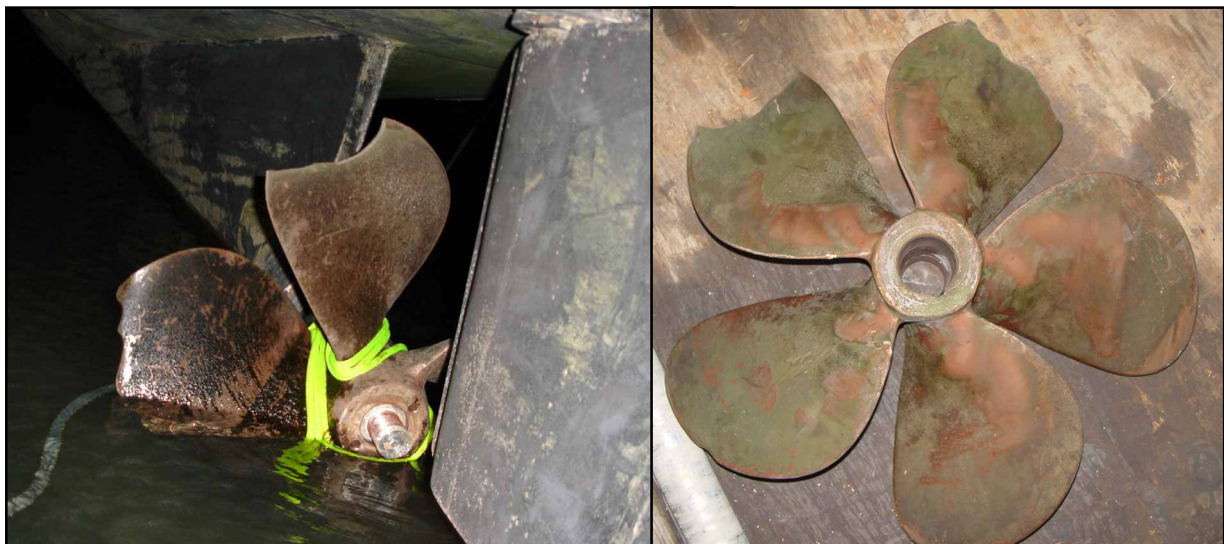
**Figure 7**  
**Propeller damage**

- 2.13 The starboard propeller damage being limited to 2 blades suggests that it hit the rock hard, but either at or about the same time as that engine was put in neutral or stopped. Alternatively, and less likely, was that the propeller hit sufficiently hard to cause the engine to stall instantly.

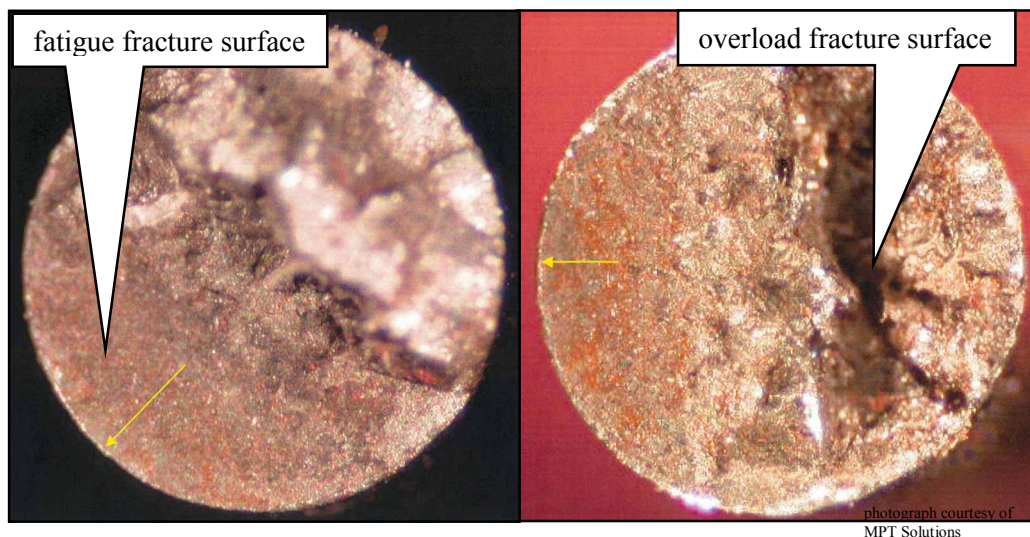
**Figure 8**  
The long and the short end fracture surfaces. The yellow arrows indicate the origin of the fatigue fracture

- 1.6.5 A consulting metallurgical engineer from Materials Performance Technologies examined the broken cable. In his analysis he determined that the inner stainless steel wire had fractured about 75 mm from where it joined the threaded shaft that connected to the actuator. The broken ends of each part of the wire had a slight permanent bend, the shorter end was bent downwards, but the direction of the bend in the longer section could not be determined. The fracture surface on the short length showed a uni-directional bending fatigue extending over about half the cross-sectional area, while the other half showed an irregular pattern, typical of an overload fracture (see Figure 8). A similar pattern was seen on the complementary fracture surface on the long end. The orientation of the fracture was such that the start of the fatigue fracture was at the top or the 12 o'clock position.

- 2.10 The metallurgical engineer concluded that the fracture in the stainless steel inner wire was initiated by a uni-directional bending fatigue, before the final overload fracture completed the failure. The fatigue fracture probably occurred because of the higher than normal bending stresses imposed on the transmission control cable by the additional weight of the electrical cables being tied to them.

- 3.2 The control cable suffered bending fatigue, which propagated a fracture over about half of its cross-sectional area before the remaining intact area of the control cable was overloaded and ultimately failed during normal operation.

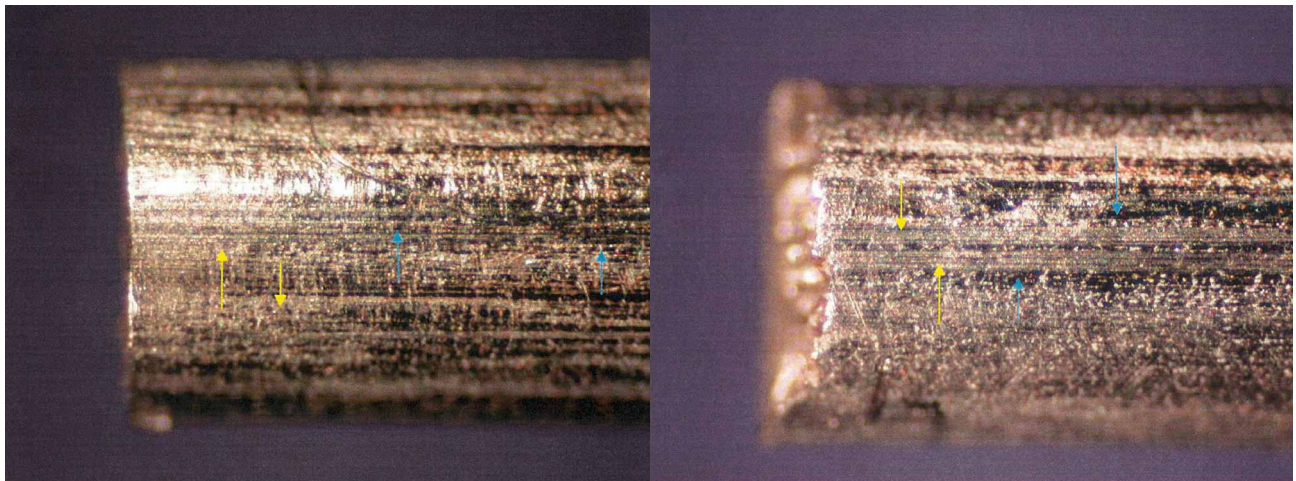
**Figure 9**  
**The upper and under sides of the wire showing scratches (yellow arrows)**  
**and polishing (blue arrows)**

- 1.6.6 The metallurgical engineer further noted that the external surface of the inner wire exhibited wear consisting of longitudinal scratches and polishing over about 70% of the upper surface from 40 mm along the short end from the fracture to 30 mm along the long end from the fracture (see Figure 9). On the under sides of the wire there were 2 distinct sets of longitudinal scratches plus polishing over a narrow strip up to 20 mm along the short end from the fracture and 65 mm along the long end.
- 1.6.7 The metallurgical engineer used the dye penetrant method to test the inner wire for further cracks over a length of about 150 mm either side of the fracture. No further cracks were found.

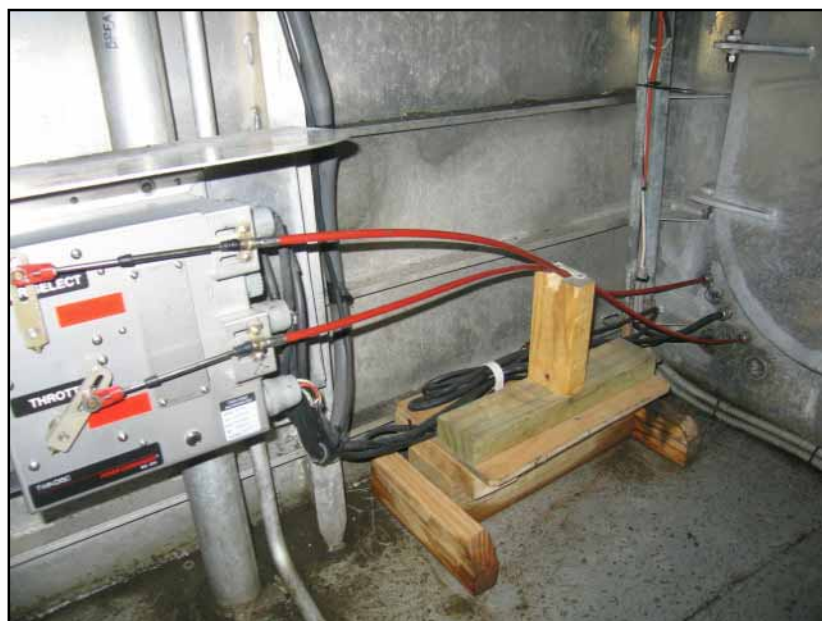
**Figure 12**  
**Control cable support as fitted after repairs**

- 4.1 Following the accident, the owner fitted a complete set of new control cables to the *Black Cat*. The control cables were separated from the electrical cables and were supported on a wooden block (see Figure 12).
