## MARINE OCCURRENCE REPORT

05-207

freight and passenger ferry *Santa Regina* and private launch  
*Timeless*, collision, off Picton Point, Queen Charlotte Sound

2 May 2005

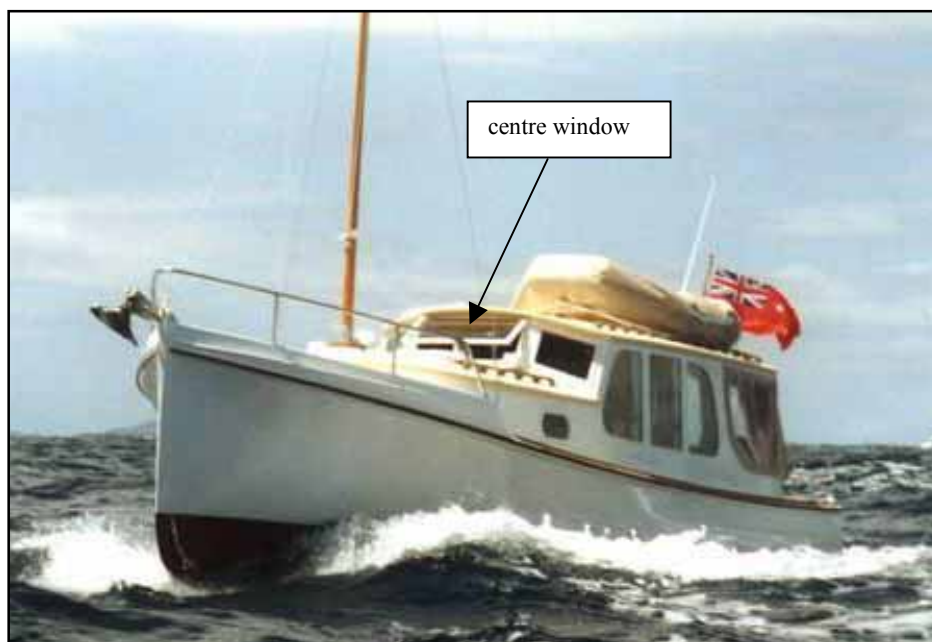
**Figure 2**

- 1.1.8 The bridge team lost sight of the launch under the *Santa Regina*'s bow and although they did not hear or feel the impact, they realised, when wreckage was seen off the starboard side of the ship, that the 2 vessels had collided. The impact had cut the launch in two and appeared to have pushed it under the water. The Skipper's partner, who had been standing on the port side at the front of the cockpit next to the Skipper, found herself underwater, but was able to feel her way around the windows until she found the centre forward one, which was open, through which she was able to escape the boat. She managed to clamber onto some flotsam to await rescue and while waiting she repeatedly called out for her partner, without getting any reply.

**A boat similar to the *Timeless* showing the window through which the partner escaped**

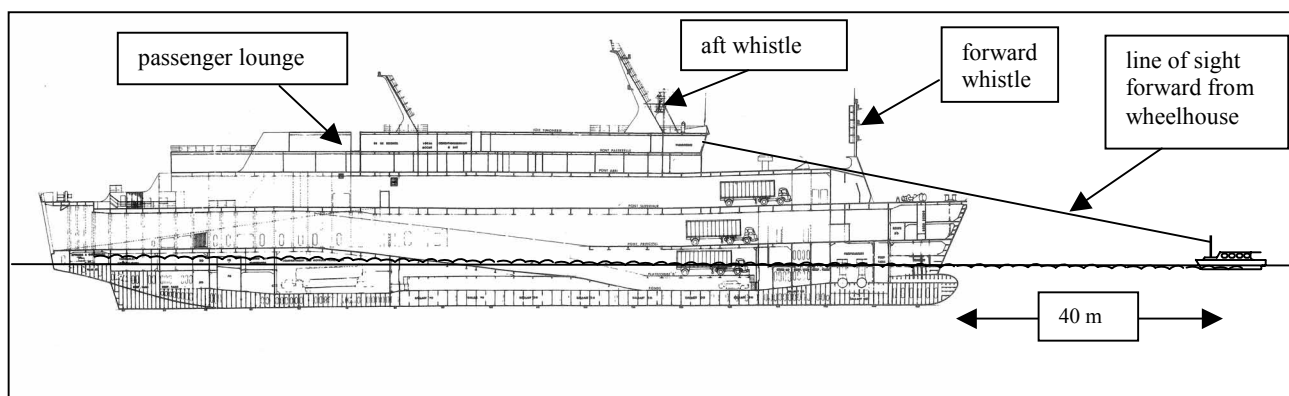
**Figure 4**  
**Profile of the *Santa Regina* showing the position of the whistles and the ahead visibility from the bridge (approximately to scale)**

1.4.6 One of the ship's whistles was situated on the foremast, and the other under the crosstrees of the radar mast situated above the bridge (see Figure 4). The horns of each of the whistles faced forward, concentrating the sound in that direction. The controls for the whistles were located on the starboard side of the console about 6 m from the helm stations on the centreline. The control allowed selection of the forward, aft or both whistles, an all-round white light that flashed in synchronisation with the whistle, and a selector for the automatic fog signal. A manual whistle button and a button to start the automatic fog signal were incorporated into the control panel. Immediately above the control panel there were independent operating buttons for each of the whistles. In addition, there were whistle-operating levers on each bridge wing. There was a mechanically operated wire and handle extending from the deckhead above and behind the helmsman station that was directly connected to the aft whistle, but this was inoperable.

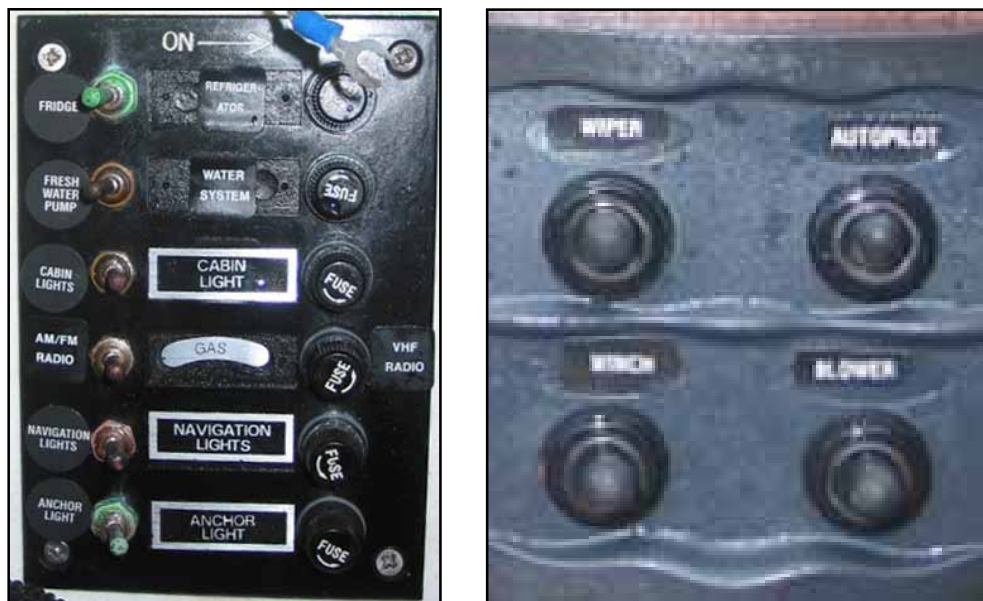
**Figure 5**  
**Switchboard located in the forward cabin and helm station switches**

- 1.4.17 When the wreckage was recovered the police noted the position of each of the switches and also determined the condition of each of the fuses. Later, relevant bulbs and electrical items were checked. Table 1 details the switch positions and the state of the fuses and bulb filaments.

- 2.25 The ignition switch was found in the off position. Given that the partner said that the boat was still under power at the time of the collision, it is likely the switch was turned off when the wreckage was recovered.

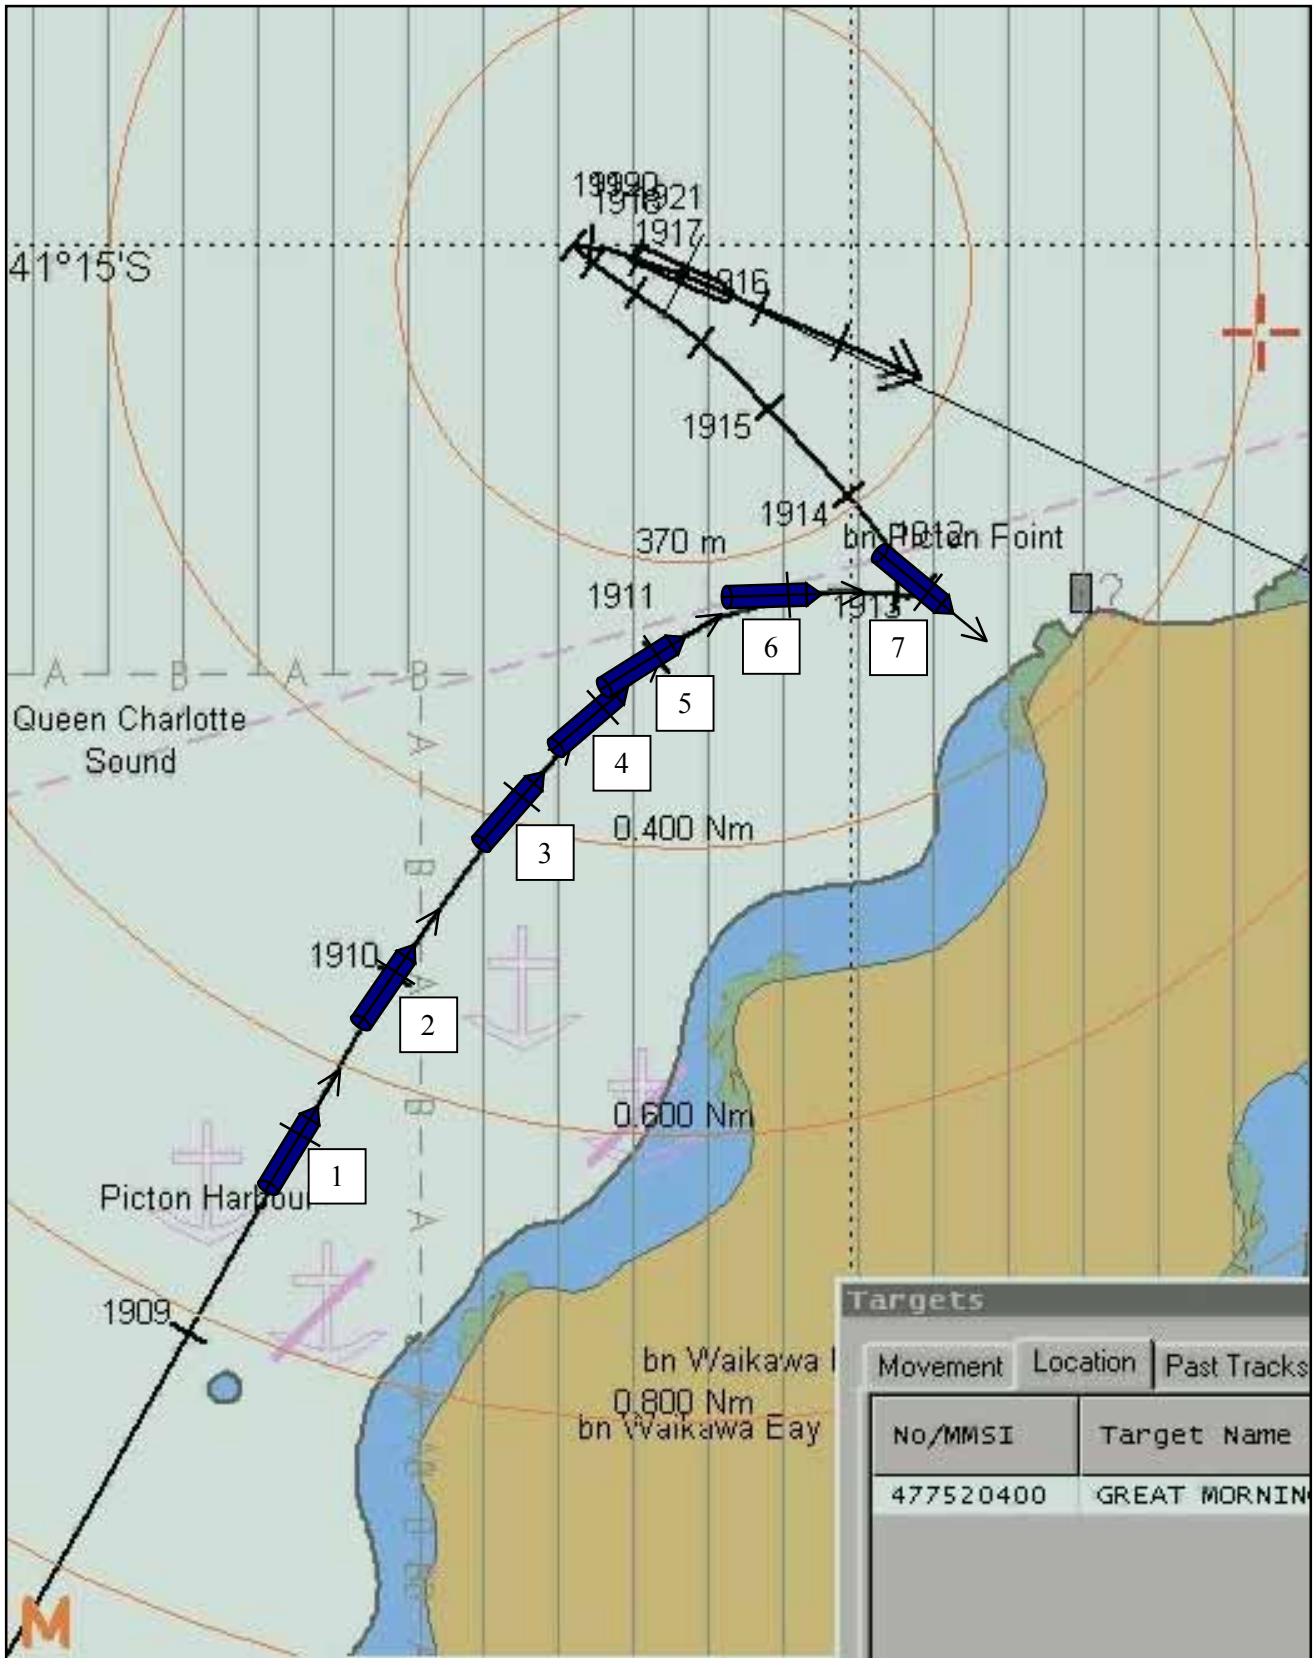
**Figure 6**  
 A screen capture from the video playback of the ENC data, showing the track of the *Santa Regina* up to and immediately after the collision

- 1.1.9 The *Santa Regina* continued to turn to starboard as its speed degraded until at about 1913, when the ship stopped and started to make sternway. The bow of the ship came to within about 125 m of the shore (see Figure 6).
- 1.1.10 Following the collision, the Mate/Master of the *Santa Regina* had the Second Mate make radio calls to Picton Harbour Radio and Picton Maritime Radio to inform them. The crew launched the ship's lifeboat and started to search the debris off the starboard side of the ship. From her calls for help, it was apparent that there was a female survivor, but before they picked her up they checked the immediate area to see if they could find anyone else in the water, without success. When they picked up the survivor, she told them that there had been 2 people on the launch, and that the other was her partner who had been the Skipper and owner of the launch.

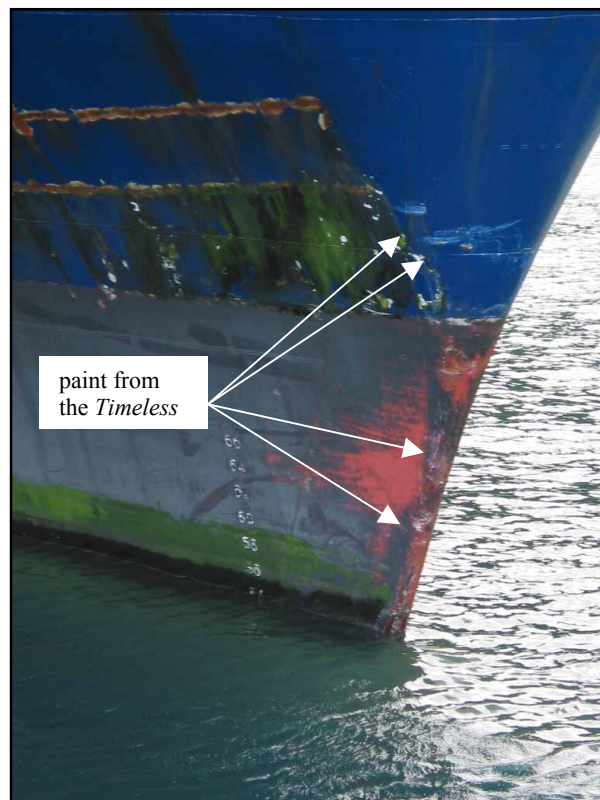
**Figure 7**  
**Bow of the *Santa Regina***

- 1.11.1 The *Santa Regina* suffered negligible damage, with some paint transfer from the *Timeless* and scratches to the paintwork at the bow (see Figure 7). Lighter abrasions were noted along each side of the hull, but none could positively be attributed to this accident.

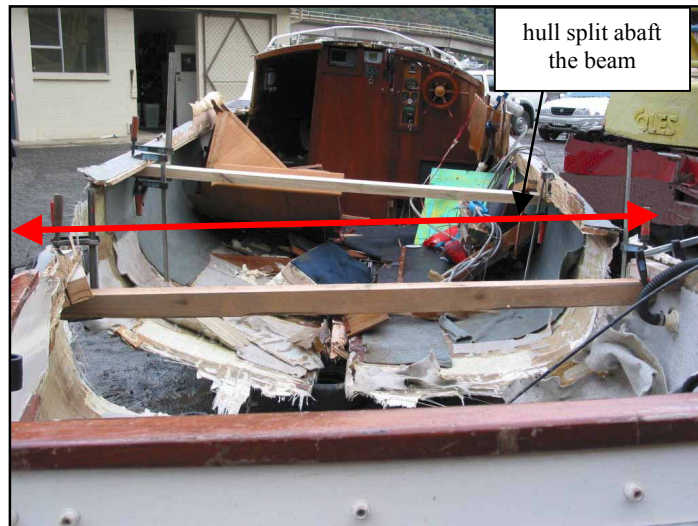
**Figure 8**  
**Hull of the *Timeless***

- 1.11.2 The *Timeless* was destroyed. The hull was split in two about two thirds of the length from forward (see Figure 8). The cabin roof was detached from the hull and separated into 2 parts at the rise of the roof, the windows were torn off and separated from the roof and hull, and the interior demolished. The propeller drive shaft that ran about three quarters of the boat's length from the engine compartment in the forward cabin to where it joined the tail end shaft, was bent nearly at right angles about 500 mm from its after end (see Figure 9). The rudder was completely missing. The hull had blue paint on it where it had come in contact with the *Santa Regina*'s hull.
