06-008	Piper PA23-250-E Aztec, ZK-PIW, landing gear collapse, Ardmore Aerodrome	21 December 2006
---------------	---	-------------------------

Report 06-008

Piper PA23-250-E Aztec

landing gear collapse

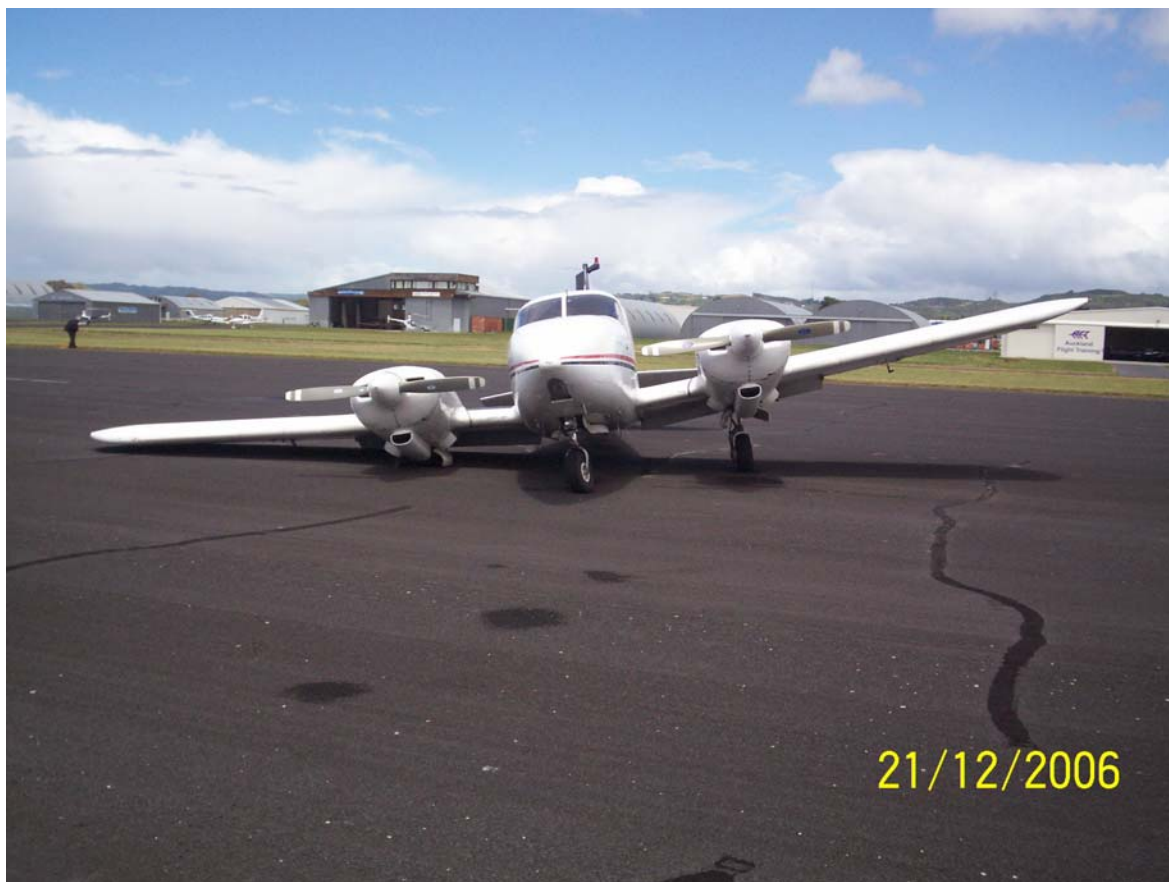
The pilots were satisfied that the right landing gear was down and locked, so continued to land at Ardmore. During the landing roll the right landing gear collapsed and the right wing came in contact with the ground, however the pilots were able to keep the aircraft on the runway. There was minor damage to the aircraft and no injury to the pilots.

**Piper PA23-250-E Aztec ZK-PIW
After landing at Ardmore**

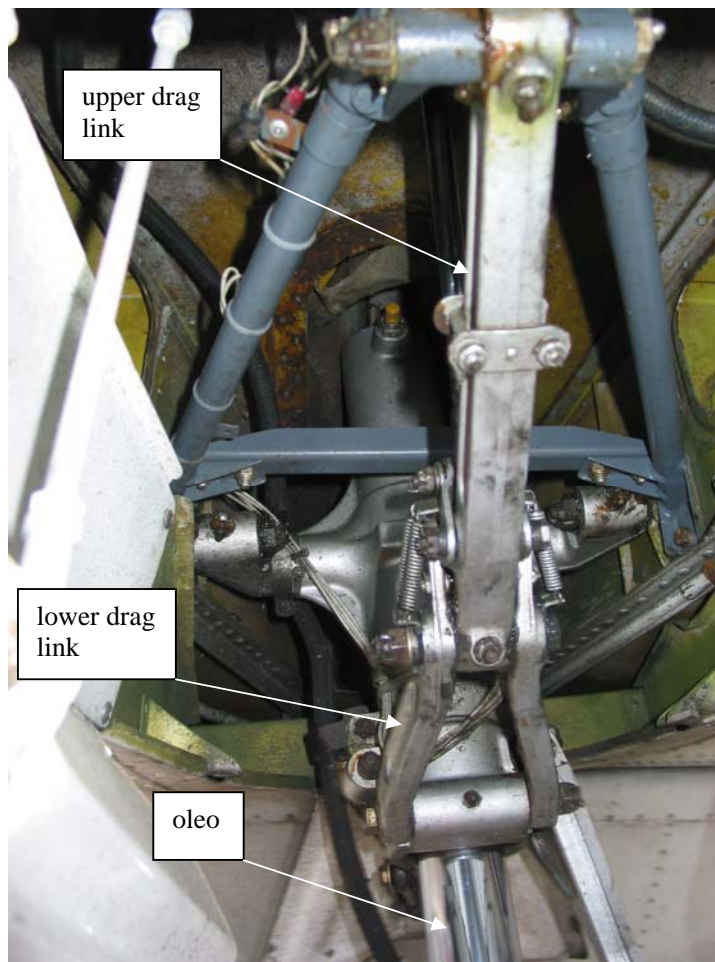
Figure 2
Right main landing gear ZK-PIW - looking aft

- 1.5.8 With the landing gear down, mechanical over-centre drag struts would lock the landing gear legs in the down position. To prevent the gear being retracted while the aeroplane was on the ground, an anti-retraction valve prevented a build-up of hydraulic pressure in the retraction system while the weight of the aeroplane was on its wheels (see Figures 2 and 3).

- 1.7.3 The landing gear assembly was then further inspected and, although there was some play within the linkages, it was determined to be rigged within prescribed limits. Closer examination of the drag brace links for all the landing gear legs found that they were approaching their wear limits. As a precaution the maintenance provider had all 3 drag brace links overhauled. The right main landing gear hydraulic actuating cylinder was removed and an internal leak was located. As a result all 3 actuators were replaced. The hydraulic priority valve that allowed the landing gear doors to operate in coordination with the landing gear was bench tested and found to be leaking. After the O-rings were replaced, the valve operated within maintenance manual limits. As a further precaution the O-rings in the timer check valves for the landing gear doors were also replaced.

- 2.5 The collapse of the right landing gear leg as the aircraft slowed could therefore have been caused by a number of faults that combined to overcome the mechanical down lock. The internally leaking actuator would have allowed pressure within the actuator to equalise over time. The faulty powerpak, possibly indicated by the selector lever being slower to return to the neutral position, could have also vented pressure from the down line or increased pressure in the up line. These possibilities, combined with the worn drag brace links, permitted sufficient fore and aft movement of the gear leg to break the over-centre down lock and allow the leg to start collapsing.

- 3.5 The cause of the collapse of the landing gear was not specifically identified, but the evidence indicated it was probably a combination of wear in the landing gear and hydraulic components.
