RAILWAY OCCURRENCE REPORT

06-101 Report 06-101, diesel multiple unit passenger Train 3163, fire in 15 March 2006
diesel auxiliary engine, Manurewa

**TRANSPORT ACCIDENT INVESTIGATION COMMISSION
NEW ZEALAND**

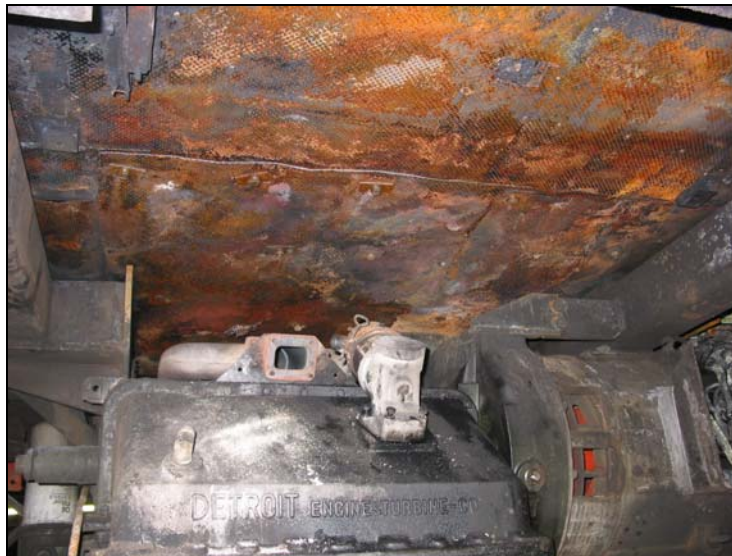
Figure 3
Damaged underfloor above the auxiliary motor

- 1.11.1 Fire damage was generally localised to the area from the auxiliary engine fuel tank to the bogie under the trailing cab. Cables, air pipes, and fuel and oil lubricating lines near to the seat of the fire were either damaged or destroyed.
- 1.11.2 The unburned insulation on the interior of the shroud panels was soaked in oil.
- 1.11.3 The fire was contained to an area bounded by the top of the auxiliary engine and the underfloor of the vehicle (see Figure 3). The flames had been fanned by the airflow beneath the moving train and had also melted plastic pipe cleats around the trailing bogie of the rear car (see Figure 4).

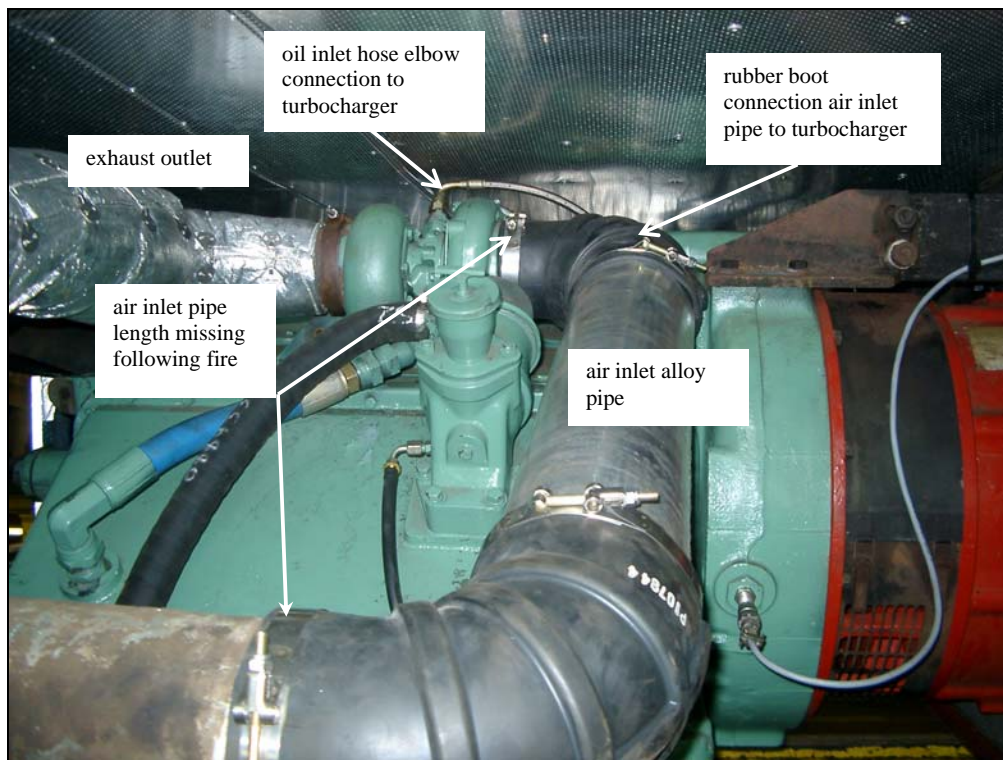
Figure 5
Connections to the turbocharger

- 1.11.4 The sound absorbing material within the auxiliary engine shroud was almost completely consumed by the fire.
- 1.11.5 About 150 mm of the turbocharger air inlet pipe was missing. The remnants were found at the bottom of the shroud casing, heavily contaminated with oil. The rubber boots, one of which connected the air inlet pipe to the turbocharger, were missing. Figure 5 shows the rubber boot which connected the alloy pipe to the turbocharger on the reconditioned auxiliary engine following the fire.
- 1.11.6 Smoke blackening and heat scorching were evident on the exterior of the DMU (see Figure 6) where the flames had risen from the turbocharger side (the left hand side in the direction of travel). The opposite side had no such markings.

- 1.11.7 From the damage, it was clear that the ignition point of the fire was in the vicinity of the turbocharger. This was confirmed by a New Zealand Fire Service inspector.
- 1.11.8 Inspection of the auxiliary engine showed there had been a mixture of oil, fuel and dirt forming a thick, flammable substance between the top of the auxiliary engine and the passenger saloon floor. Although most of this mixture had been consumed by the fire, the mixture was still present on parts of the motor which had not been affected by the fire

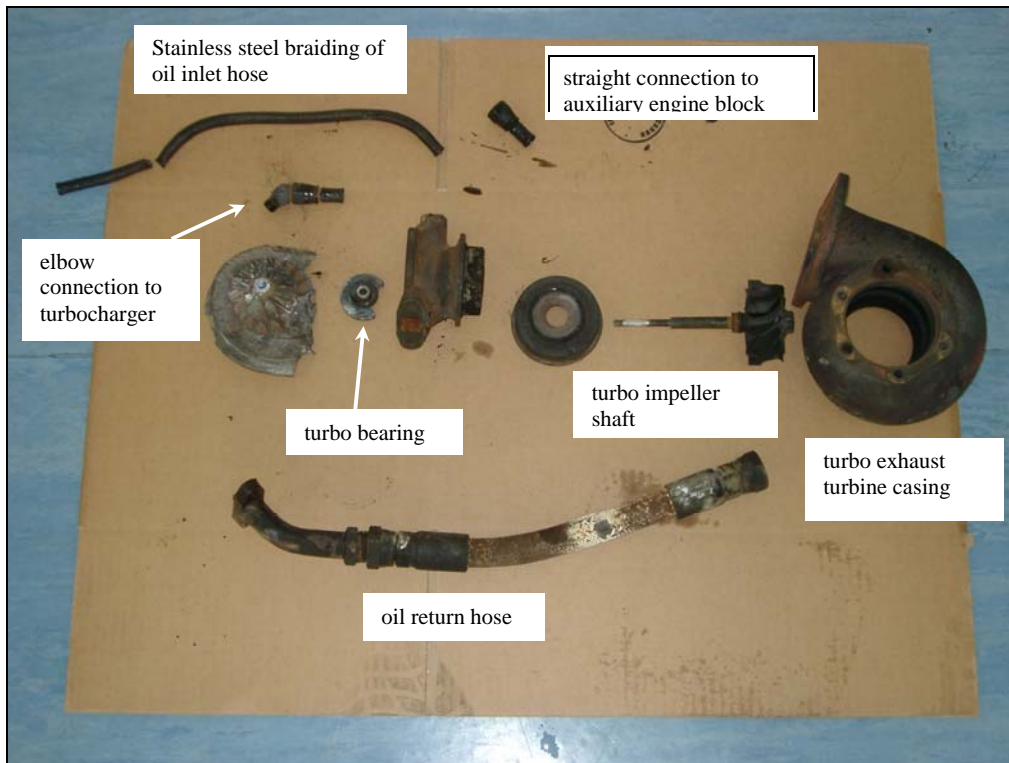
Figure 7
Dismantled turbocharger and associated parts

- 1.11.9 The turbocharger, together with its oil supply hose and return pipes, was removed from the auxiliary engine and taken for independent testing and analysis. The turbocharger was stripped down to its constituent parts for examination.
- 1.11.10 The main bearing was in good condition, and the shaft moved freely in it once the damaged air intake propeller had been removed from the shaft end.

- 2.6 The deformed appearance of the turbocharger following the fire suggested initially that it may have become defective during operation and contributed to the ignition of the fire. However, independent testing and analysis confirmed that it had been operating correctly at the time the auxiliary motor was shut down by the LES and was therefore not a causal factor.

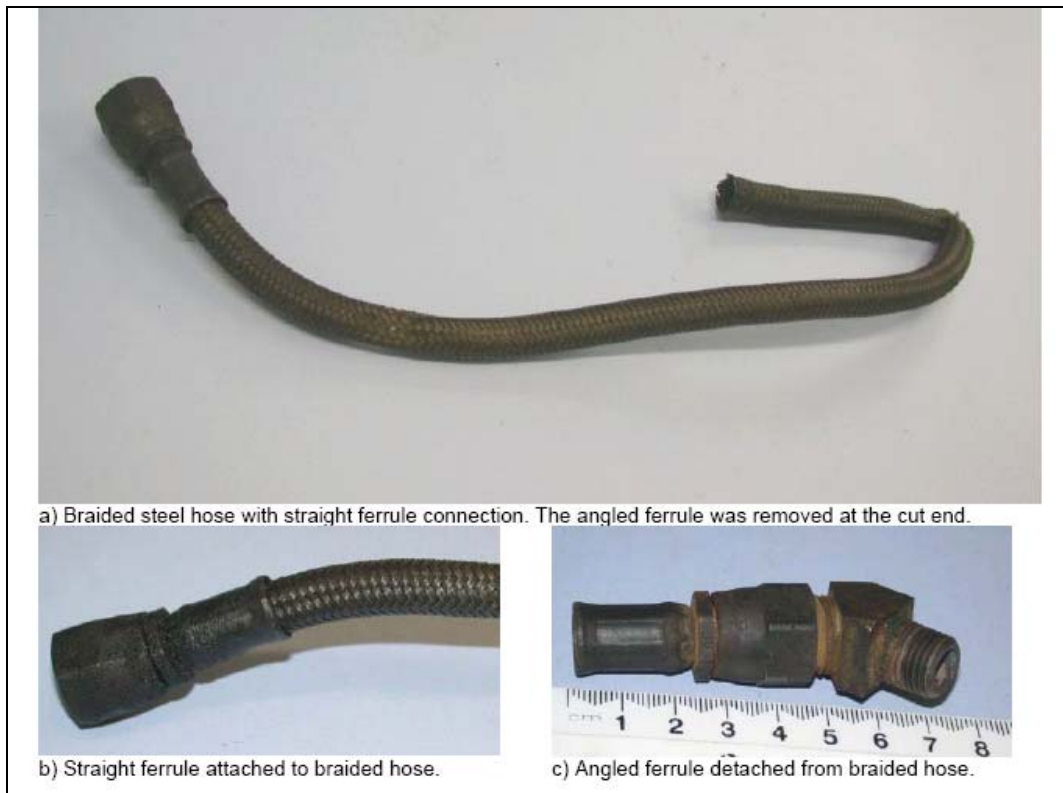
Figure 8
Braided oil inlet hose and fittings

- 1.11.11 The remains of the braided steel hose and its fittings were inspected before disassembly. One end of the hose was fitted to a straight coupling at the auxiliary engine. The connection was tight but, although contaminated with oil, did not exhibit any fire damage.
- 1.11.12 The other end of the oil inlet hose was connected to the turbocharger through a ferrule to a 45° angled nipple. The nipple threaded into the turbocharger housing and the straight ferrule connected onto the nipple. Both the ferrule and the nipple were found loose and able to be turned by hand.

The connections and the stainless steel braiding covering the polymer oil inlet hose was light brown in colour, consistent with exposure to extreme heat.

- 1.11.13 The fire-damaged oil inlet hose (see Figure 8) was examined by an independent expert.

- 1.11.14 The oil inlet hose had been crimped into threaded brass ferrules to allow free rotation of the hose so that the threaded parts could be tightened without imposing torsional stress on the hose. Figures 8(a) and (b) show the straight ferrule still attached to the braided hose. The angled ferrule (see Figure 8(c)) was also attached initially but became detached during handling.

- 1.11.16 The fire had deposited substantial amounts of soot on the outside of the metal surfaces. Visual assessment revealed no remnants of the original internal polymer tube. The braided tube was also probed to check for remaining fragments of polymer but none were found.

- 1.11.17 The steel braiding showed no evidence of melting and, apart from the soot deposit and mechanical damage caused when the tube was cut during testing, there was no evidence of damage to, or distortion of the steel braiding.

- 2.8 It is not unknown for fittings such as threaded nipples to come loose under intense heat and give the appearance of having been loose prior to the fire. If the nipple and ferrule had not been tight any leaking oil would have gone to the hot side of the turbocharger, where as oil from a split in the polymer section of the hose would have initially leaked towards the cool side of the turbocharger. Although it could not be established categorically which failure had initiated the fire, evidence suggested it was caused by oil from a loose nipple or ferrule. The reasons for this were:

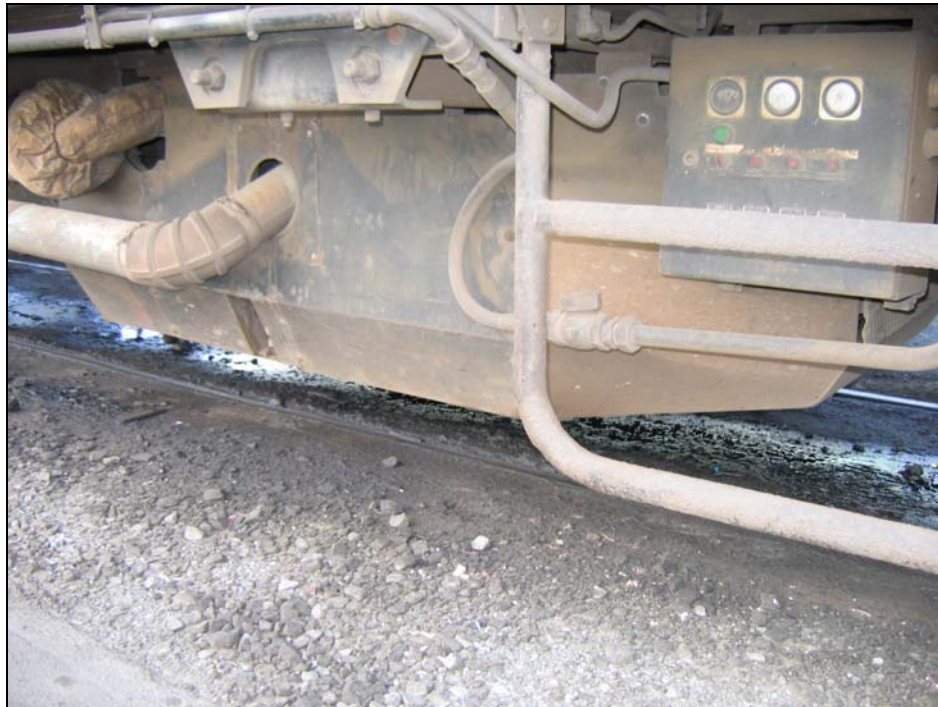
Figure 9
Side shroud on the turbocharger side of ADC857 (courtesy Toll Rail)

- 1.11.22 The shroud panel on the turbocharger side of the auxiliary engine contained ports for the exhaust pipe to exit and the air inlet pipe to enter but there were no removable panels to allow maintenance staff to access that side of the engine. For servicing, repairs or cleaning the complete side of the shroud had to be removed.

- 2.5 Although the noise suppression shrouds were designed to fire safety standards, they became too hot to handle in a fire situation and could not be removed easily.. This prevented the train crew and fire service crew from gaining immediate access to the seat of the fire. As with the previous incident at Boston Road incident this delay did not have a significant impact on the situation or endanger the safety of the passengers, but again the potential existed for more serious consequences. Safety recommendation 035/06, arising from Rail Occurrence Report 04-112 regarding the noise suppression shrouds, was made to the General Manager, Infrastructure and Rail, ARTA on 4 May 2005 (see 1.18.4). As a result of ARTAs response no further safety recommendation covering this issue has been made at this time.
