## RAILWAY OCCURRENCE REPORT

06-102

SA/SD passenger Train 4306, braking irregularity, between Westfield and Otahuhu

31 March 2006

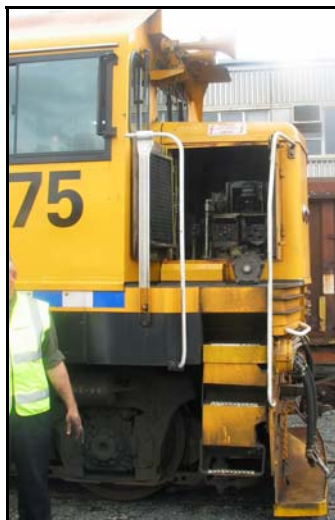
**Figure 3**  
**Brake control valve cabinet of DC4375**

- 1.3.14 The examination then focused on the operating condition of the brake control valves located in the brake control valve cabinet in the short hood of DC4375 (see Figure 3). The brake control valves were removed and disassembled for inspection.

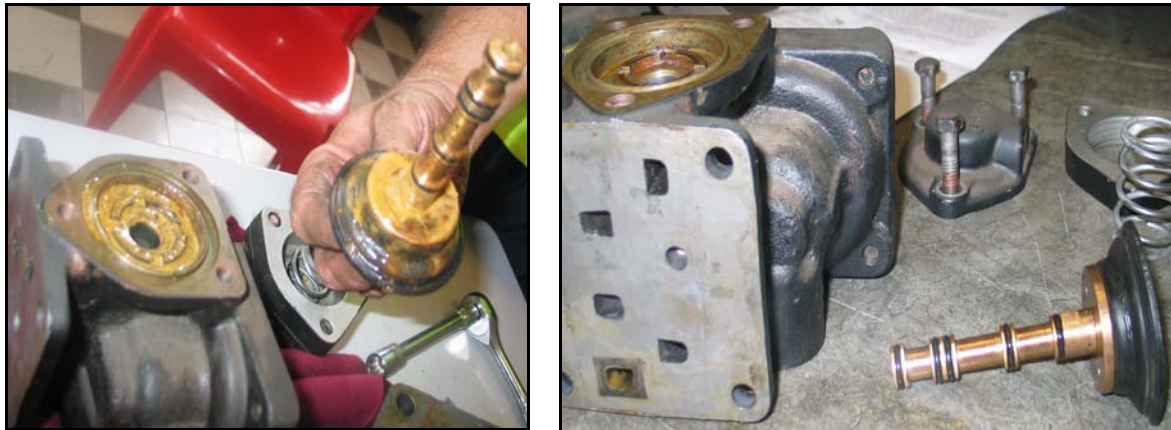
**Figure 4**

- 1.3.15 When the 26-F quick-release brake control valve (26-F valve) was disassembled, it was found that the spindle actuating the small diaphragm in the quick-release portion was sticking intermittently in response to manual pushes. The spindle was removed from its bore and an emulsion of oil and water was found in the area below the diaphragm and along the spindle (see Figure 4).

**Contaminated valve spindle/diaphragm, left, with clean spindle/diaphragm for comparison on right**

- 1.3.16 The space between the housing and the diaphragm would normally be dry, with only residues of lubricant present. However, the oil-water emulsion had found its way into the quick-release portion of the valve body, causing the intermittent sticking of the spindle.
- 1.3.17 A replacement 26-F valve was sourced from inventory and fitted to DC4375 and the locomotive was returned to service.

- 3.2 The valve was serviceable and within wear limits, but its operation had been affected by the ingress of an oil-water emulsion formed from lubricating oil from the compressor and water condensation normally associated with compressed air systems.

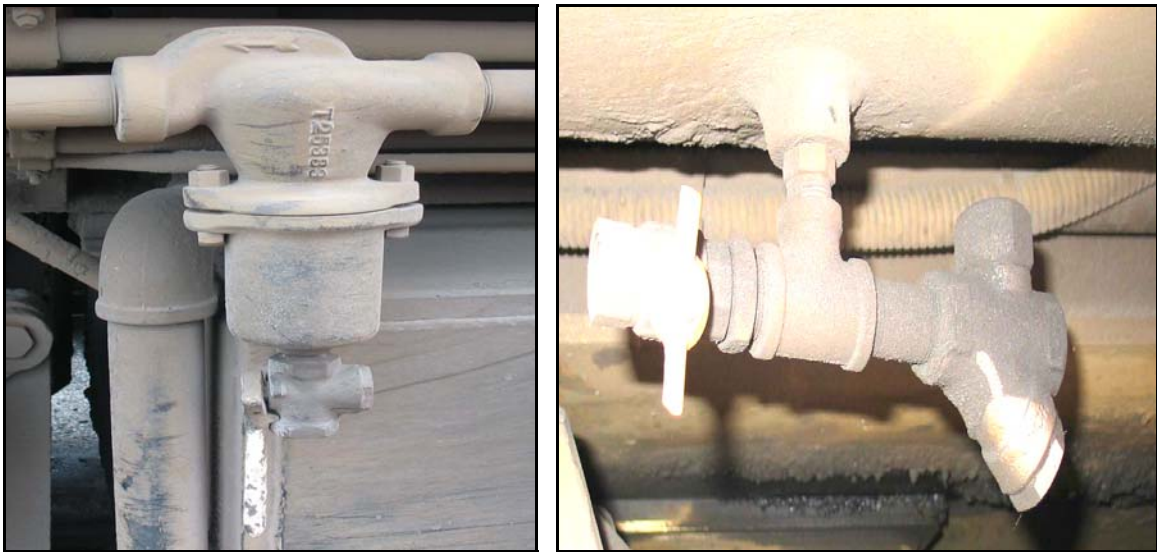
**Figure 6**  
**Manual dirt collector, left, and combined manual/automatic drain valve on right**

- 1.4.6 The dirt collectors were designed to capture scale flaking from inside the air brake piping system and soot particles caused by carbonising from the heat generated by the air compressor. There were some variations in the number of dirt collectors installed on individual locomotives and on different classes of locomotive, but all locomotives had at least one dirt collector installed. The dirt collectors consisted of a horse-hair filter and a centrifugal dirt collector and were fitted with either drain cocks for automatic purging or a bung that allowed them to be purged manually.

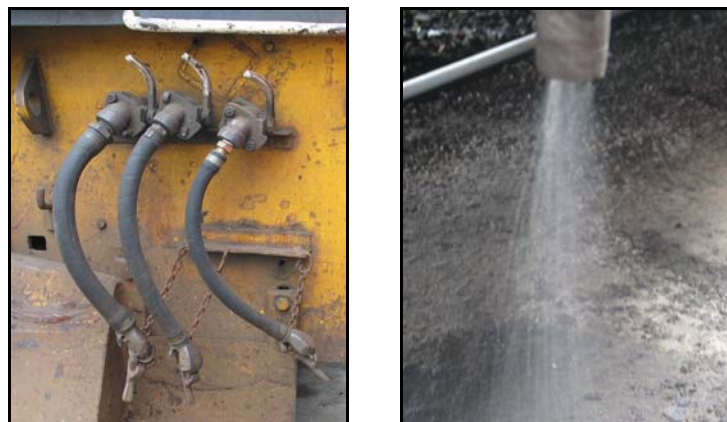
- 1.4.7 At the time of the incident, the responsibility for draining the non-automatic drain valves and dirt collectors was not clearly defined in procedures. In an attempt to reduce the amount of water condensate in locomotives' brake piping, the Servicing task instruction was in the process of being amended. It was intended that whenever a locomotive was serviced, the instruction would require dirt collectors to be drained where a manual drain cock was fitted, headstock cocks to be vented briefly to expel water, and any other manual drain cocks to be operated (see Figure 7).

**Figure 7**  
**Headstock cocks, left, and condensation being expelled from a valve on right**

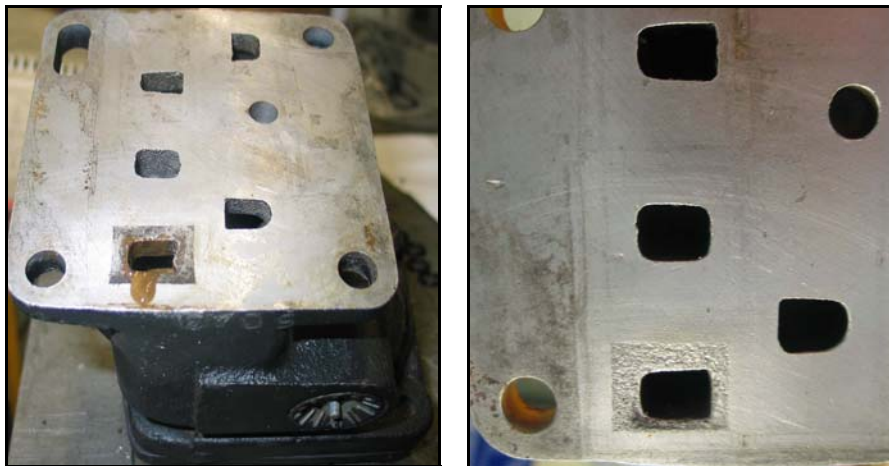
**Figure 9**  
**Mounting plate of 26-F valve**

- 1.5.10 The 26-F valve from DC4375 was sent to the air brake group for a detailed examination. A residue of oil-water emulsion was seen emanating from a port on the mounting plate at the rear of the valve (see the left-hand picture in Figure 9). After cleaning, there was a rectangular area of pitting around the same port (see the right-hand picture in Figure 9).

- 1.5.11 The valve was stripped down to its individual components and examined. Some wear on the “O rings” and in the “O ring” seats on the spindle was observed. The spindle shaft was rolled on a flat plate and was observed to be straight.
- 1.5.12 Records showed the valve had last been reconditioned on 7 November 2003.
- 1.5.13 The valve was reassembled and later passed an air brake code test.
