**Report 06-108, passenger Train 9328, derailed after running into  
landslide debris, 2.474 km Johnsonville Line, between Wellington and  
Wadestown, 26 August 2006**

**Report 06-108**  
**passenger Train 9328**  
**derailed after running into landslide debris**  
**2.474 km Johnsonville Line**  
**between Wellington and Wadestown**  
**26 August 2006**

**Abstract**

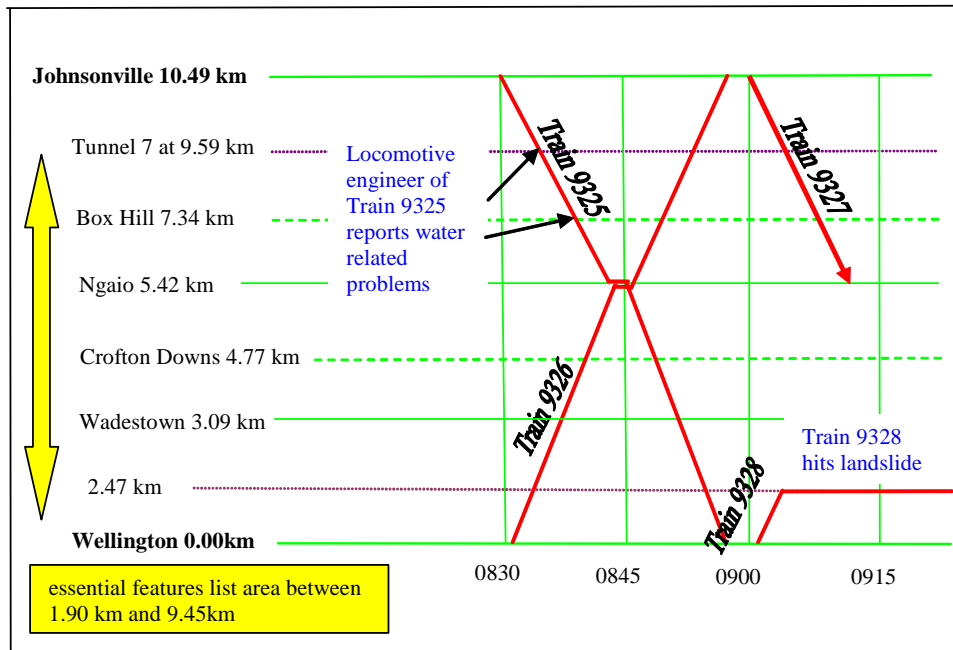
**Figure 1**  
**Details of train movements as recorded on train control diagram (not to scale)**

- 1.1.3 At 0838, the locomotive engineer of Train 9325 reported to train control that there was a blocked drain about 50 metres (m) north of Tunnel 7, and that “a ton of water was running off the platform and over the rails at the south end of Box Hill station” (see Figure 1). The train controller recorded the details on the train control diagram and informed the network control manager. The network control manager was heard passing on the details to the help desk,<sup>3</sup> requesting that a ganger attend the scene.

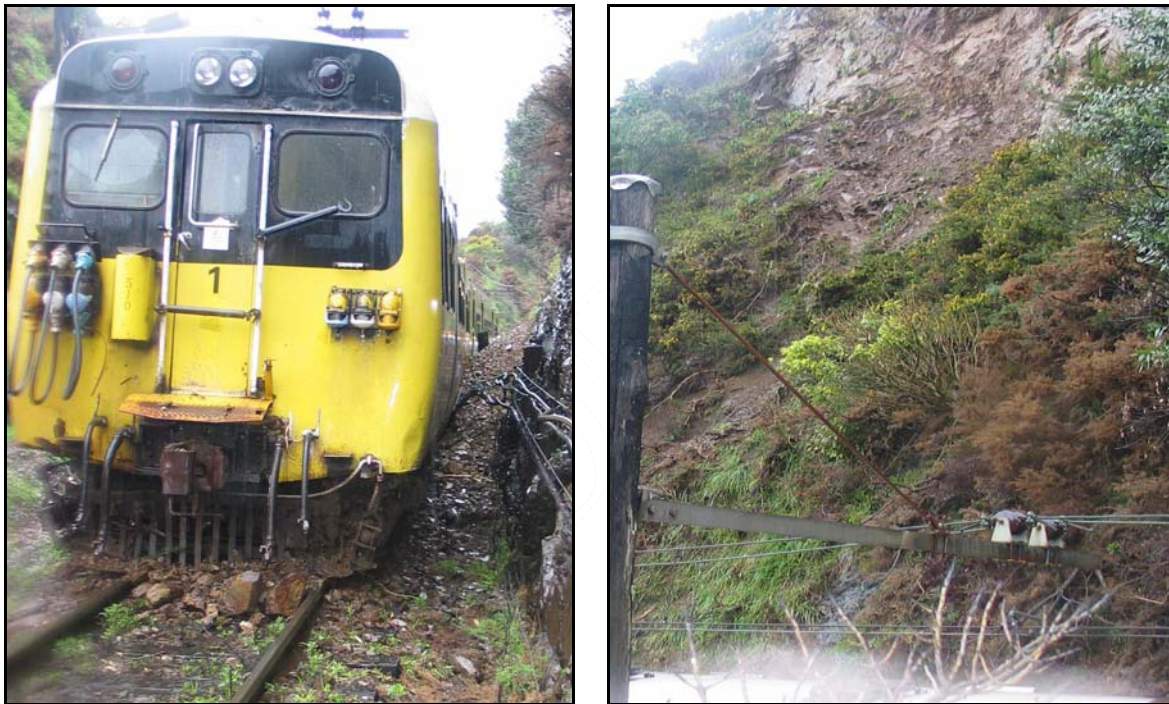
**Figure 2**  
**Derailed train (left) and origin of landslide debris from up hill face (right)**

- 1.1.7 At about 0907 and as Train 9328 exited Tunnel 1 at a speed of about 35 kilometres per hour (km/h), the locomotive engineer was looking out for debris on the right-hand side of the track and a signal aspect beyond. The locomotive engineer then saw the debris covering the opposite side of the track and applied the emergency brake. The train travelled about 23 m before stopping. The lead bogie derailed when it struck the debris (see Figure 2).

- 1.5.1 The landslide debris that derailed Train 9328 had originated about 15 m above the track. About 5 to 10 m<sup>3</sup> of weathered rocky material had subsided onto the track. The landslide was known in geological terms as a regolith<sup>6</sup> landslide and was New Zealand's most widespread and noticeable type of landslide.
- 1.5.2 Regolith landslides occurred mainly after heavy rainfall had saturated the loose surface material causing it to slide away from the underlying bedrock. The water that entered the surface material particles increased its weight, and, when the ground was fully saturated, the water pressure began to force the particles apart, making the surface materials more likely to slide.

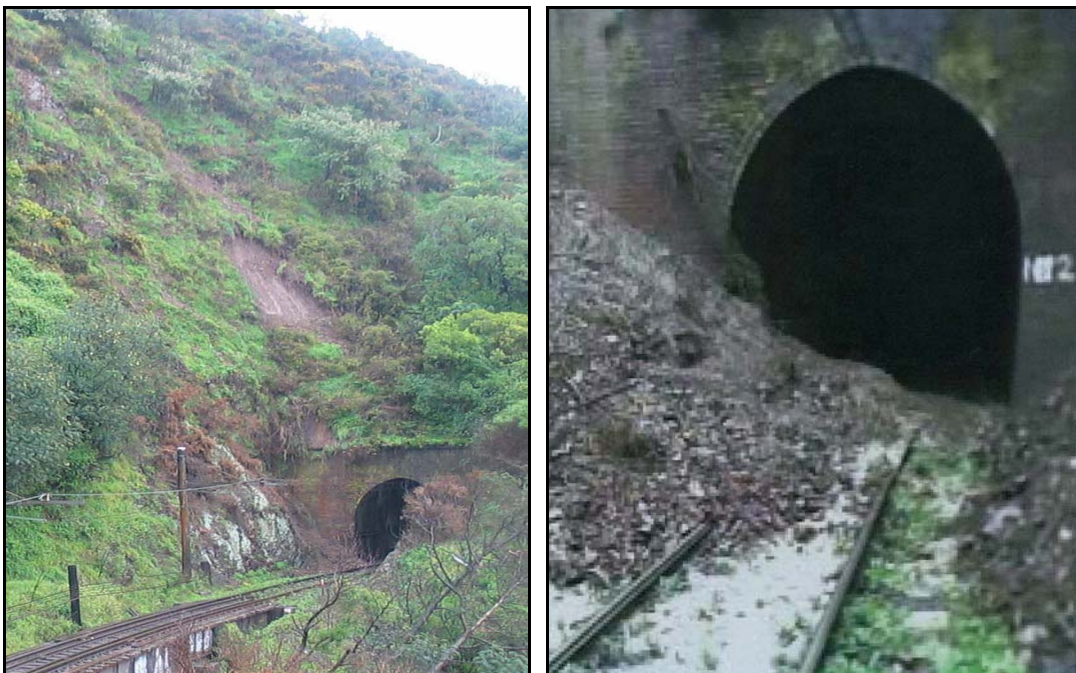
**Figure 4**  
**Developing landslide above Tunnel 2 (left) and debris blocking the track after sluicing (right)**

- 1.5.7 During the Commission’s site investigation, a developing landslide was seen above the eastern portal of Tunnel 2, located about 100 m beyond the derailment site. Further debris, which was sluiced from the area by helicopter, fell and covered the track at the portal (see Figure 4).
