MARINE OCCURRENCE REPORT

06-203

fishing vessel *Venture*, grounding, Tipi Bay, Tory Channel

19 April 2006

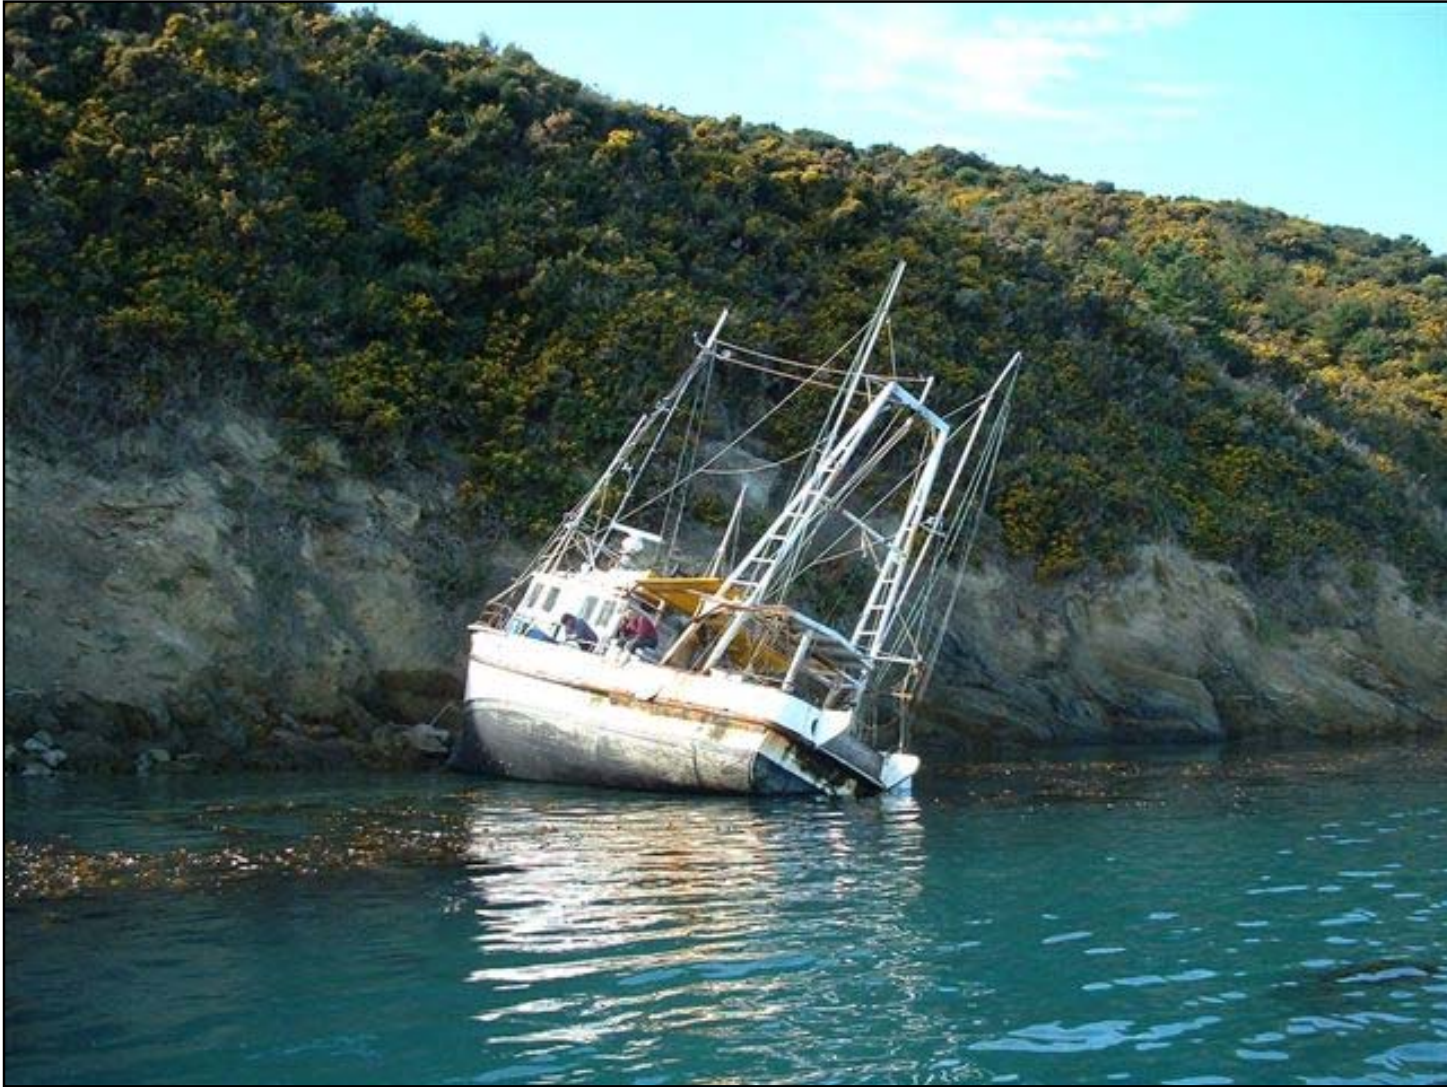
The *Venture* aground in Tipi Bay

- 1.1.7 The *Venture* had grounded on sand just north of Tipi Bay at about 0005 on 19 April. The skipper immediately pulled the gear lever to put the engine into neutral, he then woke the deckhand and his nephew, told them of the situation and ascertained that they were not harmed. The skipper then went into the engine room and checked for water ingress, while the deckhand checked the forecandle and lazarette.

- 1.9.1 The *Venture* sustained no damage during the grounding.

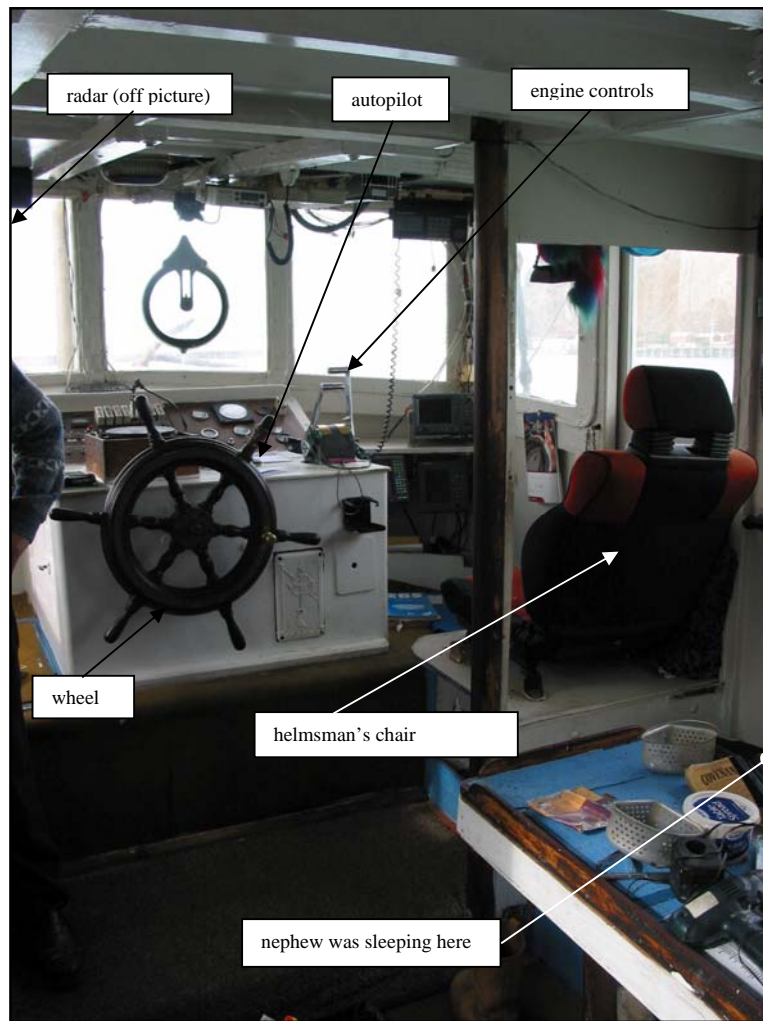
Figure 2
Wheelhouse interior

- 1.1.6 The skipper was navigating using the fitted chart plotter, with the steering in autopilot and the radar on standby. He stated later that he remembered altering course at Motukina Point and setting a course to keep to the starboard side of the channel. The next thing he remembered was feeling the boat "taking the ground", which woke him. The skipper also stated that he thought that he had been asleep for "a couple of minutes, 5 minutes max".

- a King 7000 very high frequency radio transceiver
 - 2 Furuno GPS plotters
 - a Furuno fish finder.
- 1.2.4 The *Venture* was not fitted with a watchkeeping alarm.

- 2.1 The skipper elected to take the navigational watch and con the *Venture* out of Picton, which he undertook from the helmsman's chair as the boat was operating in autopilot. The onset of fatigue coupled with the regular noise of the engine, the warm conditions inside the wheelhouse, and the lack of required input to steering and his sitting position could possibly have lulled the skipper to sleep.
