Report 07-010, Fletcher FU24-950, ZK-DZG, in-flight vertical fin failure, loss of control and ground impact, 5 kilometres west of Whangarei (Pukenui Forest), 22 November 2005

Report 07-010

Fletcher FU24-950

ZK-DZG

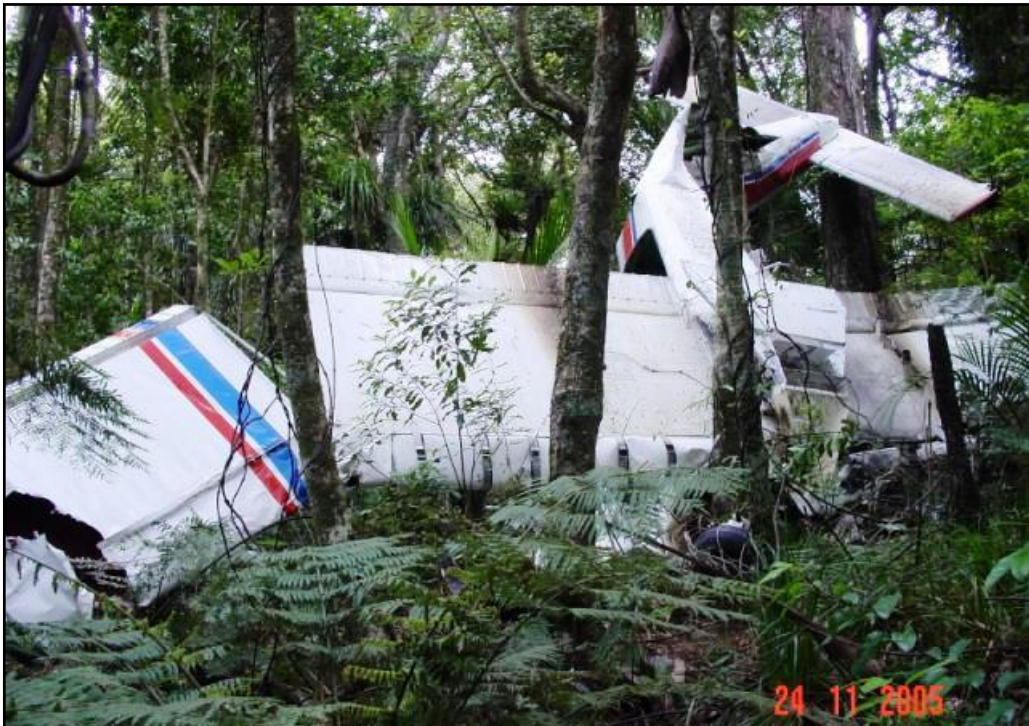
Figure 2
Wreckage of ZK-DZG (image by CAA)

- 1.2.1 ZK-DZG was destroyed during the accident and had come to rest in an inverted, nose-down attitude, with the tail section folded around a tree trunk (see Figure 2). No fire occurred.
- 1.2.2 The vertical fin had detached and was situated on the ground a few metres away from the main wreckage. The rudder control surface was still attached to the aft fuselage by its torque tube. The wing root attachments had not broken and the inner sections of the wings were still attached to the fuselage. The outboard section of the left wing had detached from the main portion of the wing and there was damage consistent with the left wing leading edge striking a large tree. The hopper was empty.

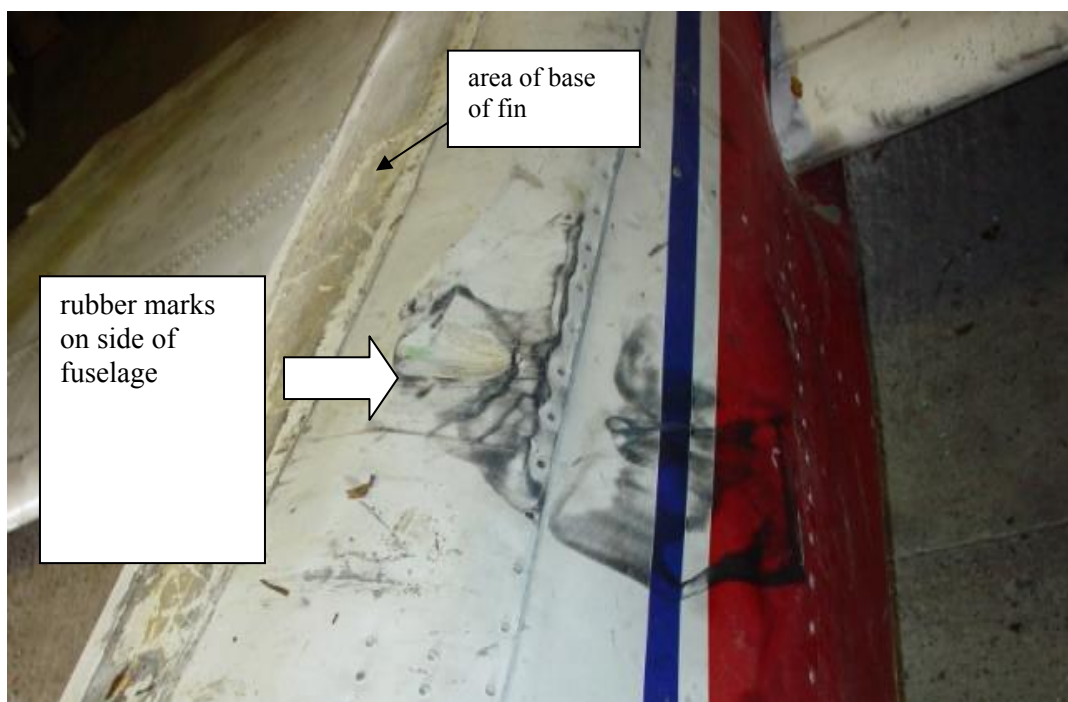
Figure 3
Aft fuselage witness mark (image by CAA)

- 1.2.9 The 2 main landing gear oleos and wheels were separated from their attachments and were located near the wreckage.
- 1.2.10 There were paint and rubber transfer marks and impact damage on the left side of the aft fuselage (see Figure 3). These marks corresponded with the damage and marking on the vertical fin. Paint transfer marks and damage on the fin showed that the fin had been folded around the leading edge of the left stabilator².

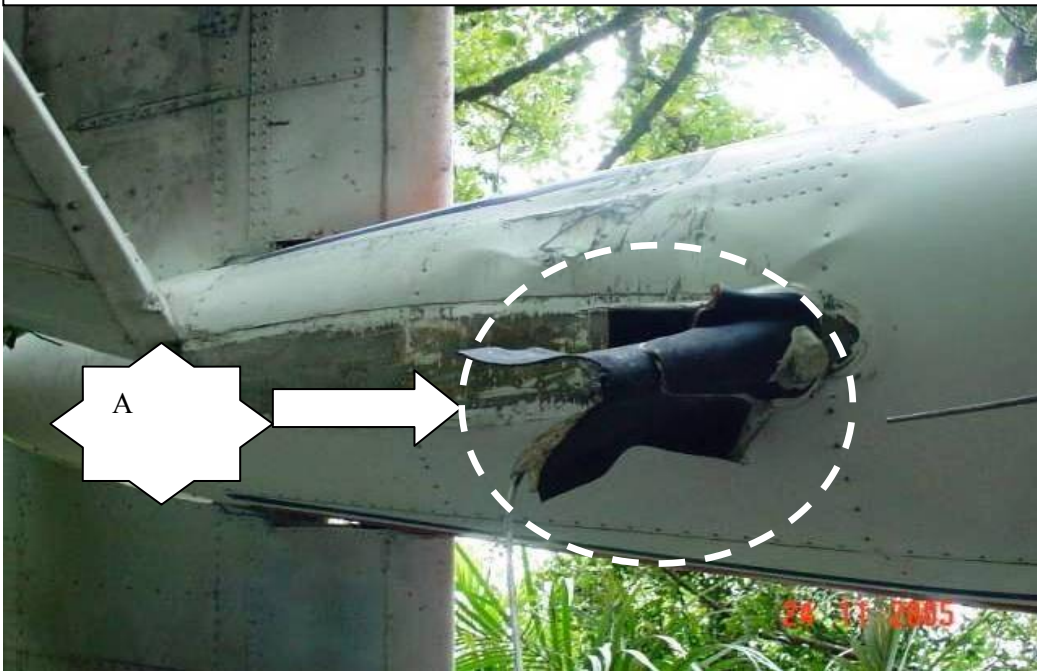
Figure 4
Forward attachment (from above) (image by CAA)

- 1.2.11 A 30-centimetre (cm) high portion of the vertical fin's leading edge around the forward attachment fitting remained connected to the aircraft by its attachment bolt (see Figure 4). Further examination of this structure showed that a rectangular section about 4 cm long was missing from the fin leading edge skin (see Figure 5). There were 2 horizontal marks about 1 cm long inside the protective rubber anti-abrasion strip that covered the fin's leading edge. These marks were approximately in line with the upper and lower edges of the missing rectangular section. The skin on either side of the fracture surfaces had been bent back, showing that the fin had at some point in the failure sequence moved in a rearward direction. The damage to the fin rear-attachment support beam showed that the fin had folded to the left as it failed. The rudder was also bent towards the left side of the aircraft around its torque tube.

Letter A indicates lower section of vertical fin leading edge with forward attachment point still in place.

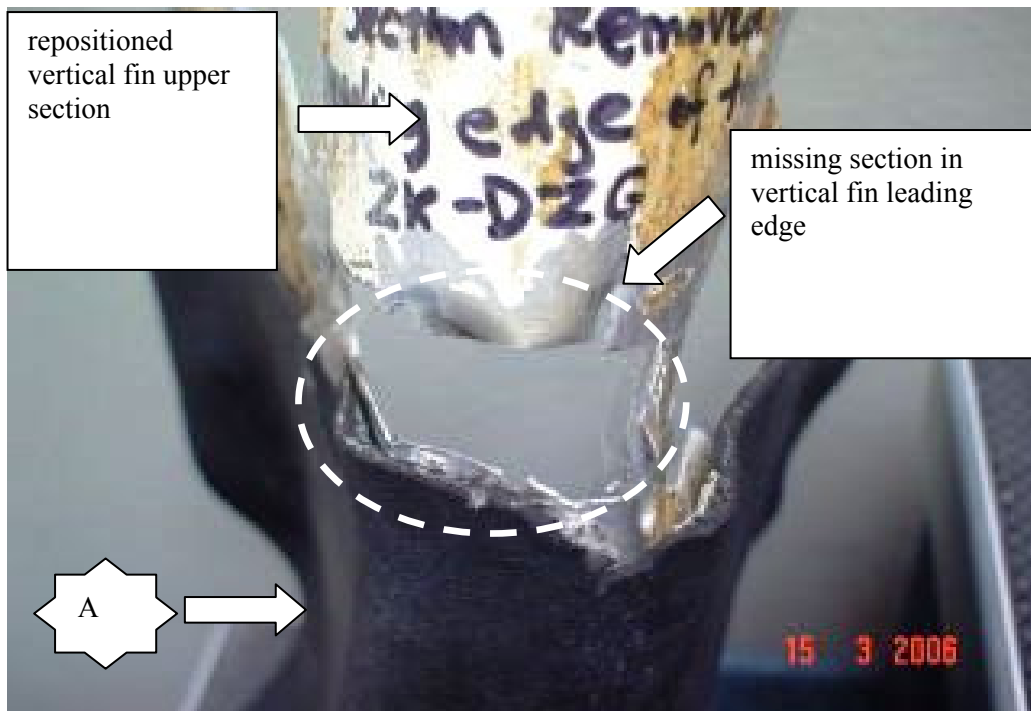
Figure 5
Missing section in fin leading edge (image by CAA)

- 1.7.8 The specialist examined sections of the fracture surfaces of the fin leading edge aluminium alloy to determine the nature of the failure and whether fatigue cracking had been present. The specialist concluded that marks on the rubber anti-abrasion strip on the fin indicated the probable presence of 2 fractures in the leading edge skin prior to the fin failure. Each fracture showed wear from the mating surfaces rubbing together, which prevented determination of the age and propagation rate of the fractures. Optical and electron microscopic examination of the surfaces showed that fatigue cracking had probably been present in the area of the failure before the failure, but no initiation site could be determined. Extensive shear and tensile overload was present on the fracture surfaces either side of the fatigue region.

- 1.7.11 The second specialist concluded that the complex configuration of the cracks and the form of the damage on the fracture surfaces suggested that the cracks had been caused by metal fatigue in the fin leading edge.

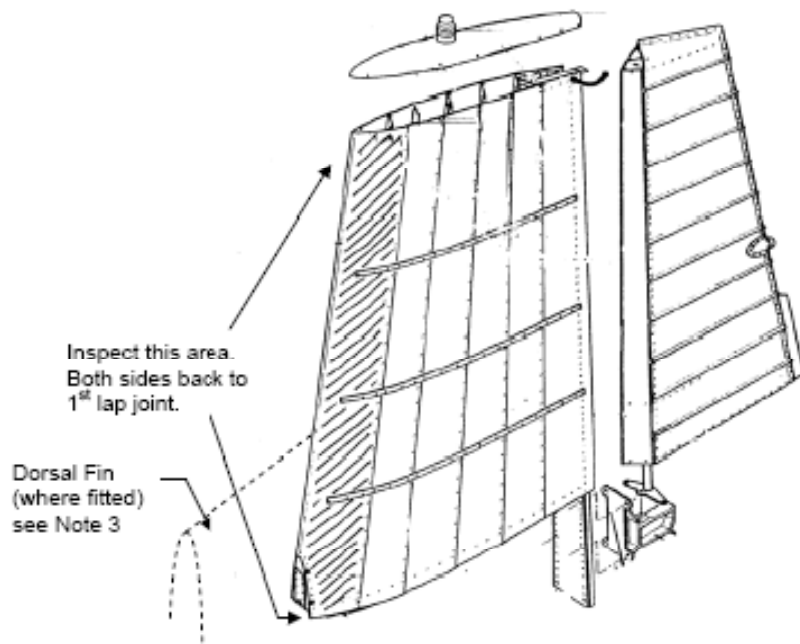
Figure 1: Fin Leading Edge Inspection

Perform a detailed visual inspection of the leading edge skin in the area detailed in Figure 1 to detect cracking, corrosion, scratches, dents, creases or buckling.

Any damage must be repaired using an approved repair scheme before further flight.

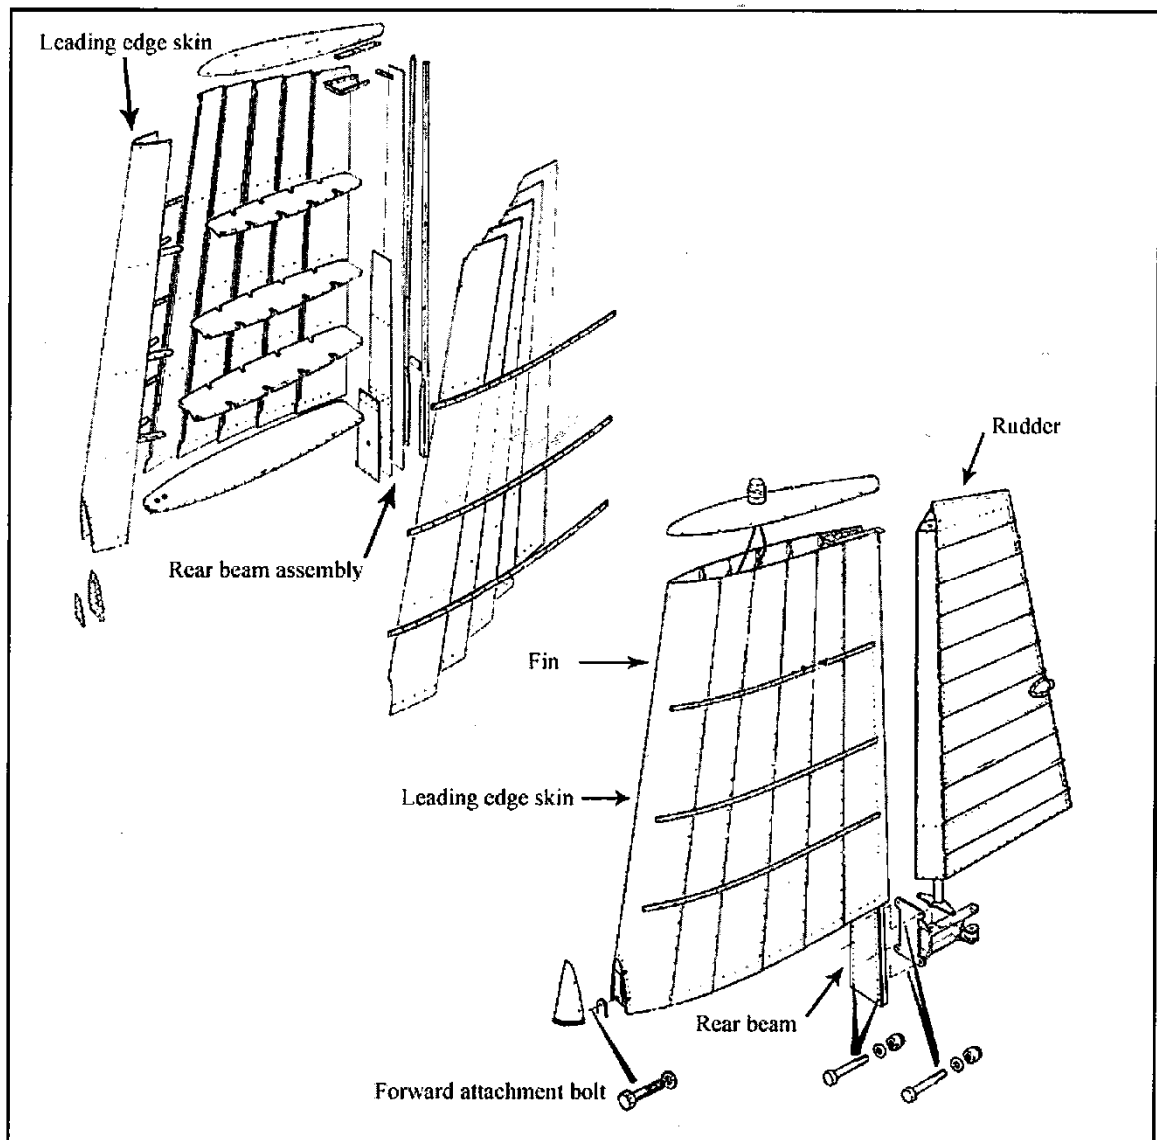
Figure 6
Fletcher FU24 fin structure (from a FU24 maintenance manual)

- 1.9.1 The Fletcher vertical fin design had remained the same since the aircraft had first been designed and issued with a TC more than 50 years earlier. The fin construction used a single-channel vertical beam assembly at the rear, and a single-point pivoting front attachment (Figure 6). The forward attachment point provided no redundancy, and any side loads on the fin were transferred to the stressed skin leading edge. A failure of the forward attachment point or leading edge skin would cause a transfer of aerodynamic loads to the rear vertical beam assembly. This could result in overload and failure of the beam assembly and loss of the fin.
