**Report 07-101**    **express freight Train 736, derailment,**  
**309.643 km, near Vernon**

**5 January 2007**

**Abstract**

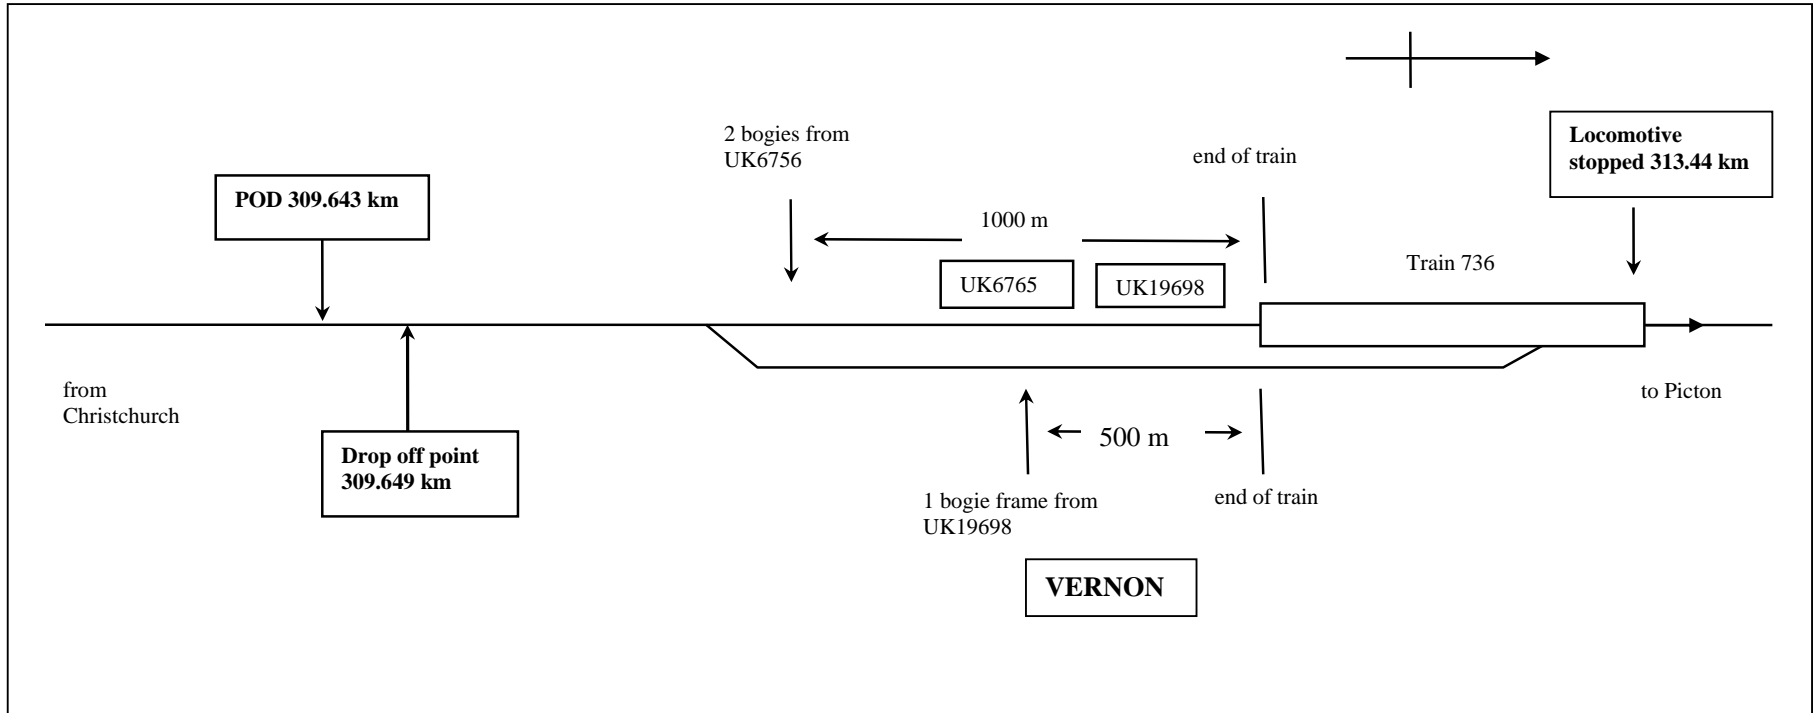
**Figure 1**  
**Diagram of derailment site (not to scale)**

On Friday 5 January 2007, at about 2200, the leading bogie of UK6765, the rear wagon on Christchurch to Picton express freight Train 736, derailed at 309.643 kilometres (km) on the Main North Line. The derailed wagon was dragged a further 3.5 km until it struck the south end main line points at Vernon, derailing the wagon immediately in front.

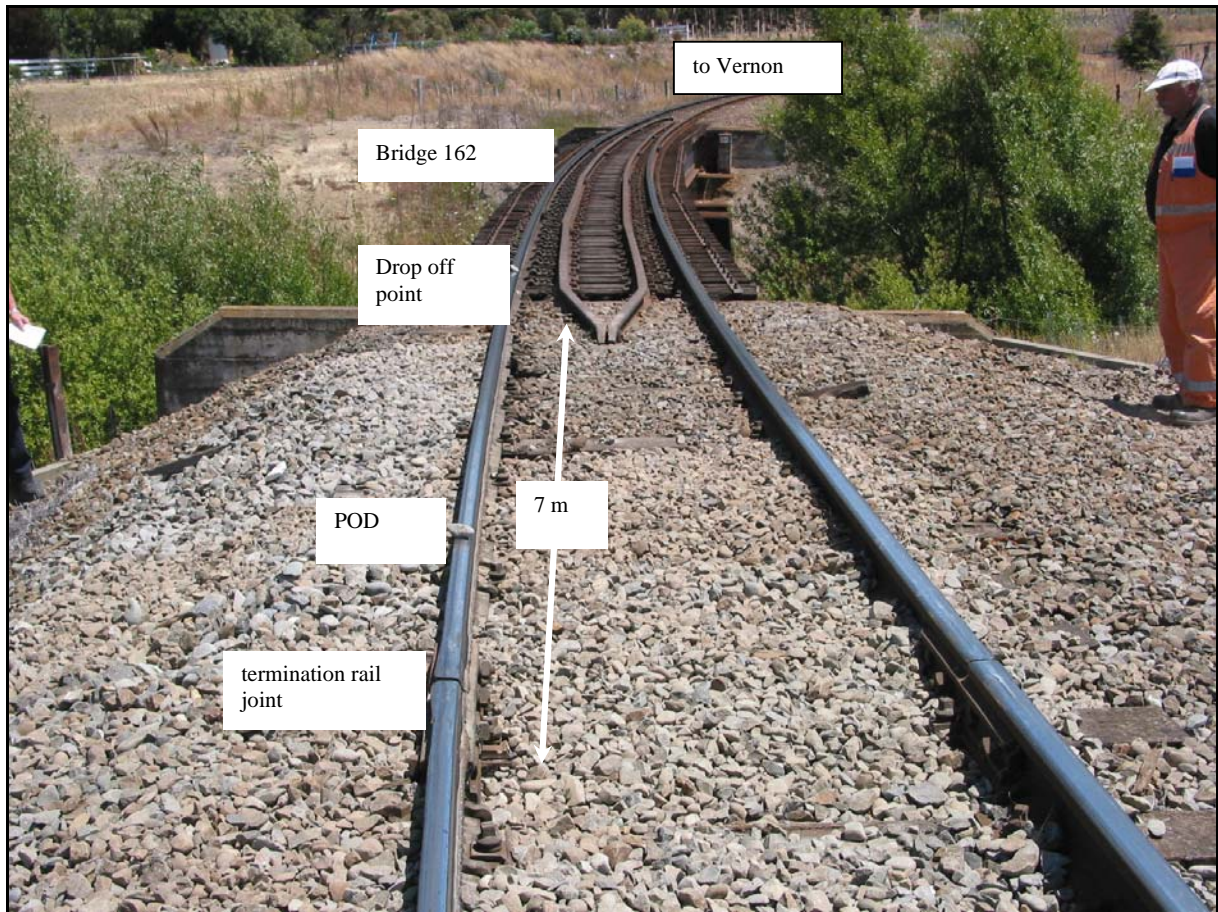
**Figure 2**  
**Track formation at the POD**

- 1.2.2 The point of derailment (POD) was 309.643 km, near Vernon on the MNL. The northbound approach to the POD was a 500 m long descending grade of 1 in 60, preceded by a 7 km long descending grade of 1 in 53 from the Dashwood Pass.
- 1.2.3 A wheel flange mark on the left-hand rail identified the POD at 309.643 km. The marks indicated that the flange travelled along the railhead for a distance of 6 m before dropping off.

- 1.2.4 The POD was on a 500 m long, 200 m radius right-hand curve. The maximum authorised speed for the curve was 50 km/h.
- 1.2.5 The 2 bogie frames from UK6765, the rear wagon, were found about 1000 m from the rear of where the train stopped. UK6765 had been dragged from there to where the train eventually stopped without the bogies attached. The leading bogie of UK19698, the second wagon from the rear of the train, was found about 500 m from the rear of the train.

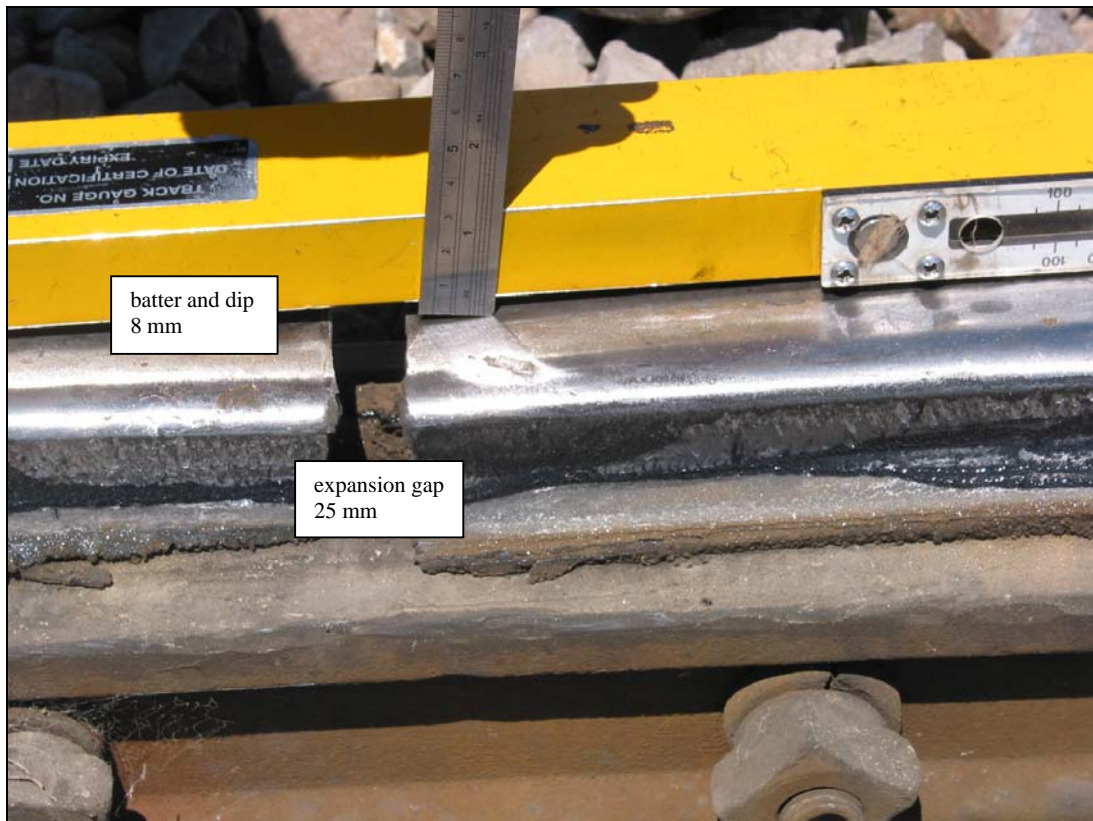
**Figure 3**  
**Termination joint at 309.642 km**

A 25 mm expansion gap and a combined batter and dip of 8 mm were measured at the termination joint.

- top down, mainly left-hand high leg through joint
- line peaked
- 15 – 18 mm off cant
- gauge 1090 mm.

- 1.5.7 The track measure-up following the derailment identified a 17 mm twist at the bolted rail joint at 309.643 km. This was between Priority 2 and Priority 3 tolerances specified in the T200 Infrastructure Engineering Handbook.
- 1.5.8 The gauge at the POD was recorded as 1085 mm. A 10 mm void<sup>7</sup> was recorded under the left-hand rail and 8 mm under the right-hand rail.
- 1.5.9 The track measure-up and subsequent analysis identified a ROCOCD measurement of about 174 mm at the POD. This was between Class 2 and Class 3 and would not have required the imposing of a temporary speed restriction.
- 1.5.10 The expansion gap was measured during the day when the rail temperature would have exceeded 30 degrees, but the gap may have been wider at the time of the derailment, which happened at night.

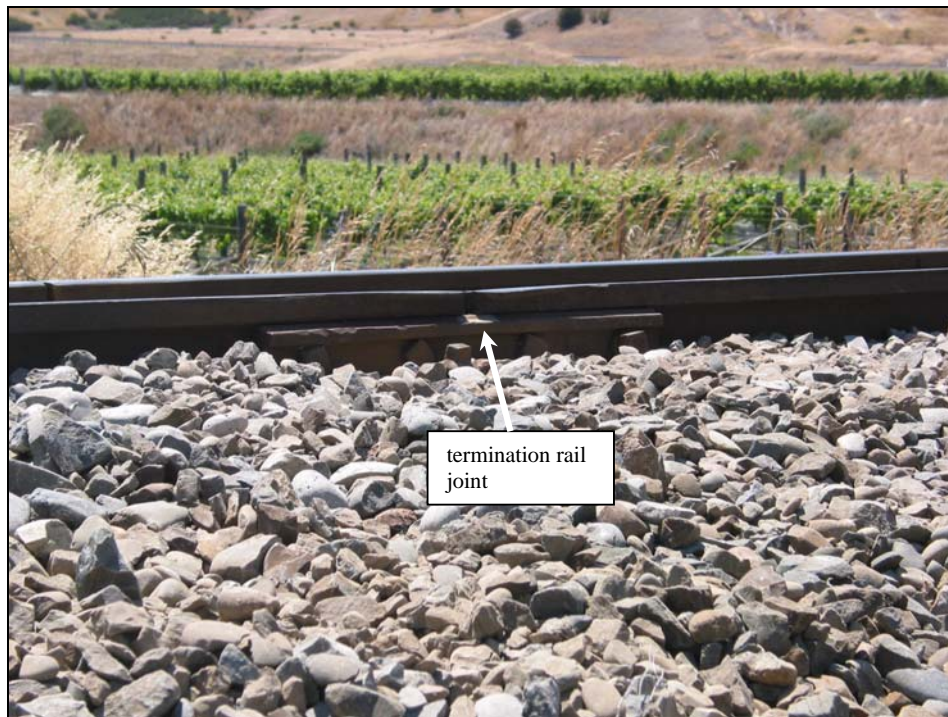
**Figure 4**  
**Batter and dip at termination joint; left-hand rail in direction of travel**

- 1.3.6 A rail joint served the following functions:
- provided a connection between the rails, acting as a continuous girder to provide a uniform running surface and alignment
  - provided a resistance to deflection, similar to that of the adjacent rail
  - prevented vertical and lateral movement of the rail ends relative to each other.
- 1.3.7 Ontrack's T200 Infrastructure Engineering Handbook stated in part that:
- for rails longer than 10 m, an expansion gap of 5 mm between the rail ends is to be allowed for when the rail temperature is between 21°C and 25°C
  - for laying bolted rail when rail temperature greater than 30°C the expansion gap is to be 3 mm
  - combined batter and dip at a bolted joint must be less than 6 mm.

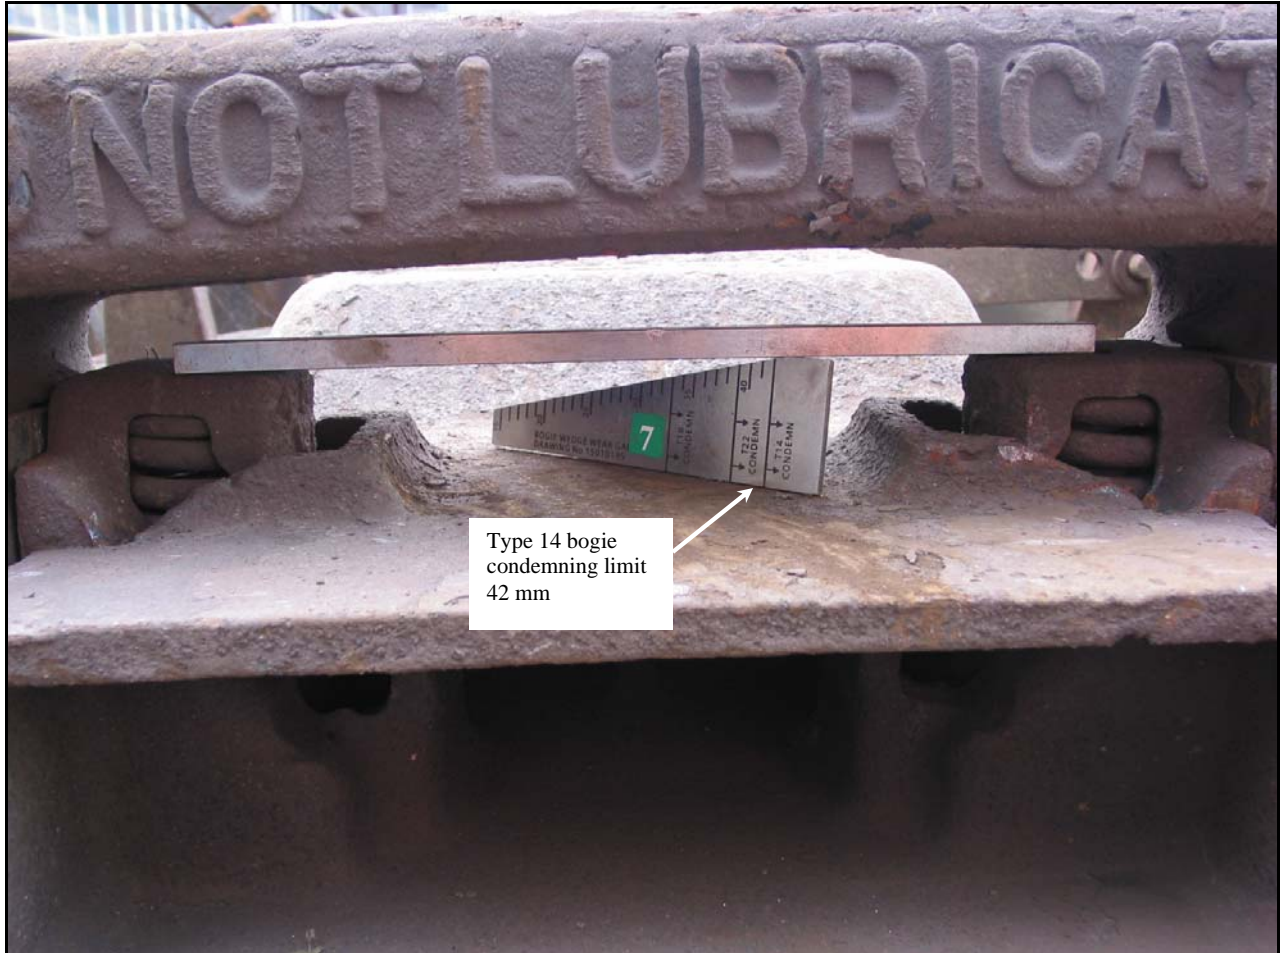
**Figure 5**  
**Wedge measurement leading bogie of UK6765**

1.8.1 On Thursday 25 January, following the derailment, examination of the bogies of UK6765 showed that the friction wedge measurements<sup>9</sup> on the bogies were:

- on the leading bogie – 42 mm, which was on the condemning limit (see Figure 5)
- on the trailing bogie – 41 mm, which was within limit and had one mm of wear remaining.

- 2.5 The friction wedge on the leading bogie of UK6765 was right at the condemning limit when measured following the derailment. The wagon was loaded with a 24 t container, which may have closed the friction wedge gap over the condemning limits, but this alone should not have caused the wagon to derail. Dynamic interaction describes a derailment where the track geometry, wagon condition, wagon loading and train speed are individually within tolerance limits, or only marginally in excess, but to the extent that each variation in itself is not sufficient to be a prime cause of derailment. However, in combination these conditions can result in a derailment.

- 2.7 The friction wedge gap being just on or over limits would have placed UK6765 at increased risk of derailment due to dynamic interaction between track and wagon. Such a condition can lead to the wagon oscillating, sometimes referred to as “rocking and rolling” or “harmonic roll” in time with its natural frequency. Any other upsetting force that either interrupted or enhanced this natural oscillation could lead to a derailment.
