Report 07-114: Derailment caused by a wheel-bearing failure, Huntly, 19 October 2007, and 11 subsequent wheel-bearing failures at various locations during the following 12 month period

Final Report

Rail Inquiry 07-114

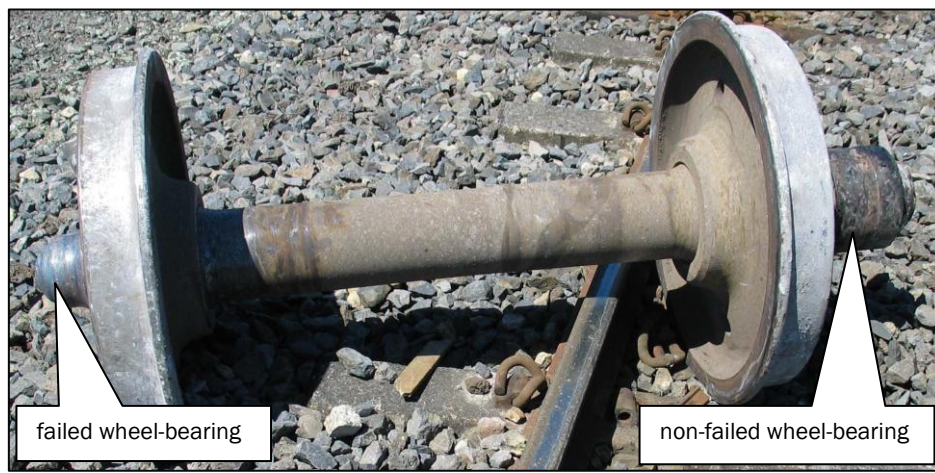
Figure 2
Lead wheel set from IB53

- 3.1.3. When the wheel-bearing failed completely, the wheel set derailed and was dragged to No.17 points (a diverging turnout from the main line) approaching Huntly station where IB53 completely derailed. Nine other wagons subsequently derailed at the now-damaged points (see Figure 3). Damaged and melted components from the failed wheel-bearing were found scattered over 4 kilometres of track.

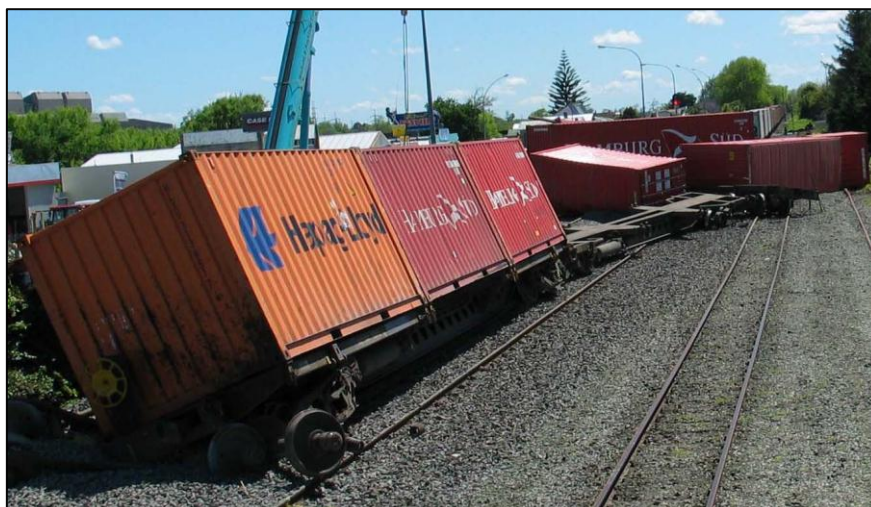
Figure 3
Huntly derailment site

- 3.1.4. The locomotive engineer had felt a slight “tug” followed shortly afterwards by a complete loss of air pressure in the automatic brake system when the train was approaching Huntly. At the same time the train controller radioed the locomotive engineer to report a loss of detection on his signalling mimic screen after the train had passed over several motorised turnouts, including No.17 points.
- 3.1.5. The locomotive engineer left his cab on stopping and saw the derailed wagons. Emergency services were informed of the derailment because some hazardous freight was being conveyed within some of the containers and also some of the containers had spilled onto the adjacent State Highway 1, blocking the lanes for road transport. There were no injuries.
