Report 07-207, bulk carrier, *Taharoa Express*, cargo shift and severe list, 42 nautical miles southwest of Cape Egmont, 22 June 2007

**bulk carrier
*Taharoa Express***

cargo shift and severe list

22 June 2007

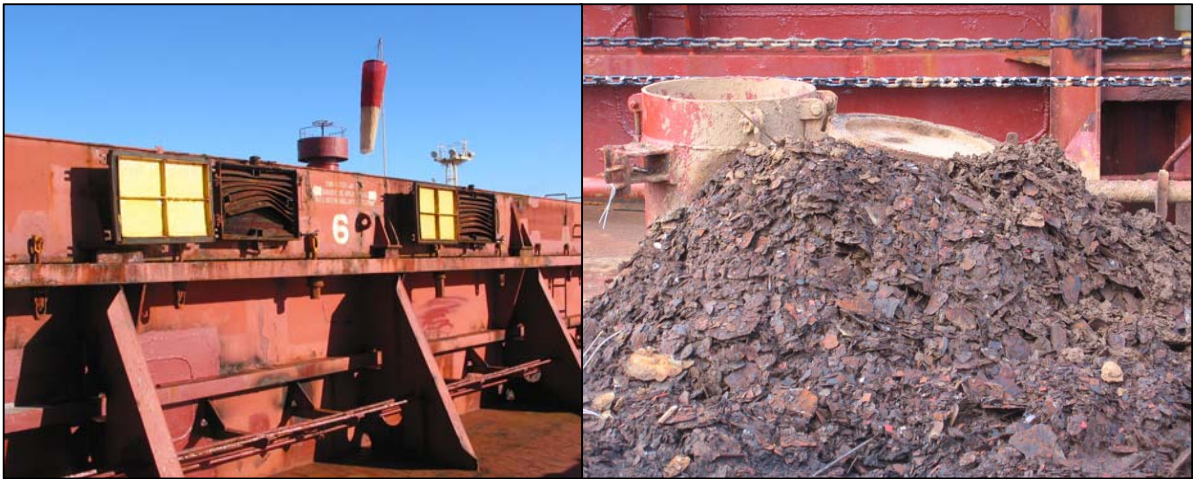
Figure 2
Damage to vents in number 6 hold and scale removed

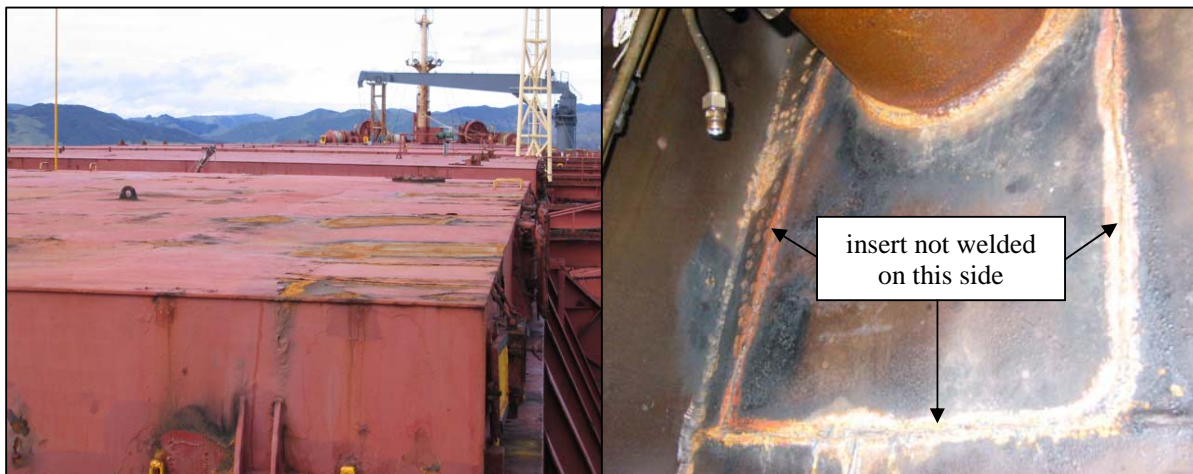
- 1.2.7 On 2 July 2 investigators returned to the ship in Tasman Bay. During an inspection of the number 1 hold overflow recess, weld defects were noted where one of a number of additional free-water valves had been fitted. These defects were pointed out to one of the officers on board. The insert plate around the valve had not been back-gouged and welded from the inside of the overflow recess (see Figure 3).

Figure 3
Deformed plates in hatch lid and insert in number 1 overflow recess

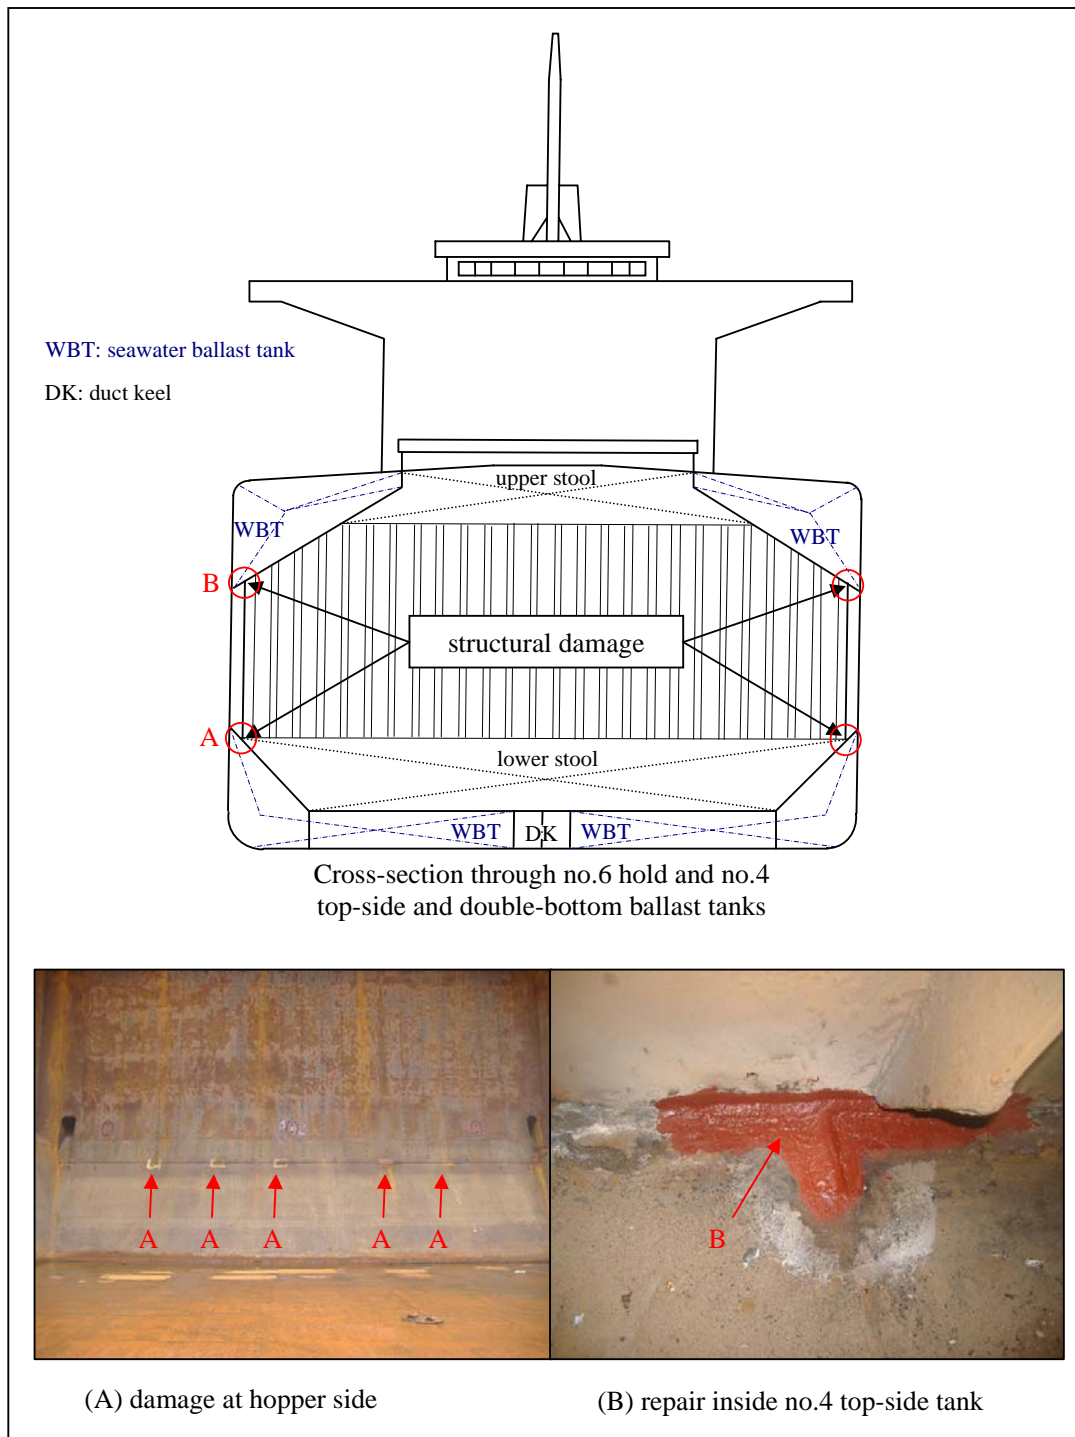
Figure 4
Structural damage to number 6 hold and number 4 ballast tank

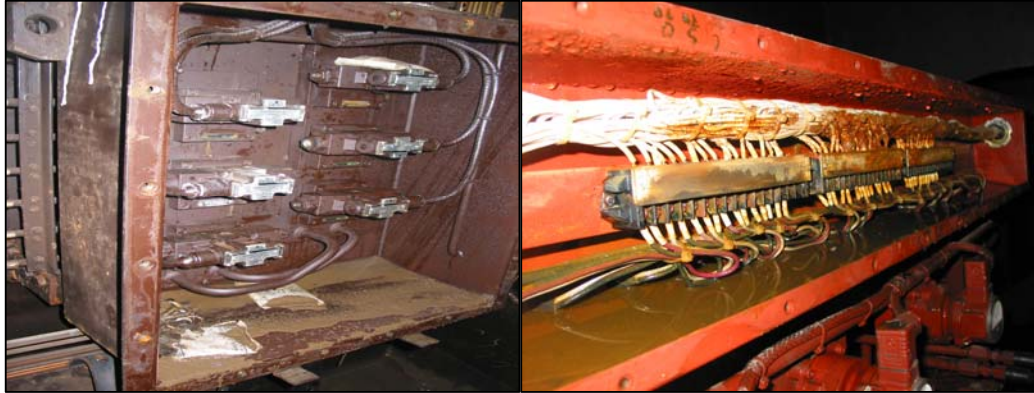
Figure 10
Water ingress to solenoid box (left) and terminal box in duct keel

- 1.7.13 The solenoid valves and terminal boxes were submerged during the flooding and water got inside, leading to the fault condition that activated the 220-volt earth fault alarm and eventually tripped the circuit breakers owing to excess current (see Figure 10).
- 1.7.14 Inspection of the valve cabinets showed that most of the seals were in place on the covers of the terminal boxes and cabinets, but the seals had been disturbed in the past for maintenance, as had some of the cable glands. Class NK advised that there were no rules that required the electrical systems from the solenoid valves in the duct keel to be waterproof.

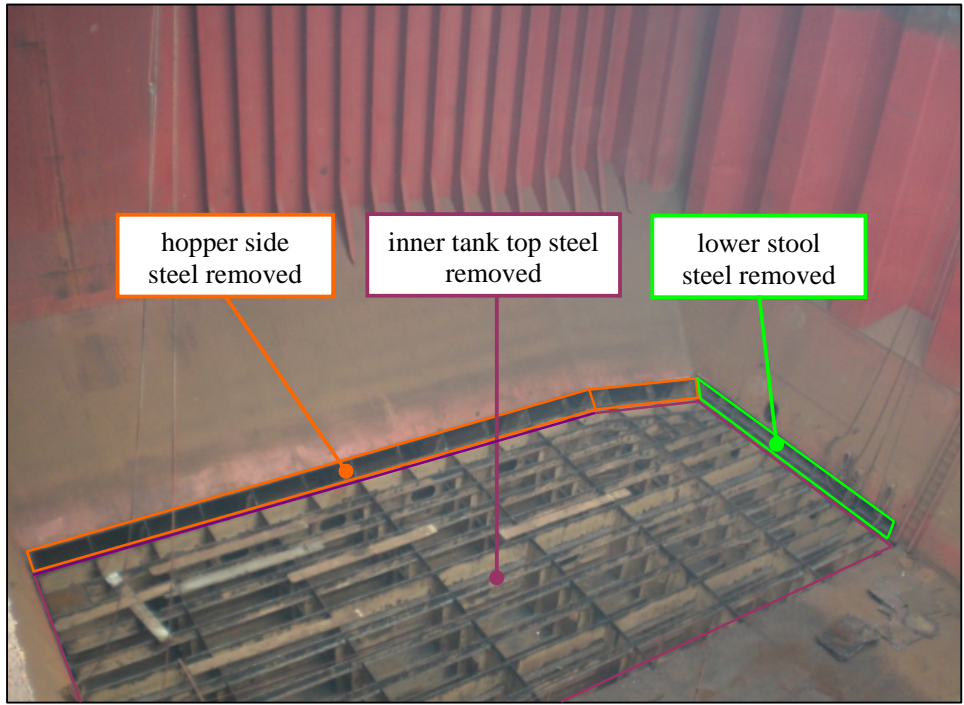
Figure 12
Steel removed in number 2 hold during repairs in Zhoushan

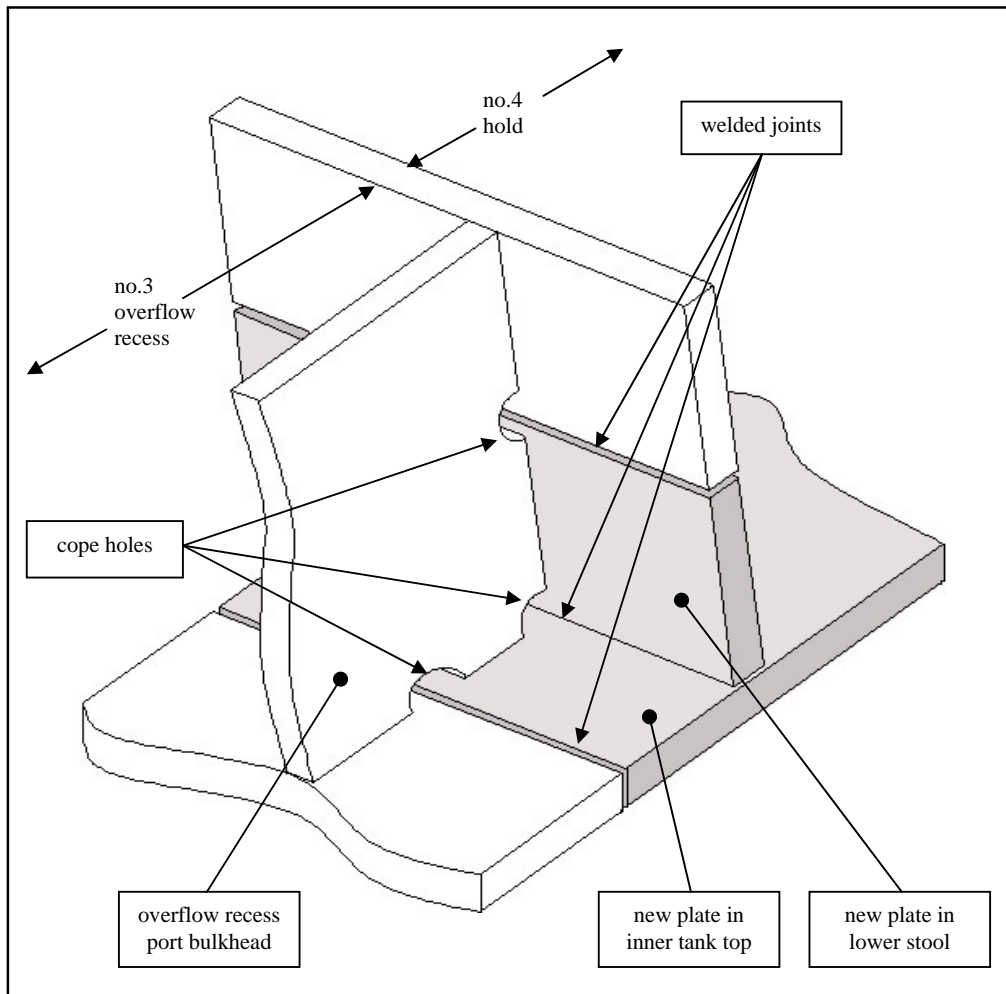
Figure 14
Joint arrangement of new plates and cope holes inside lower stool

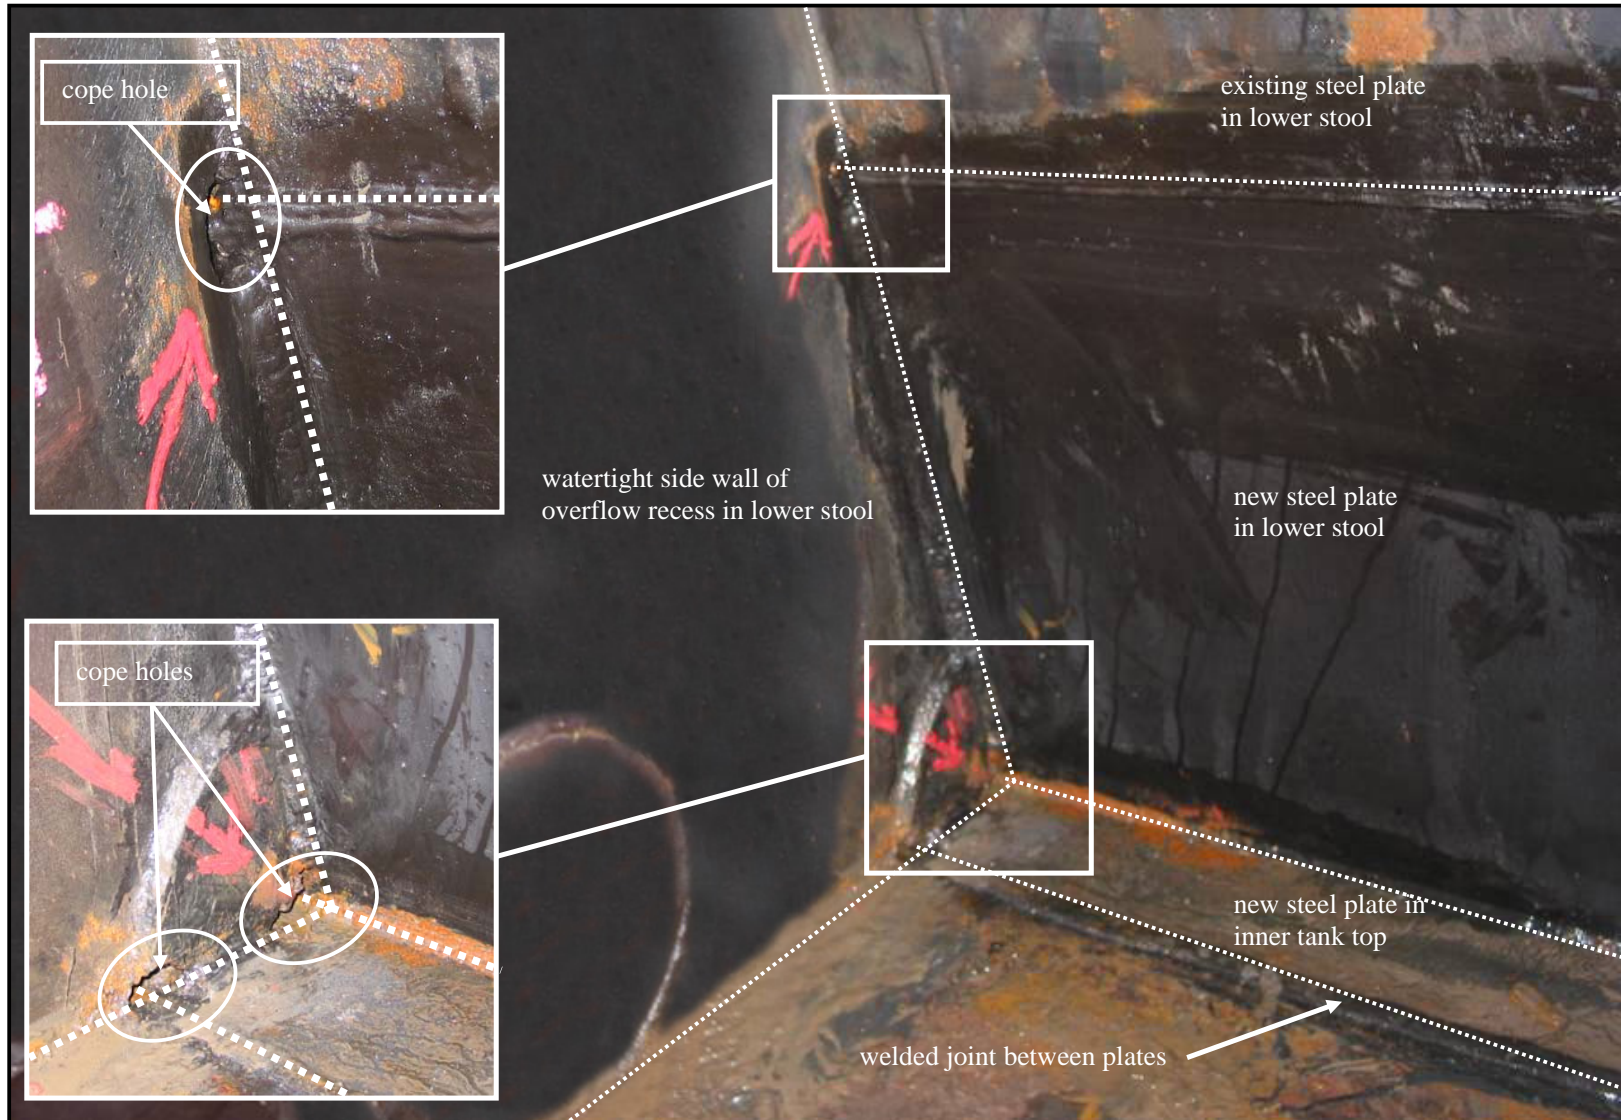
Figure 15
Unsealed cope holes in port side of number 3 overflow recess in lower stool (dotted lines added for emphasis)

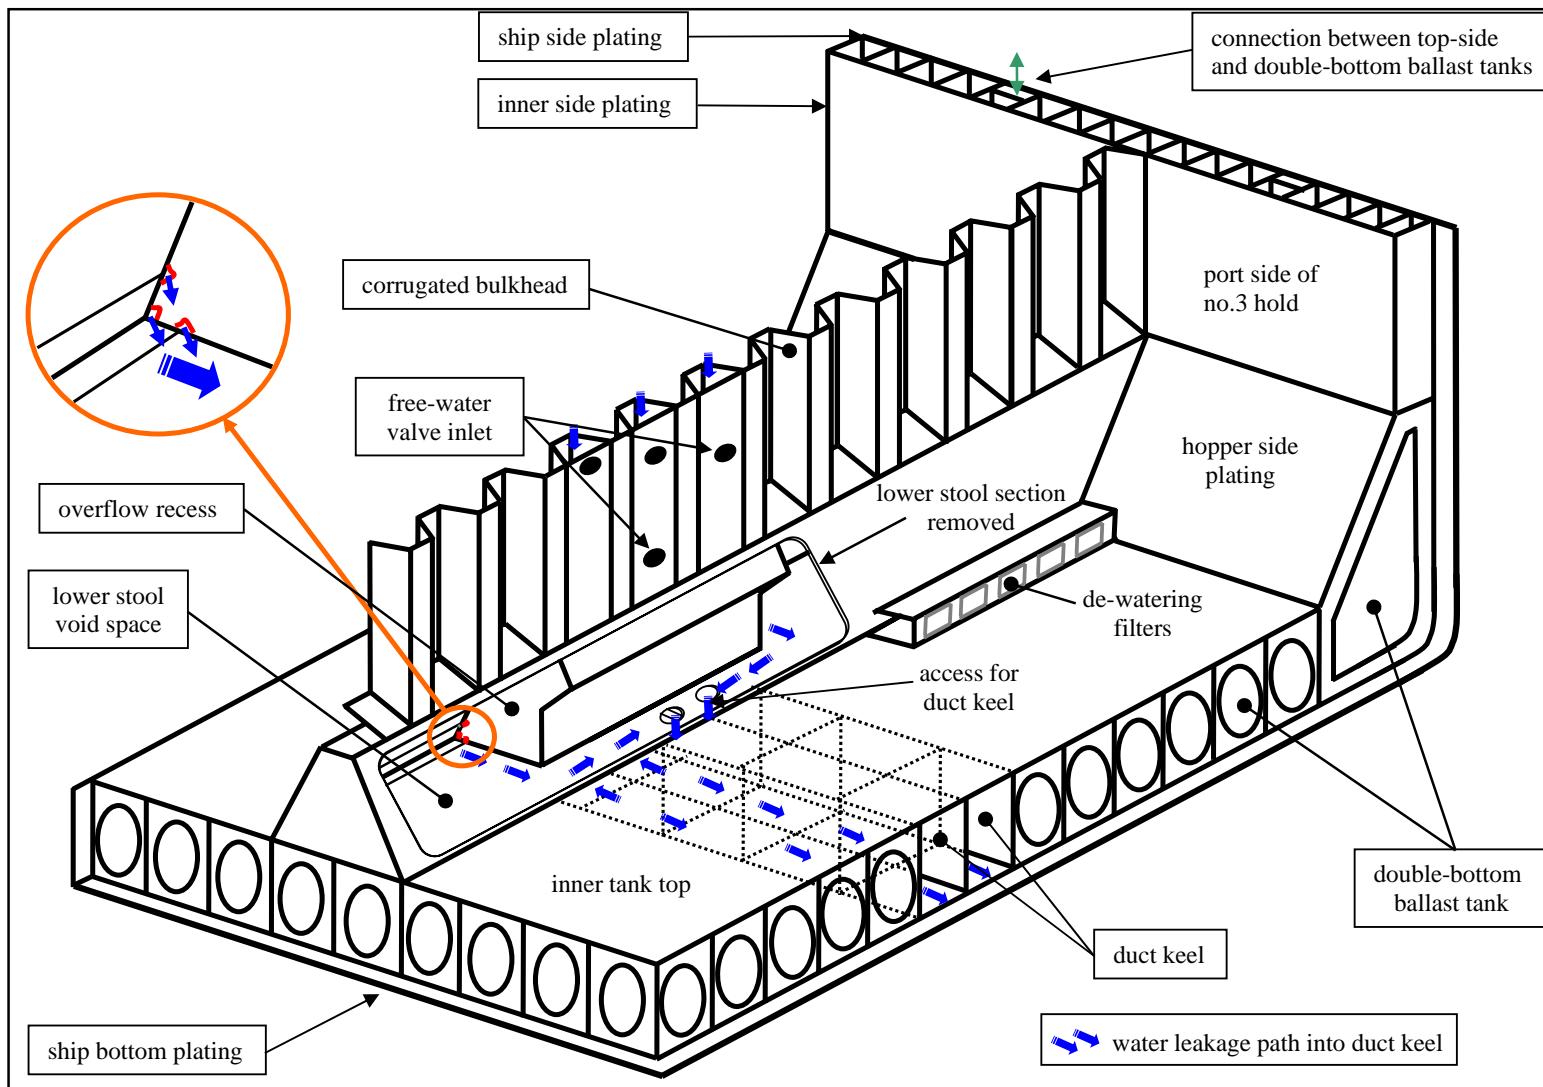
Figure 16
Simplified section of ship showing number 3 overflow recess and leakage path (not to scale)

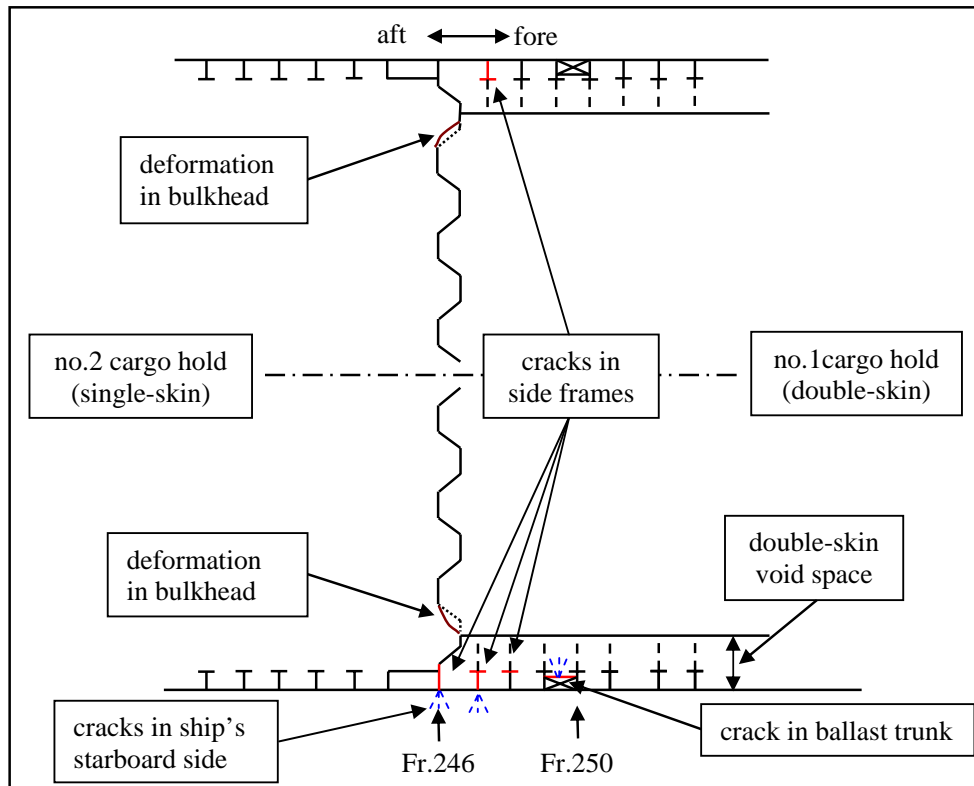
- 1.10.20 A section of the corrugated bulkhead in number 1 hold had been replaced in Zhoushan in May 2007, because corrosion had reduced the thickness of the steel in this area by more than 25% of the original thickness. The replaced section is shown inside the black dotted area in Figure 19, and the distortion that occurred adjacent to this replaced section is highlighted by a white dotted line.

Figure 17
Location of defects in number 1 hold
